Issued February 15, 2022

MIR-22/03

## Grounding of Fishing Tender Barge *SM-3*

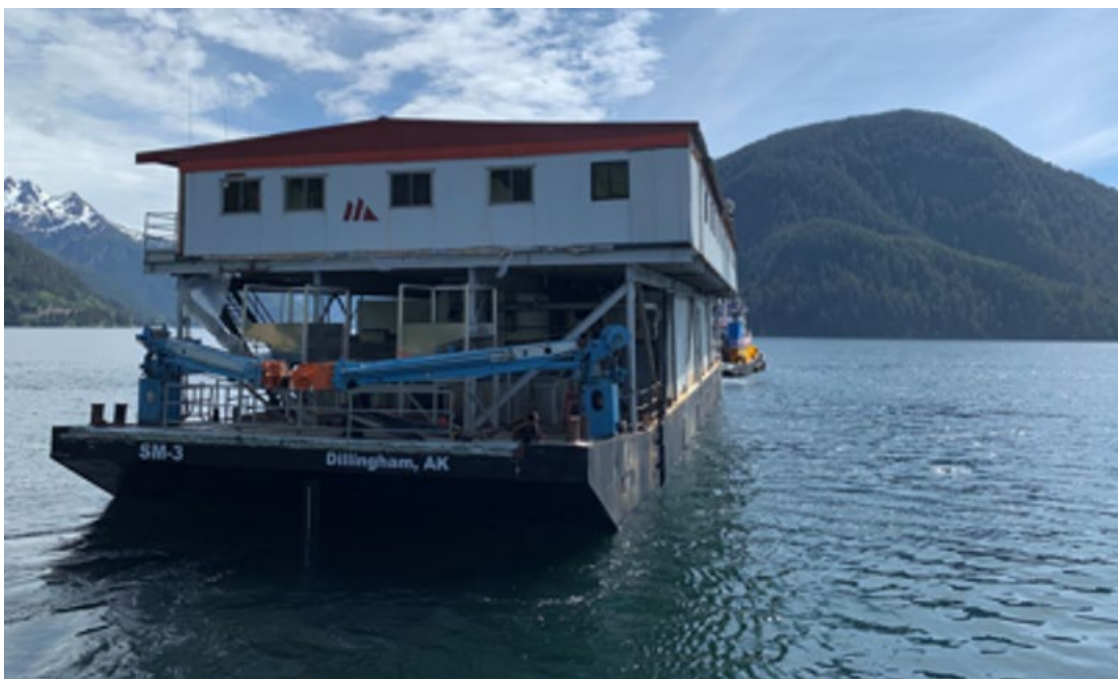
**Figure 1.** *SM-3* under tow before the grounding. (Source: Northline Seafoods)

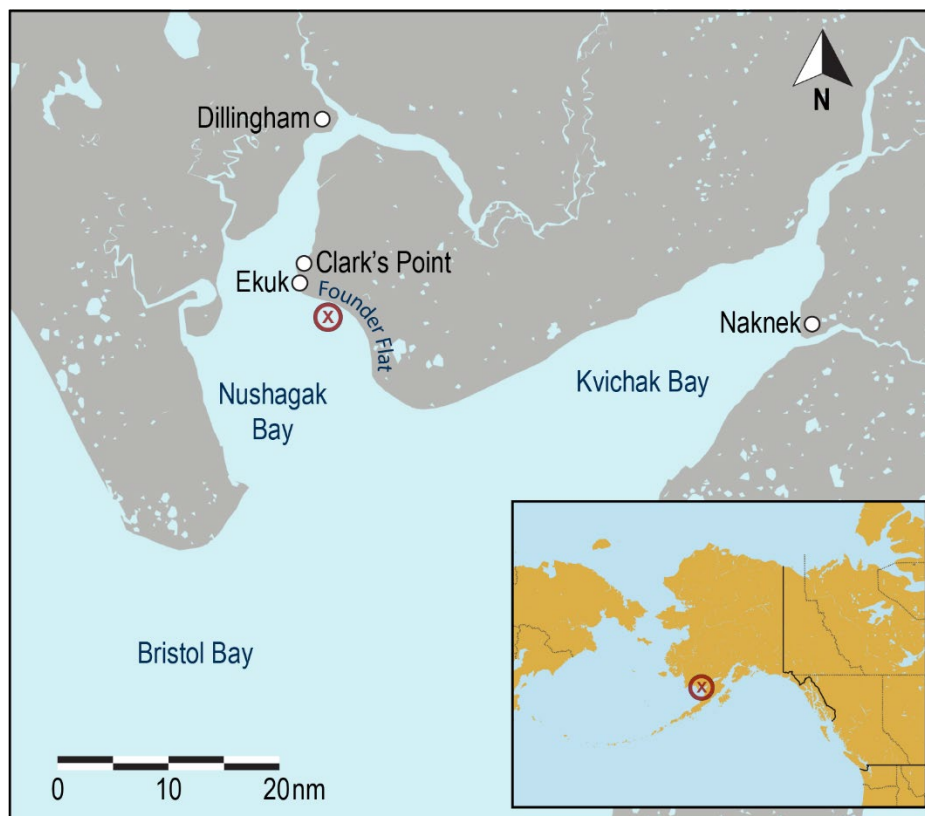
**Figure 2.** Area where the *SM-3* grounded, indicated by the red X. (Background source: Google Maps)

About 5 minutes later, the *SM-3*'s bow grounded on Flounder Flat, a sandy beach. Incoming waves turned the barge starboard side to the shore with a slight list to port. The PIC stayed by a weathertight door in the fish house; the rest of the crew mustered above in the recreation room. They all wore life jackets and weather gear. The PIC noted that the vessel shuddered as incoming waves hit the beached barge's port side. Water ran over the main deck against the house, and, at the same time, floated the barge, moving it up the beach. Each time the water receded, the barge would settle on and wrack against the beach. The PIC stated that he was concerned that the wracking motion at the end of each incoming wave would collapse the upper decks, and he deemed it unsafe to attempt to jump to shore, so he had the crew take shelter below in Bay 4 (fish elevator and storage room) of the lower deck. He stated that he knew high tide would not occur until about 0200 (the National Oceanic and Atmospheric Administration predicted high tide would occur at 0240), so they were "going to be in this for a couple hours until it settled."

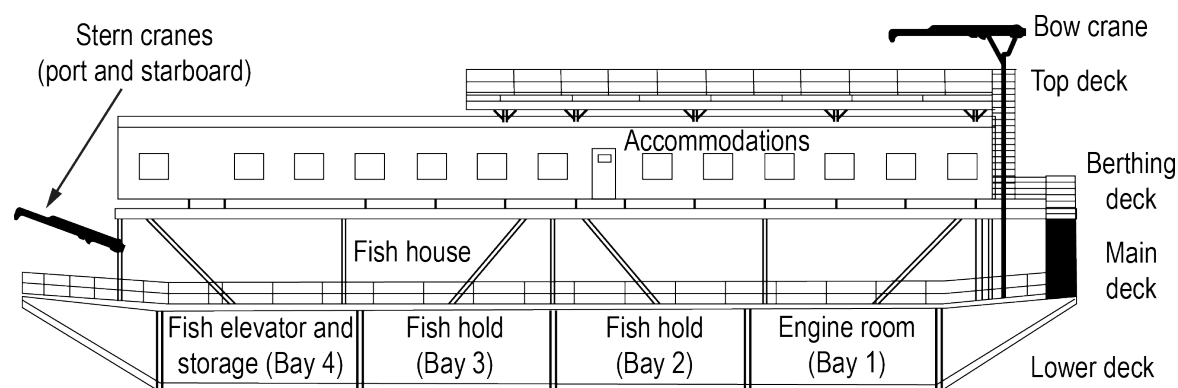
The *SM-3* had four decks. Within the barge hull was the lower deck, consisting of four compartments: an engine room (Bay 1), two fish tank holds (Bays 2 and 3), and a pump, maintenance, and storage room, which also contained a fish elevator (Bay 4). The four compartments were separated by watertight bulkheads, each fitted with a watertight door. The main deck had an enclosed fish house, used for processing fish, and three deck cranes (one on the bow and two on the stern). Above the main deck was the berthing deck, which housed crew accommodations. Above the accommodations forward on the vessel was the former helipad, also referred to as the top deck, which was used for storage.

**Figure 3.** *SM-3* profile. (Background source: Northline Seafoods)

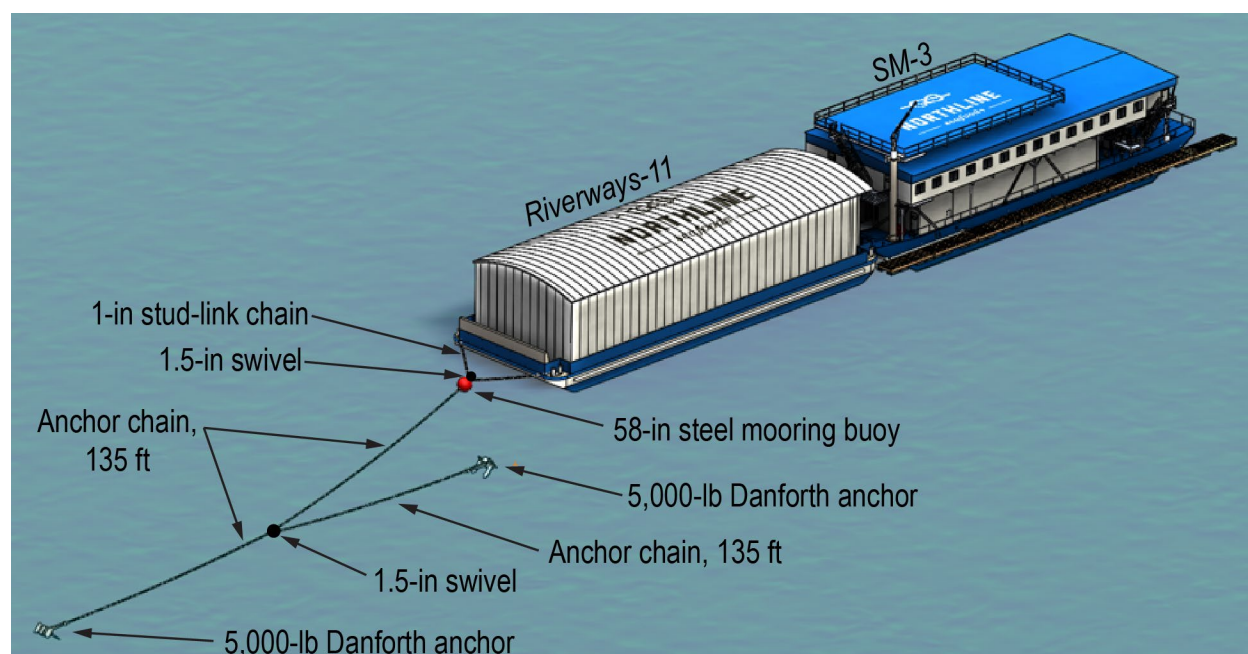
**Figure 4.** *SM-3* and *Riverways-11* anchoring arrangement at the beginning of the season (not to scale). (Background source: Northline Seafoods)
