Issued March 17, 2022

MIR-22/08

Contact of *Kevin Michael* Tow with Melvin Price Locks and Dam Guide Wall

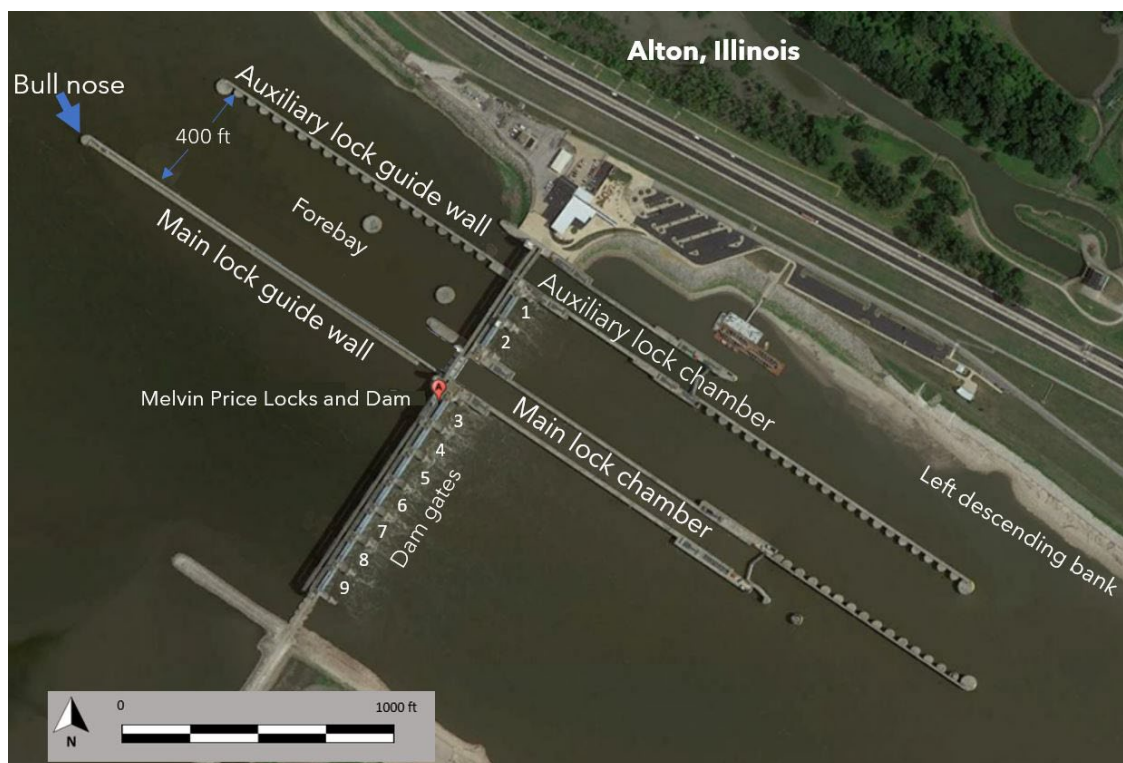
A cross current, also known as an outdraft, was caused when high flow past the dam pulled water laterally from the bank toward the dam gates. Because the lock was situated with two gates on the left descending bank side and seven gates on the right descending bank side, most of the water was pulled toward the seven gates (when open) on the right descending bank side of the lock. To lessen the outdraft upstream of the guide wall, the dam and locks were designed to direct water flow between 6-foot-diameter cylinders, called caissons, made of steel and filled with concrete, which supported the main lock guide wall and allowed water to flow under the wall, creating a transverse flow toward the main lock guide wall in the forebay.

Figure 3. Melvin Price Locks and Dam. (Background source: Google Earth)
