Issued April 6, 2022

MAB-22/12

Flooding and Sinking of Towing Vessel *Proassist III*

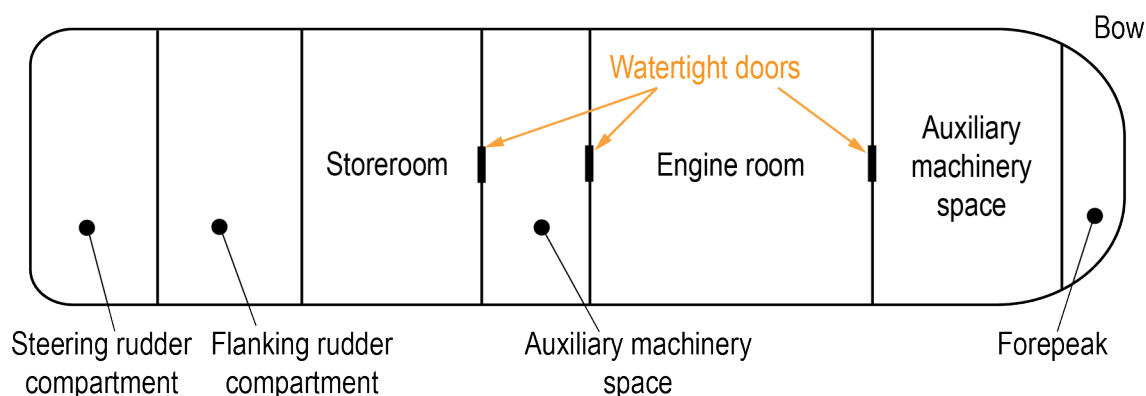
Figure 3. Compartments of the *Proassist III*, with approximate door locations. Scale approximate. (Source: Drawings and statements by *Proassist III* deckhands)

The vessel's bulwarks had four freeing ports—openings on each side of the vessel for draining water from the main deck. The openings each measured an estimated 36 by 6 inches (total opening size of 1.5 square feet). The height of the bulwark measured 43 inches at the bow, tapering to 16 inches near amidships, and rising again to 32 inches at the stern.

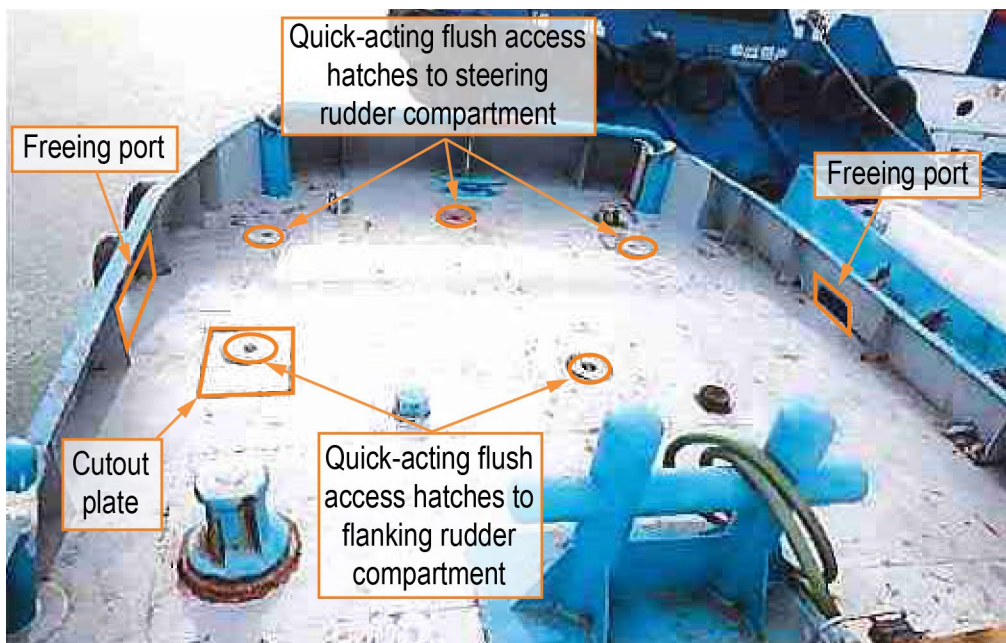
About 1640, when the vessel neared the Punta Tuna Lighthouse, the second deckhand said he noticed that the stern "was riding a little low." The deckhand/engineer said that he and the second deckhand removed the quick-acting flush access hatch for the flanking rudder compartment near the centerline of the vessel to see if the vessel was taking on water. (There were additional quick-acting flush access hatches on the starboard and port sides of the deck; the starboard-side hatch was encompassed by a rectangular cutout of the deck plate measuring about 27 inches wide by 40 inches long, which the captain believed was welded in place.) They stated that they saw about 3 feet of water in the compartment. The deckhand/engineer said he then checked for water in the vessel's other compartments, including the steering rudder compartment and engine room, and found none.

Figure 4. Main deck at the stern of the *Proassist III*. (Background source: Coast Guard)
