MIR-22/19

Engine Room Fire aboard Bulk Carrier *Roger Blough*

Sturgeon Bay, Wisconsin

February 1, 2021

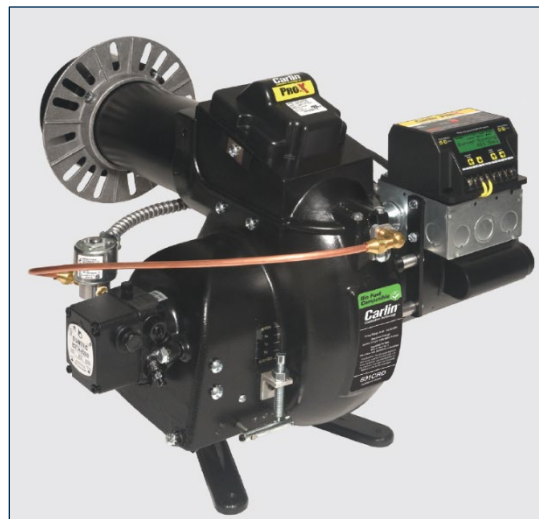
On the *Roger Blough*, the Carlin 601CRD oil burner assembly, which weighed 65 pounds and was typically used in furnaces for heating shoreside buildings, was Underwriters Laboratory (UL)-listed and complied with the American National Standards Institute (ANSI)/UL 296 UL Standard for Safety Oil Burners (see figure 8).⁷ Based on the manufacturer's instructions, it was to be installed in accordance with National Fire Protection Association (NFPA) 31 (Standard for the Installation of Oil-Burning Equipment) and ANSI/NFPA 70 (National Electric Code) standards as well as all applicable local codes. Encased in a sheet-metal enclosure, the burner assembly was comprised of a burner housing fitted with a mounting coupling, an air blower and motor, a fuel pump unit, a system controller, an ignitor, and a combustion head assembly. The fuel passed through a pipe within the air tube, which supplied the furnace with combustion air, to a nozzle where the flame was maintained and provided heat to the air box. There, ambient air was heated before being distributed within the engine room by ventilation fans and ducts.

Figure 8. Burner assembly with pedestal support. (Source: Carlin Combustion Technology)

The cast aluminum burner housing was designed to be mounted on the furnace's horizontally positioned air tube or, for some installations, to be supported by a pedestal (see figure 9). In the furnace of the *Roger Blough*, it was mounted to the air tube with a coupling, an arrangement that did not require the pedestal. A technical service manager from the manufacturer, Carlin Combustion Technology, told investigators that while the burner can be mounted without the pedestal, it is common practice for installers to use the pedestal to provide support below the burner to ensure it will not move. The company that installed the furnace submitted to the vessel's owner a furnace design proposal that did not include the pedestal support for the burner.
