Issued September 29, 2022

MIR-22/24

Engine Room Fire on board Towing Vessel *Capt. Kirby Dupuis*

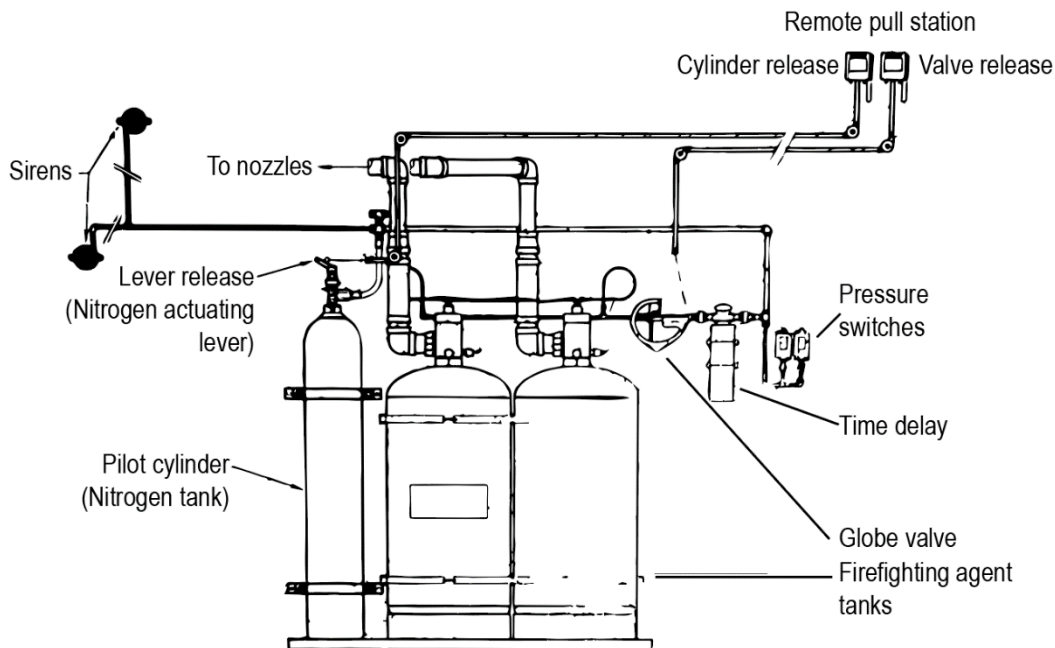
Figure 7. Schematic of *Capt. Kirby Dupuis* fixed fire-extinguishing system.

When investigators inspected the fire-extinguishing system, they observed that the “valve release” remote pull lever was pulled out as per the instructions, and its corresponding globe valve was open. However, the “cylinder release” remote pull lever was not fully extended, and its corresponding nitrogen cylinder’s actuating lever remained in the “set” position.
