Issued October 4, 2022

MIR-22/25

Grounding of Passenger Ferry *Commodore*

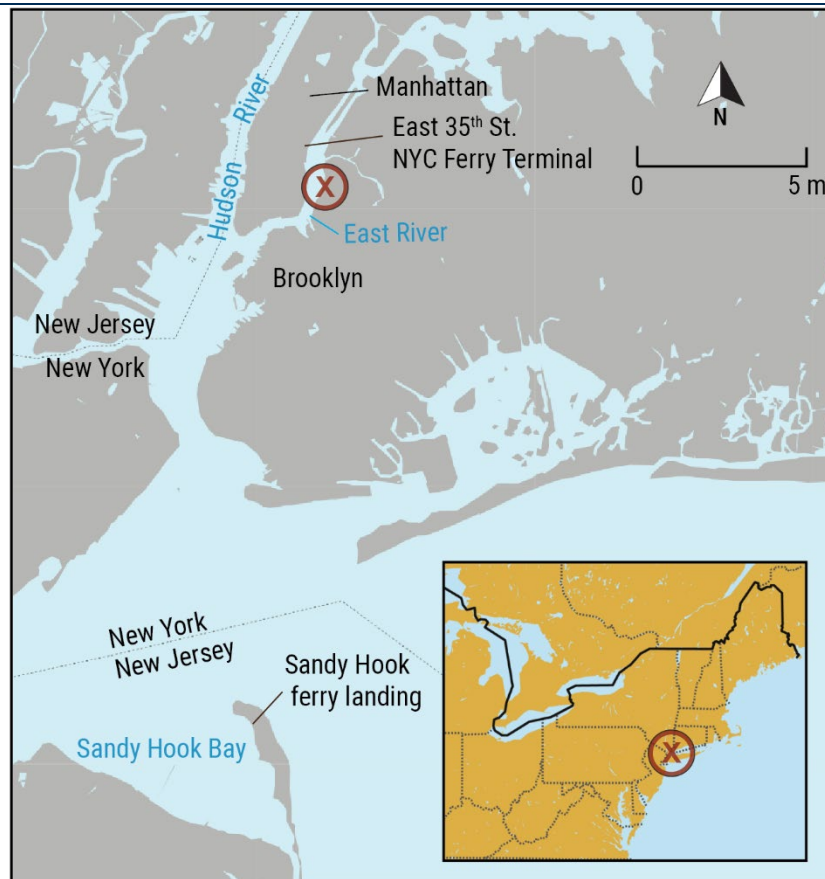
Figure 2. Area where the *Commodore* grounded, as indicated by a red X. (Background source: Google Maps)

The *Commodore* sustained an 18-inch-long-by-3.5-inch-high tear in the port hull plating as a result of the vessel's contact with submerged pilings on the northern shoreline of the Bushwick Inlet. The tear crossed the watertight boundaries of the fuel void tank and port engine room. Both spaces flooded and filled with 6-8 feet of water, and the vessel came to rest on the inlet's seafloor. There was also a crack from the leading edge of the 18-inch tear that measured about 12 inches. In addition, a 2-inch crack was recorded 10 feet aft of the 18-inch tear. There was damage to the entire port engine room wiring harness, both port propulsion engines, clutches, transmissions, and the port generator, which were repaired. There was also minor damage to the starboard hull. The total estimated cost to repair the vessel was about \$2.5 million.

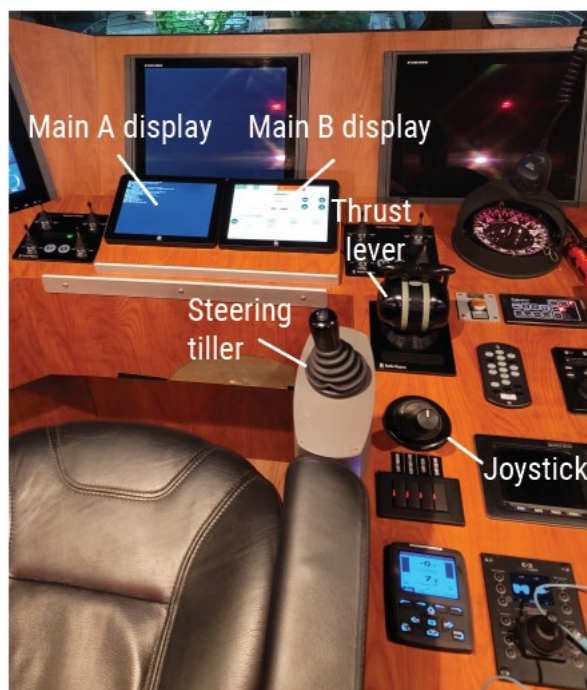
Figure 3. *Commodore's* main control station hand controls and water jet display screens. (Background source: US Coast Guard)

the jet alarm panel actuated, providing audible and visual (flashing light) indicators that “control failure” had occurred in both the Port Jet Outer 1 and Port Jet Inner 2 water jet systems. At the same time, display screen main A went blank. The vessel’s automatic identification system (AIS)-recorded speed at the time was 37.9 knots with a heading of 015°.
