MIR-22/26

Capsizing of Liftboat *SEACOR Power*

Port Fourchon, Louisiana

April 13, 2021

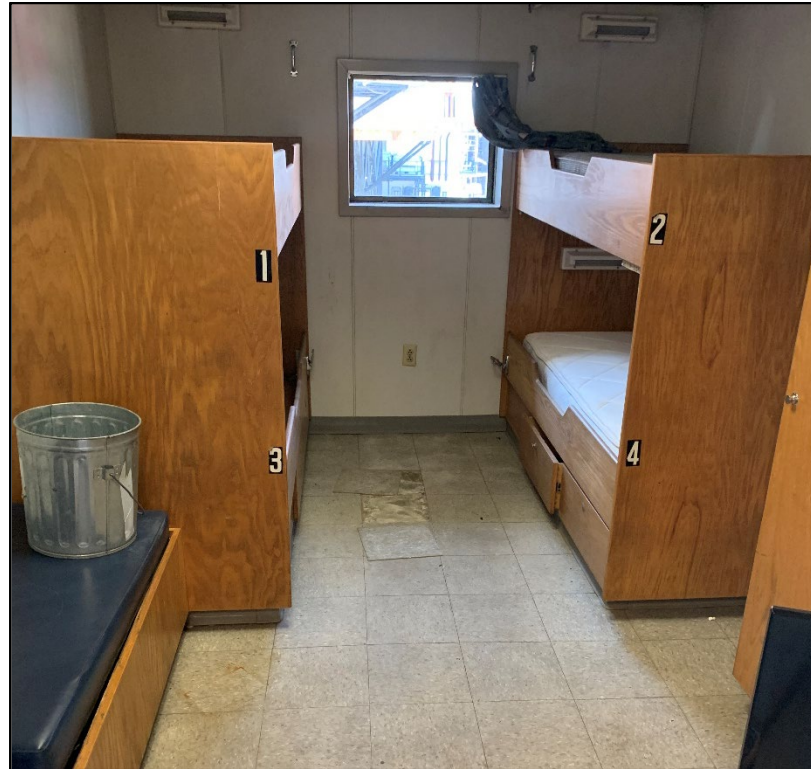
OWs 1 and 2 were asleep when the vessel capsized. Lockers on the port side of the room came loose from the bulkhead and fell inboard, blocking the inward-swinging door to the passageway. OW 2 was able to push ceiling tiles aside and egress the room via the crawl space in the overhead and into the [athwartship](#) passageway, now a vertical shaft, where he saw water already halfway up the space.⁴ OW 1 was unable to egress through the crawl space, so he donned a lifejacket, broke the window in the aft bulkhead of the room with an extinguisher while standing on the side of the bed, and exited (see Figure 5).

Figure 5. Stateroom with window on aft bulkhead, similar to the one OW 1 and 2 were in, aboard the *SEACOR Legacy* (a similar vessel). Note this vessel was not in service and outside equipment was stowed in rooms during an NTSB visit.

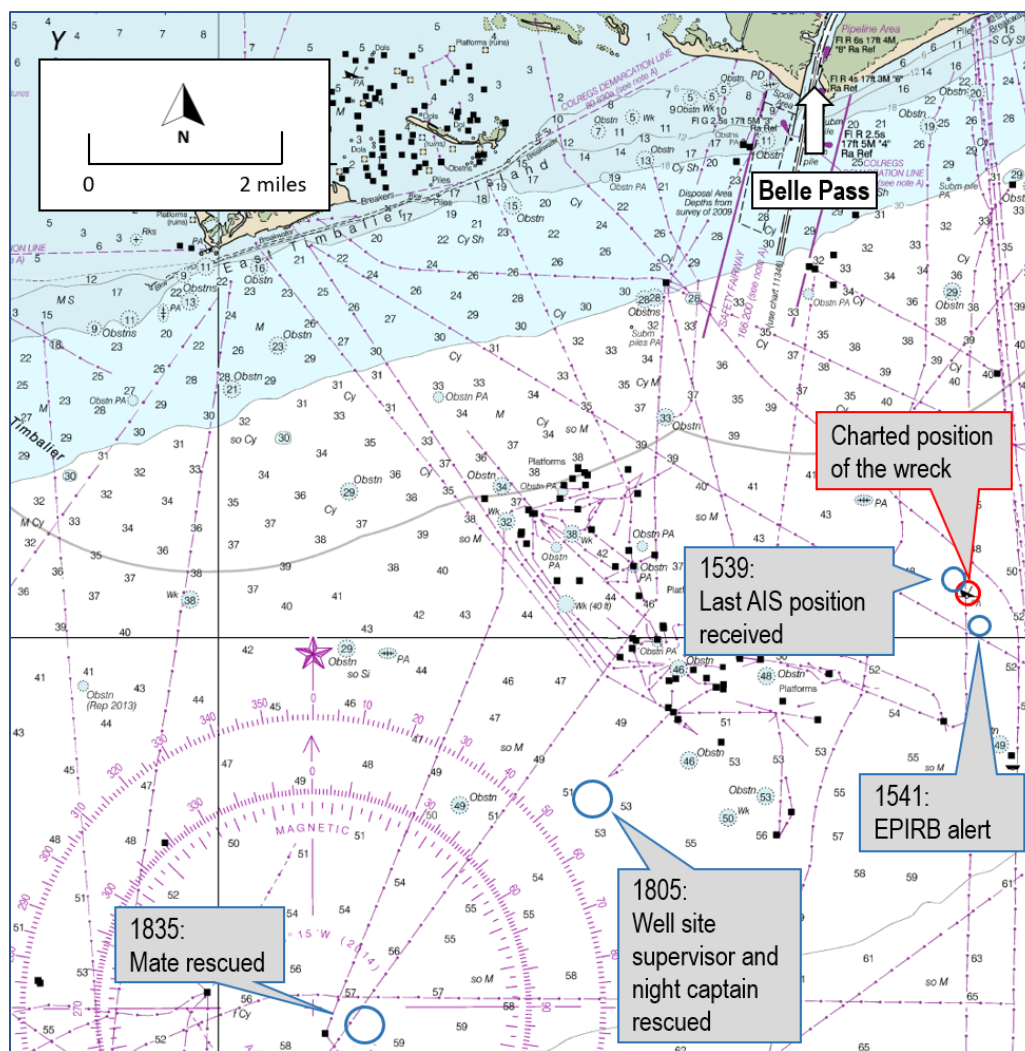
Figure 7. Extract of updated National Oceanic and Atmospheric Administration chart 11357 (annotated by NTSB), showing the locations of the Good Samaritan rescues and the actual location of the wreck. Black squares denote oil rig platforms. Depths are in feet.
