Issued November 3, 2022

MIR-22-28

# Grounding of Towing Vessel *Marquette Warrior*

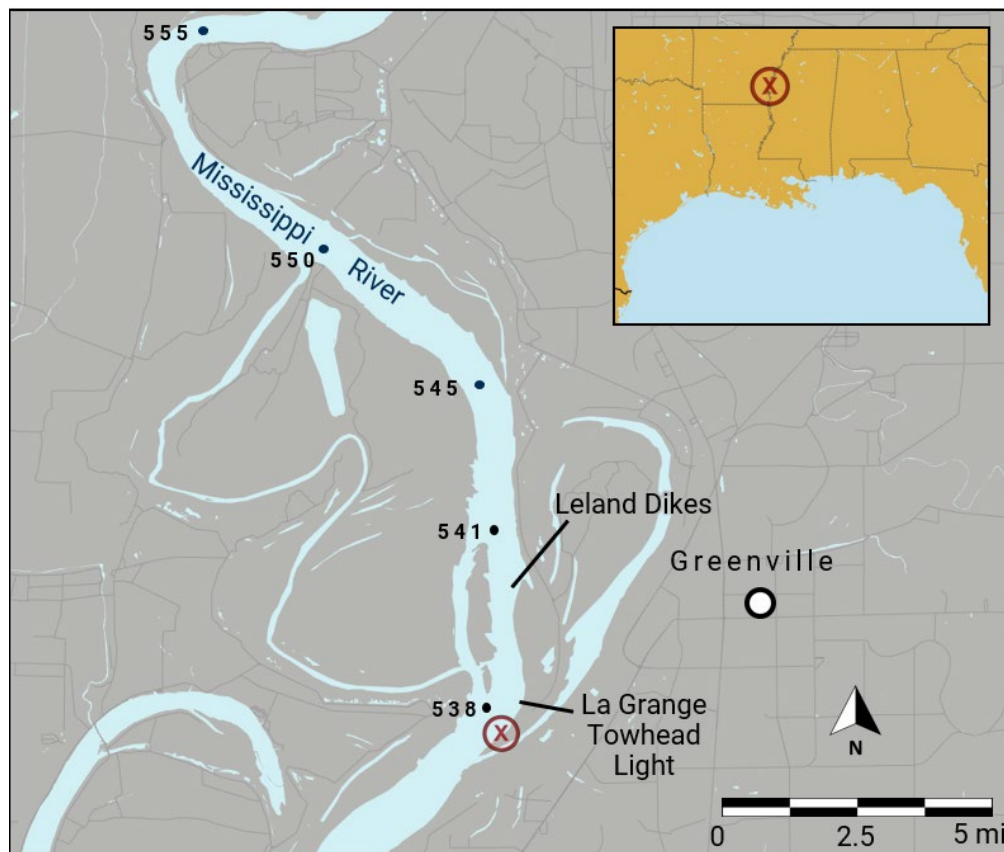
**Figure 2.** Area where the *Marquette Warrior* tow grounded, as indicated by a red X. (Background source: Google Maps)
