MIR-23-03

# Loss of Crane on board Construction Barge

## *Carolyn Skaves*

On February 8, 2022, about 0725 local time, the construction barge *Carolyn Skaves* was spudded down in the Willoughby Bay area on the south side of the Hampton Roads Bridge Tunnel in Norfolk, Virginia, when the crane operator shifted the position of the onboard crawler crane toward the stern, and the crane toppled off the barge into the water.<sup>1</sup> The crane was later recovered and declared a total constructive loss. An oil sheen was visible after the casualty; there were no injuries reported. The value of the crane was estimated at \$2 million.

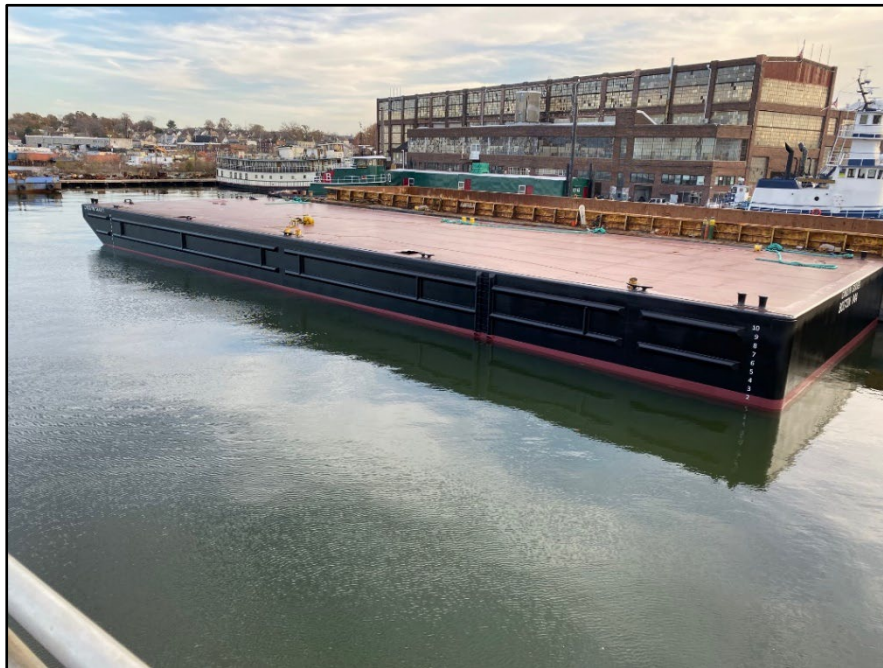
**Figure 1.** *Carolyn Skaves* moored before being leased to Seaward Marine Corporation. (Source: Sterling Equipment.)

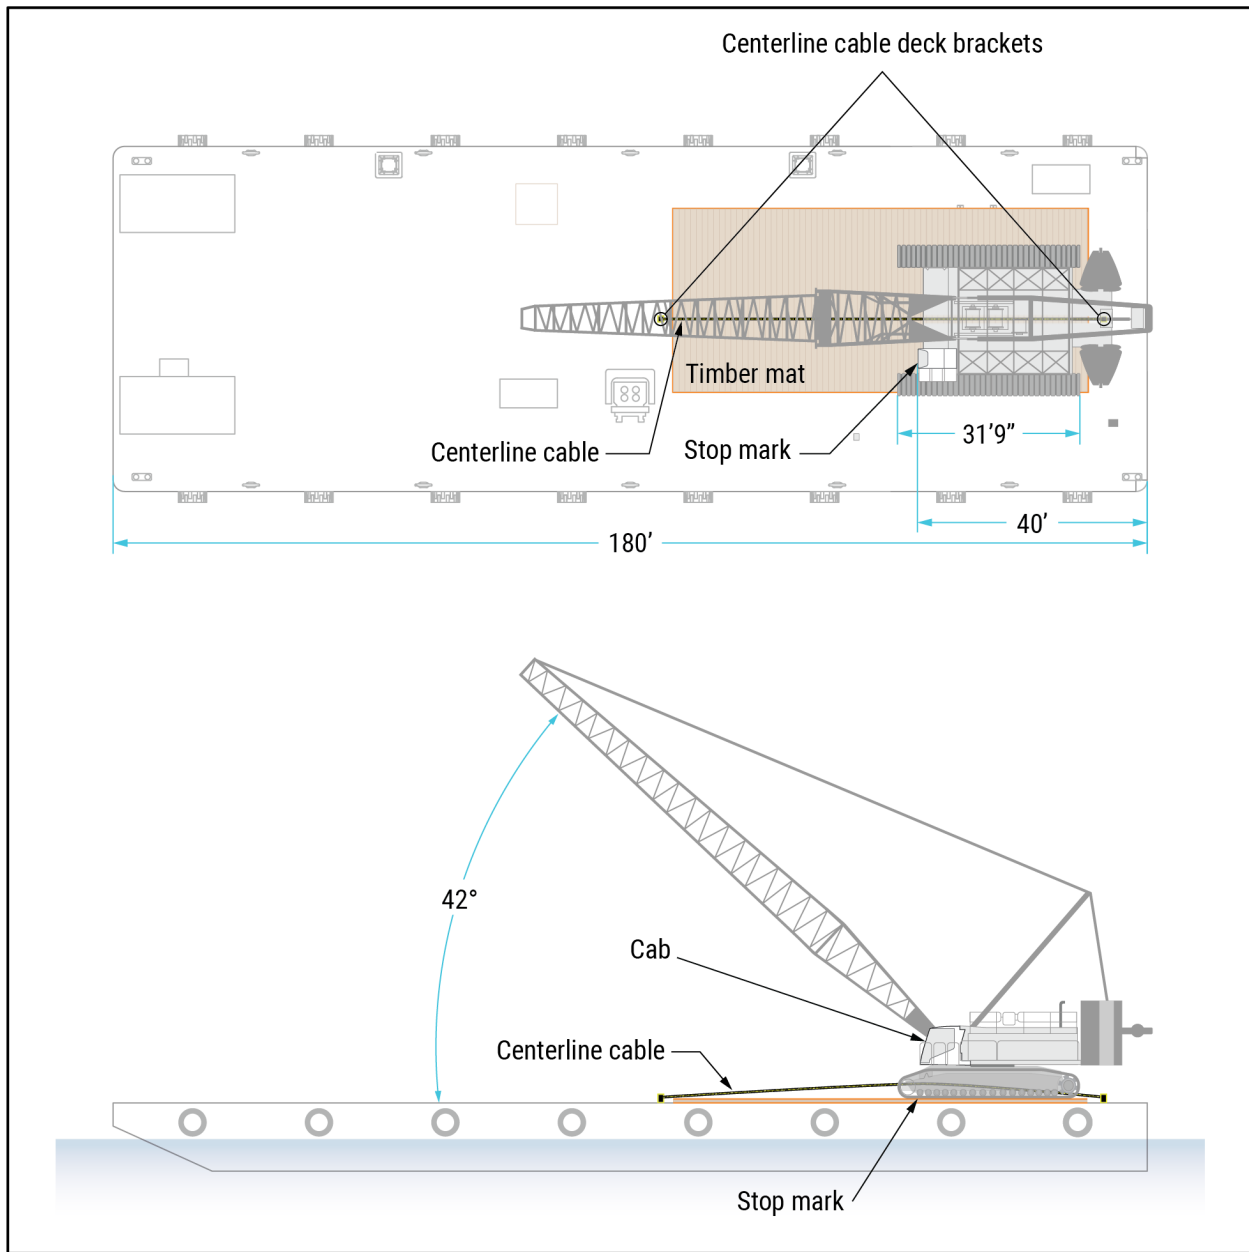
The crane was affixed to the barge using a centerline cable system that allowed longitudinal (fore and aft) movement of the crane; the cable system, required by OSHA, prevented the crane from moving laterally or rolling off the barge. The centerline cable (wire rope) ran the length of the mat. The cable ends were formed into loops (eyes) that were connected to shackles that were in turn connected to brackets welded on the deck of the barge forward and aft of the mat. The loops were created by securing the cable's

bitter (dead) ends with cable clips (clamps). The centerline cable passed through shackles hanging from loops of wire rope on the underside of the crane, allowing the crane to move along the cable.

**Figure 3.** Plan and portside views of the *Carolyn Skaves* and the Liebherr 1300.1SX model crawler crane.

After the casualty, investigators found the cable eye that secured the centerline cable to the aft deck shackle and bracket had opened. The bitter (dead) end of the wire rope had slipped through three cable clips and out of the shackle. OSHA regulations required the centerline cable system, which included the method and components used to secure the cable to the barge deck, to be of sufficient strength to keep the crane on the barge.<sup>4</sup> OSHA issued Seaward

OSHA regulations required the *Carolyn Skaves* to have a centerline cable (wire rope) system of sufficient strength to keep the crane on board the barge. However, after the casualty, investigators found the centerline cable's aft eye (loop) had opened, disconnecting it from the aft deck bracket, causing the cable system to fail. The cable disconnected due to the tension exerted on it as the crane moved aft, causing the bitter end of the cable to slip through the cable clips that closed the loop (the noise the crane operator heard as he was moving the crane aft was likely the centerline cable striking the underside body of the crane as it disconnected). A centerline cable system of sufficient strength, per OSHA regulations, would have prevented the crane from being driven off the barge (as occurred in this casualty). Measures to secure the crane on the barge such as the cable system (or the corral system that the operator will now use because of this incident) are the last line of defense to keep a crane on board a barge.

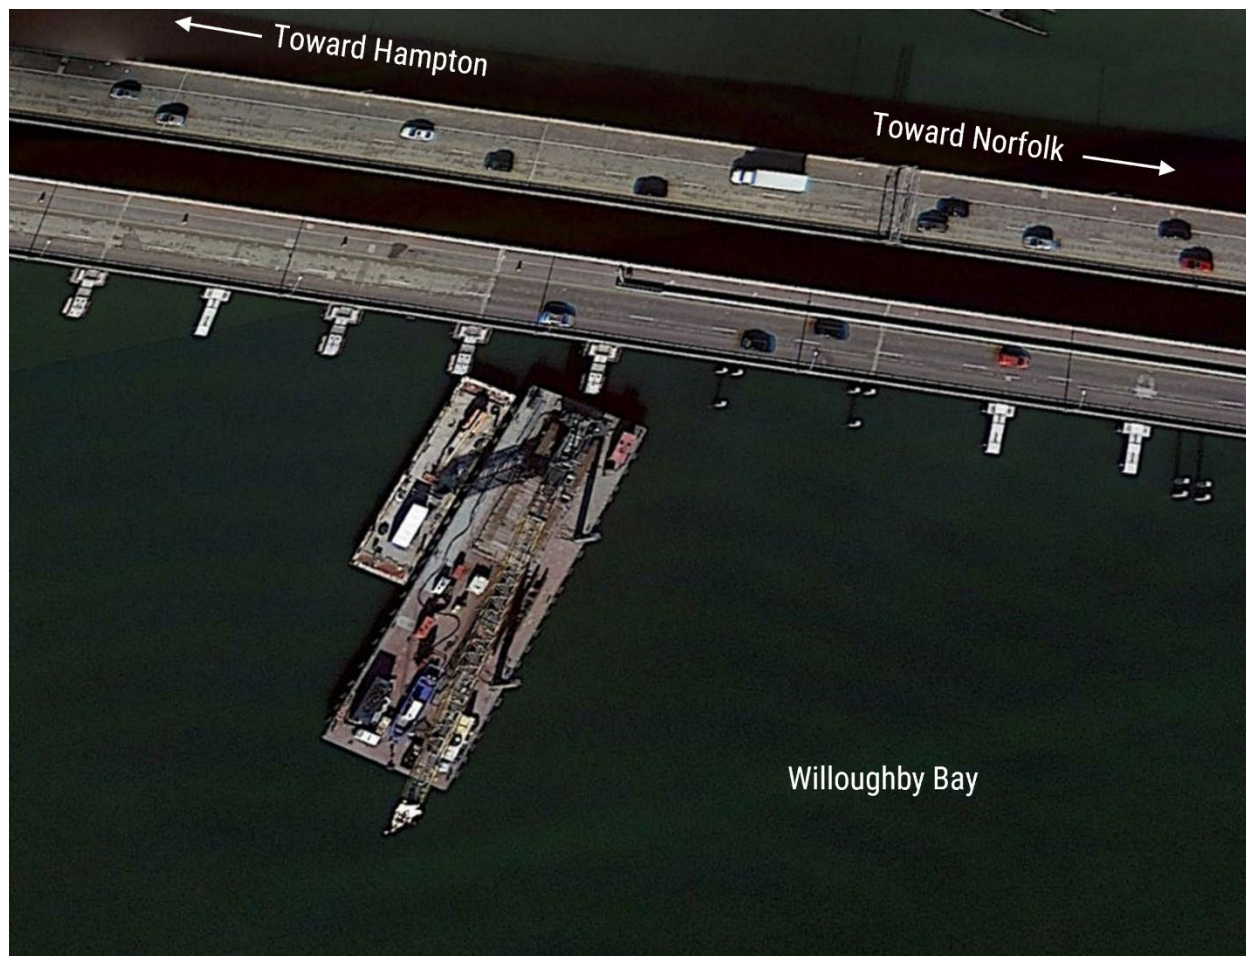
**Figure 5.** *Carolyn Skaves* spudded down near the Hampton Roads Bridge-Tunnel in November 2021. (Background source: Google Earth)
