Issued March 8, 2023

MIR-23-06

# Contact of *Robert Cenac* and Tow with Houma Twin Span Bridge

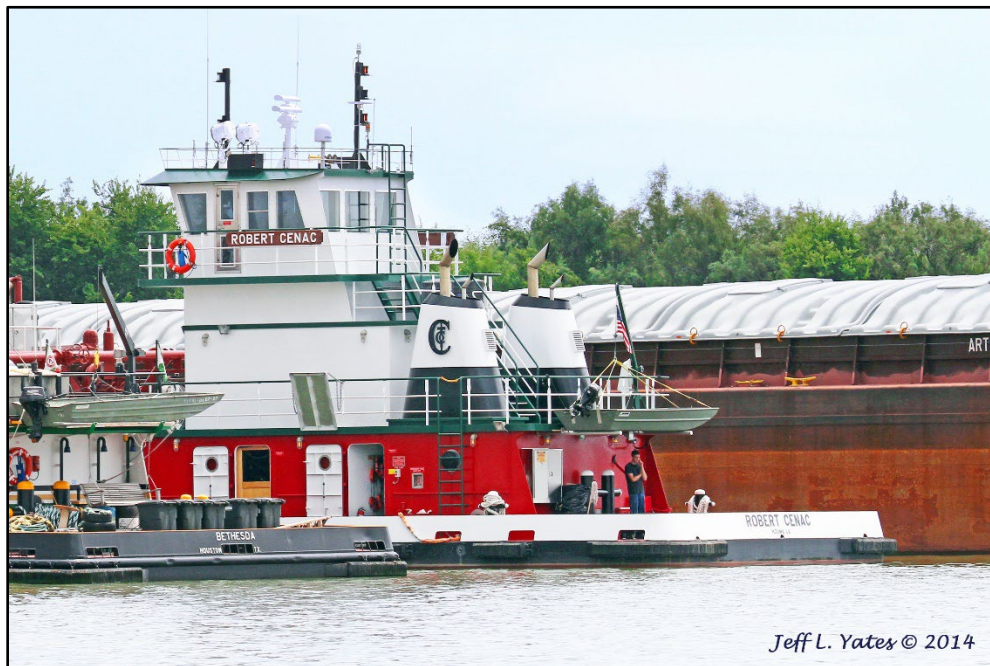
**Figure 1.** *Robert Cenac* before the casualty. (Source: Jeff L. Yates)

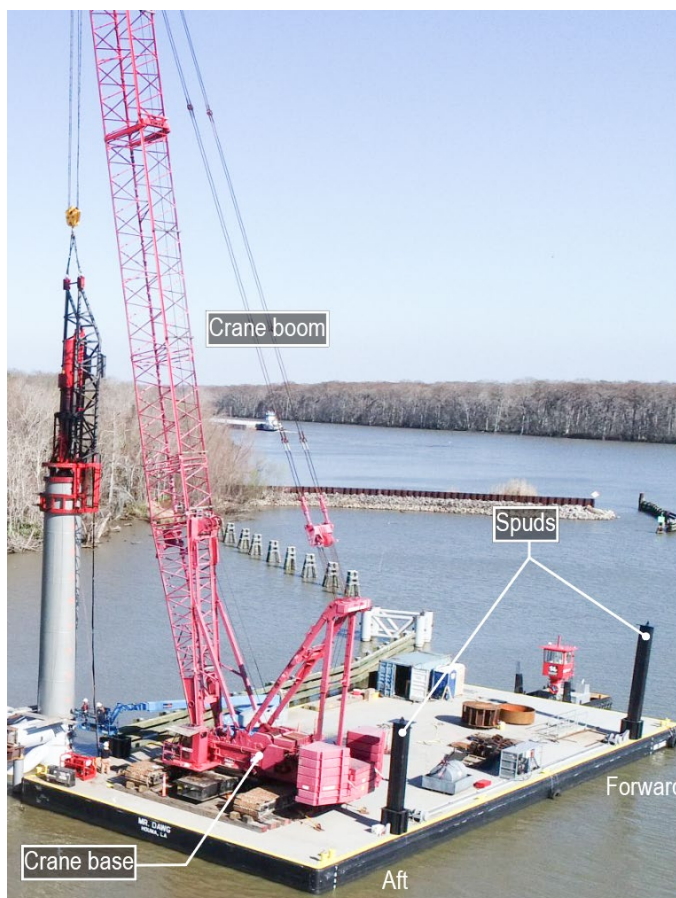
The *Mr. Dawg* was a 150-foot-long crane barge constructed of welded steel by Conrad Shipyard in Morgan City, Louisiana, in 2020 for Sealevel Construction, a Louisiana-based civil construction company. A crawler crane with a 300-ton lift rating was secured on *Mr. Dawg's* aft deck with its 180-foot-long boom facing forward. There was no crane boom rest. Two spuds, each 60 feet long, were located on the starboard side of the barge. When raised, the top of each spud was about 56 feet above the water given the *Mr. Dawg's* 4-foot draft.

**Figure 3.** Crane barge *Mr. Dawg* in operation. (Source: Houma Times)

Unbeknownst to Sealevel staff, who chartered the tow, their last crew to use the crane aboard the *Mr. Dawg* did not lower the boom to an angle typically used for transport—with the boom lowered below the barge’s raised spud tops. Both the towboat operator (Al Cenac Towing) shoreside staff and their towboat crew aboard the *Robert Cenac* were concerned about the height of the crane, and the captain observed that the head of the crane boom was higher than the crane barge spuds, contrary to what Sealevel had initially communicated to Al Cenac Towing. Despite being asked at least twice about the height of the crane by the towboat operator before departure, Sealevel staff did not provide Al Cenac Towing with a verified crane height.

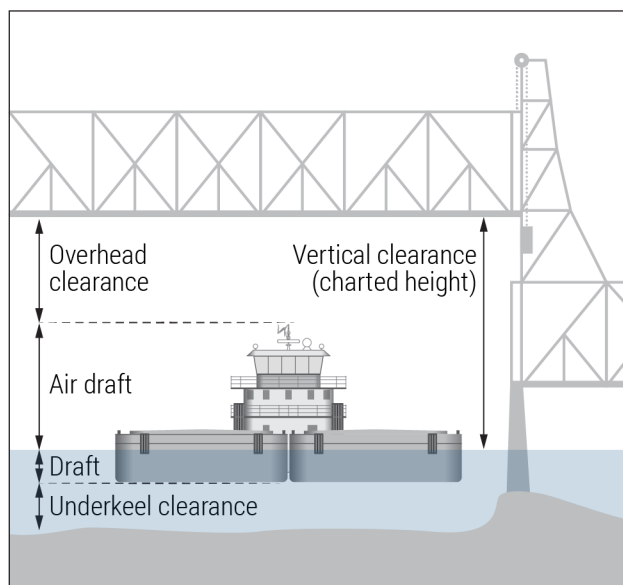
**Figure 6.** Critical dimensions and terms for bridge transits.

Tow operators are required to know the air draft of their vessel and tows and should not make assumptions. As the NTSB has also recommended before, tow operators should have a detailed voyage plan with specific information concerning/about all known risks, including calculated overhead clearance limitations for tows. Additionally, the Coast Guard has recommended that "assumptions are not made regarding a vessel or its cargo's 'air draft' or of 'bridge heights.' Specific data must be known when planning transits." In this case, the captain should have waited to get underway until the exact air draft of the tow was established.
