MIR-23-10

Contact of Cruise Ship *Radiance of the Seas* with Sitka Sound Cruise Terminal Pier

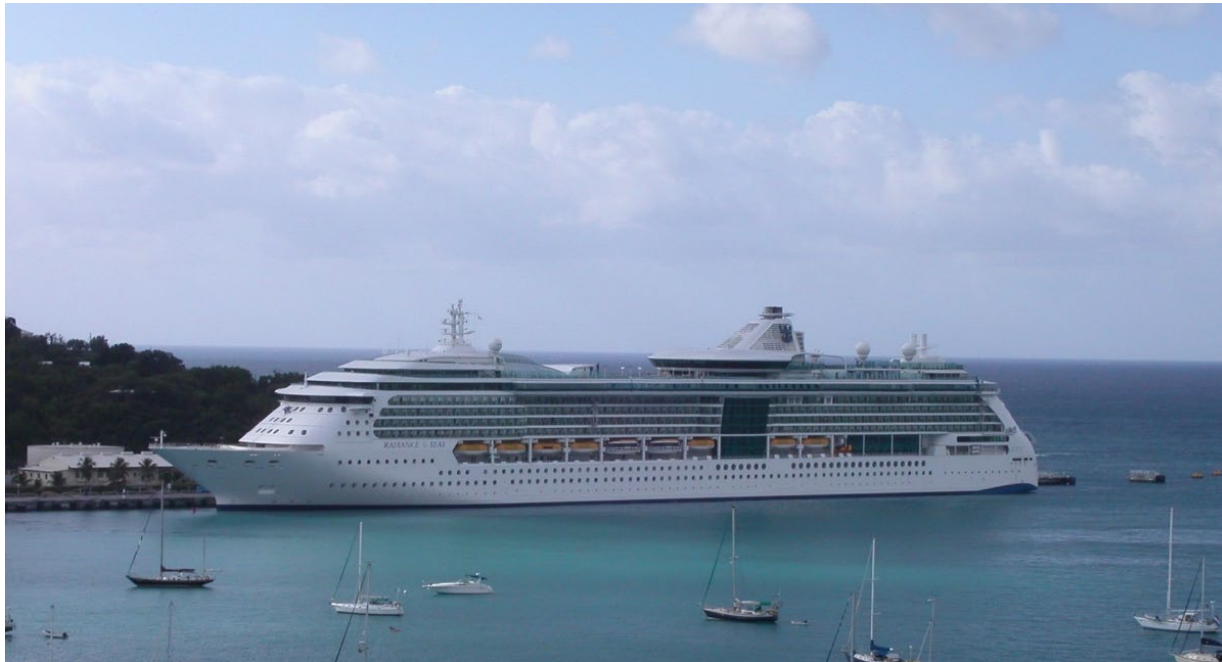
Figure 1. *Radiance of the Seas* before the casualty.

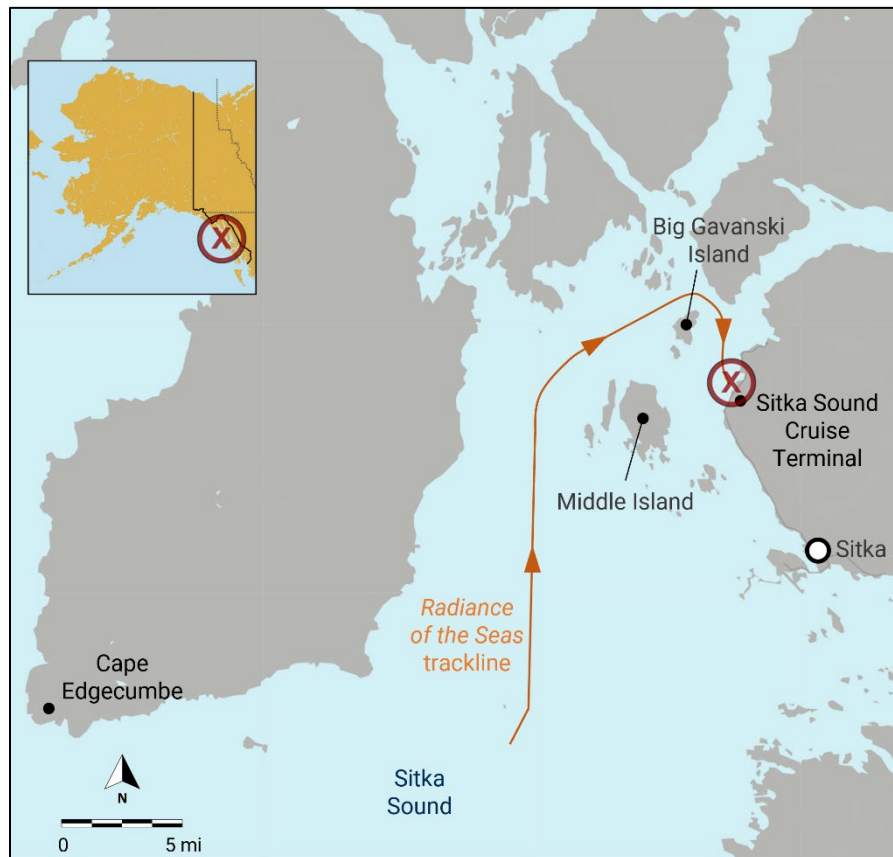
Figure 2. Area where *Radiance of the Seas* contacted the Sitka Sound Cruise Terminal mooring dolphin, as indicated by a red X. (Background source: Google Maps)
