# Grounding and Capsizing of Fishing Vessel *Challenger*

On August 7, 2022, about 0700 local time, while transiting along the northwestern shore of Kodiak Island, Alaska, the fishing vessel *Challenger* struck a submerged rock and began taking on water.<sup>1</sup> The captain and three crewmembers used onboard pumps to remove the floodwater, but the pumps were unable to keep up, and the crew abandoned the vessel. A nearby Good Samaritan fishing vessel rescued them. The *Challenger* eventually capsized. There were no injuries, and no pollution was reported. Damage to the vessel was estimated at \$600,000.

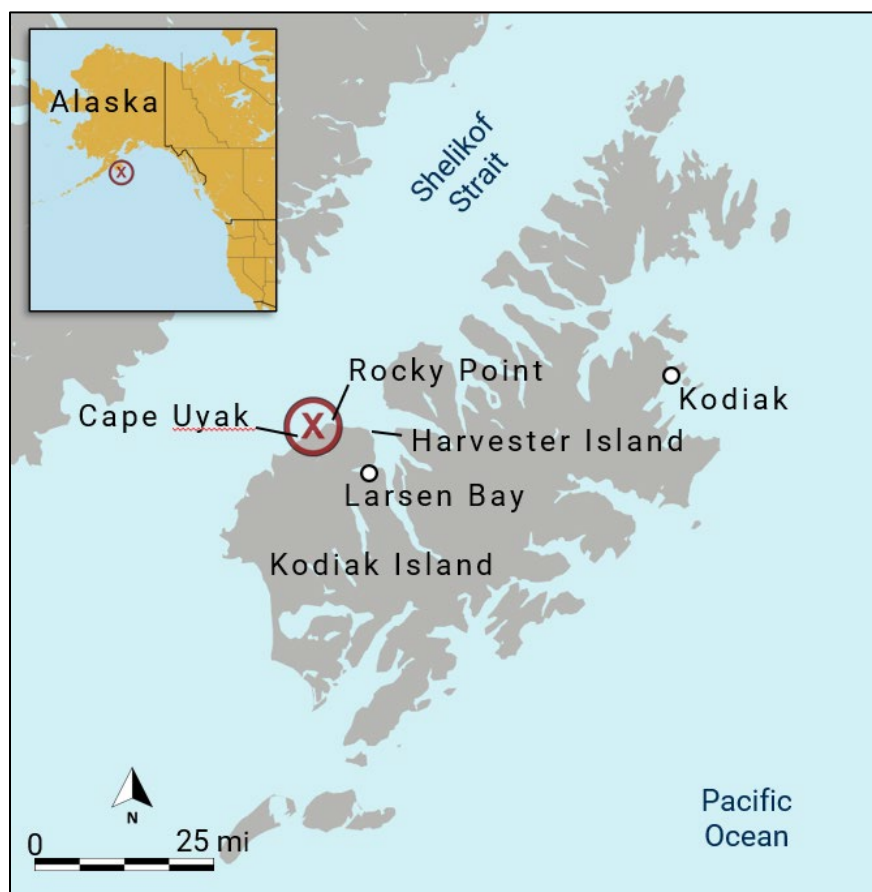
**Figure 2.** Area where the fishing vessel *Challenger* grounded, as indicated by a red X. (Background source: Google Maps)
