MIR-24-01

Anchor Strike of Underwater Pipeline and Eventual Crude Oil Release

San Pedro Bay

Near Huntington Beach, California

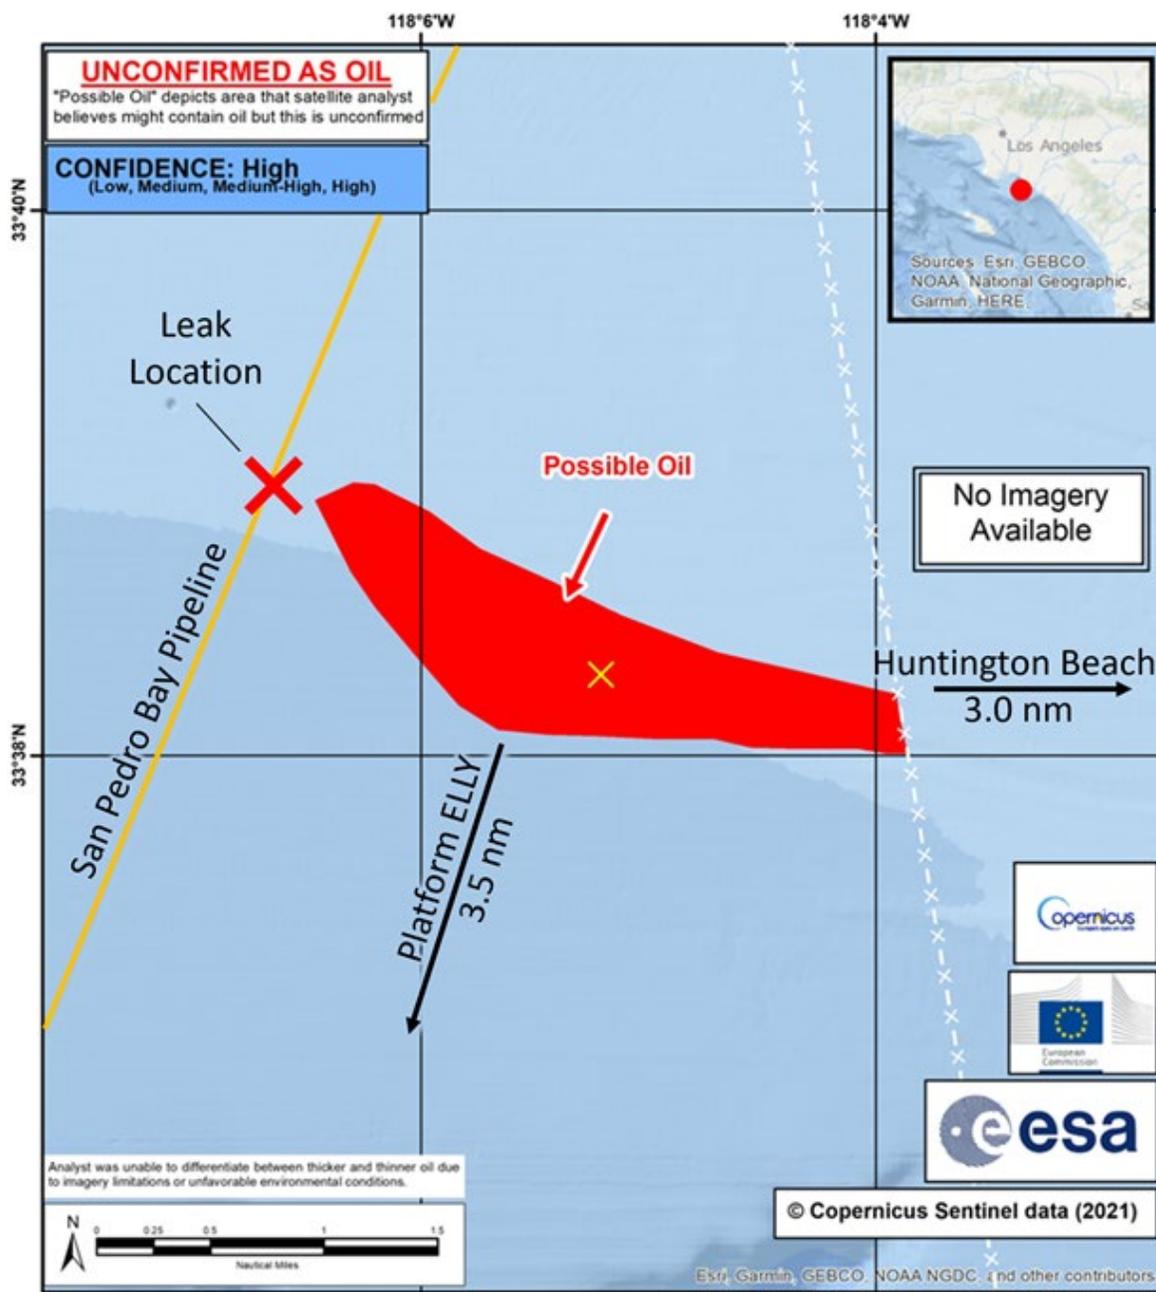
Separately, at 1858, the NOAA Environmental Satellite, Data, and Information Service satellite analysis branch observed a possible oil anomaly on satellite imagery in San Pedro Bay less than 3 miles from the San Pedro Bay Pipeline (see figure 4).⁷ On October 2 at 0157, NOAA reported the oil anomaly to the NRC.⁸ The NRC shared this information with BSEE. The NRC did not inform Beta of these reports, nor was it required to.

Figure 4. NOAA marine pollution surveillance report image from 1858 on October 1, 2021, showing the oil anomaly in red. The yellow X, indicating the center point of the potential oil slick, was less than 3 miles from the San Pedro Bay Pipeline. Pipeline location, leak location, and distances to Platform ELLY and Huntington Beach added by the National Transportation Safety Board. (Background source: NOAA)

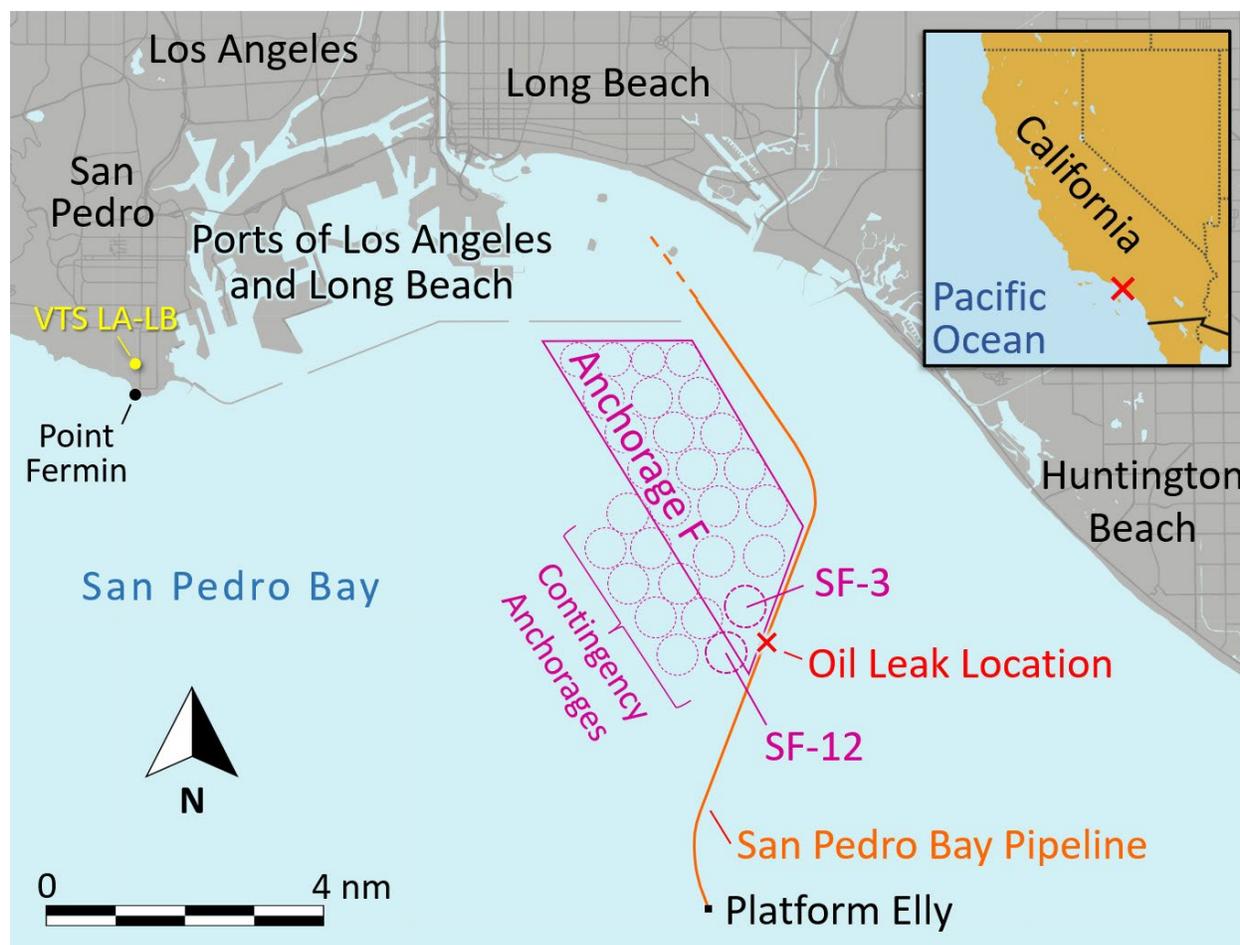
SF-3 and SF-12 were circular anchorage positions with radii of 1,800 feet. SF-3 was located within the charted Anchorage F, while SF-12 was one of several Coast Guard designated "contingency" locations added southwest of Anchorage F (see figure 9). Immediately after the *MSC Danit* and *Beijing* arrived at their respective anchoring positions, the crews set up their electronic chart display and information systems (ECDISs) to alert them in the event of an anchor dragging. On each vessel, the officer of the watch input parameters into the system for a circle centered on the anchor drop position with a diameter about the length of the distance between the anchor and the vessel's GPS antenna (anchor chain length plus distance from the [hawsepipe](#) to the GPS antenna). If their respective vessel's position moved outside of the circle displayed on that ship's ECDIS, an audible alarm sounded.

Figure 9. San Pedro Bay Pipeline, with locations of oil release, federal Anchorage F, and contingency anchorage positions near Anchorage F. Other anchorage areas and contingency anchorage positions in San Pedro Bay are not shown. (Background source: Google Maps)

A portion of the San Pedro Bay Pipeline ran parallel to the southeast boundary of Anchorage F; the distance between the anchorage and the pipeline's charted location was about 180 feet. At its closest point, the pipeline's charted position was 2,586 feet from the center and 786 feet from the outer edge of anchorage position SF-3. The pipeline's charted location was 2,733 feet from the center and 933 feet from the outer edge of anchorage position SF-12.

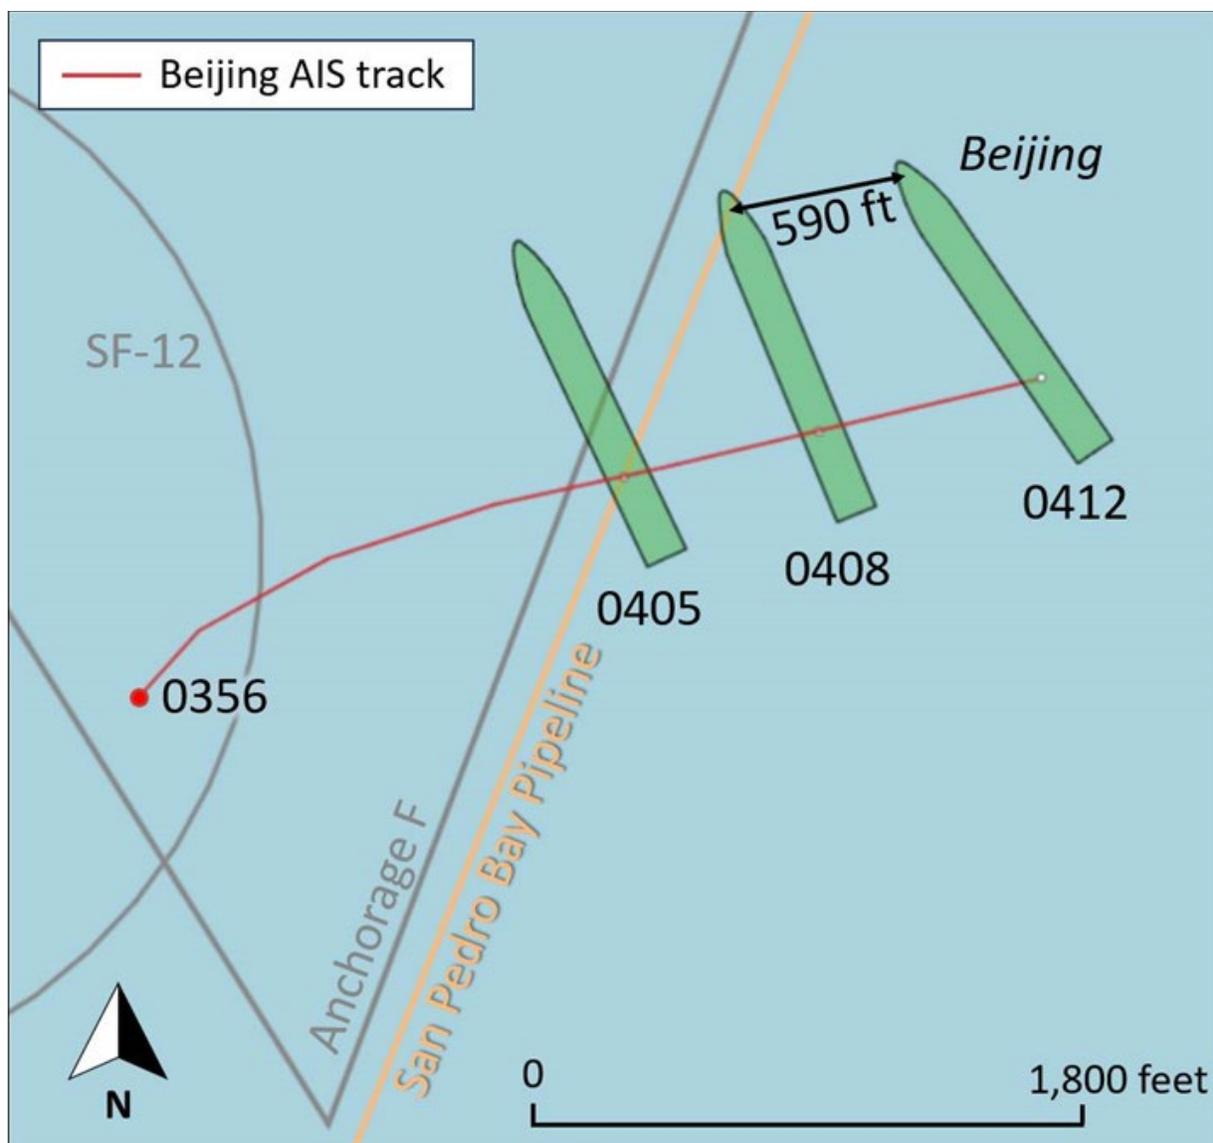
At 0356, the *Beijing's* engine had not yet been started, but AIS data showed that the vessel started to move eastward out of SF-12 on a course over ground of about 70° and a speed over ground between 1.5 and 2.1 knots (see figure 11).¹³ The vessel moved laterally, with its heading to the northwest. Four minutes later, wind speeds at the *Beijing's* location reached Beaufort scale force 8 (34–40 knots), according to the vessel's deck log.¹⁴

Figure 11. Initial AIS track of the *Beijing* as it moved out of anchorage position SF-12 and crossed the San Pedro Bay Pipeline on January 25, 2021. (See figure 12 for full track of the *Beijing* during anchor dragging.)

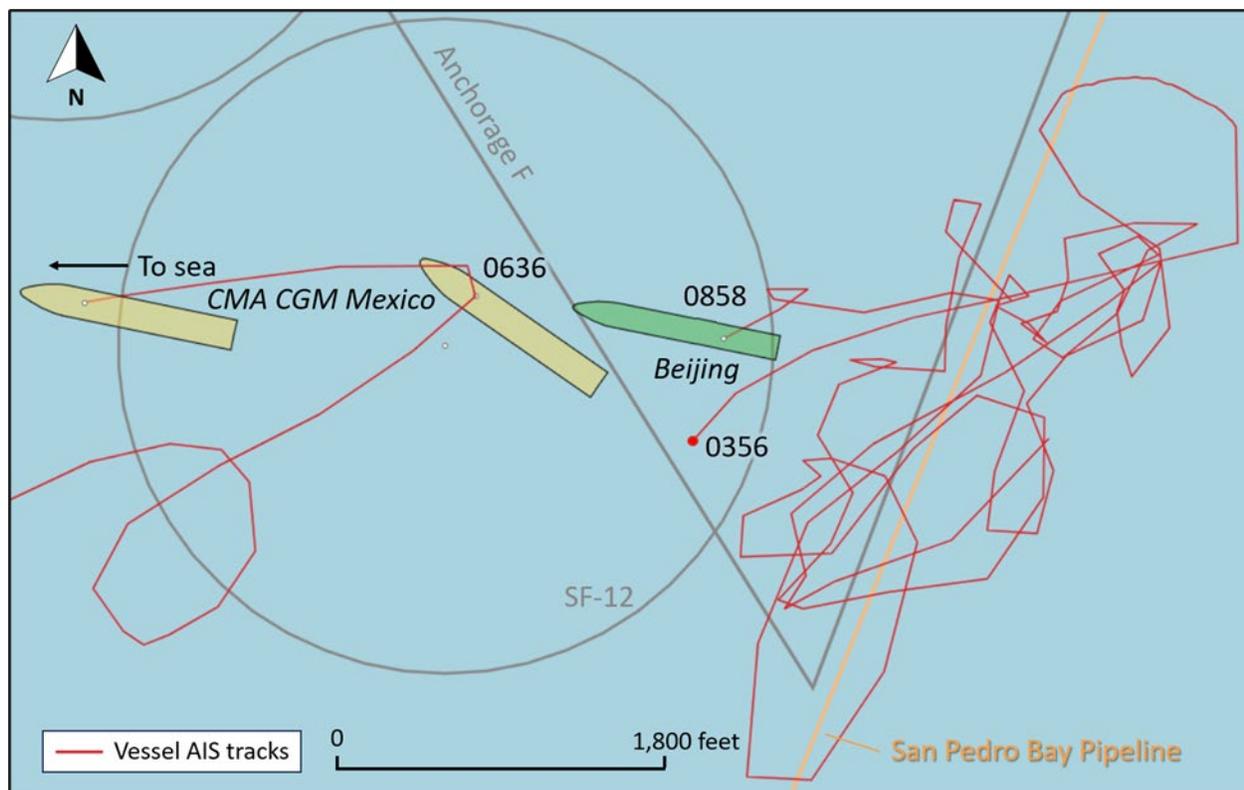
After the *Beijing* had initially passed over the pipeline, it continued to maneuver nearby, with its AIS position passing over the charted location of the pipeline at least 10 times (see figure 12). During this time, the vessel’s AIS position was as much as 1,044 feet to the east and 1,158 feet to the west of its last pipeline crossing.

Figure 12. AIS track of the *Beijing* between 0356 and 0858 on January 25, 2021. Also shown is the AIS track of the *CMA CGM Mexico* as it dragged anchor into contingency anchorage position SF-12 between 0551 and 0652 on the same morning.

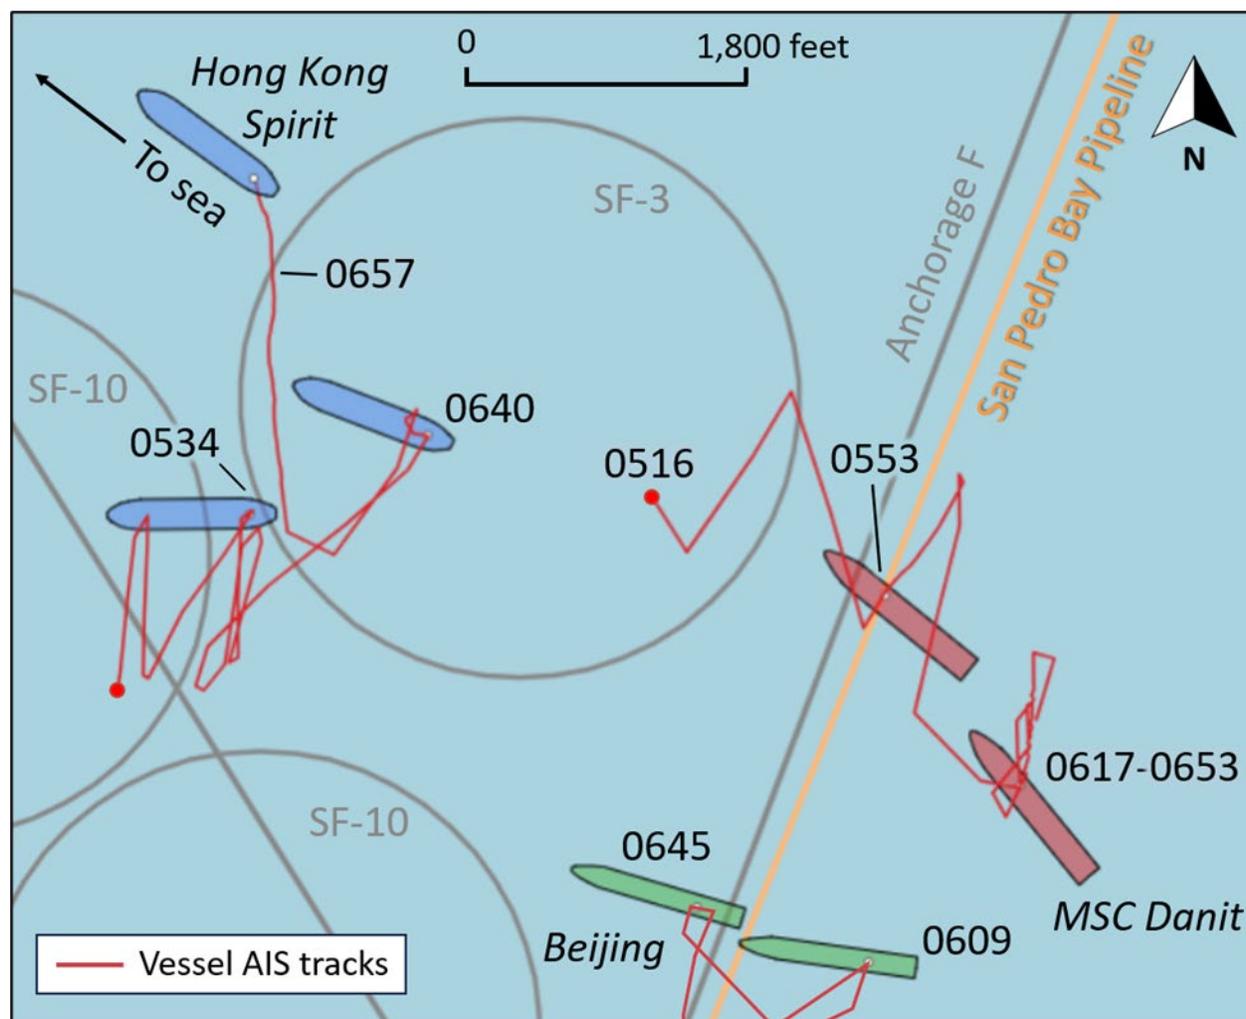
AIS data showed that, about 0516, the *MSC Danit* began moving in a generally eastward direction while swinging to the south and then back to the north (see figure 13). The ship's headings were westerly. The crew started the ship's main propulsion engine and, at 0523, shifted control of the engine to the bridge. Over the next 39 minutes, the bridge team issued engine orders alternating between dead slow ahead (27 rpm) and stop.

Figure 13. Initial AIS track of the *MSC Danit* as it moved out of anchorage position SF-3 and crossed the charted location of the San Pedro Bay Pipeline. Also shown is the AIS track of the *Hong Kong Spirit* as it dragged anchor into the *MSC Danit*'s assigned anchorage, and the AIS track of the *Beijing* as it dragged anchor off the port side of the *MSC Danit*, during the same period. (See figure 14 for remaining track of *MSC Danit* during anchor dragging.)

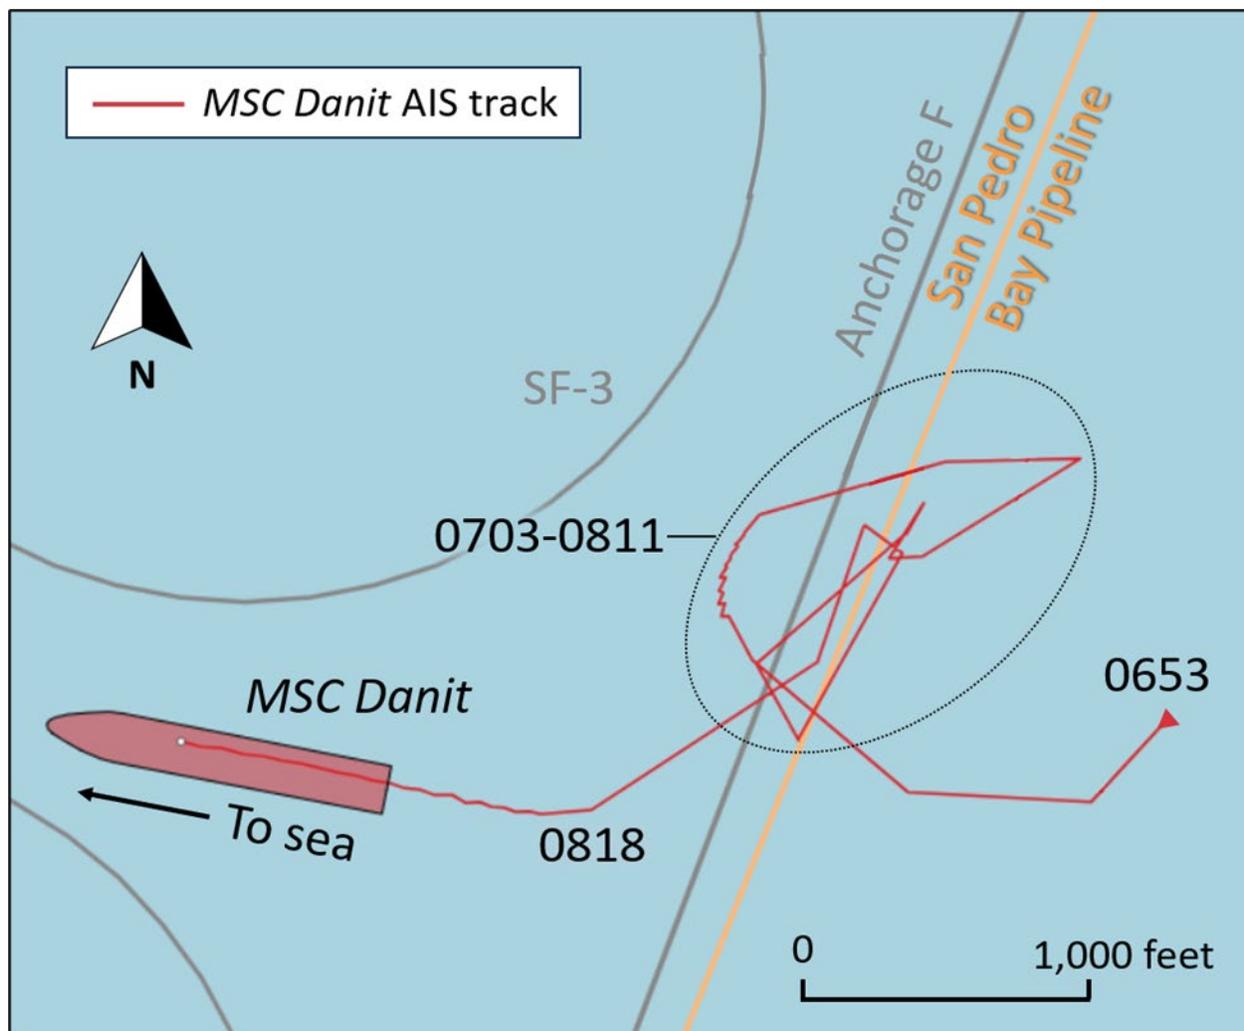
At 0703, the *MSC Danit*'s forward progress halted, with the ship directly over the pipeline (see figure 14). For the next 1 hour and 8 minutes, the ship's AIS position remained within an area about 600 feet in radius, centered on the eventual leak location on the pipeline.

Figure 14. AIS track of the *MSC Danit* between 0653 and 0818.

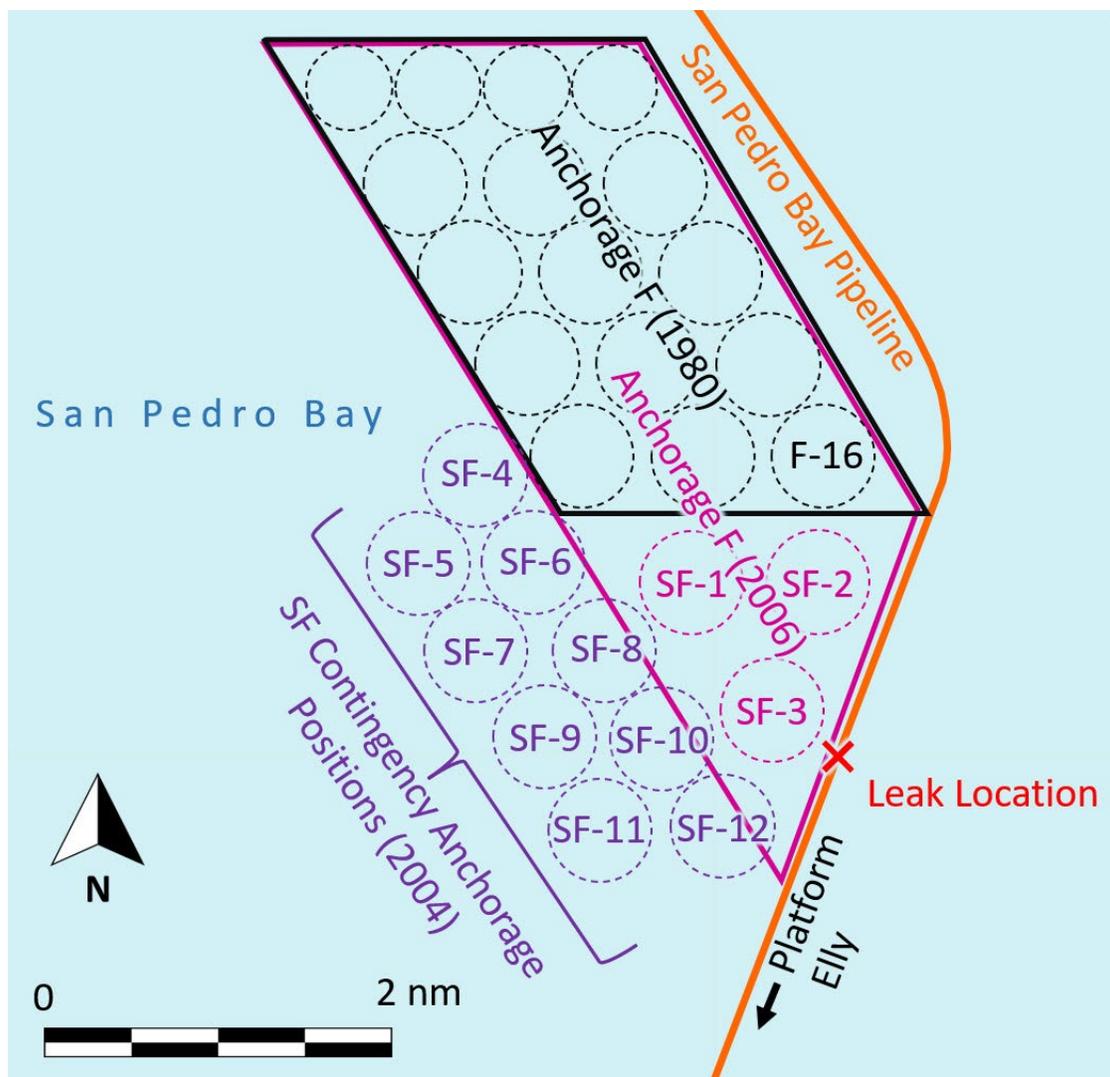
Anchorage F in San Pedro Bay was established in 1980, about the same time that the San Pedro Bay Pipeline was being constructed. The anchorage's original boundaries were defined in the *CFR* such that only the southeast corner of the area was close to the San Pedro Bay Pipeline (see figure 15).²³ The outer boundary of the closest anchorage position within Anchorage F, position F-16, was 2,430 feet from the pipeline.

Figure 15. Boundaries of Anchorage F, as originally drawn in 1980 (in black) and as revised in 2006 (in magenta). Also shown are nine contingency anchorage positions established in 2004 (in purple). (Other contingency anchorages in San Pedro Bay are not shown.) (Background source: Google Maps)

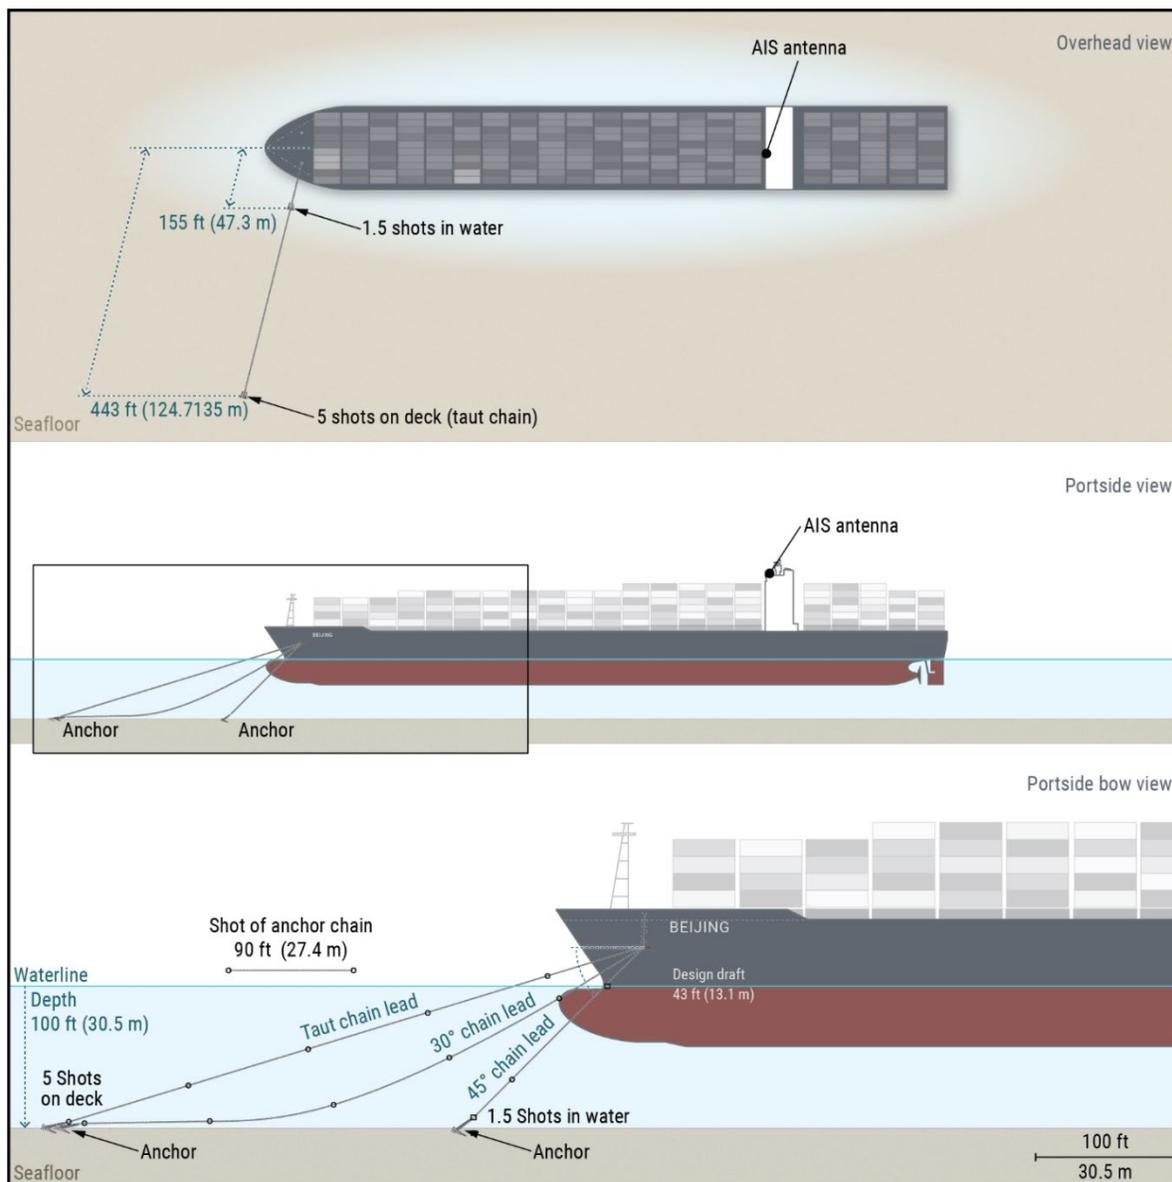
Based on the movement of the *Beijing* while it dragged anchor and the differing lengths of anchor chain reported by both the master and the second officer, the NTSB modeled the *Beijing*, its anchor chain, and anchor to determine the possible locations of the anchor relative to the vessel on January 25, 2021 (see figure 20). The model was based on ship and anchoring system drawings and the charted water depth and assumed that the vessel was operating at its designed draft. Given the *Beijing's* lateral movement when it initially dragged anchor, the model assumed that the anchor chain tended in the direction opposite the vessel's course

over ground (by about 70°) during this time. The NTSB modeling found that, at 1.5 shots in the water, the anchor position would be off the *Beijing's* port bow at 155 feet from the centerline of the vessel; at 5 shots on deck, the anchor position would be between 403 and 443 feet (dependent on the strain on the anchor chain) from centerline of the vessel, as shown at the top of figure 20.

Figure 20. NTSB modeling of *Beijing* anchor position relative to the vessel for moderate to heavy strain on the anchor chain. (In the profile views, the anchor chain is shown tending directly ahead of the vessel for illustrative purposes.)

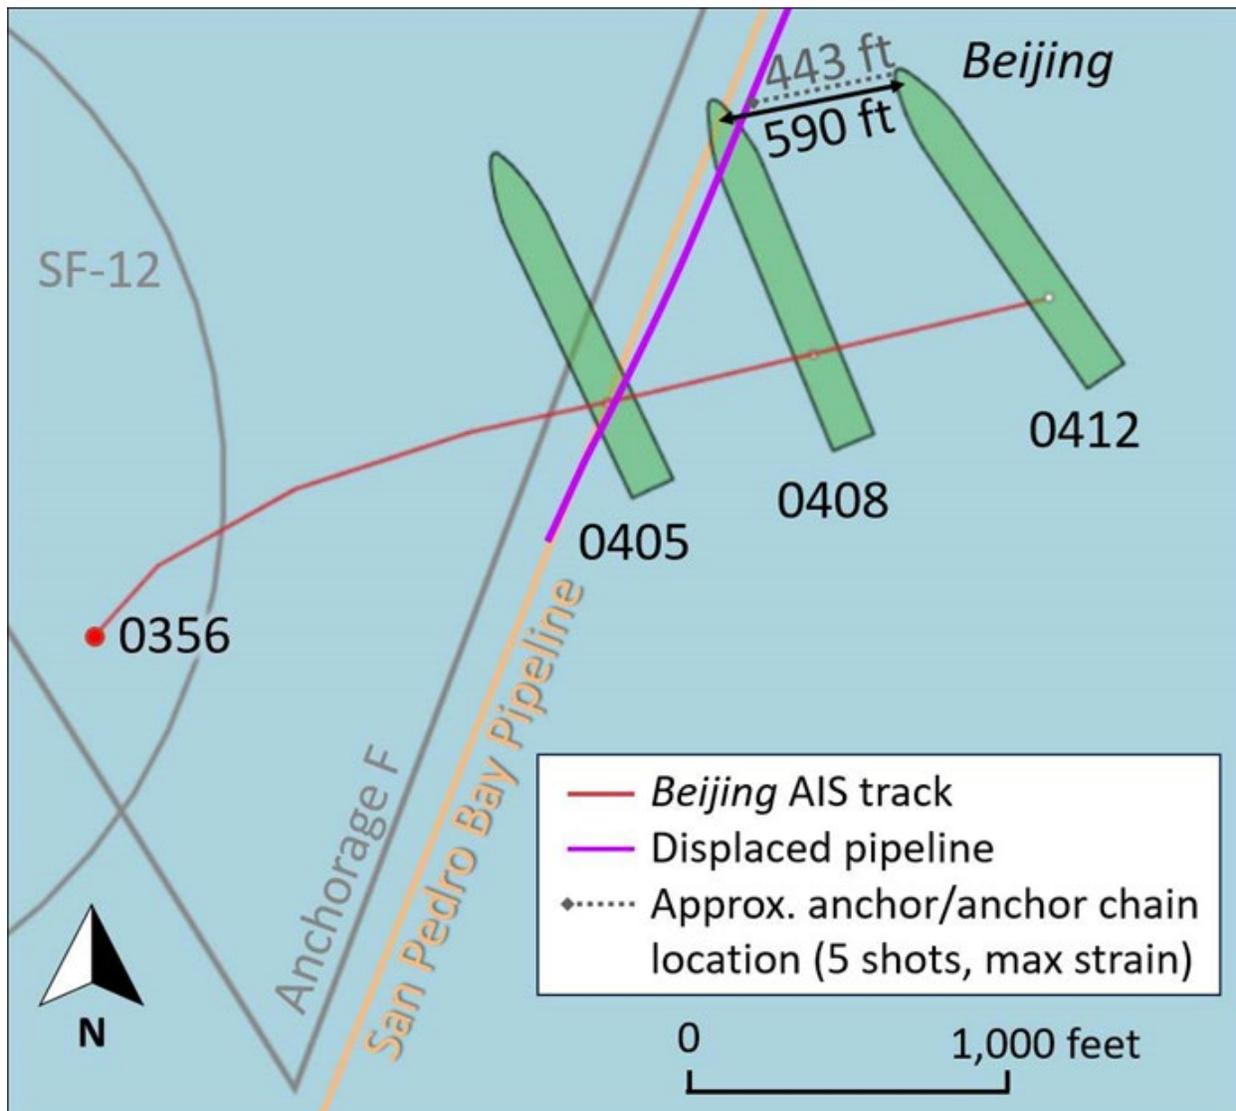
When the *Beijing* initially dragged anchor, it moved laterally eastward until its progress stopped with the bow 590 feet from where it had passed over the pipeline's charted location (see figure 21). Based on the NTSB's modeling of the *Beijing's*

anchor position (maximum of 443 feet off the bow), it is clear that the anchor would have struck the pipeline as the ship drifted past it.

Figure 21. The *Beijing's* position as the vessel dragged anchor over the San Pedro Bay Pipeline.

After its initial crossing over the San Pedro Bay Pipeline, the *Beijing* continued to maneuver near the pipeline, with the vessel's AIS position passing over the pipeline at least 10 times. The AIS position during this period was recorded as much as 1,044 feet east and 1,158 feet west of the charted pipeline location. Location data from anchor dragging scars on the seabed, when overlaid with the vessel's AIS data, indicate that the *Beijing* anchor likely struck the pipeline multiple times during this period (see figure 22). The pipeline was displaced and the concrete coating damaged in the locations where these incursions occurred.

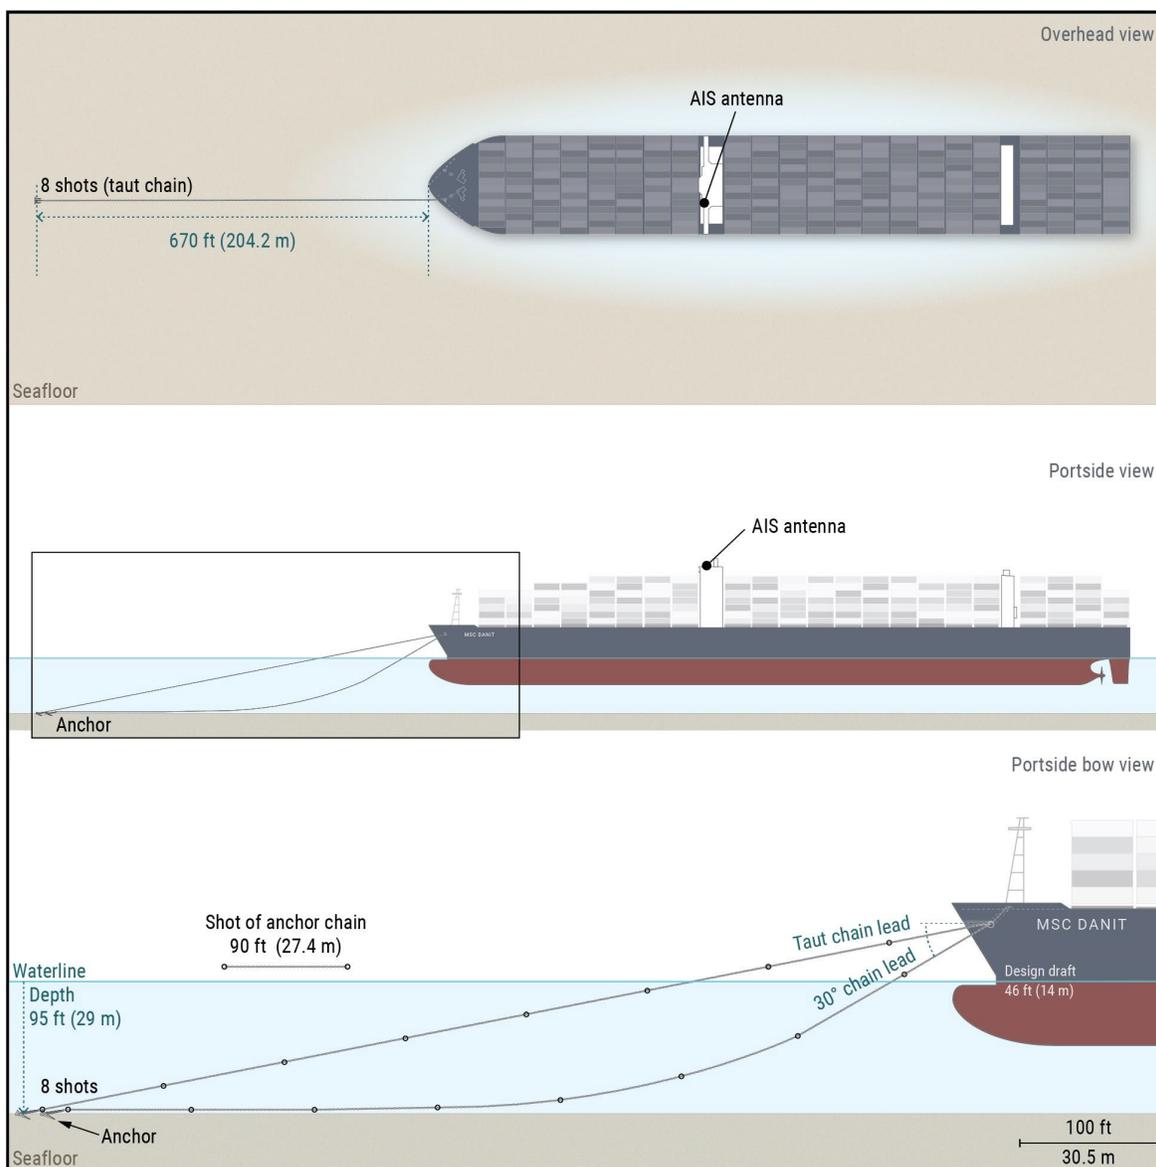
Using the vessel's motion and a range of anchor chain lengths between 6 and 8 shots, the NTSB modeled the *MSC Danit*, its anchor chain, and anchor to determine a range of values representing the location of the anchor relative to the vessel's bow

(see figure 23). Similar to the modeling of the *Beijing*, the NTSB assumed that the vessel was operating at its designed draft. Because the vessel moved in a generally astern direction, the model assumed that the anchor chain tended directly off the bow (any direction other than directly off the bow could be estimated using an arc of the length of the anchor chain). The NTSB modeling found that, at 8 shots (the maximum length of chain), the anchor position would be between 618 and 670 feet forward of the vessel's bow.

Figure 23. NTSB modeling of the *MSC Danit*'s anchor position relative to the vessel for moderate to heavy strain on the anchor chain.

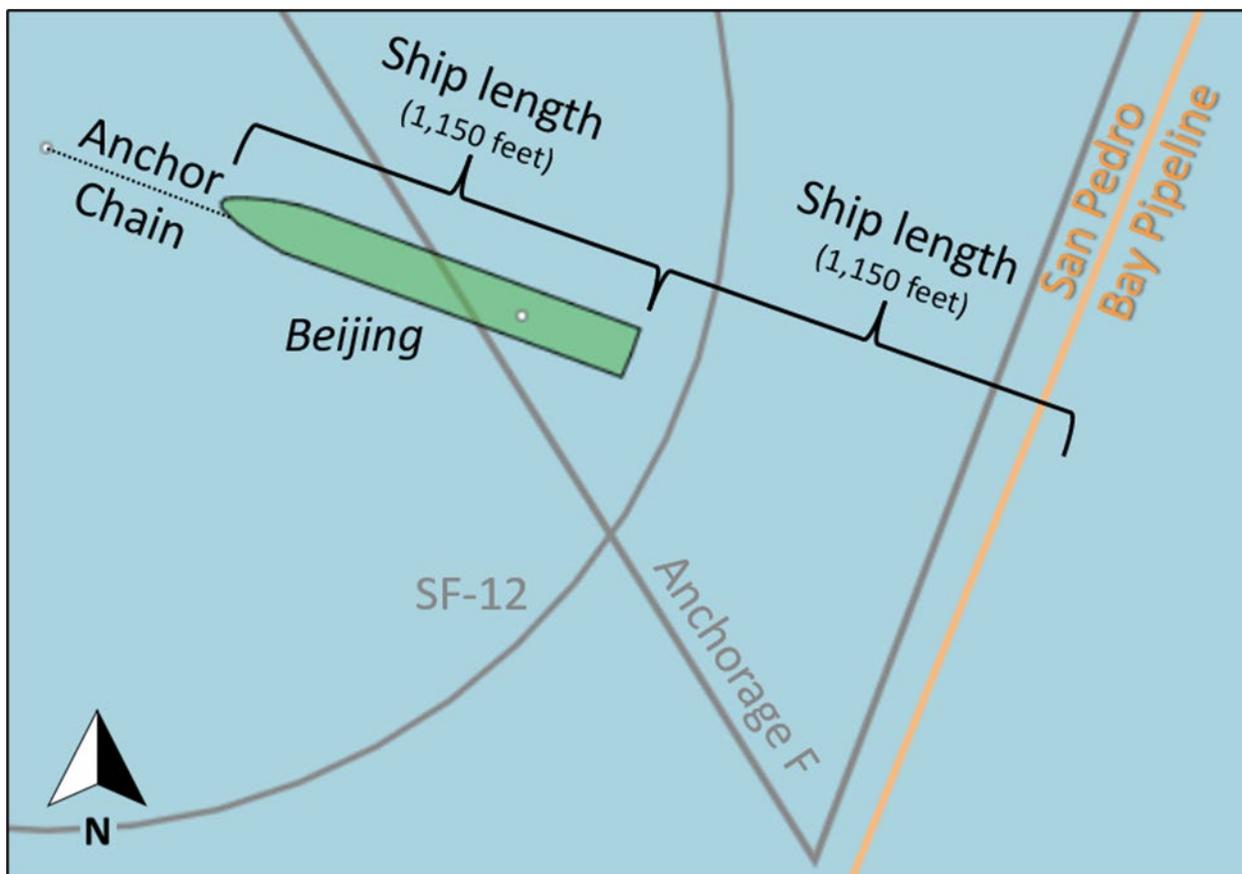
The margin of safety around designated anchorage positions must also account for the size of vessels anchoring. The *Beijing* had been anchored in position SF-12, as assigned by VTS LA-LB. The pipeline's charted location was 2,733 feet from the center and 933 feet from the outer edge of anchorage position SF-12. The length of the *Beijing* was 1,150 feet, and when it arrived in San Pedro Bay, the crew had paid out 6 shots (540 feet) of anchor chain. Thus, when winds were from the northwest, as they were on January 25, the vessel was potentially less than one ship length away from the pipeline even before its anchor began to drag (see figure 26). The *MSC Danit* was likewise within one ship length of the pipeline as it swung at anchor before dragging began.

Figure 26. *Beijing* before its anchor began to drag, with less than one ship length between the vessel and the San Pedro Bay Pipeline.

The ships' crews determined that their vessels were dragging anchor, started their main engines (which had been on standby), and began heaving in their anchors in a reasonable amount of time, given the time necessary to confirm their navigation situation, complete the engine starting procedures, and crew the anchor station on each bow. However, once the *Beijing* and *MSC Danit* began dragging anchors, the crews could not heave in their anchors before the anchors struck the San Pedro Bay Pipeline, because of the size of the vessels and distance between their assigned anchorage positions and the pipeline. The NTSB concludes that, because of the proximity of anchorage positions to the pipeline, the crews of the *Beijing* and *MSC Danit* had insufficient time and space to heave in their dragging anchors in high winds and seas before the anchors contacted the pipeline. The NTSB further concludes that the southeast boundary of Anchorage F and the location of contingency anchorage positions southwest of Anchorage F did not leave a sufficient margin of safety between anchored vessels and the San Pedro Bay Pipeline.

After the pipeline leak, VTS LA-LB discontinued use of anchorage positions SF-3 and SF-12, as well as other anchorage positions close to the San Pedro Bay
