April 8, 2024

MIR-24-07

Flooding and Partial Sinking of Towing Vessel *Joanne Marie*

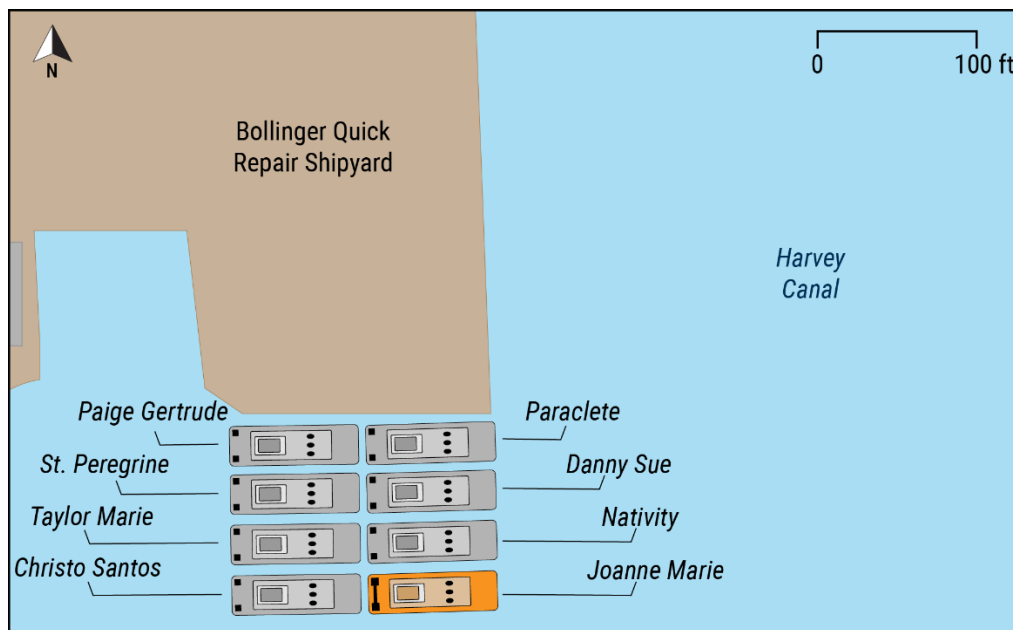
On June 23, 2023, about 1050, the *Joanne Marie* arrived at the Bollinger Quick Repair Shipyard, after completing fleeting operations for a customer on the Lower Mississippi River (see figure 2). The company that had contracted the *Joanne Marie* no longer needed the vessel, and the operating company directed the crew to move the vessel to the shipyard and deactivate it. A captain and two deckhands operated the vessel, working 12-hour shifts. Upon arrival at the shipyard, the *Joanne Marie* crew moored the vessel with its starboard side to a fleet of seven other company towboats (see figure 3). No vessel was moored to the port side of the *Joanne Marie*.

Figure 3. Mooring arrangement at the shipyard on June 23. The *Joanne Marie* is highlighted in orange. (Scale approximate.)
