April 15, 2024

MIR-24-09

Contact of Tank Vessel *Bow Triumph* with Pier

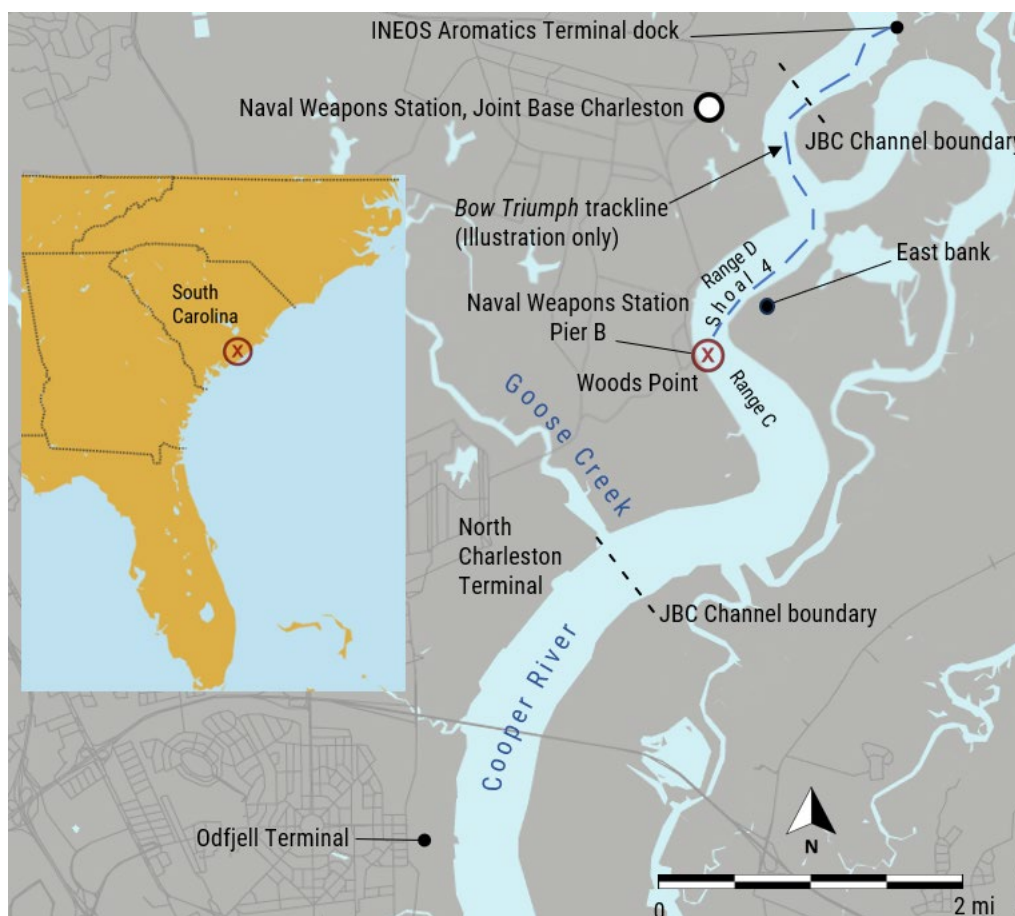
Figure 2. Area where the *Bow Triumph* contact with Pier B occurred, as indicated by a red X. (Background source: Google Maps)

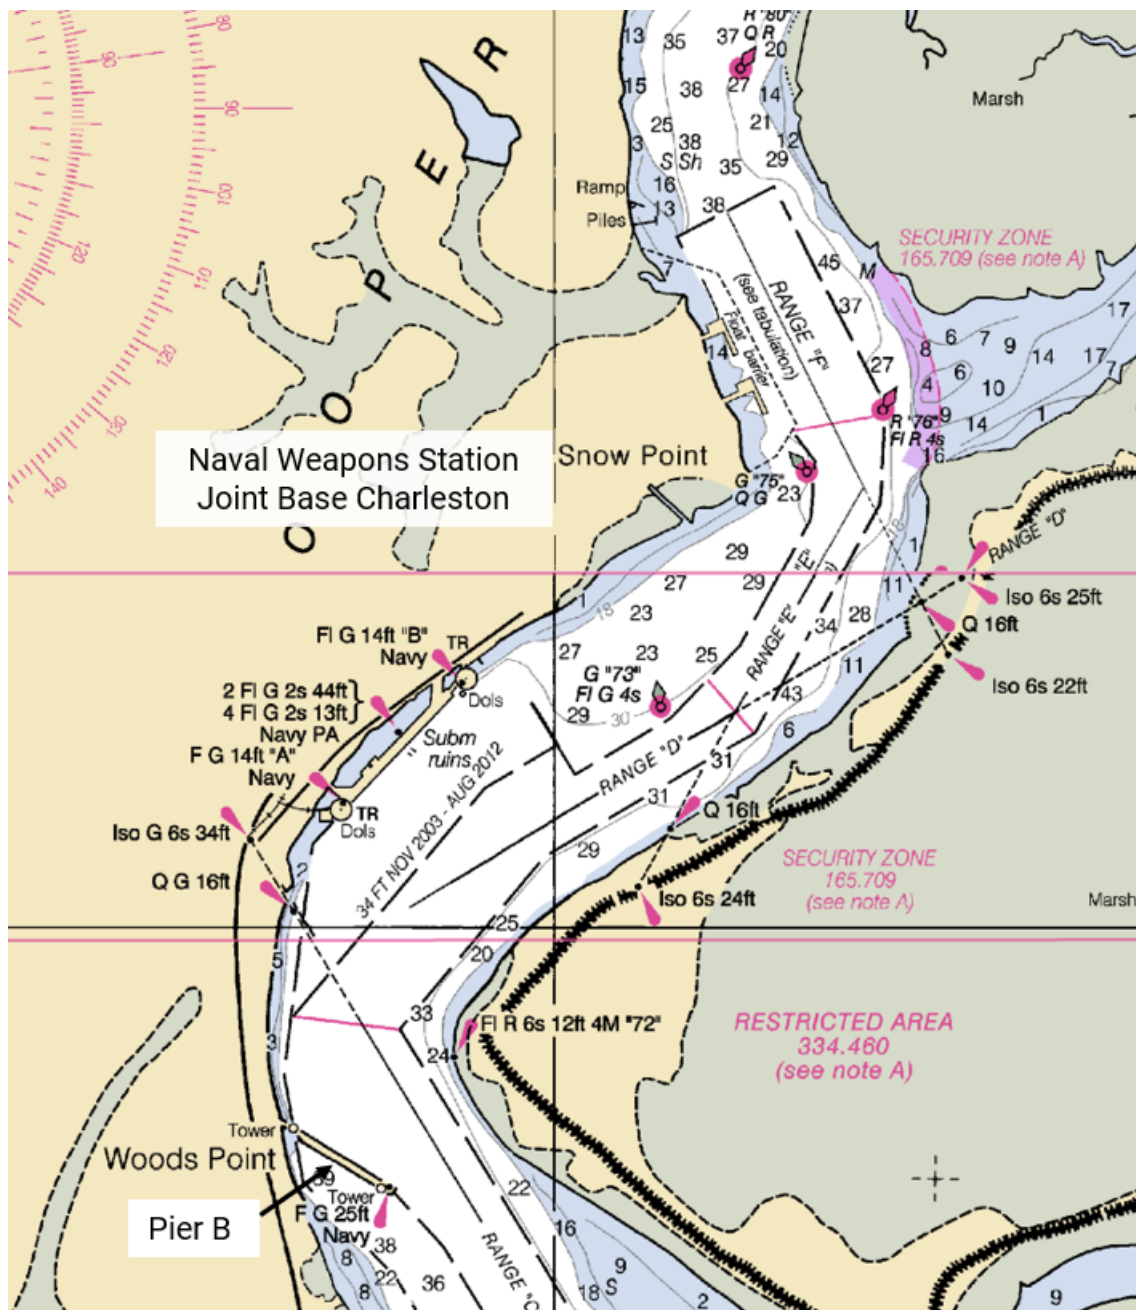
Figure 3. National Oceanic and Atmospheric Administration (NOAA) chart 11527, showing the area of the Cooper River where the *Bow Triumph* would eventually strike Pier B. (Background source: Rose Point)
