# Loss of Propulsion aboard Containership *Maunalei*

On August 11, 2022, about 1834 local time, the containership *Maunalei* was transiting the North Pacific Ocean, about 245 miles northwest of the entrance to the Columbia River, en route to Portland, Oregon, when the crew intentionally shut down the main engine due to problems in the controllable pitch propeller system, resulting in a loss of propulsion.<sup>1</sup> The vessel's controllable pitch propeller system may have lost up to 1,632 gallons of hydraulic oil. There were no injuries reported. Damage to the vessel was estimated at \$3.03 million.

<b>Casualty type</b>	Machinery Damage
<b>Location</b>	North Pacific Ocean, 245 miles from Columbia River entrance, Oregon 47°35.31' N, 132°01.49' W
<b>Date</b>	August 11, 2022
<b>Time</b>	1834 Pacific daylight time (coordinated universal time -7 hrs)
<b>Persons on board</b>	23
<b>Injuries</b>	None
<b>Property damage</b>	\$3.03 million
<b>Environmental damage</b>	Up to 1,632 gal hydraulic oil lost from controllable pitch propeller system
<b>Weather</b>	Visibility 10 mi, winds south-southwest at 5 kts, seas 2-3 ft, air temperature 64°F, water temperature 66°F
<b>Waterway information</

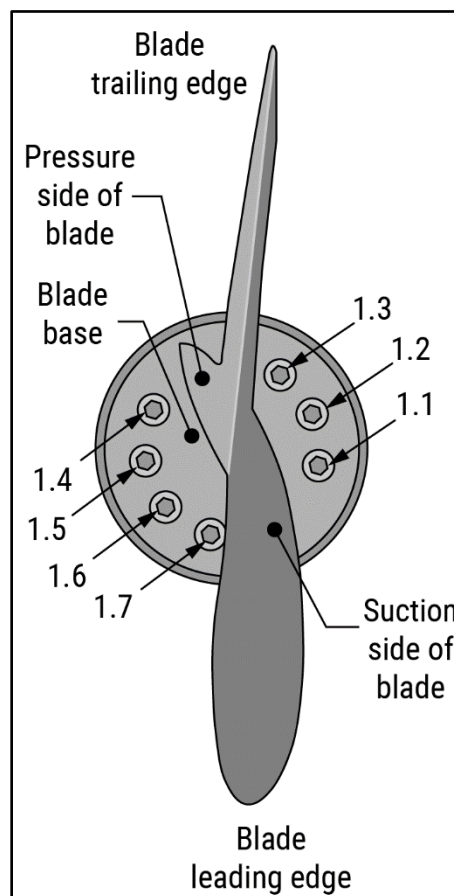
The CPP system consisted of five propeller blades, each secured to the hub by seven bolts, through a blade coupling flange, servo piston, hub cylinder assembly, and an intermediate shaft system. The bolts for each blade were situated with three on the forward side of the blade (1.1 through 1.3) and four on the after side (1.4 through 1.7) (see figure 3). Bolt no. 1 (1.1) began at the 4 o'clock position, and bolt holes were numbered in the counterclockwise direction. When facing the blade base, the trailing edge of the blade was in the 12 o'clock position, and the leading edge of the blade was in the 6 o'clock position.

**Figure 3.** *Maunalei* propeller blade no. 1 bolt positions.

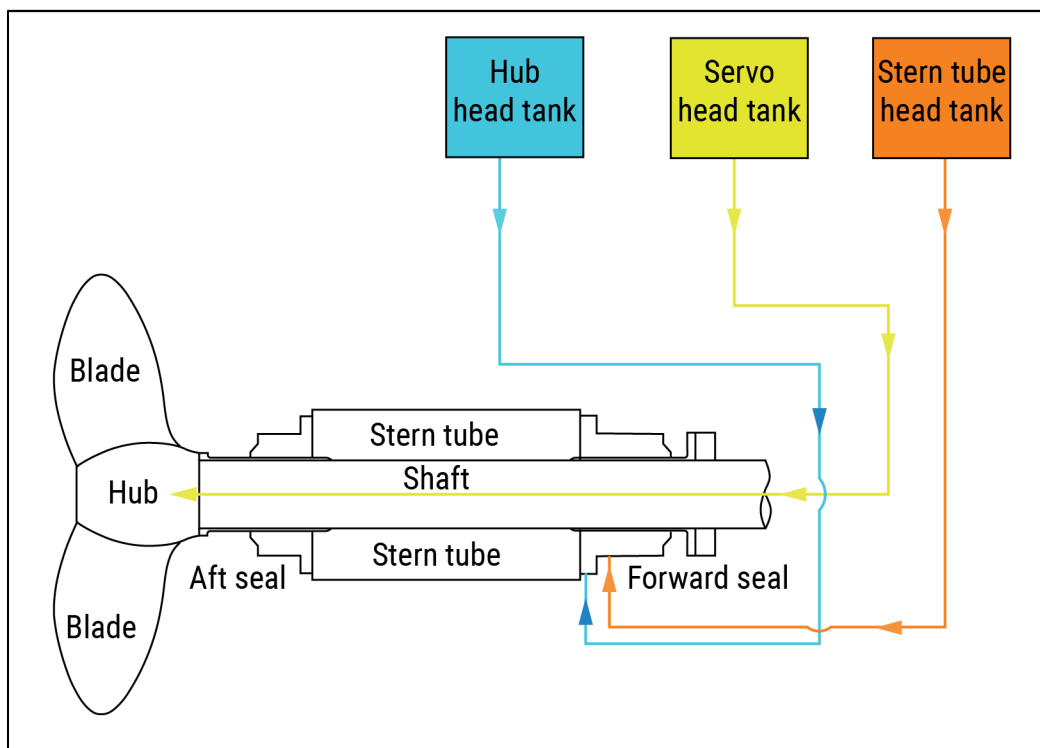
The CPP system contained three separate hydraulic oil systems: a hub lubricating system, a stern tube lubricating system, and a servo hydraulic system (see figure 4). The hub lubricating system was kept under a static pressure by a separate hub head tank; at the time of the casualty, the hub lubricating system was the only

system losing hydraulic oil. The stern tube lubricating system provided lubricating oil to the stern tube bearings and seals; a stern tube head tank kept the bearings and seals under static pressure. The servo hydraulic system was enclosed in the servo cylinder of the hub and was fed by a hydraulic power pack. The hub and stern tube lubricating systems had separate, independent hydraulic systems and head tanks but shared a common forward stern tube lip seal. The sealing surface of the lip seal was maintained by slightly higher pressure in the hub system. Upon a large loss of hydraulic oil in the hub system and head tank, the system head pressure would be reduced, and the lip seal would no longer be able to prevent oil flowing from the stern tube hydraulic system into the hub lubricating system.

**Figure 4.** Simplified schematic of hydraulic oil system head tanks for CPP system on *Maunalei*.
