Grounding of the Bulk Carrier *American Mariner*

On January 7, 2023, about 0734 local time, the bulk carrier *American Mariner* had begun transiting outbound in the Vidal Shoals Channel, near Sault Ste. Marie, Ontario, en route to Superior, Wisconsin, when the vessel grounded and sustained damage to three ballast water tanks (see figure 1 and figure 2).¹ No pollution or injuries were reported. Damage to the vessel was \$600,000.

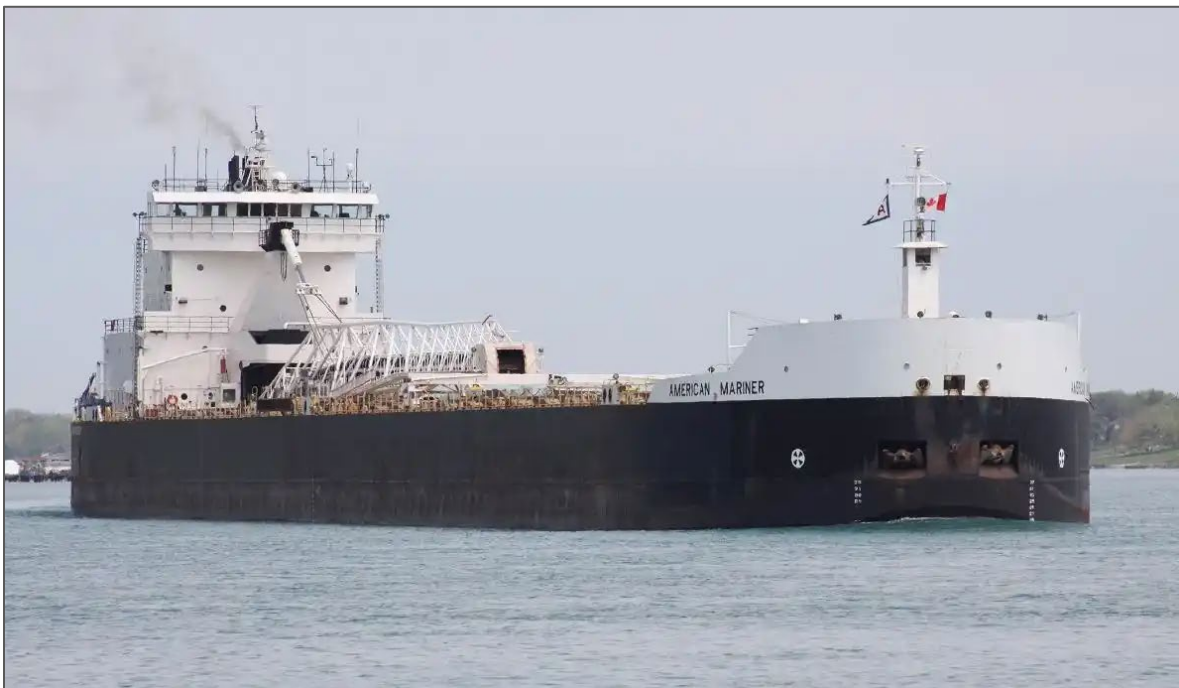
Figure 1. *American Mariner* underway at unknown date before the grounding. (Source: US Coast Guard)

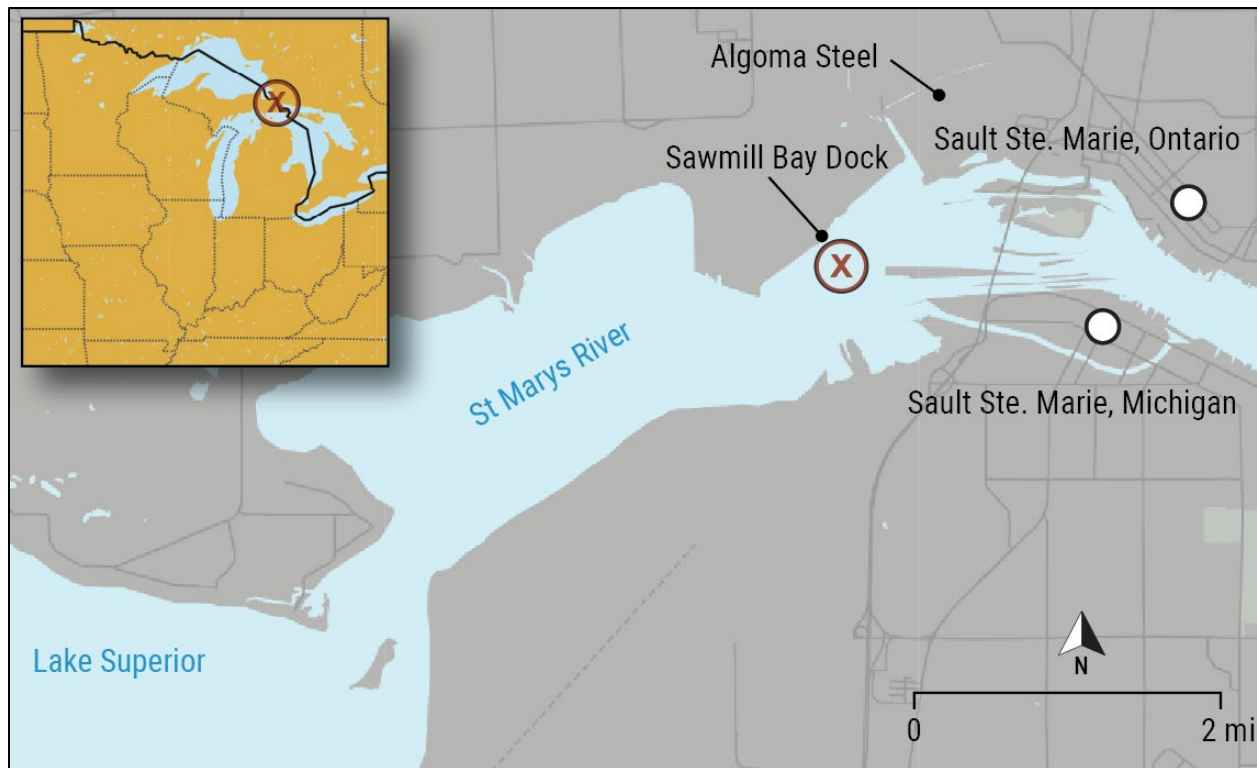
Figure 2. Area where the *American Mariner* grounded, as indicated by a circled X. (Background source: Google Maps)

Crewmembers reported a sound and “shudder” while the master was maneuvering the vessel into the Vidal Shoals Channel; they then discovered that one of the vessel’s ballast tanks appeared to be communicating with the lake, and therefore was likely damaged. Although the master stated the ship was in the channel, the shoals were located immediately outside the buoyed channel and the AIS data from that time showed the vessel on the far (southeast) side of the channel. After the vessel was drydocked, damage to three ballast tanks at the bilge chine along the port side was found—including breaches of the hull to hold no. 6. Given the crew reports, damage to the port chine and bottom plating, and the vessel’s position at the southeast edge of the channel, the *American Mariner* grounded on Vidal Shoals at the edge of the channel.
