MIR-24-37

Fire aboard Passenger Vessel *Spirit of Boston*

Commonwealth Pier, Boston Harbor

March 24, 2023

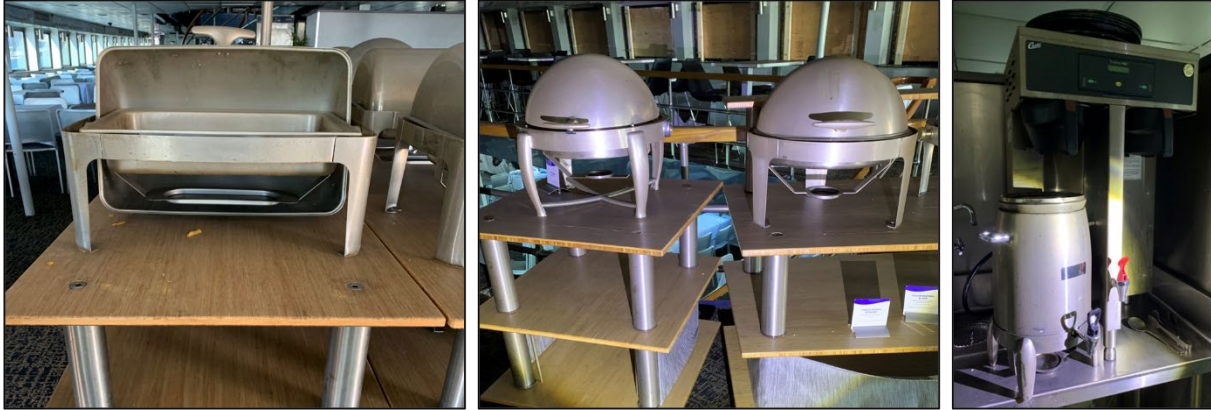
Figure 4. Left to right: *Spirit of Boston* chafing dishes (with the chafing fuel heating canisters removed) in passenger areas on deck 2 and deck 3 after the fire. Exemplar coffee maker and dispenser used aboard *Spirit of Boston* with the chafing fuel heating canisters removed from under the dispenser.

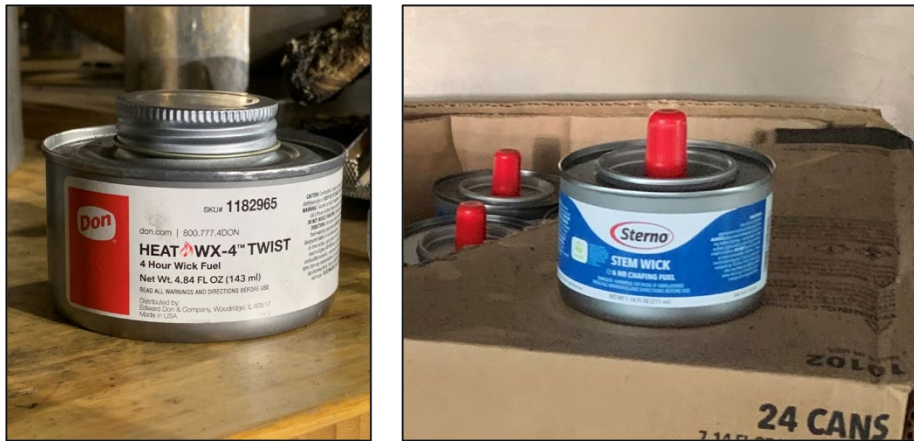
Figure 5. Chafing fuel heating canisters used aboard *Spirit of Boston*.

City Cruises US provided two types of chafing fuel heating canisters for the employees to use aboard the vessel: (1) "4-hour Wick Fuel" and (2) "Stem Wick 6-hour Chafing Fuel" (see figure 5). Each was manufactured by a different company.

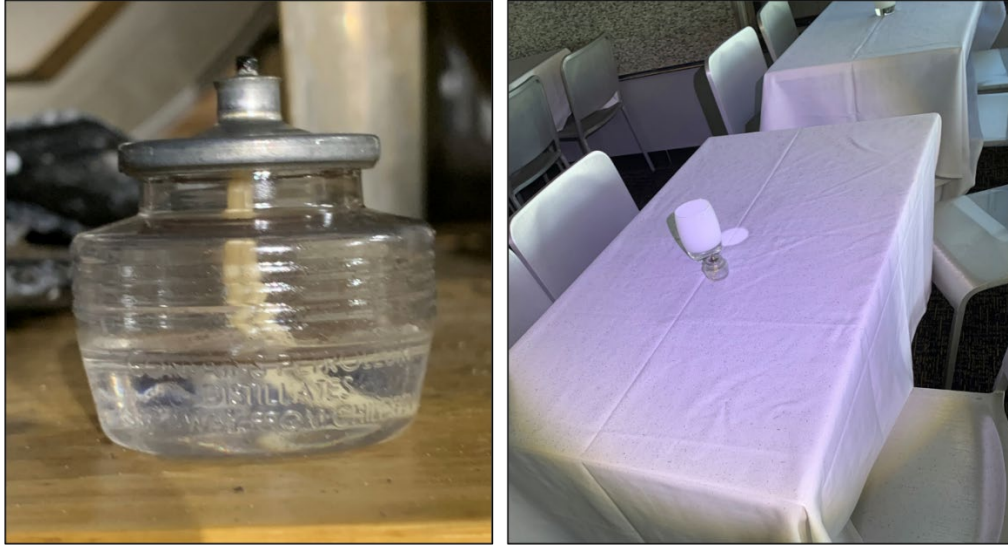
On deck 1, there were several tables in the passenger areas. The hospitality staff set each table with lit disposable liquid wax candles placed inside glass candleholders. Figure 6 shows a sample of the type of disposable liquid wax candles used aboard the *Spirit of Boston* and typical candle placement on a dining table in a passenger area.

Figure 6. Left to right: Liquid wax candle used aboard *Spirit of Boston*. Candle removed from glass candleholder on table in the passenger area on deck 2 after the fire (the hospitality staff were resetting the tables at the end of the March 24 dinner cruise).

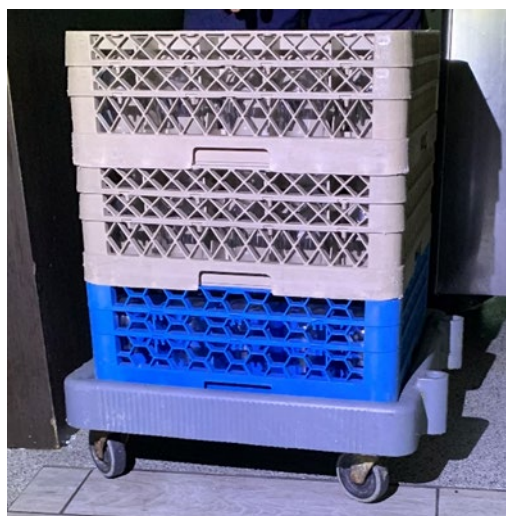
About 2250, server assistant 2 entered the deck 1 wait station and saw gray smoke near the wait station’s overhead light. She heard “something down below” described as “nit-nit-nit.” She looked down toward the deck and saw “a spark moving around” under one of the two plastic glassware rolling carts in the wait station (figure 7 shows an exemplar cart). She did not see any flames and notified the senior restaurant manager that “something [was] burning.”

Figure 7. Exemplar plastic glassware rolling cart used aboard *Spirit of Boston*.

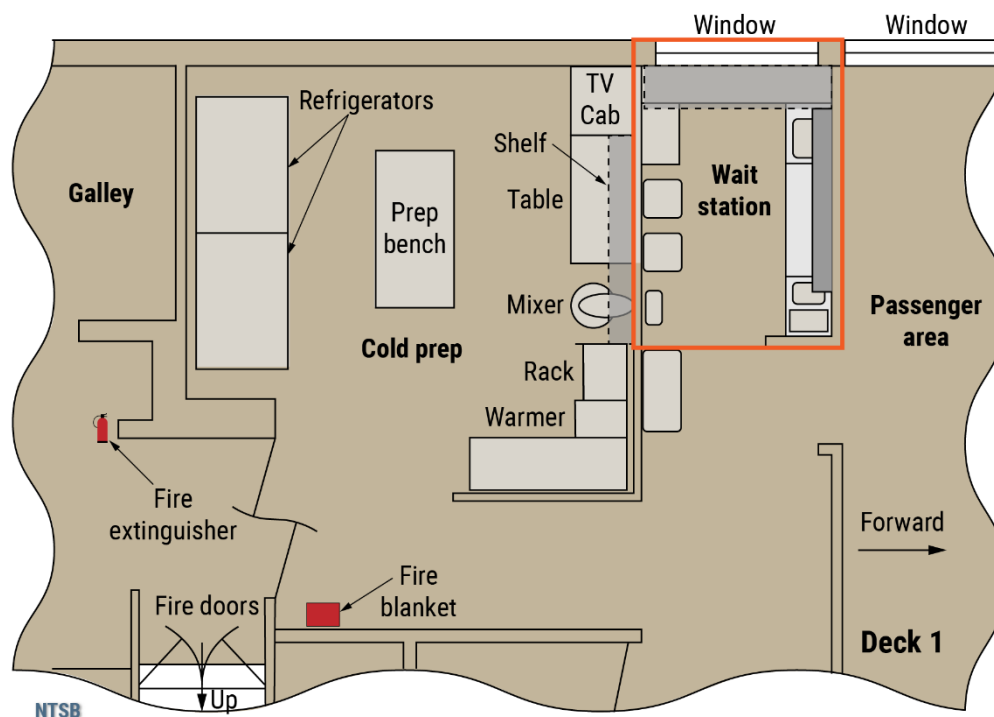
The *Spirit of Boston* was equipped with two fire pumps in the engine room and six fire stations around the vessel. There were 12 fire extinguishers located throughout the vessel. In the area of the galley, one of these fire extinguishers (ABC-type) was bracket-mounted on the bulkhead adjacent to the entrance to the cold prep room, aft of the wait station on deck 1.¹⁰ A fire blanket was mounted on the bulkhead in the passageway across from the cold prep room.¹¹ Figure 13 shows the locations of the ABC-type fire extinguisher and fire blanket in the galley area.

Figure 13. *Spirit of Boston* galley area layout on deck 1. The deck 1 wait station—where the hospitality staff saw the fire—is outlined.
