January 14, 2025

MIR-25-01

## Contact of *Kitty* Tow with Algiers Lock Gate

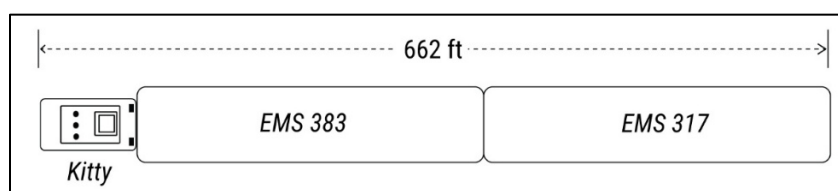
The two tank barges, owned and operated by Enterprise Marine Services, LLC, were strung out with the *EMS 317* (built 2004) at the head of the tow and the *Kitty* faced up to the *EMS 383* (built 2013) at the rear of the tow (see figure 4). Each barge was 297 feet long by 54 feet wide and loaded with about 24,000 barrels of light cycle oil. The deepest draft of the tow was the loaded barges (10 feet). The overall length of the tow was 662 feet, and the width was 54 feet.

**Figure 4.** *Kitty* tow configuration.

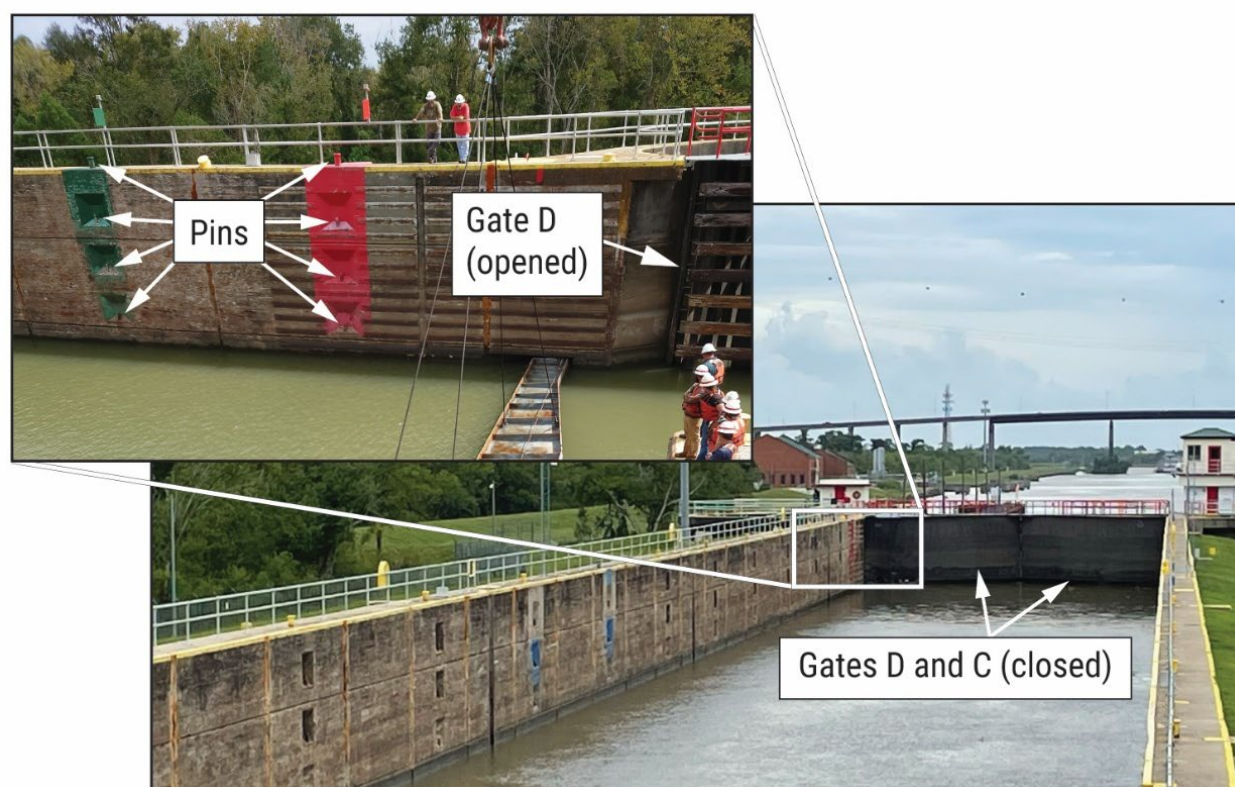
The lock operator requested the *Kitty* have two crewmembers at the head of the tow and its bumpers (fenders) ready as the tow entered the lock. The lock operator also instructed the captain to proceed down and tie up the head of the tow at one of the green pins (about 66 feet from the closed lock gates) on whichever side of the lock he preferred (see figure 5).<sup>6</sup>

**Figure 5.** View downstream (looking southwest from chamber) of the Algiers Lock, showing the area where the red and green pins are located and closed Gates C and D. Inset shows the red and green pins' proximity to Gate D.
