January 17, 2025

MIR-25-03

Grounding of Cargo Vessel *Bonnie G*

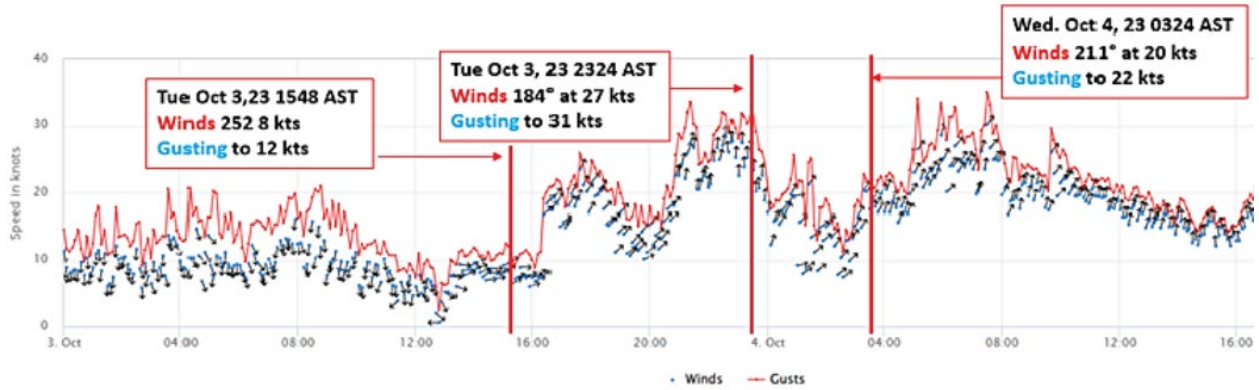
Investigators collected data from the Charlotte Amalie Harbor weather station, located about 3.5 miles east of the grounding location, to determine the conditions in the hours leading up to the grounding. An excerpt from a 24-hour plot of the winds and tide information is included in figure 8. The first bar near the time of departure from St. Croix indicated winds from the south-southwest at 8 knots. As the ship approached St. Thomas, the period of strongest winds was noted immediately around the time of the attempted docking, with winds from the south at 27 knots. The winds began to subside while the *Bonnie G* was anchored and began to drift with winds from the south-southwest at 20 knots. The winds again increased to above 30 knots around the time the vessel crew was being rescued.

Figure 8. Graphed wind observations recorded at the Charlotte Amalie Harbor weather station on October 3 and 4, 2023. Red bars indicate the approximate times of the *Bonnie G*'s departure from St. Croix, arrival into Crown Bay, and the grounding. (Background source: NOAA)
