Marathon Pipe Line LLC
Operational Records
Title & Contract Transmittal Form

Roxana - Patoka Woodpat 22"

The triggering event for this Risk Assessment was an ILI tool run in March of 2017.

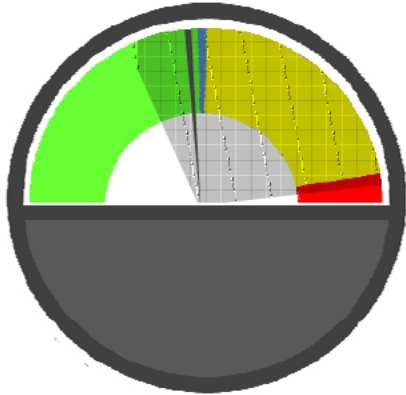
Weather/ Natural Forces (WNF)

Average	MPL Average
4.06	4.23
Range	5% Indicator
3.16 - 8.00	6.25

Feet Scoring in Top 5%	32,266 (11%)
Earthquake Rank	Moderate
Hurricane Rank	Low
Flood Hazard Rank	High
Landslide Rank	High
Subsidence	Present
Watercrossings ≥ 100 ft.	6
Max Watercrossing Width	1870 feet
WNF Related Incidents	0

High WNF score for the first 5.5 miles of the line and moderate for the next 2 miles. This location has a medium Earthquake rank and Karst present, also high Flood rank (close to the Mississippi River) and high Landslide rank.

All of the remaining locations with a high (top 5%) WNF score are at waterway crossings. There were four (4) waterways with a high WNF score not in the WWX program. They were reviewed by the Program Leader and determined to not be a concern (details on following pages). There were 6 waterways with high WNF score that are managed by the WWX inspection / repair program.

-Ops asked about the WWX at HWY 143 near Edwardsville - there's submar matting over the creek. We visually inspect them after flooding events. These were installed in 2015 due to the waterway encroaching on our pipe ROW. The matts are considered stable.

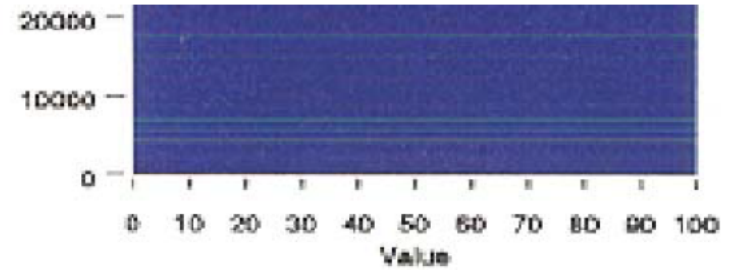
Earthquake Hazard Rank

FEMA Earthquake hazard map. The part of the line closer to Wood River is in a higher Earthquake rank zone.

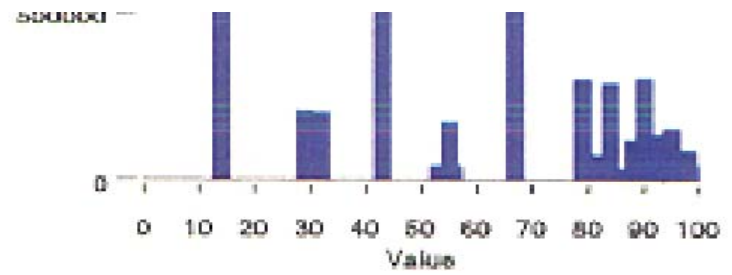
Landslide Hazard Rank

FEMA Landslide hazard map. The part of the line in Wood River is in a higher Landslide rank zone.

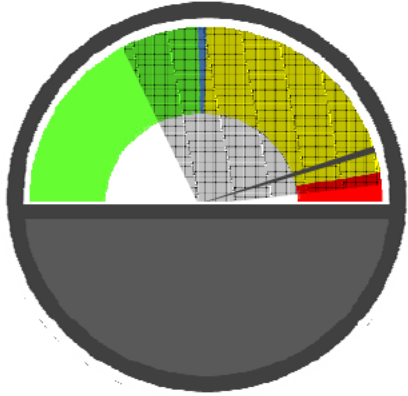
Likelihood of Failure (LOF)

Feet Scoring in Top 5%	23,198 (8%)
Threats Scoring in Top 5%	EC IC MD WFD WNF
Max LOF Score	4.69 (175 feet)

Average	MPL Average
4.11	2.47

Range	5% Indicator
1.80 - 4.69	4.26

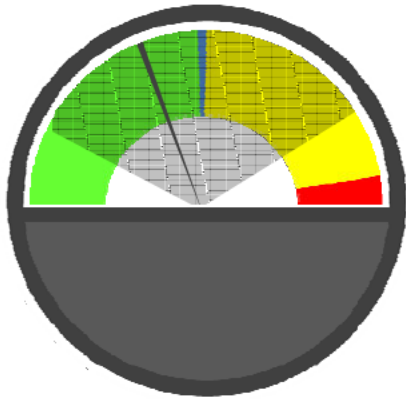
Consequence of Failure (COF)

Average	MPL Average
2.40	3.08
Range	5% Indicator
1.00 - 5.61	6.47

Feet Scoring in Top 5%	0 (0%)
HCA Direct Impacts	HPA OPA ECO DKW
HCA Indirect Impacts	HPA OPA ECO DKW CNW
Predominant Land Use	Cultivated Crops
Max Estimated Release Volume	13,631 bbls.
Product Type	Crude
HVL Buffer Zone	N/A
Max COF Score	5.61 (789 feet)

High Population Areas around Roxana and Edwardsville.

ECO impacts in South Roxana, and at Carlyle Lake around the 48 mile mark. The tributaries into Carlyle Lake also have a DKW impact.

The highest calculated Rupture volume is 13,631 bbls and is [REDACTED]. This location is relatively low in elevation, and results in a larger drain-up volume.

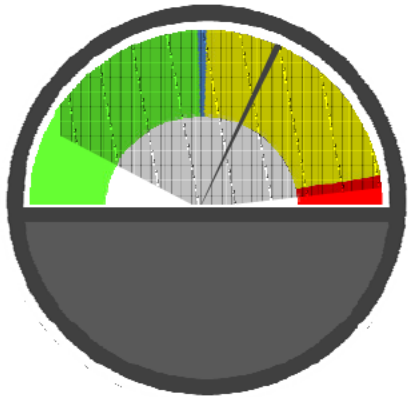
Risk of Failure (ROF)

Feet Scoring in Top 5%	41951 (15%)
Max ROF Score	24.36 (9 feet)
Begin Measure	[REDACTED]

Average	MPL Average
9.90	7.40

Location with highest ROF is at [REDACTED] with an ROF score of 24.36. This is near [REDACTED] and is caused mainly by the high COF score where it intersects an HPA in combination with the high WNF score. Everything within the first [REDACTED] as a high ROF due to this HCA impact.
