Edwardsville Supplemental Response

Marathon Pipe Line LLC

October 2023

Edwardsville Failure Analysis

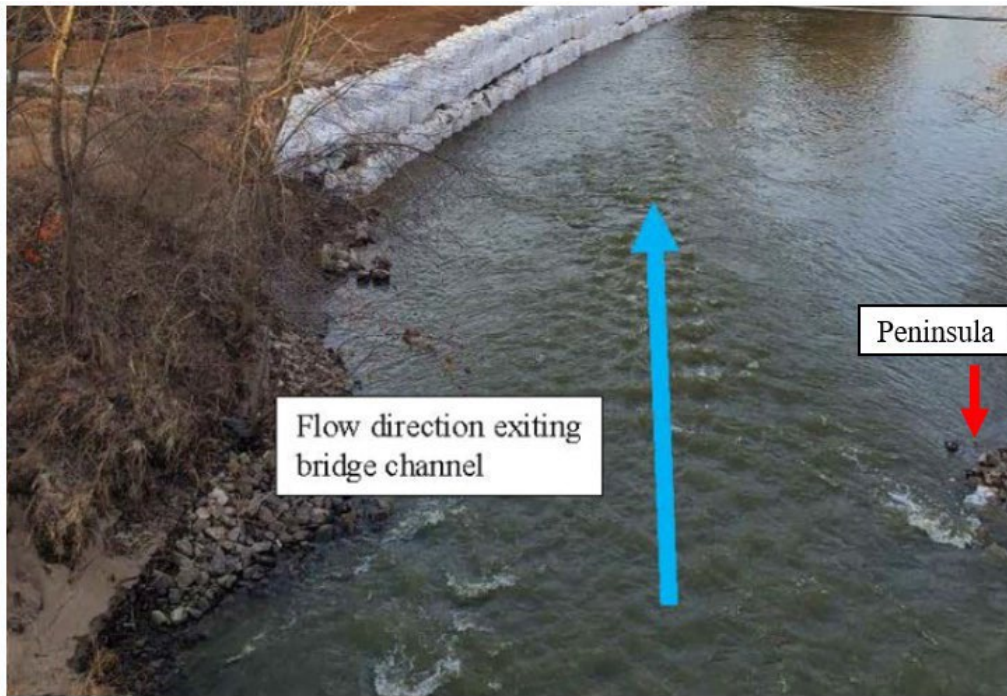
Figure 6: Cahokia Creek Flow with Peninsula

To prevent a recurrence of the geohazard conditions that caused the release, MPL completed site stabilization improvements. To prevent further erosion, a 190-foot-long super-sack wall filled with sand three sacks high was placed along the stream bank near the accident location. MPL placed sloped imported clay fill at no greater than a three horizontal to one vertical slope with a preference to reduce the slope inclination as much as practical while still establishing the minimum depth of cover on the repaired pipeline. To prevent water from crossing the pipeline, MPL constructed a temporary berm. The rip rap peninsula installed off the north bank immediately downstream of the Edwardsville Road bridge was removed with the approval of Illinois Department of Transportation (IDOT) to divert the water flow away from the impacted stream bank. The figure below shows the water flow with the peninsula intact. Notice the water's trajectory toward the south bank, which coincides with the failure's location.

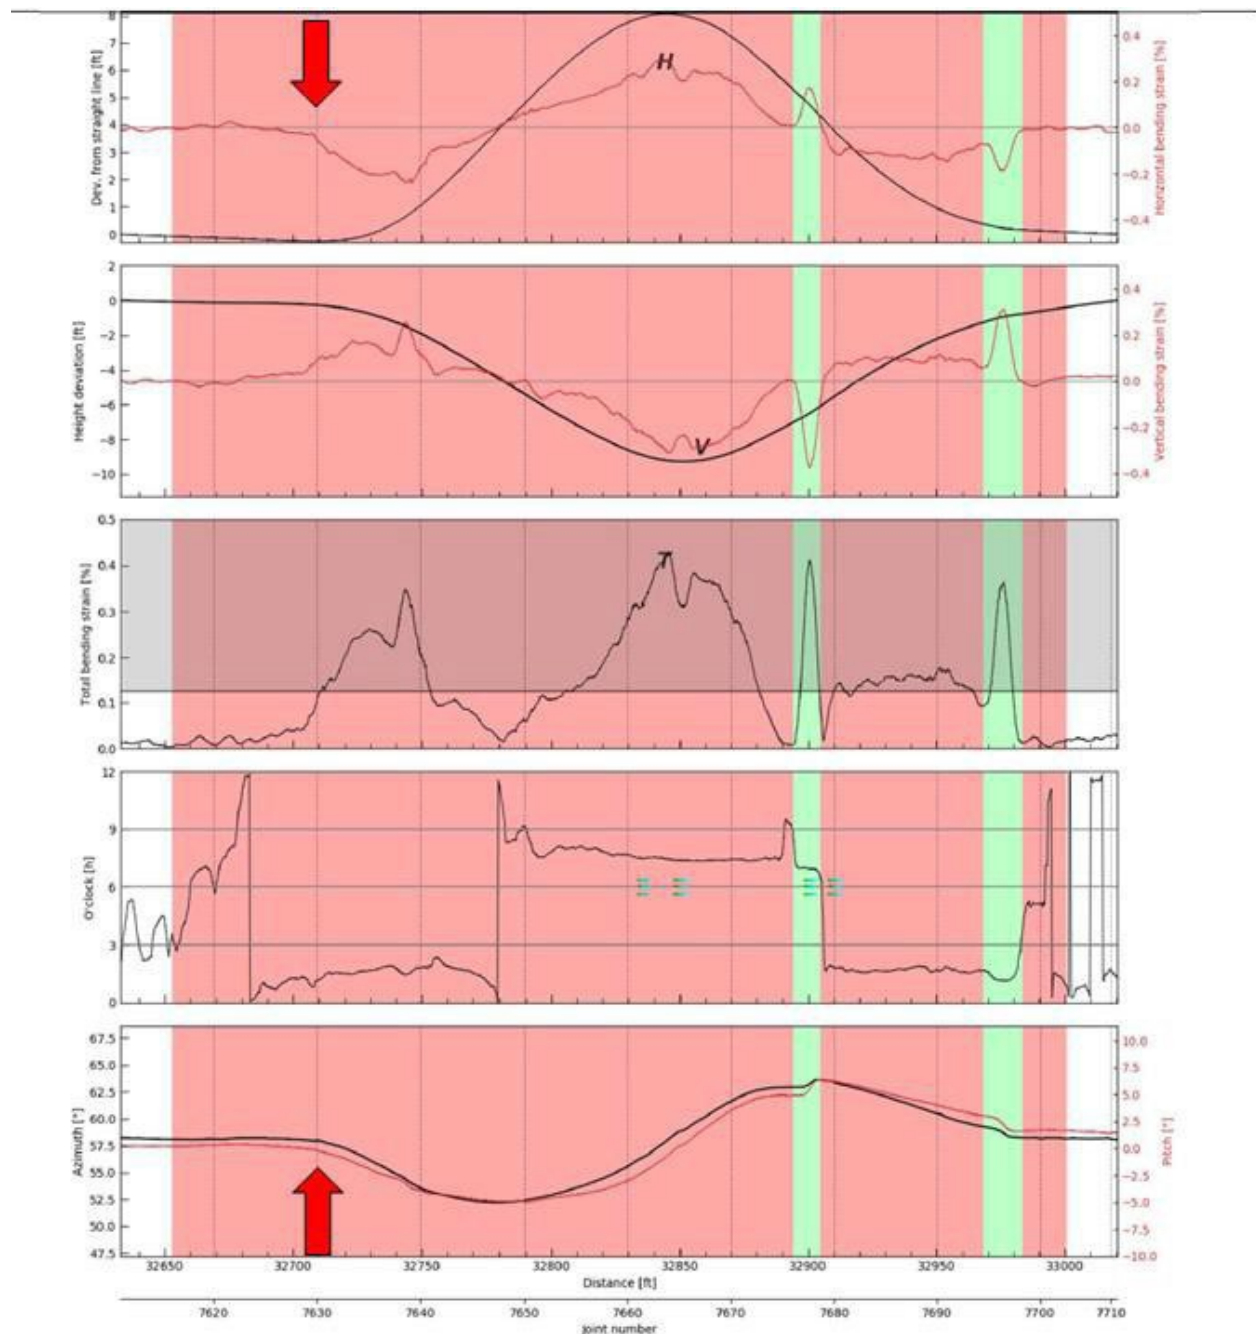
Figure 3.1: Bending Strain Site #7610 (ref: Strain Comparison Report)

The bending strains based on the inspection from October 28, 2021 are reproduced in Figure 3.1. The maximum combined bending strain at this location is 0.41%. The girth weld that failed is #7630, located at odometer 32709.3 ft, and is annotated in the image with the red arrow. The IMU data indicates approximately 8-ft of horizontal deviation from a straight line across the impacted area and 9.3 feet of vertical deviation from a straight line across the impacted area.

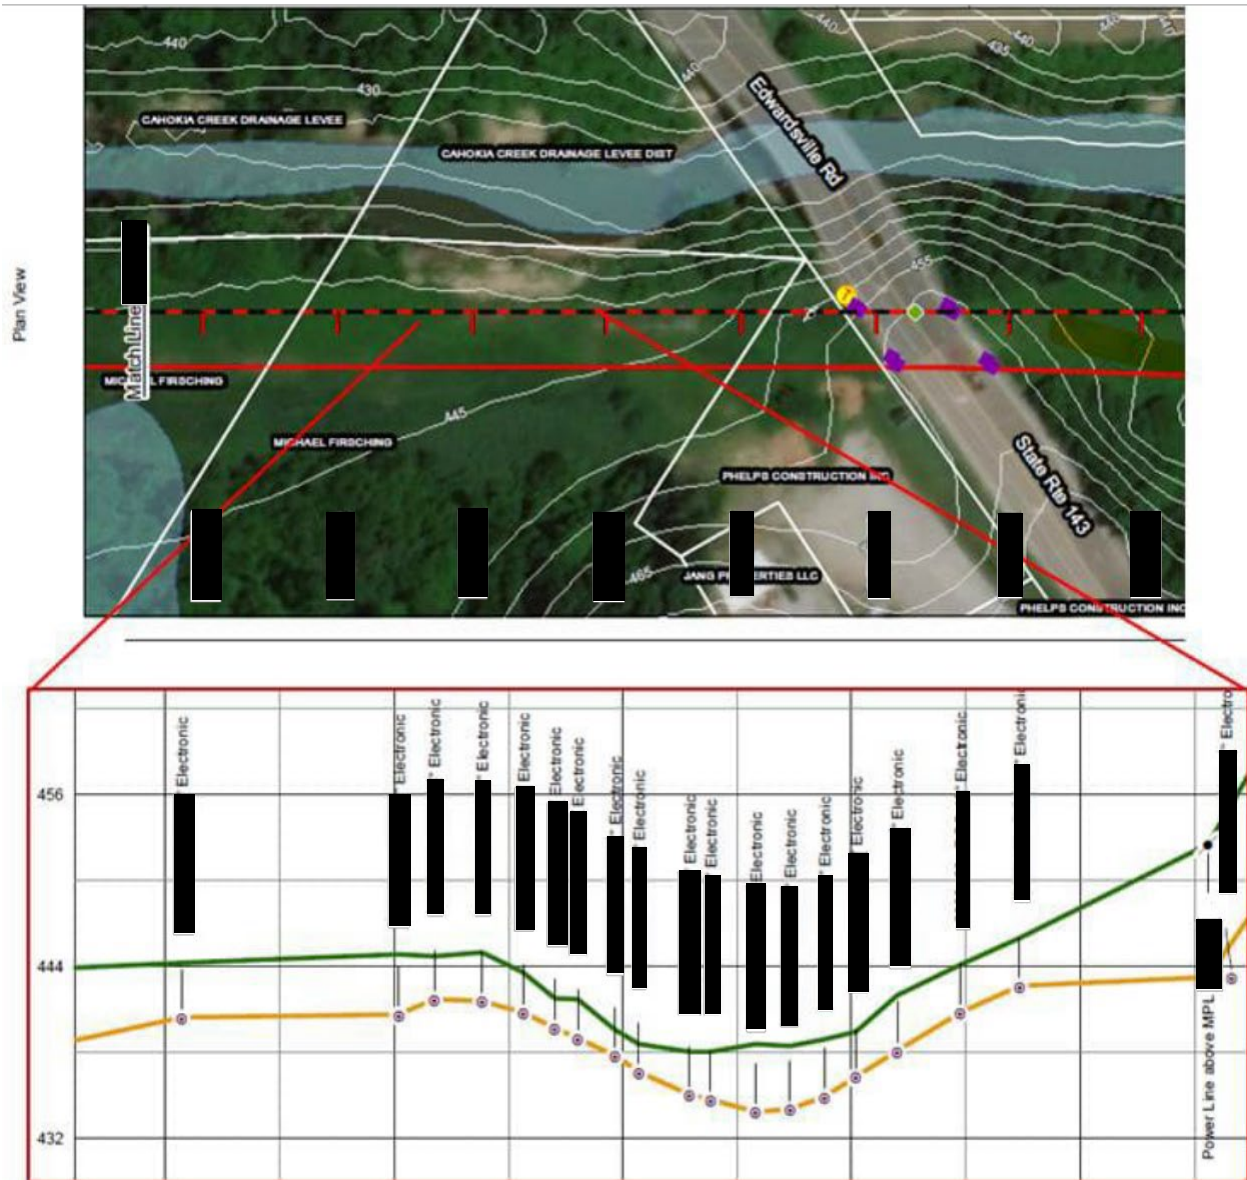
Figure 3.3: Alignment Sheet Information

Information showing the original pipeline construction location from 1949 was not available. Marathon provided alignment sheets with information on the surface elevation, top of pipe elevation, and depth of cover. The information from the alignment sheet near the failure is enlarged in Figure 3.3. This information does not reflect as-built conditions but was collected prior to the incident (the alignment sheet was dated February 18, 2022). The information shows that the ground elevation near the failure was characteristic of a depression with the low-point approximately 4-6 feet lower than the surrounding area. This

information was confirmed by satellite imagery showing a drainage channel crossed over the pipeline near the failure location. The alignment sheet also confirmed the depth of cover near the failure varies from [REDACTED].

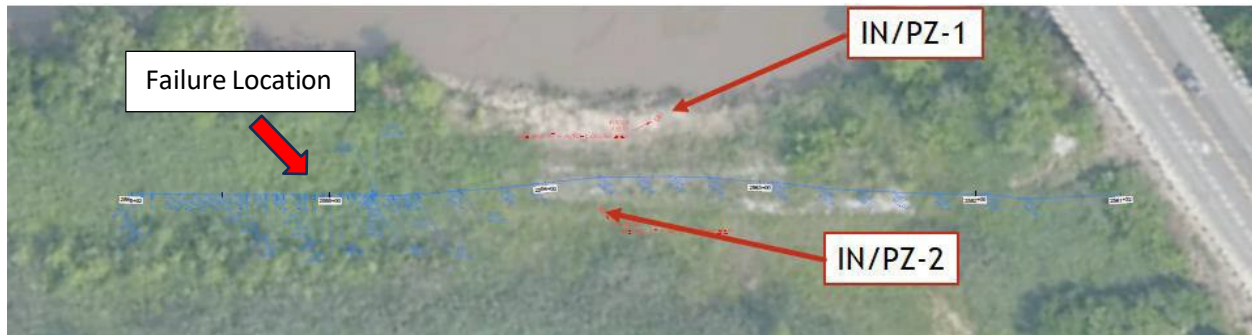
Figure 3.4: Borehole Locations

Soil characteristics were collected from two boreholes located near the failure as shown in Figure 3.4. Based on the depth of cover survey, the soils of interest would occur between 3 and 8 feet deep. An image of the data from the IN/PZ1 borehole is provided in Figure 3.5. The IN/PZ1 borehole shows soft to medium stiff clays at the pipeline depth. The information from the IN/PZ2 borehole is provided in Figure 3.6,

showing soft clay at the pipeline depth. The pocket penetration values for unconfined compressive strength varied from 0.5 to 1 ton per square foot between the two boreholes. The lab results indicated a dry unit weight of 100.3 pcf and a moist unit weight of 125.8 pcf.

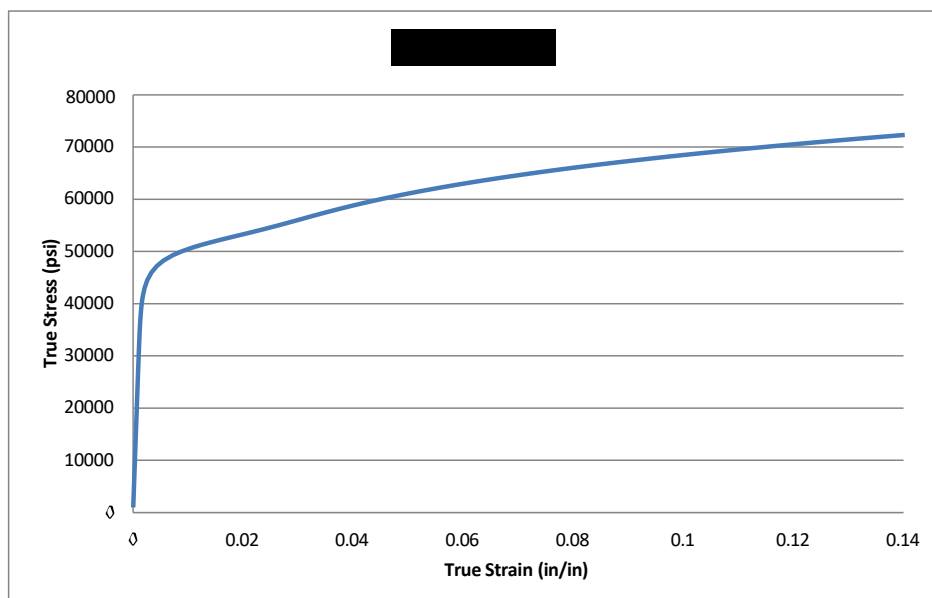
Figure 4.1: API [REDACTED] Elastic Plastic Material Properties

The numerical model was evaluated using the Abaqus general-purpose finite element code and utilized beam elements (type PIPE31) to represent the pipeline. The beam elements were modeled as 22-inch outer diameter with a nominal wall thickness of 0.344-inches. The effective weight of the elements was modeled as 1,370 lb/in³ accounting for the weight of the steel pipe and internal contents. Elastic-plastic material properties were specified for the pipe material based on the specified minimum properties for [REDACTED] pipe material. A Ramberg-Osgood formulation was used to generate the true stress – true strain curve based on a yield strength of 46,400 psi and an ultimate tensile strength of 63,100 psi. The resulting material curve is shown in Figure 4.1.

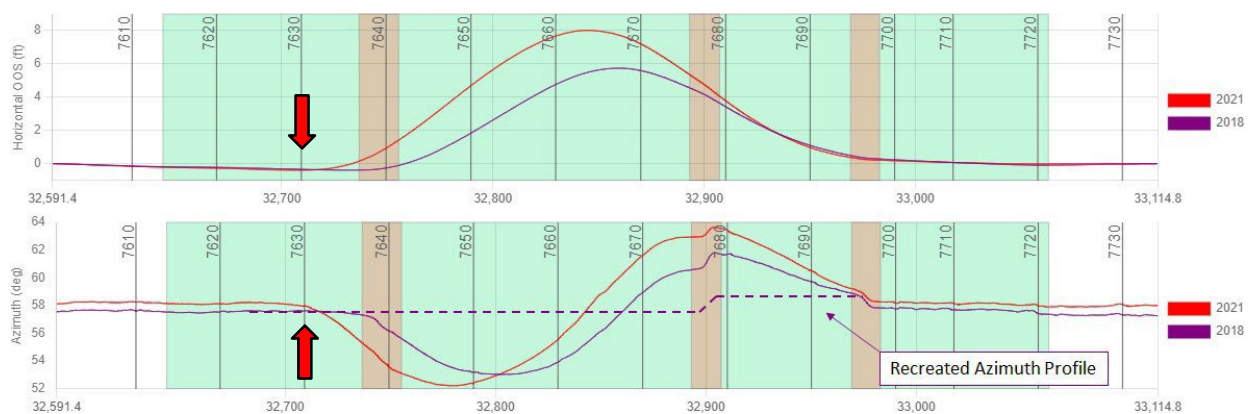
Figure 4.2: Azimuth Recreation

Figure 4.2 provides a comparison of the horizontal out-of-straightness profiles and azimuth angles from the 2018 and the 2021 inspections. The 2012 data was not included in the comparison as the heading

angles and out-of-straightness profile were not considered accurate as discussed in the previous section. Both inspections show similar behavior in the azimuth angle consistent with external loads acting on the pipeline. The azimuth angle is approximately 58-degrees near the beginning and end of the bending strain and movement area in both inspections. Two minor 2-degree horizontal manufactured bends appear in the data near odometer 32,900 feet and 39,990 feet. This information suggests that the pipeline was initially laid nearly straight throughout this area with minor deviations. This pattern is typical of most pipelines. Within the displaced area, the azimuth shows a distinct “S”-shaped pattern. This pattern is produced when a pipeline is displaced from its initial location. It is reasonable to conclude that the pipeline was initially laid straight through the area and account for the two minor manufactured bends in the recreated heading profile as shown with a dashed line in Figure 4.2.

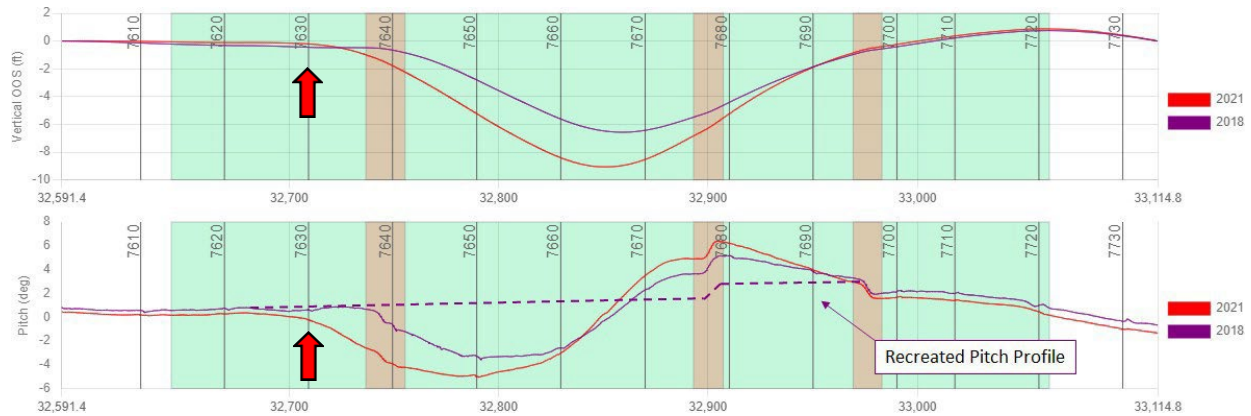
Figure 4.3: Pitch Recreation

Figure 4.3 provides a comparison of the vertical out-of-straightness profiles and the pitch angles from the 2018 and the 2021 inspections. Both inspections show similar behavior in the pitch angle consistent with external loads acting on the pipeline. Near the beginning of the movement area, both tools enter with a near-flat pitch of approximately 0.5-degrees and exit the movement area with a pitch of approximately 2-degrees. Within the movement area, three small vertical bends can be seen near odometer 32750 feet, 32,900 feet, and 33,990 feet. These vertical bends form an overbend-sagbend-overbend combination that is typical of pipeline construction at shallow crossings. The presence of these vertical manufactured bends confirms the information from the depth of cover assessment that showed a shallow drainage area at this location. It is reasonable to conclude that the pipeline was constructed with shallow bends to cross the drainage. Similar to the azimuth heading angles, the pitch angles in both inspections show the characteristic “S” shape within the movement area as a result of external loads. The recreated pitch profile is shown in Figure 4.3 with the dashed line. The recreated profile preserves the manufactured bends near 32,900 feet and 33,990 feet.

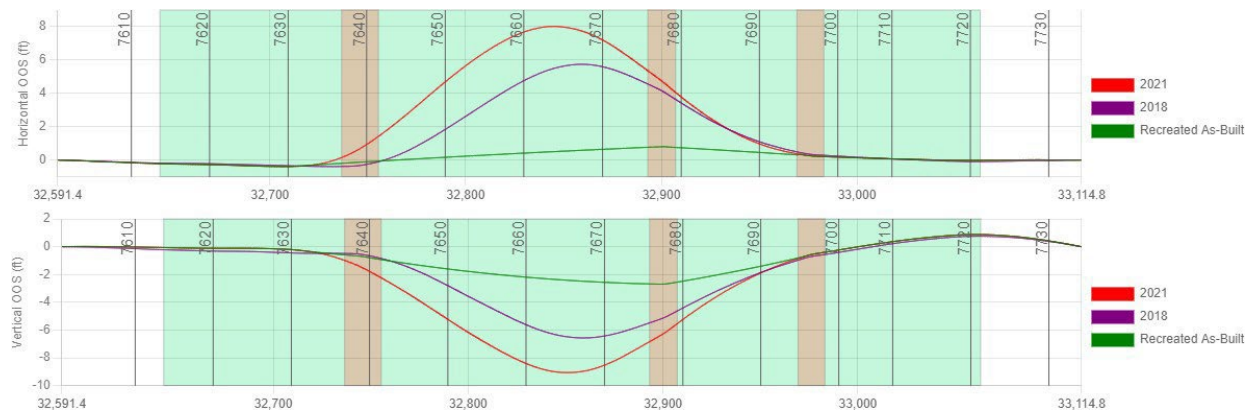
Figure 4.4: Recreated Out-of-Straightness Profiles

The resulting as-laid condition used for the baseline is shown in Figure 4.4 for both the horizontal and vertical profiles. The recreated as-built profile is shown as a green line. The horizontal out-of-straightness shows a near straight trajectory with less than 1-ft of deviation, and the vertical out-of-straightness shows an initial vertical change of approximately 3-ft. This agrees well with the depth of cover information which showed similar deviations in the ground elevation near the drain crossing.

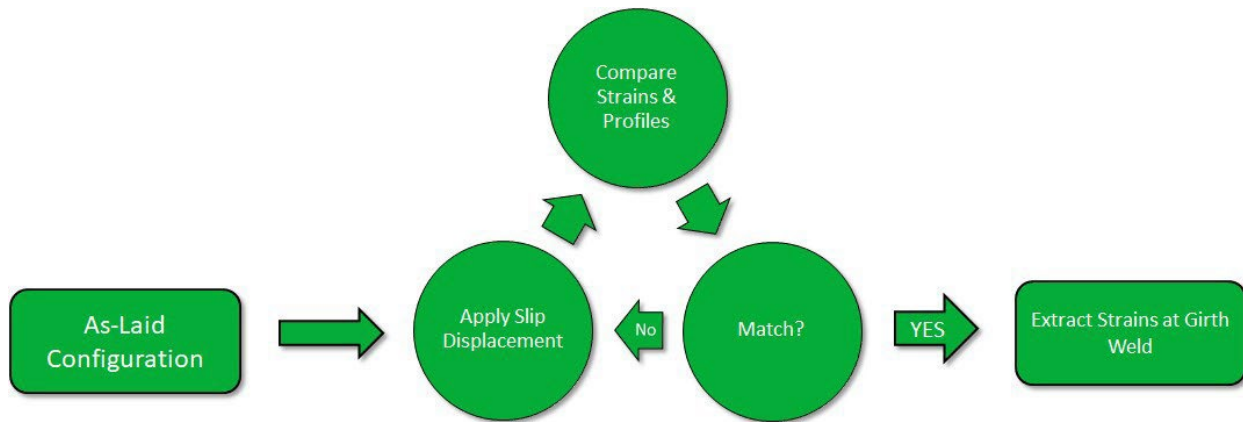
Figure 4.5: Analysis Methodology

The analysis utilized an iterative approach to determine the strain demand placed on the weld prior to failure. This approach is shown graphically in Figure 4.5. The as-laid configuration as described in the previous section was taken as the starting point for the analysis. The as-laid configuration was assumed to be constructed in a stress-free condition. Displacements were applied to the soil nodes which in turn produce pipeline displacements. The soil displacements are incrementally applied to match the conditions from the 2018 and 2021 inspections as well as the as-found measurements. The strains and resulting pipeline displacements from each increment are compared to the displacements captured from the IMU tool or the as-found survey measurements. If a good match is obtained, the strains at the girth weld of interest are extracted from the model. If a match is not obtained, the displacement profile is iteratively

adjusted until a match is obtained. For the purposes of this report, only the final calibrated models and associated results are presented.

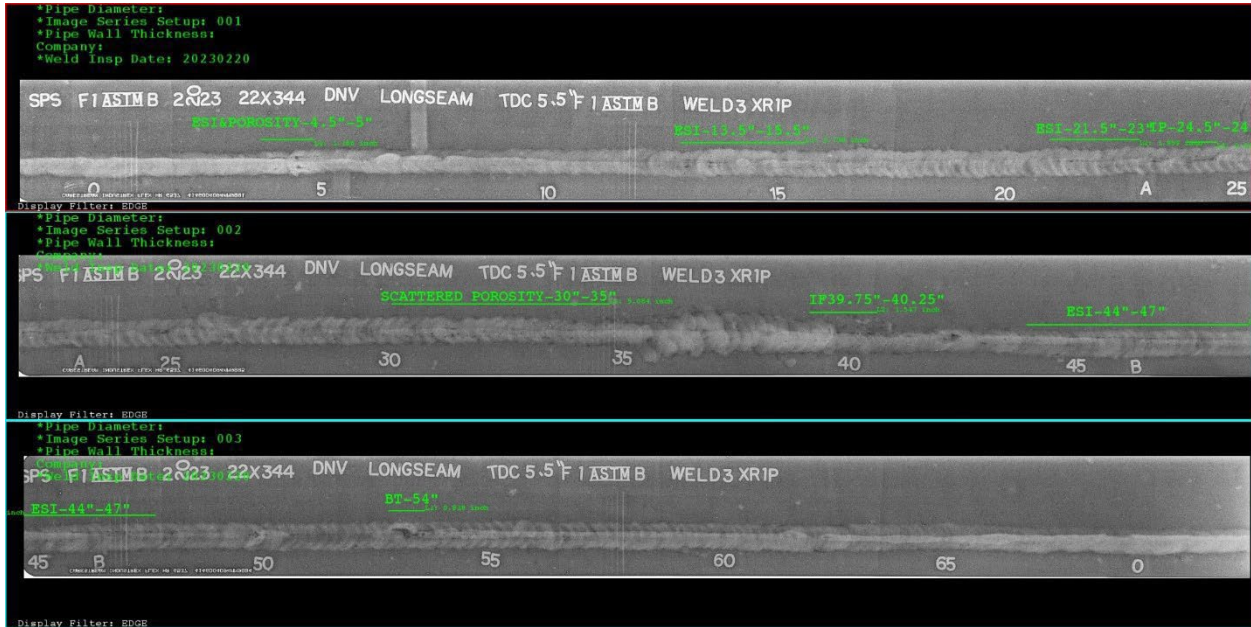
Figure 3: RT image of intact girth weld.

- Intact weld: shown in Figure 3
 - Volumetric Features:
 - Elongated slag inclusions and porosity, 0.5 inch long, 12:47 to 12:52 o'clock orientation (4.5 inch to 5 inch)

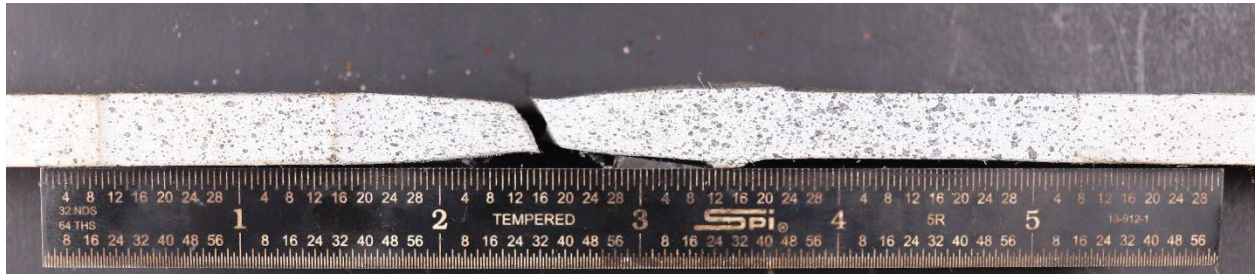
Figure 4: 12:00 o'clock orientation cross girth weld tensile.

The results were compared to the closest API 5L edition from the time of manufacturing: API 5LX, 5th Edition (1954). Tensile test (per ASTM A370) results, summarized in Table 1, respectively, are consistent with the requirements of [REDACTED]. The cross girth weld tensile test prepared at the 12:00 and 3:00 o'clock orientation failed in the weld metal with obvious signs of weld flaws (incomplete penetration and porosity). Images of all three tensiles are shown in Figure 4 through Figure 6. Videos of the DIC tests were provided in a separate file. Some of these videos failed outside the virtual extensometer as they failed in the base pipe. These results are considered further in the tensile strain capacity calculations.

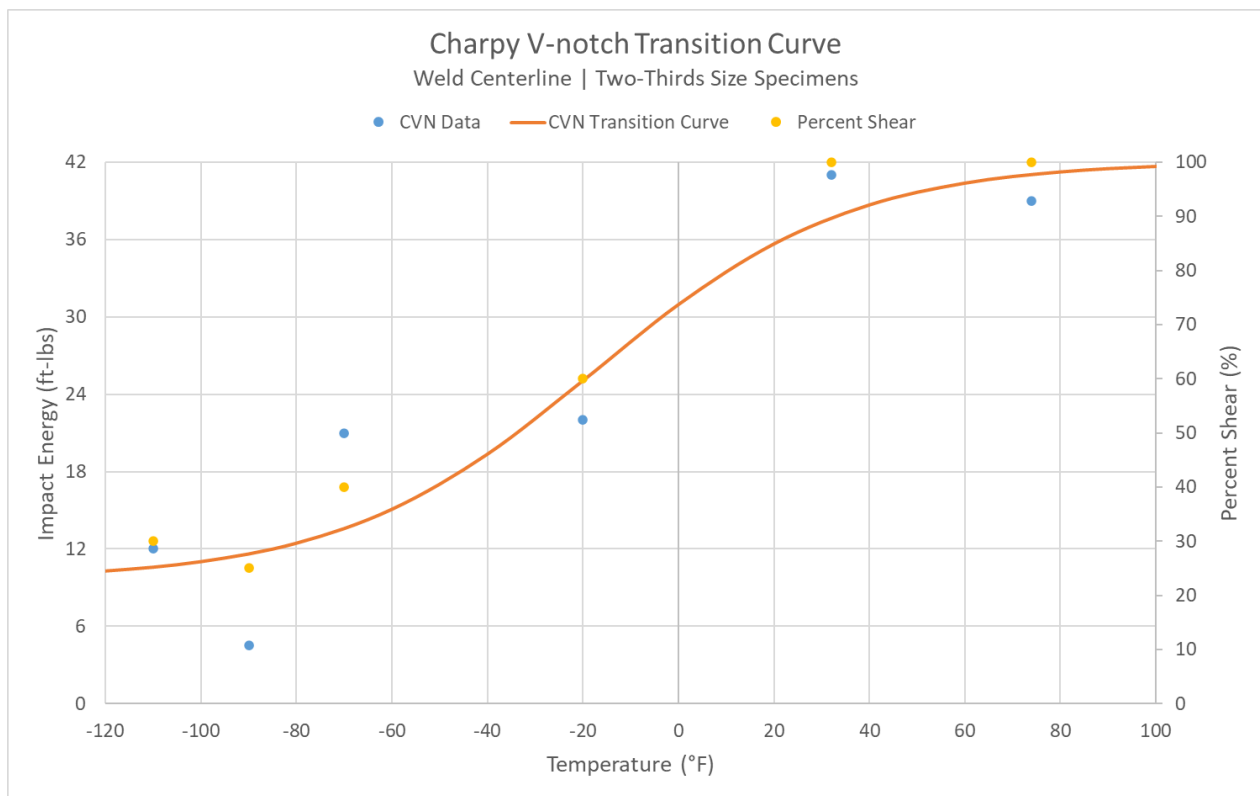
Figure 7: Girth weld centerline CVN transition curve.

Girth weld centerline and girth weld heat affected zone (HAZ), two-thirds size Charpy V-notch tests (per ASTM A370) were performed to generate a transition curve; results are summarized in Table 2. Charpy V-notch transition curves were generated using a hyperbolic tangent curve-fit (API 579, Annex 9F) and summarized in Figure 7 and Figure 8.

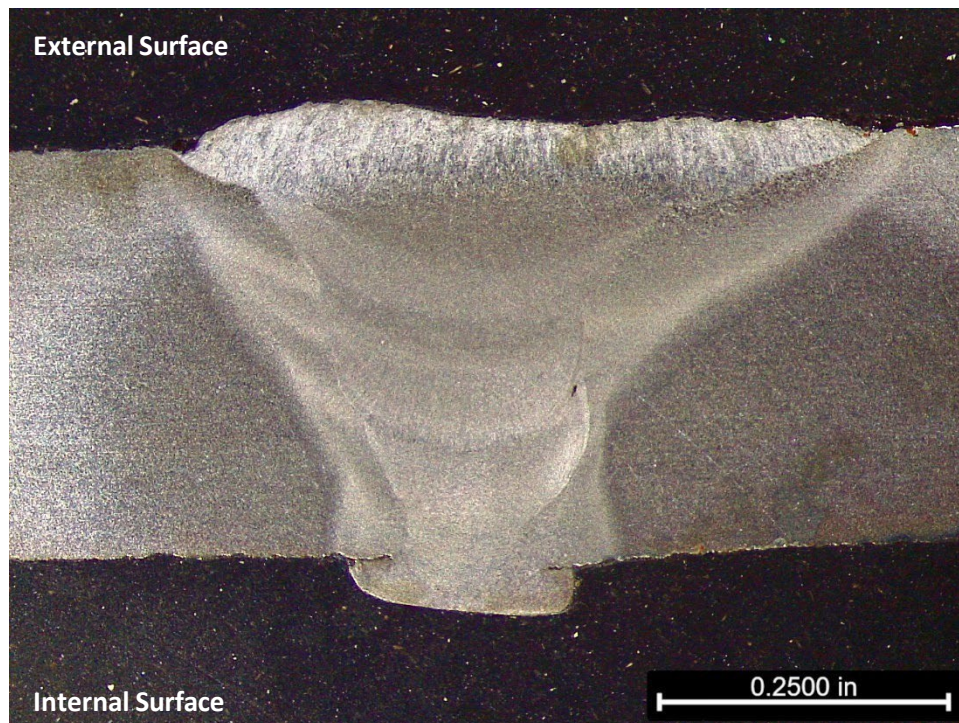
ADV prepared two metallurgical cross sections of the girth weld, one at the 12:00 o'clock and one at the 3:00 o'clock orientation. These cross sections are shown in Figure 9 and Figure 10, respectively. High-lo was identified in the 3:00 o'clock cross section, as annotated in the figure. The high-lo present at the 3:00

Figure 9: Photomicrograph of across the intact girth weld at the 12:00 o'clock orientation. Etchant is 2% Nital; original magnification is 0.6x.

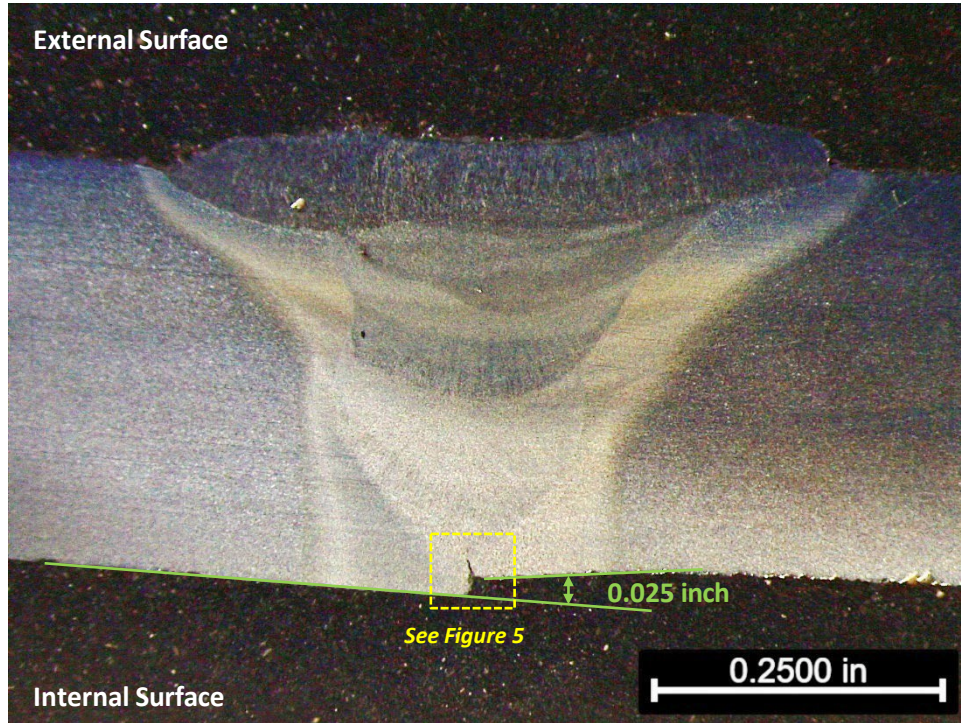
o'clock orientation is shown in Figure 11. An area of incomplete penetration was identified connected to the high-lo present. The base pipe microstructure on both sides of the girth weld is consistent with a ferrite-pearlite mixture expected for carbon steel, shown in Figure 12 and Figure 13.

Figure 10: Photomicrograph of across the intact girth weld at the 3:00 o'clock orientation. Etchant is 2% Nital; original mangification is 0.6x.

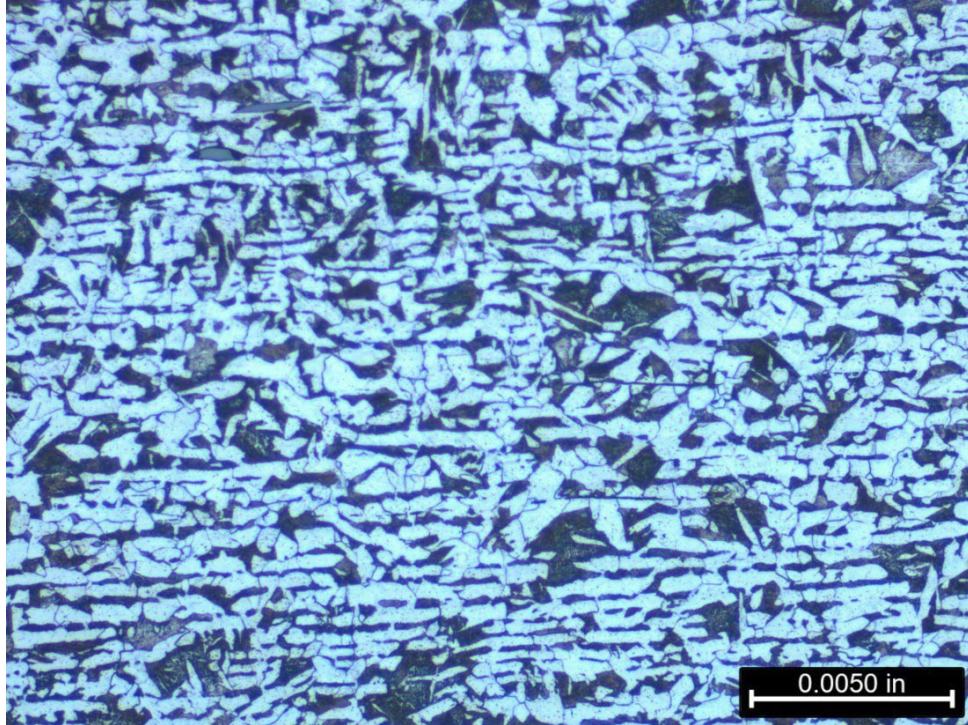
Figure 12: Photomicrograph of the base pipe material upstream of the girth weld. Etchant is 2% Nital; original magnification is 200x.

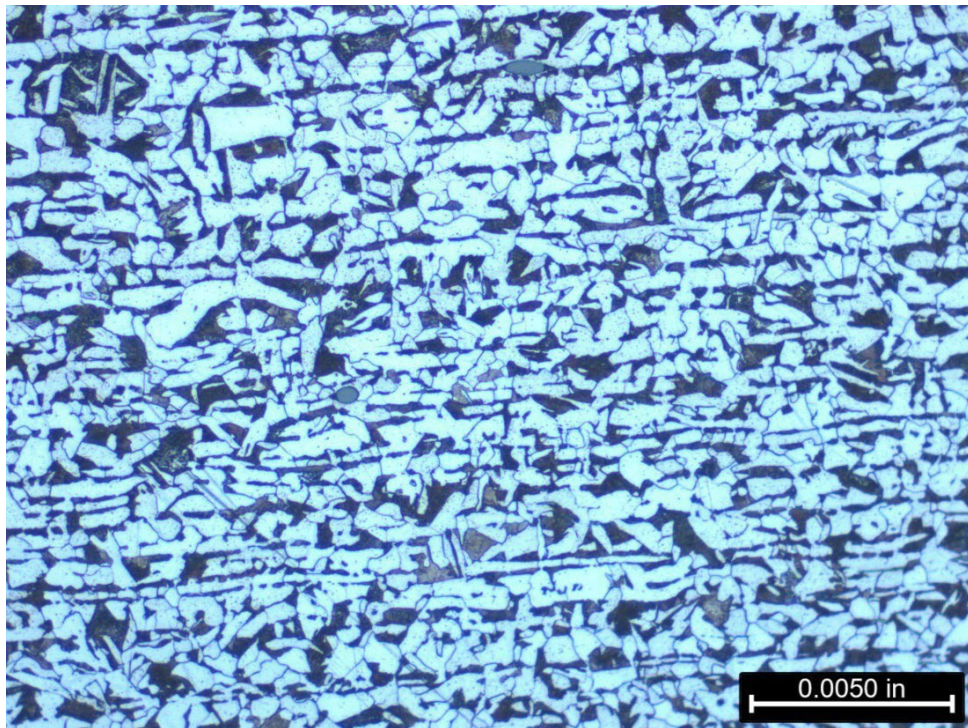
Figure 13: Photomicrograph of the base pipe material downstream of the girth weld. Etchant is 2% Nital; original magnification is 200x.

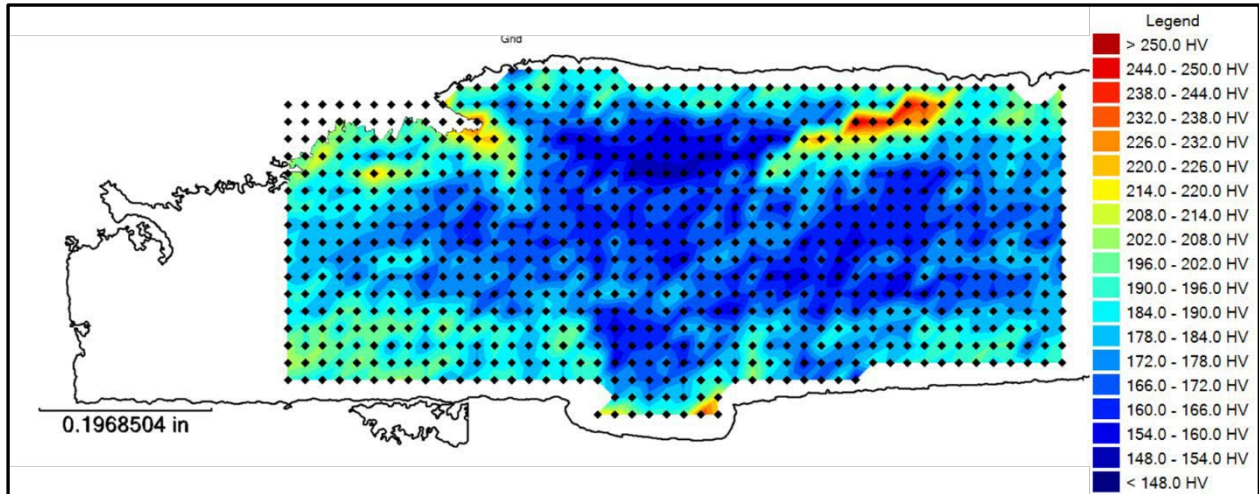
Figure 14: HV0.5 hardness map of weld, 12:00 o'clock orientation.

Full hardness maps were performed on the cross sections at a 500-gram load (HV0.5). Images of the hardness traverse are shown in Figure 14 and Figure 15, respectively. No evidence of widespread heat affected zone softening was identified. ADV further calculated a weld strength factor (weld strength / pipe strength) for each macro: both were approximately 0.95. The full hardness reports are attached in Appendix B.

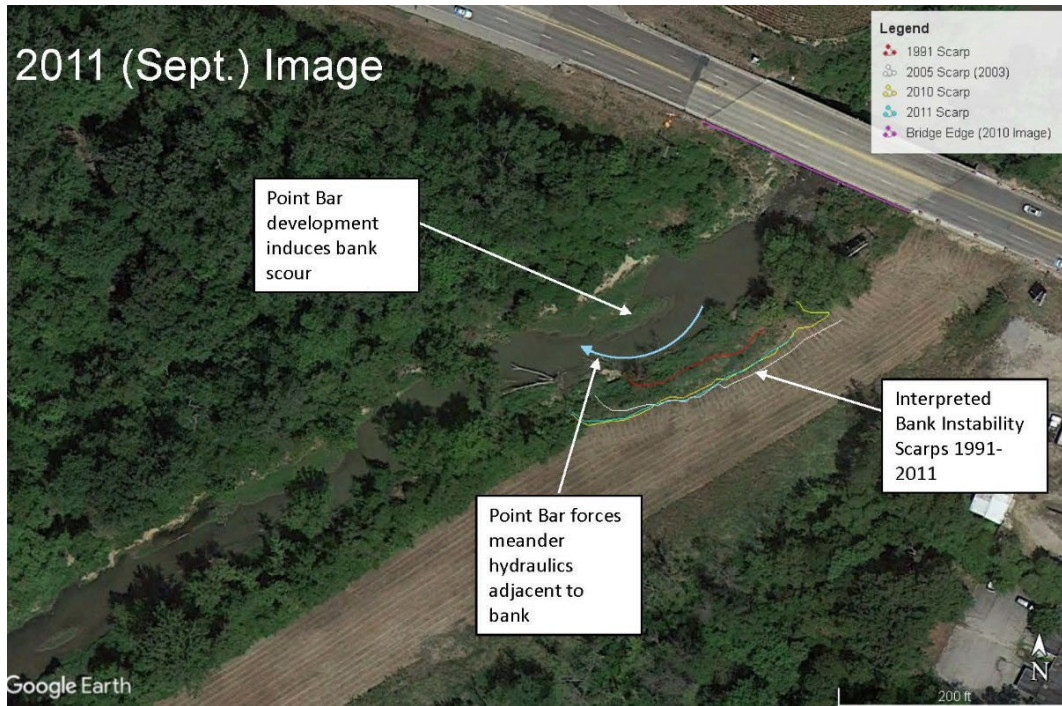
Figure 2 - Aerial Image Dated September 2011 (from Google Earth™)

- The image from September 2011 (Figure 2) shows the absence of deep-rooted forest canopy along the streambank, a defined scarp at the head of the ground instability, presence of large woody debris (LWD), and a point bar on the opposite side of the creek that is re-directing the flow hydraulics toward the Site.

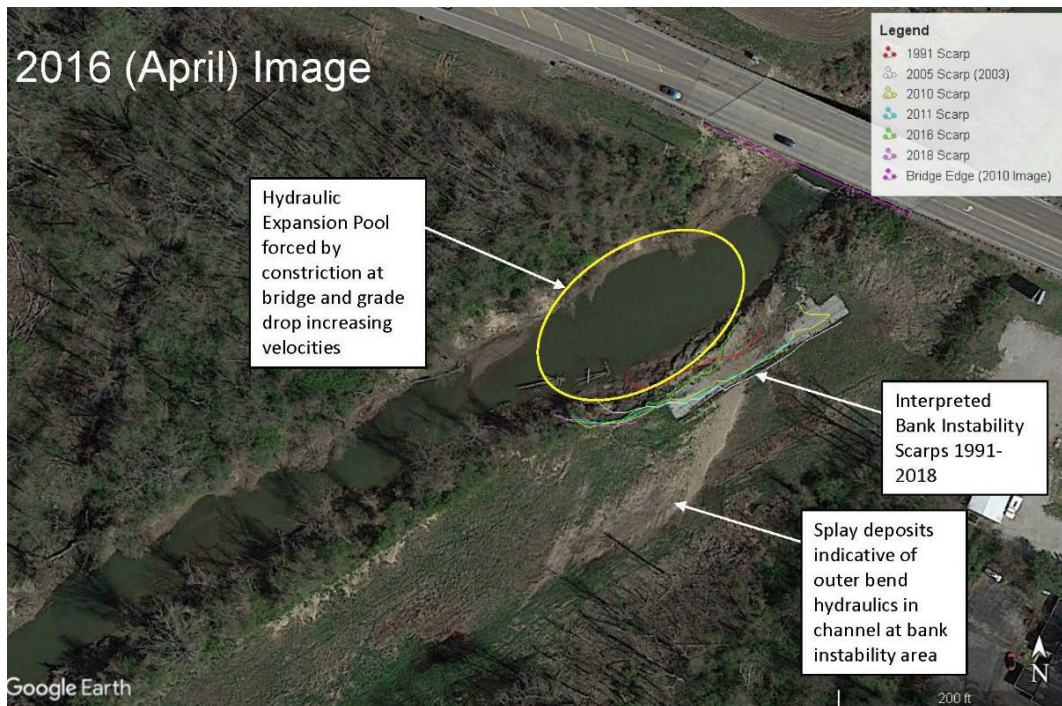
Figure 3 - Aerial Image Dated April 2016 (from Google Earth™)

- The image from April 2016 (Figure 3) shows the bank conditions without vegetive cover along the streambank, presence of LWD along downstream end of left bank at Site, the development of hydraulic expansion pool created by increased flow velocities downstream from the bridge floodway constriction and grade drop downstream of the bridge, and splay deposits indicative of flooding and outer bend hydraulics. The photo also shows articulated concrete mats that were installed for erosion control above a section of the Pipeline in 2014, but which generally do not appear to be protecting the bank from scour or contributing to the stability of the slope.

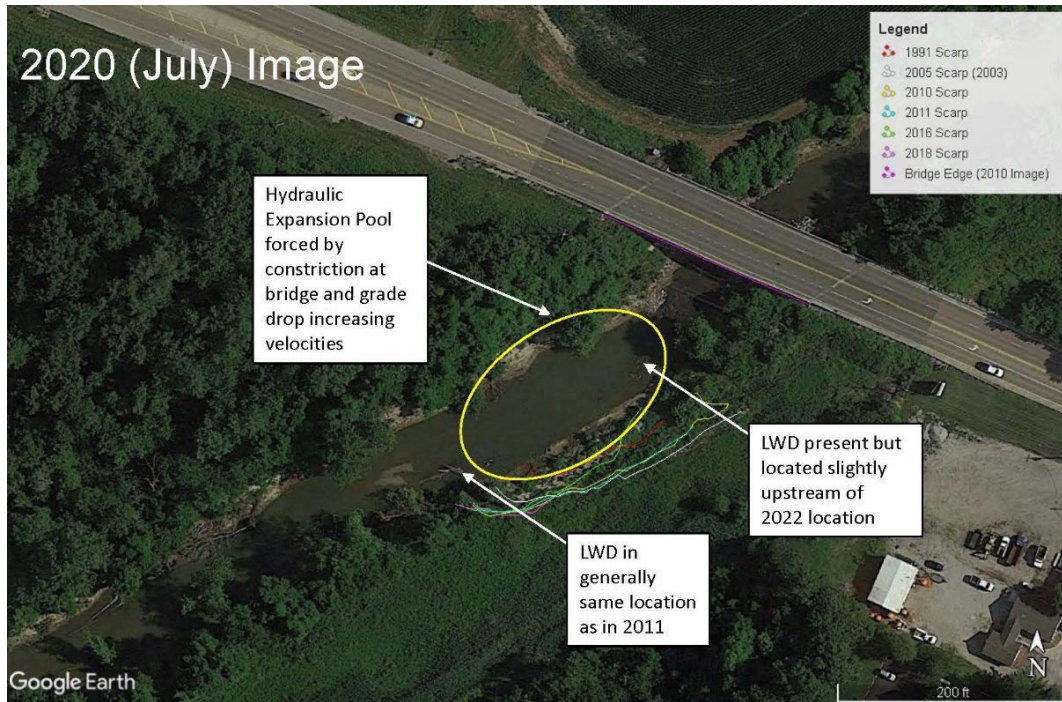
Figure 4 - Aerial Image Dated July 2020 (from Google Earth™)

- The image from July 2020 (Figure 4) shows an additional area of LWD accumulation at the upstream end of the left bank at the Site. The existence and proximity of LWD to the left bank complicate scour hydraulics creating local scour conditions resulting for localized velocity accelerations and multidirectional flow patterns.

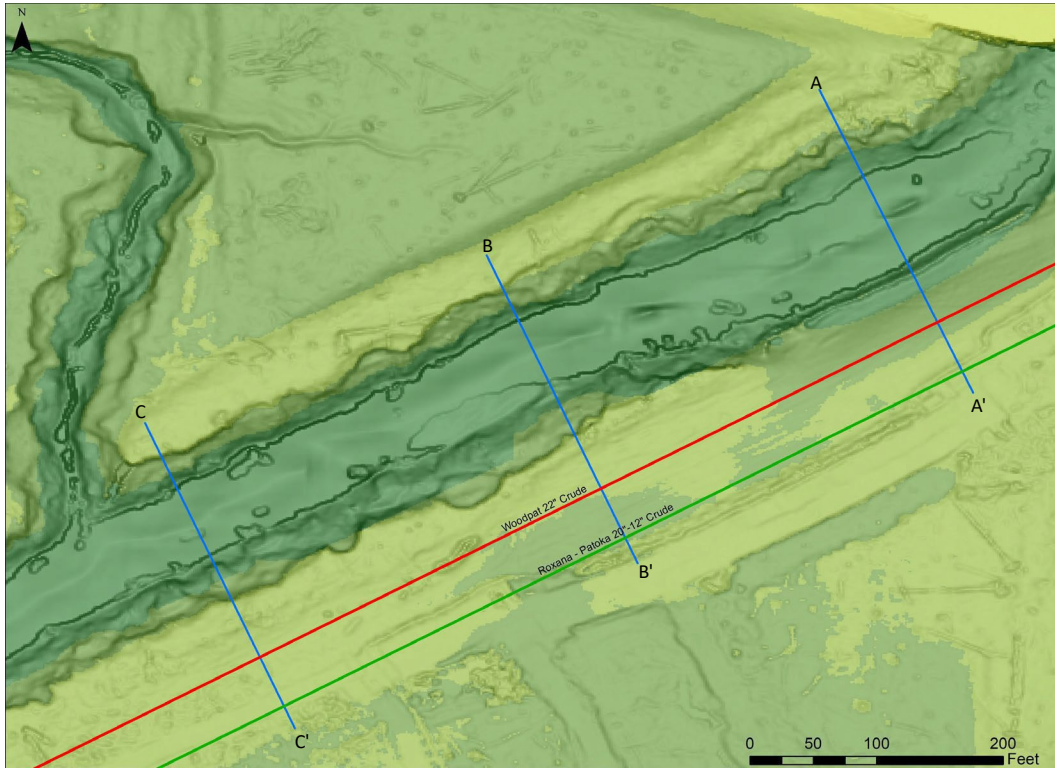
Figure 7 - Plan Showing Locations of Cross Sections

The creek bathymetry and bank topography collected by DoC Mapping LLC after the 11 March 2022 ground movement is shown in Figure 6. These contours, along with the cross sections in Figure 8, illustrate topographically the impact of scour and ground movement on the left bank relative to the forested upstream and downstream streambanks. The instabilities along the left bank are coincident with deeper creek bed depths (i.e., resulting from bed scour), lateral bank position, and altered bank slope inclination. As shown in Figure 8, in the area of the ground instability, the creek bed depth is about five feet deeper and the bank is recessed laterally about 15 feet, compared to the upstream and downstream streambanks.
