MARiTECH COMMERCIAL, INC.

Report No.: 185286

SURVEY REPORT

M/V "SIROCCO" (Voy.32L)

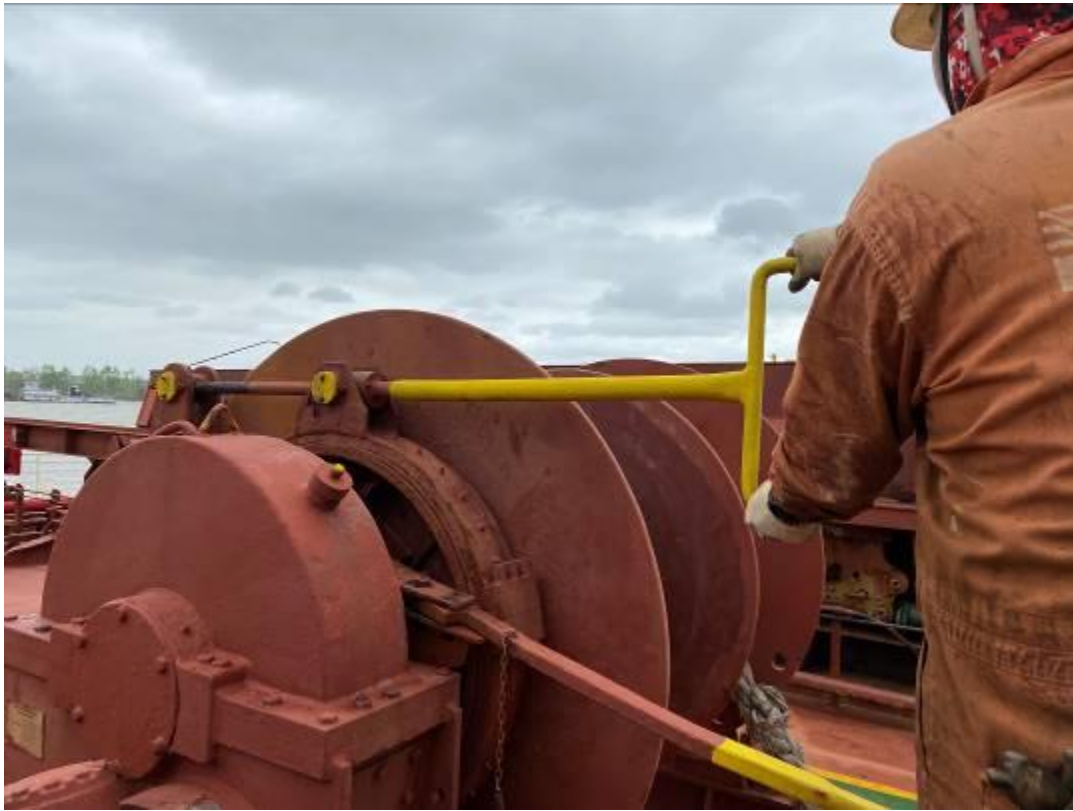
27. Forward Midship mooring winch break test.

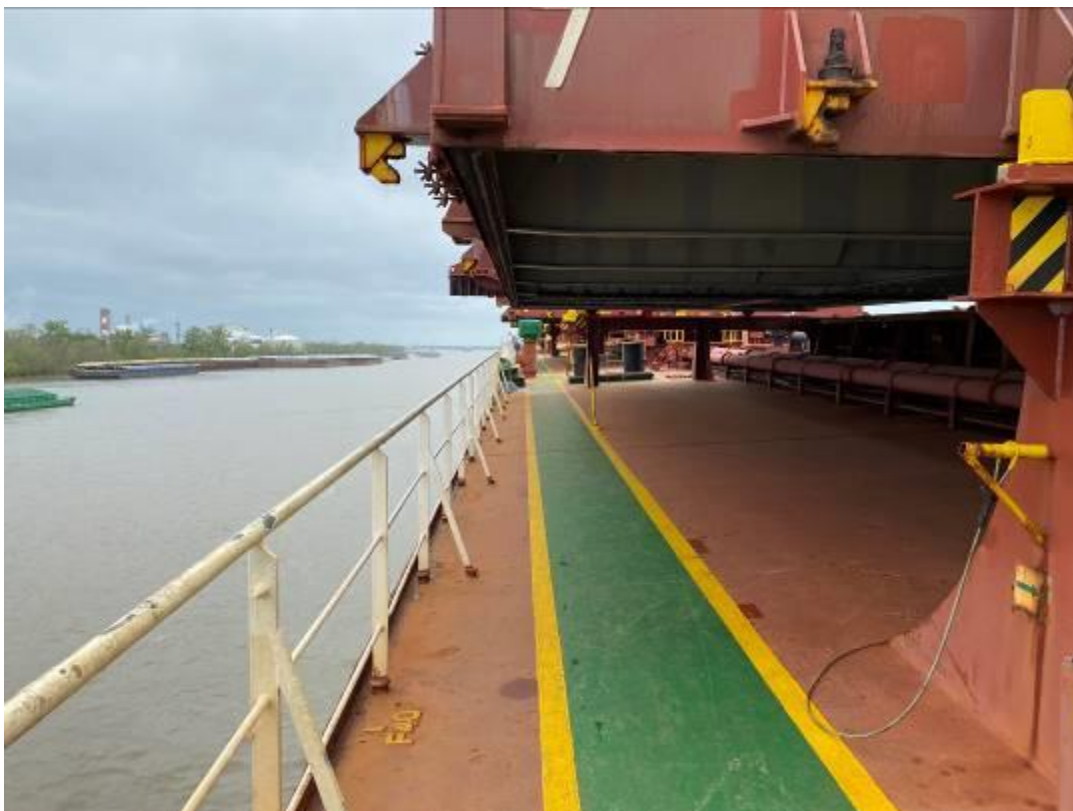
28. Viewing port side main deck with hatch cover.

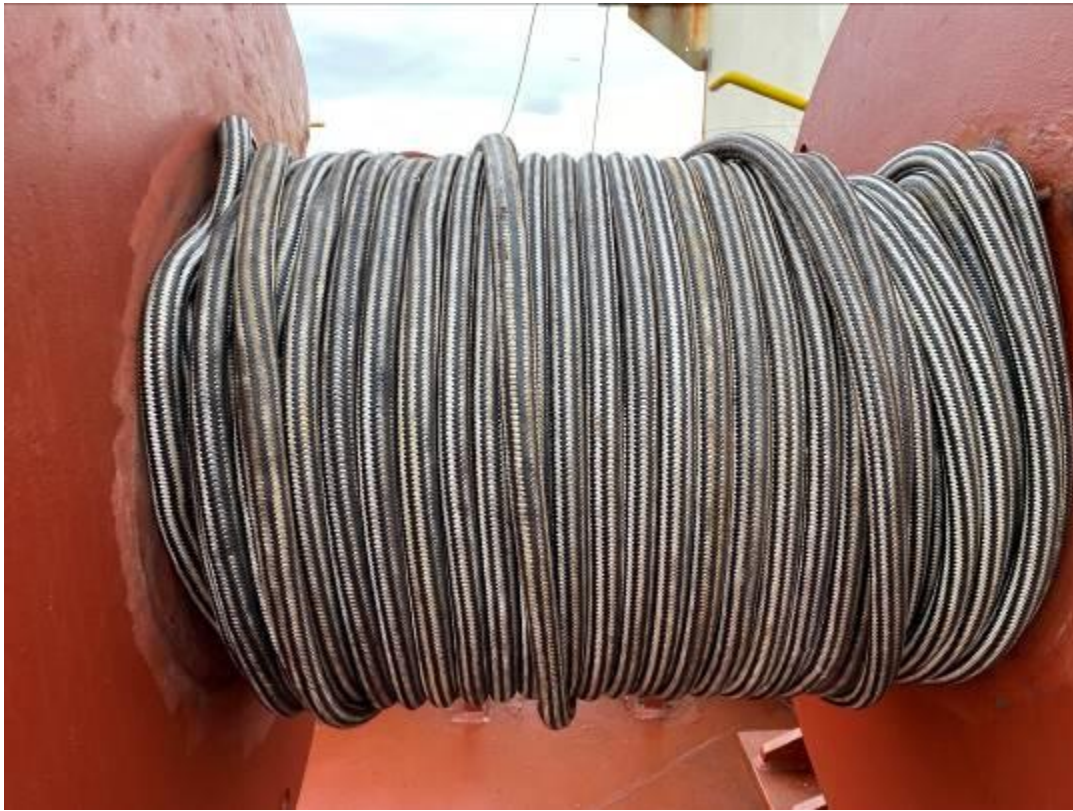
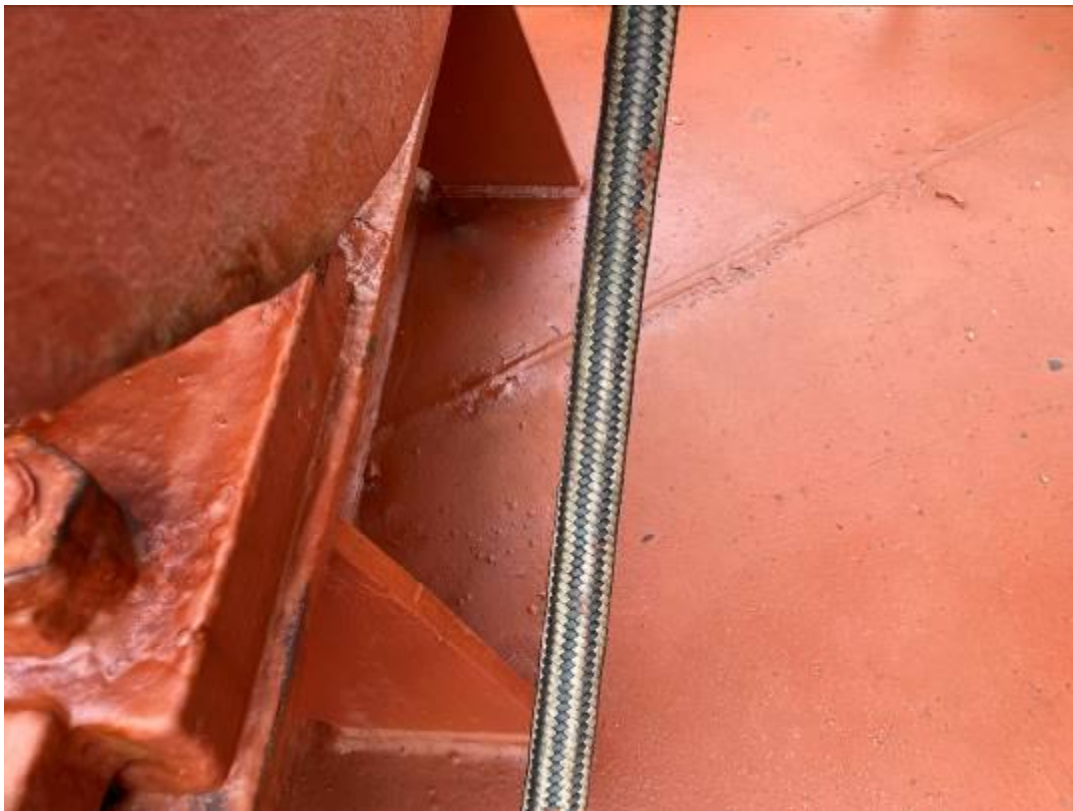
37. Close view of Mooring winch HMPE-Polyethylene rope located at starboard side forward mooring station.

38. Close view of Mooring winch HMPE-Polyethylene rope located at starboard side forward mooring station.

39. Close view of Mooring winch HMPE-Polyethene rope located at starboard side forward mooring station.

40. Close view of Mooring winch HMPE-Polyethene rope located at starboard side forward mooring station.
