# National Transportation Safety Board

DCA23FM036

Factual Report 24-011

Location: Atlantic Ocean  
Date: June 18, 2023  
Vehicle: OceanGate Experimental Submersible Titan  
Investigator: Marcel Muise, MS-10

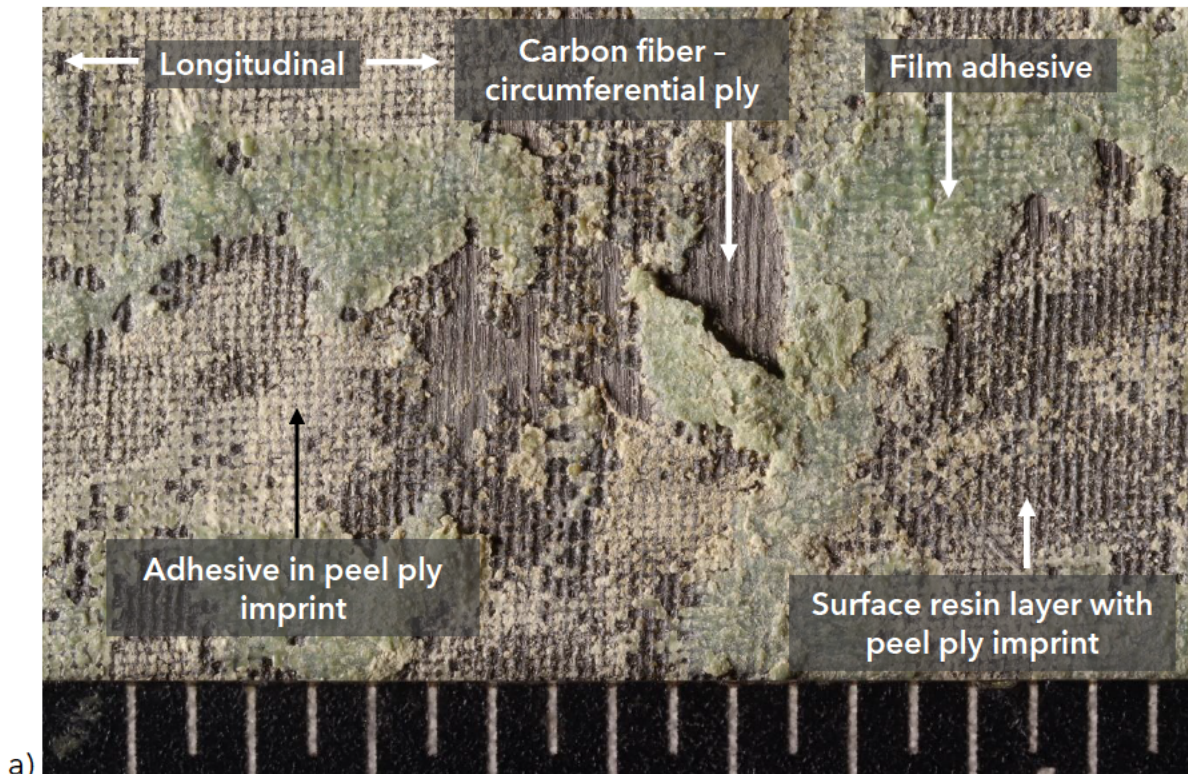
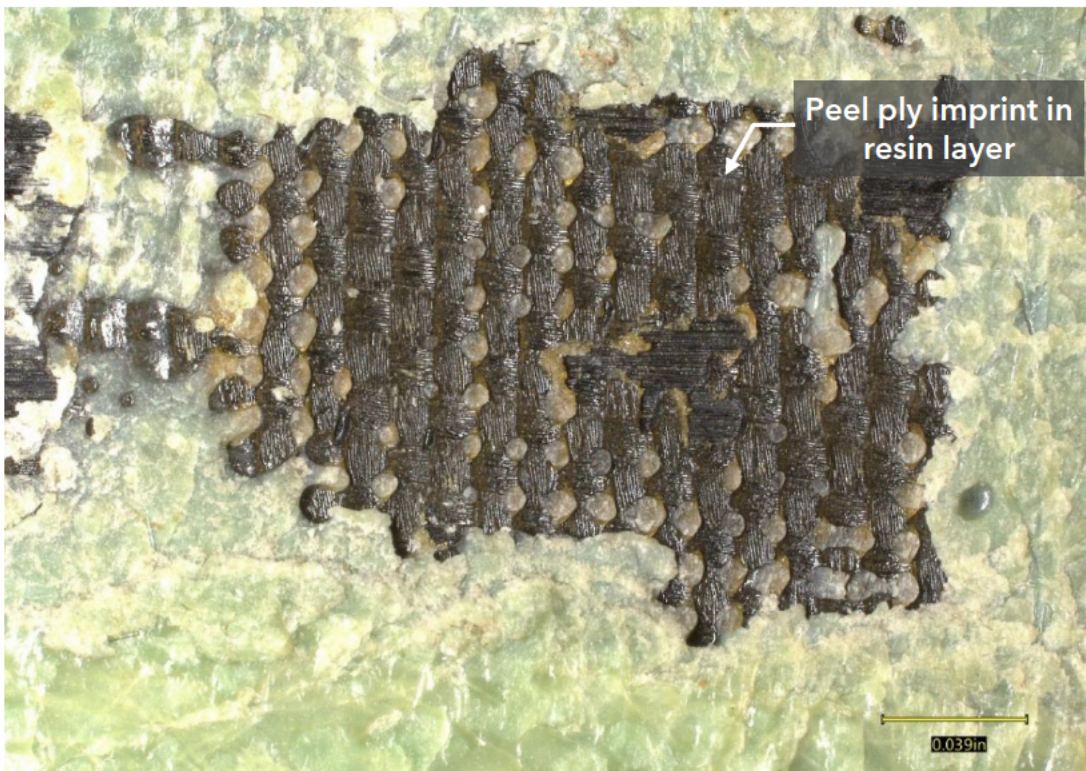
**Figure 9.** Images of layer 1 surface: a) region with all the components of the layer interface with labels; b) void in adhesive. Underlying resin with a peel ply imprint is exposed.

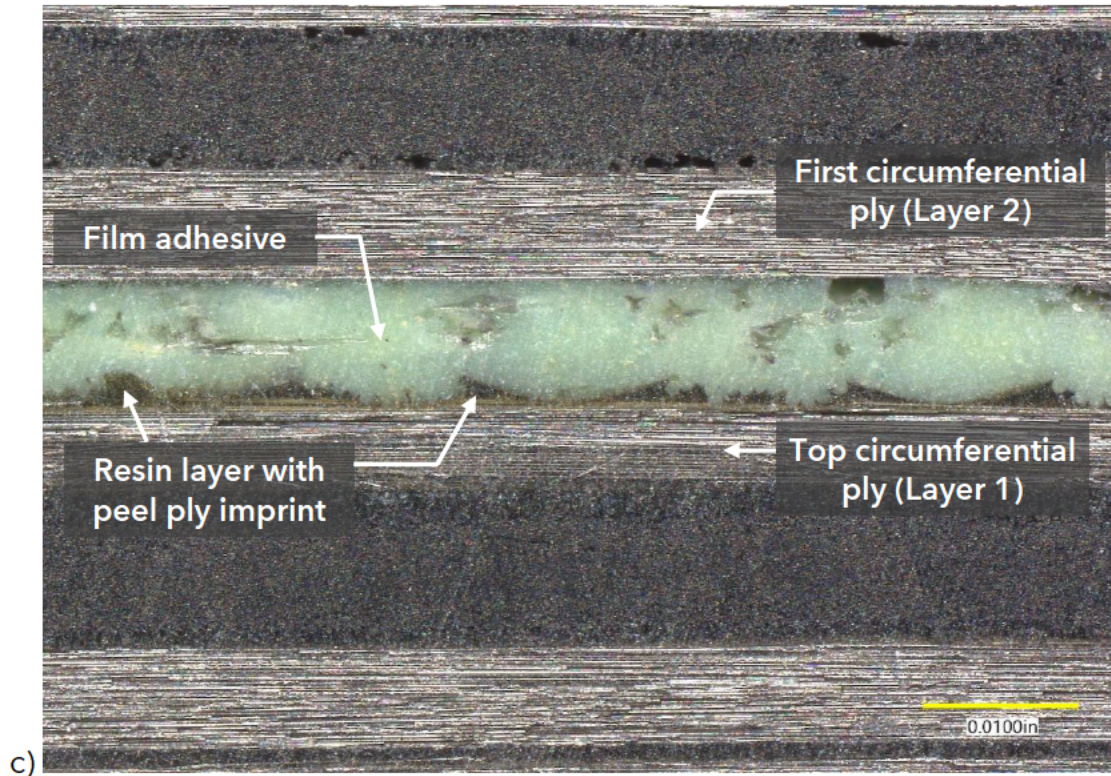
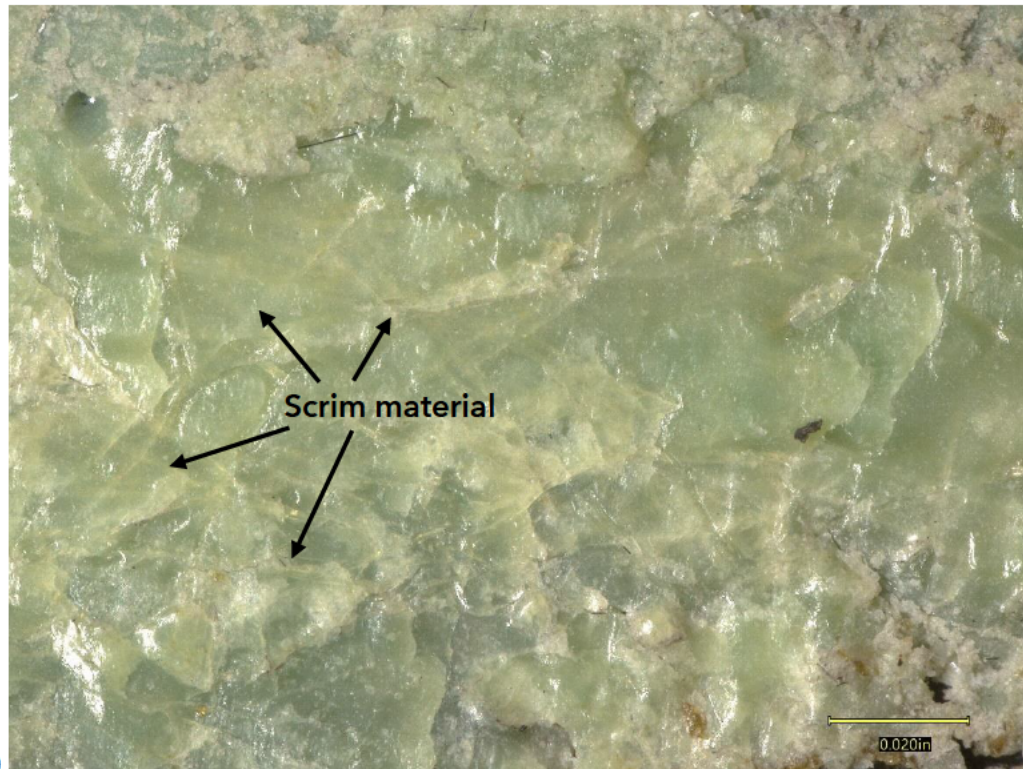
**Figure 9 (cont.).** c) cross section from a trimmed end piece of the Titan hull showing the location of the amber resin layer, overlying adhesive, and interface between the adhesive and the second co-bonded layer; and d) image showing non-woven scrim material.

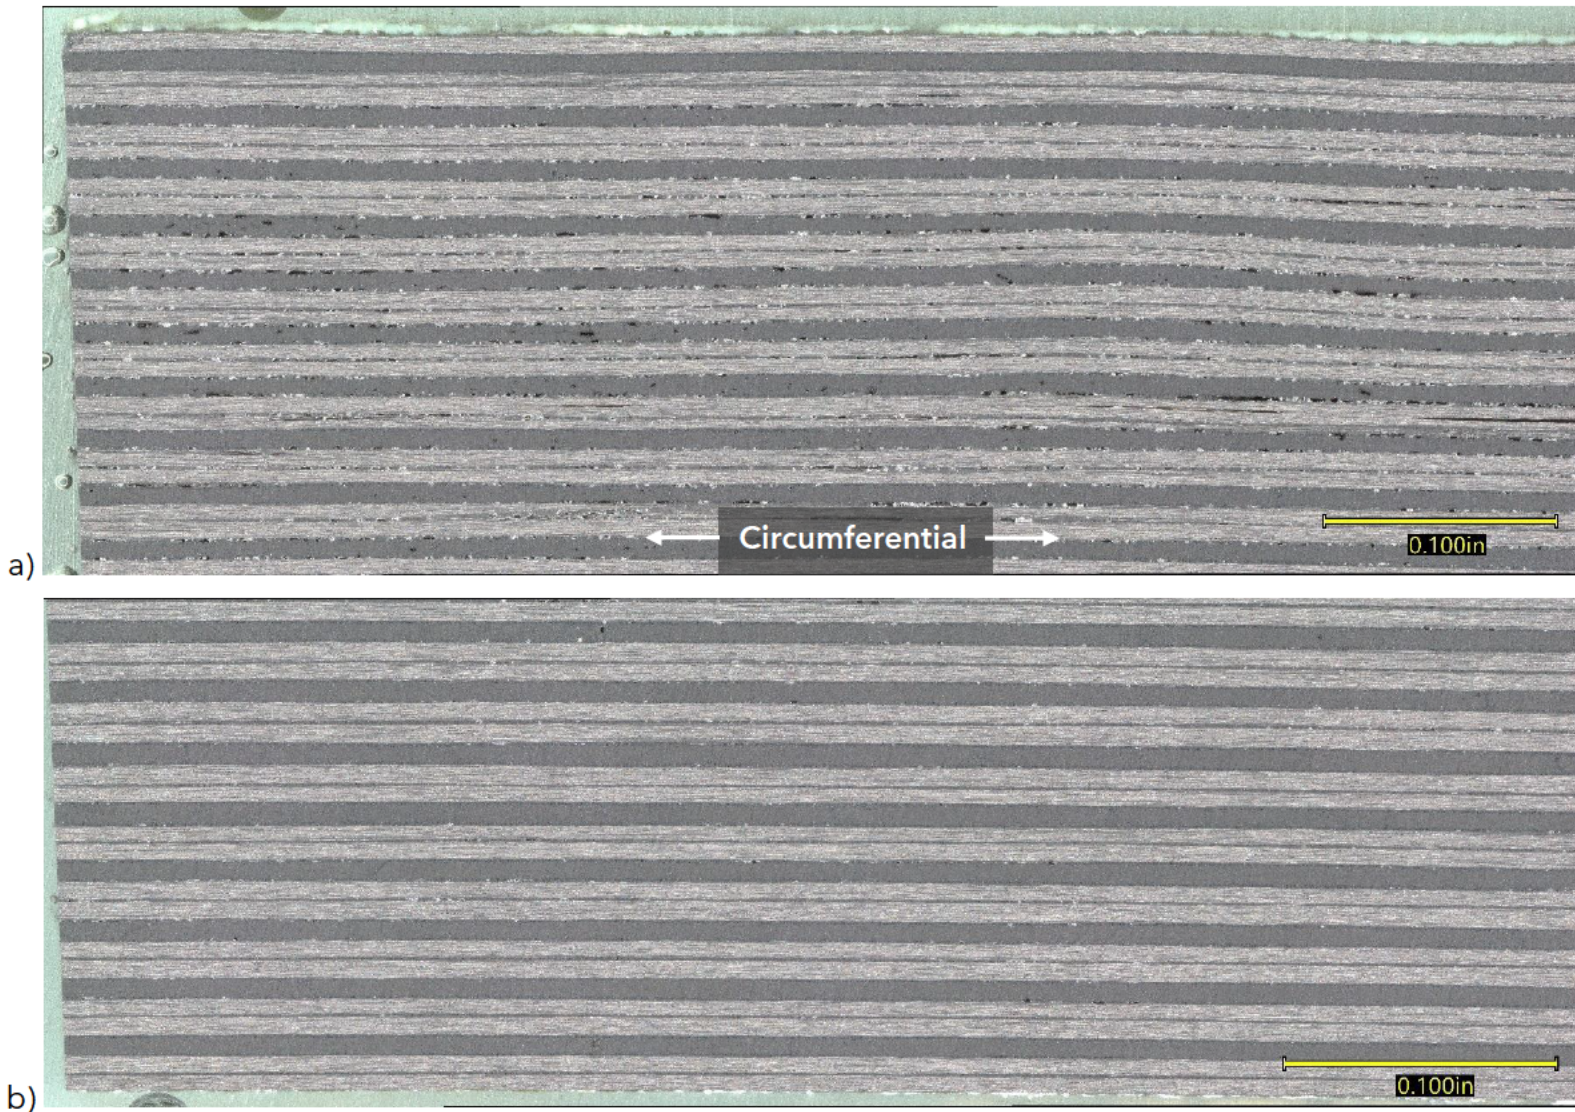
**Figure 10.** Images showing the composite ply stack: a) near the top of layer 1 and b) near the base of layer 1.

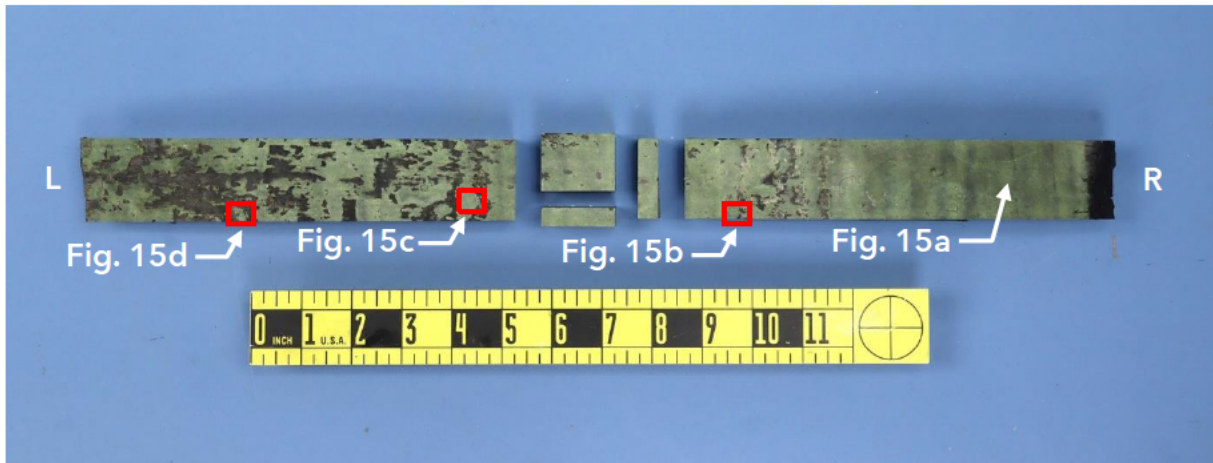
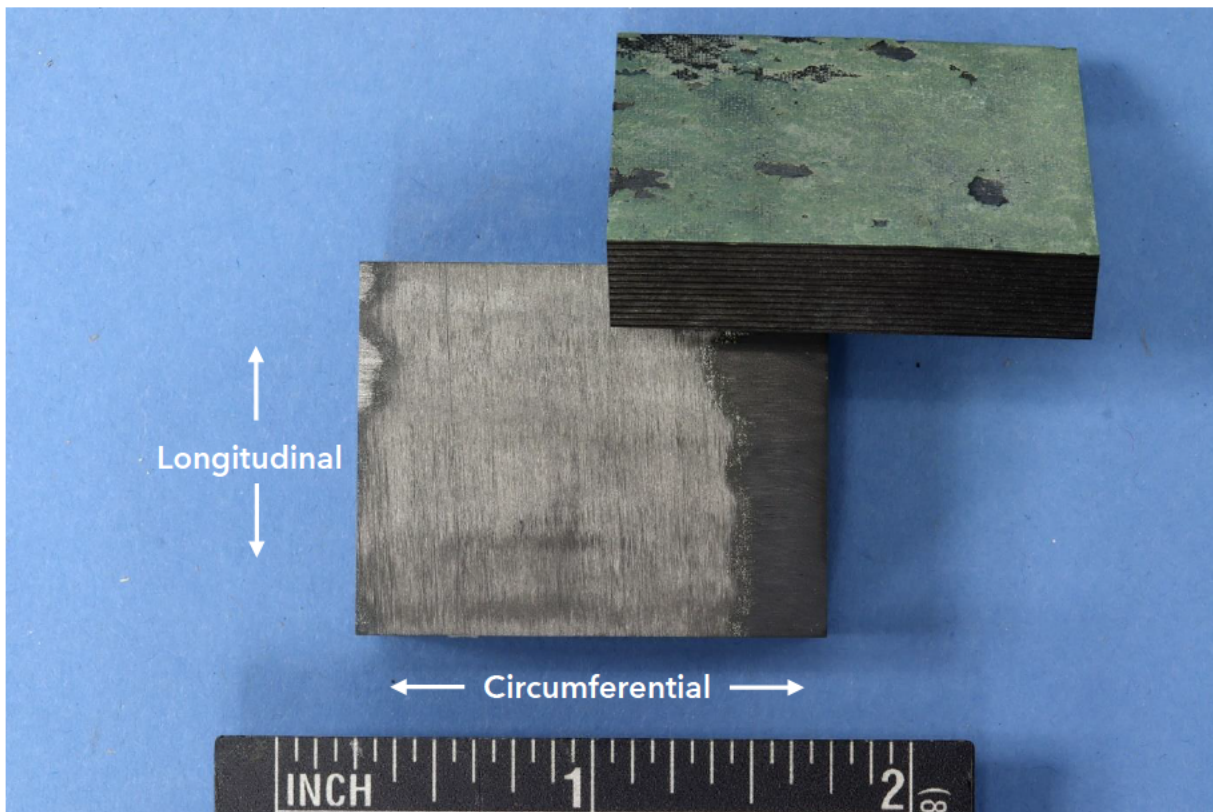
**Figure 12.** Upper image: overview image showing the location of cut pieces and the locations of images in figure 15. Lower image: Cross section cut roughly parallel to the hull outer and inner surfaces and near the middle of the layer.

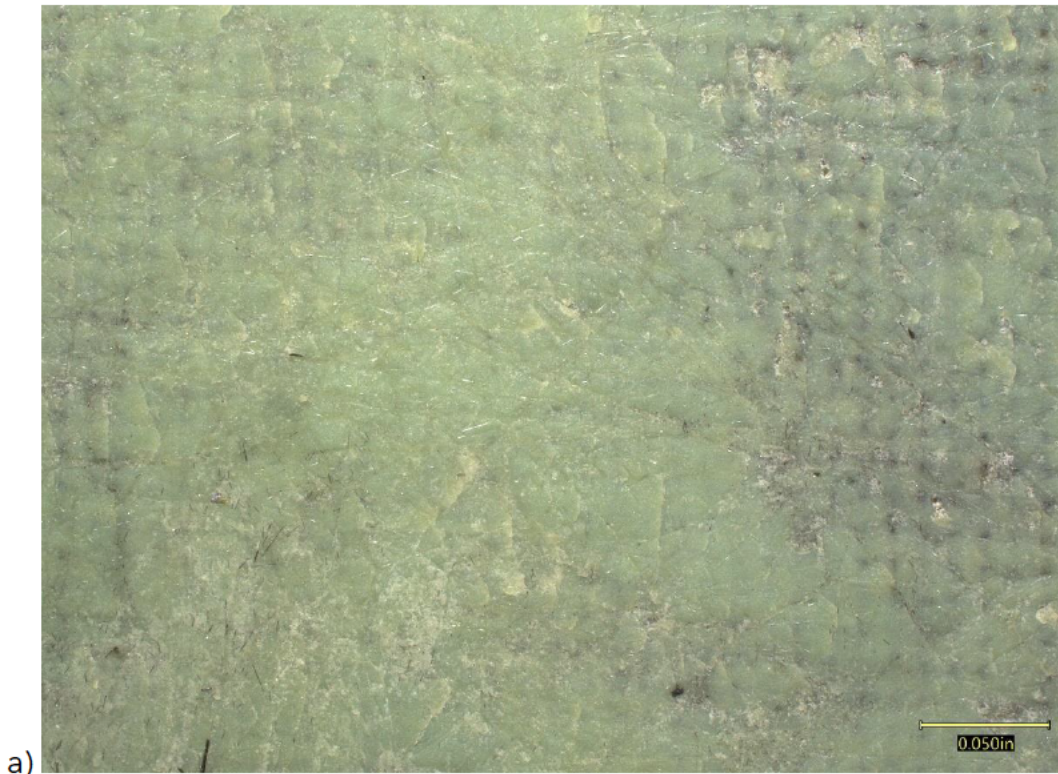
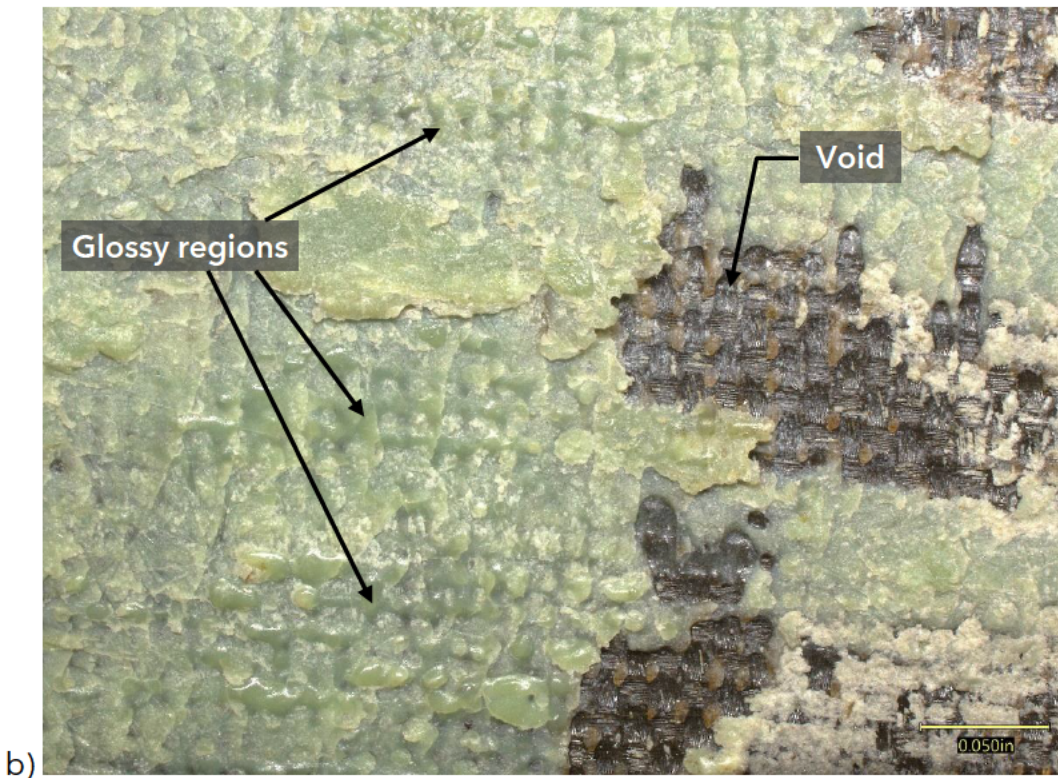
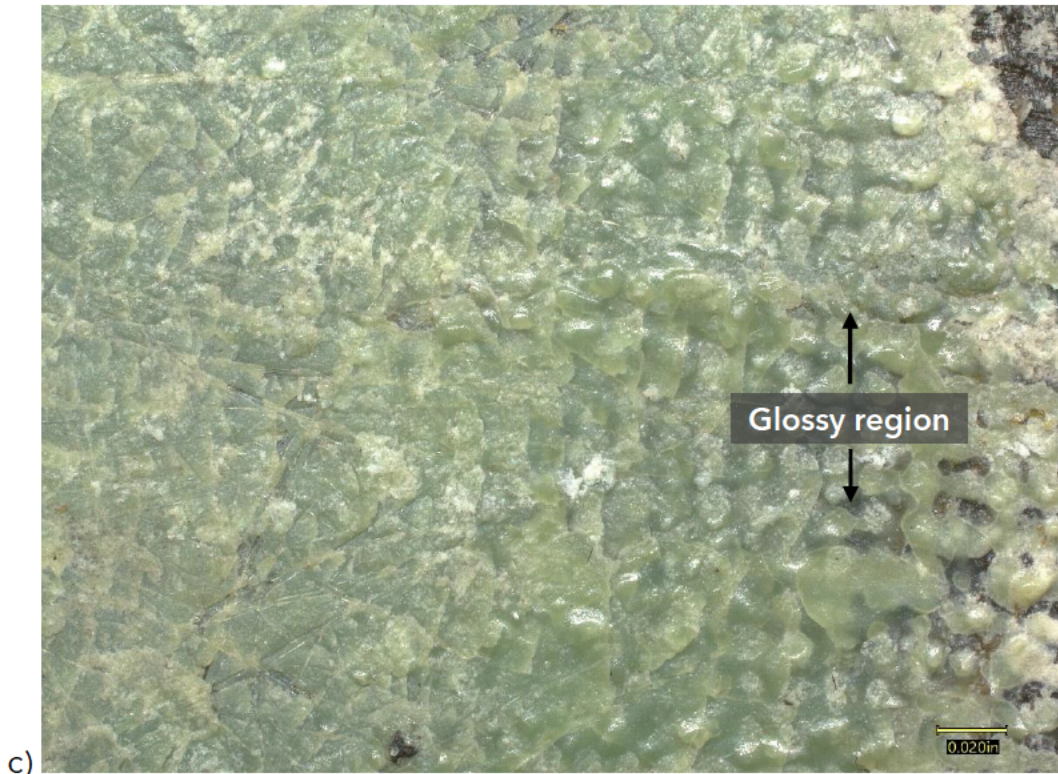
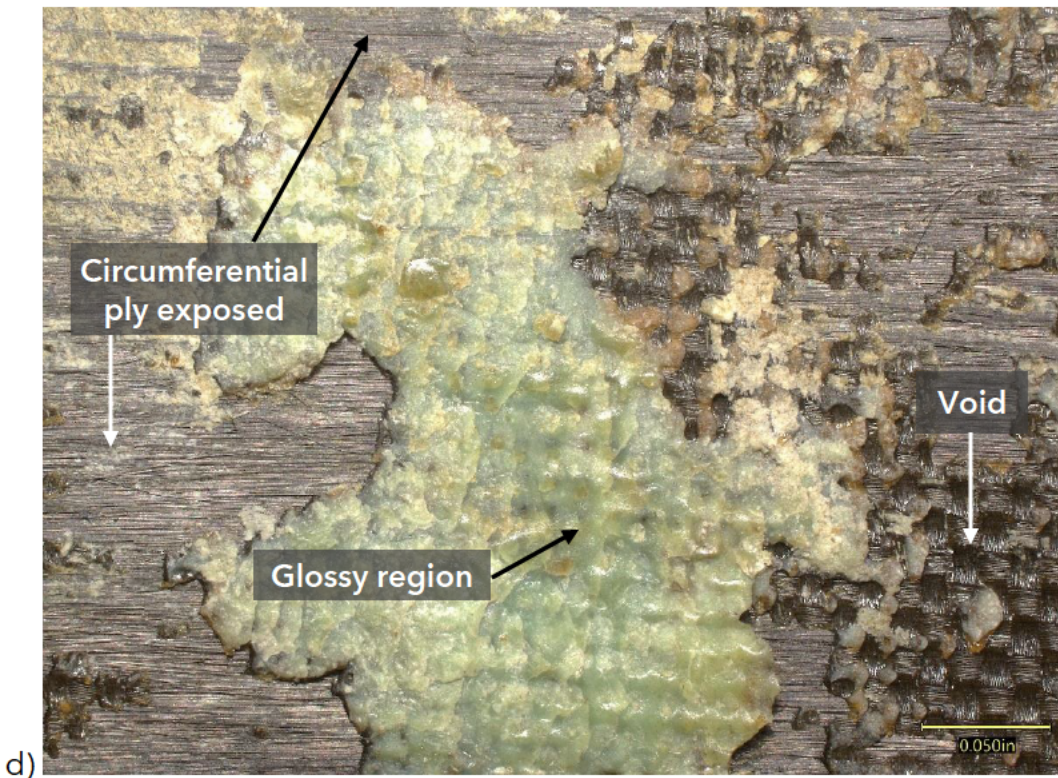
**Figure 15.** Image of adhesive surface as indicated in figure 12: a) rubbed appearance near "right side"; glossy regions and voids.

**Figure 15 (cont.).** c) more glossy regions; and d) similar features but with additional regions where the adhesive and resin have separated exposing the underlying composite ply.

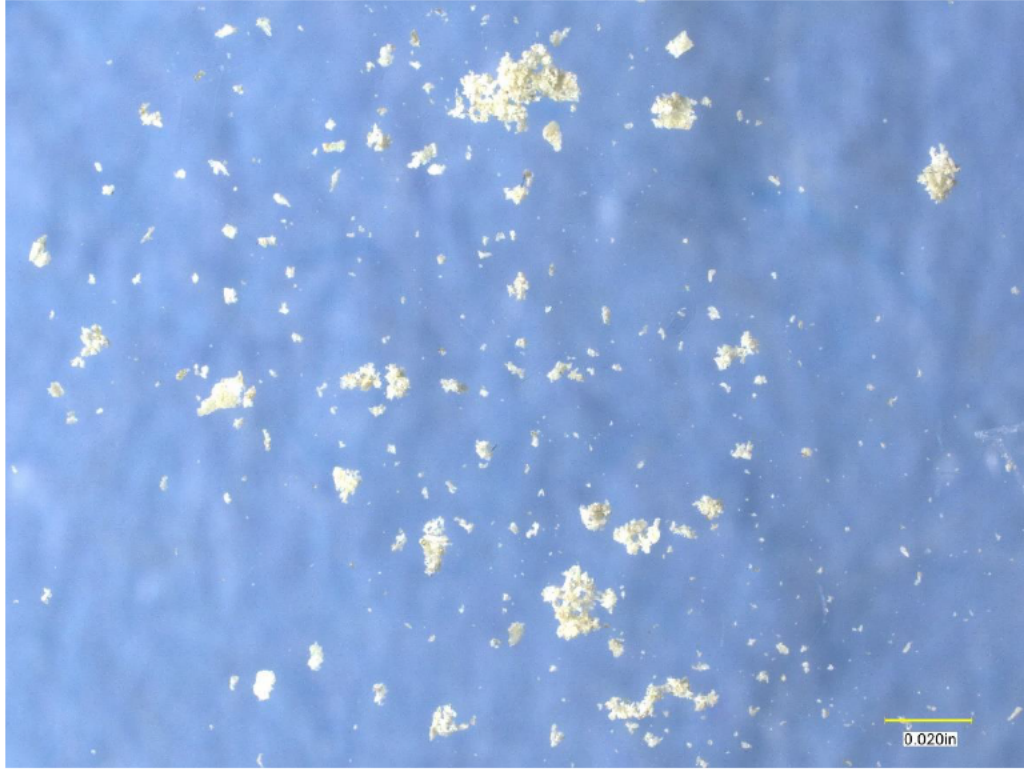
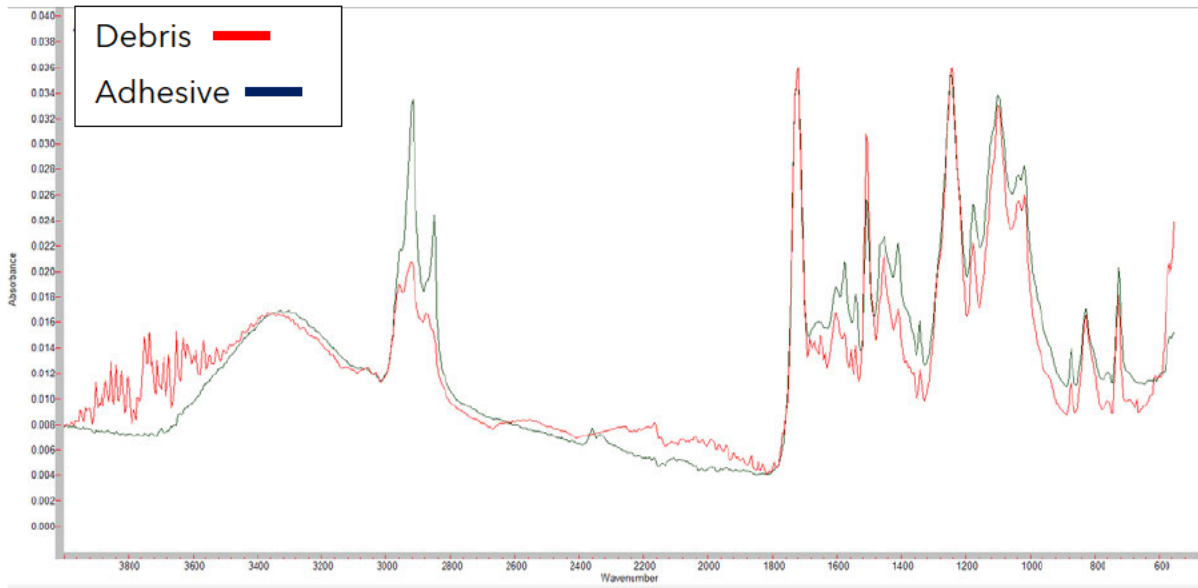
**Figure 23.** a) Image of debris removed from peel ply impressions in figure 22 and b) comparative FTIR-ATR spectra of the debris and of a sample of adhesive.

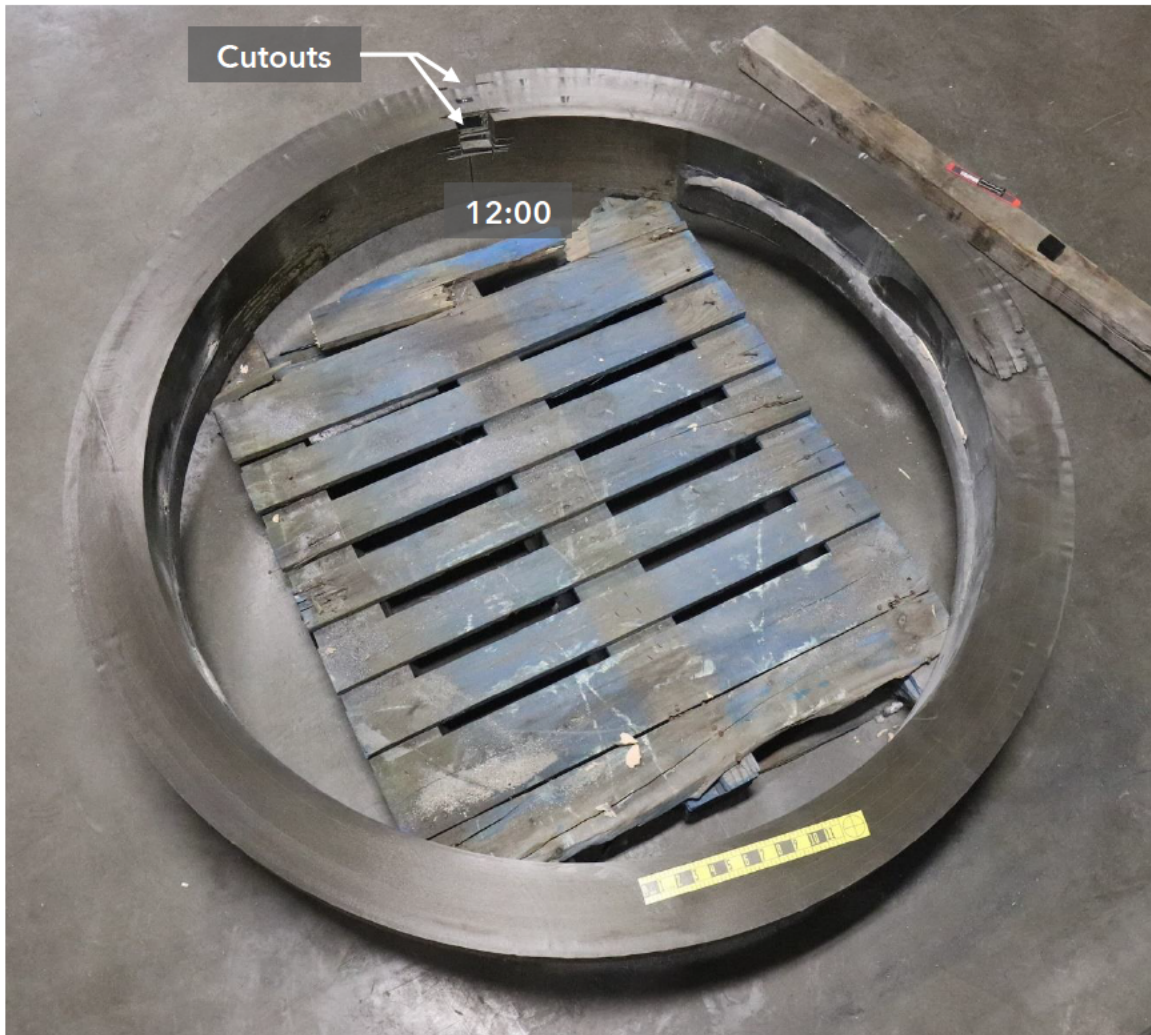
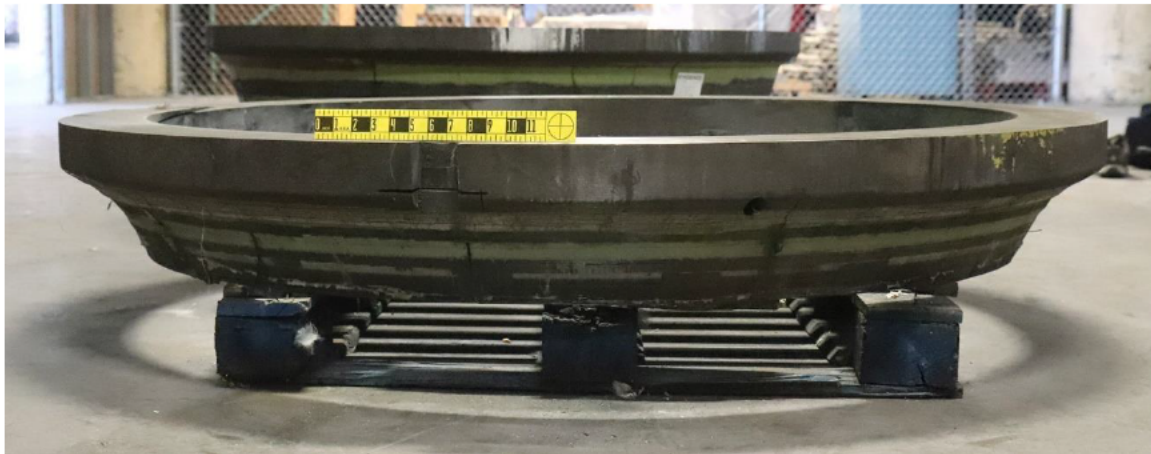
**Figure 26.** Images of trimmed end 'A' from the Titan hull; a) view of cut end face and b) side view.

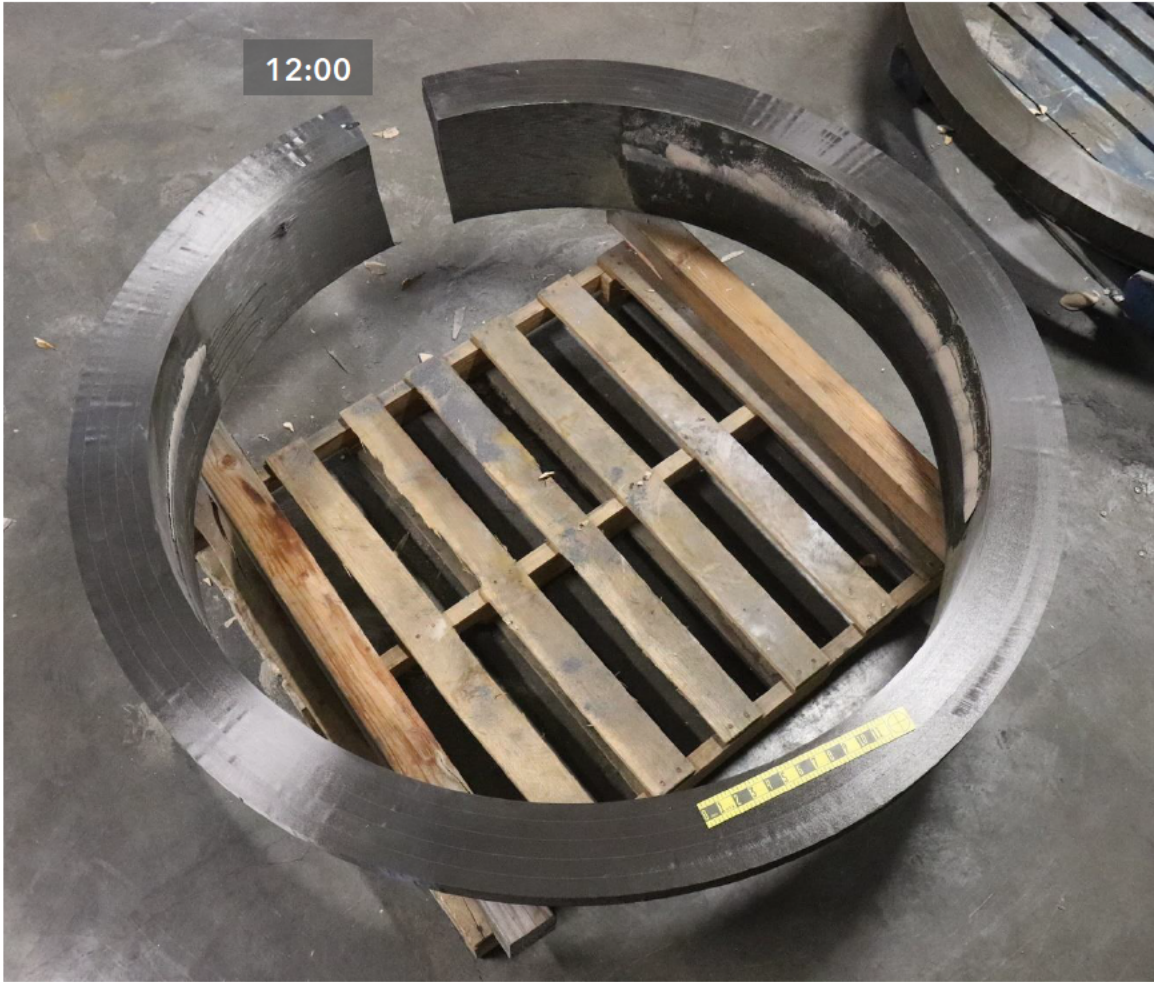
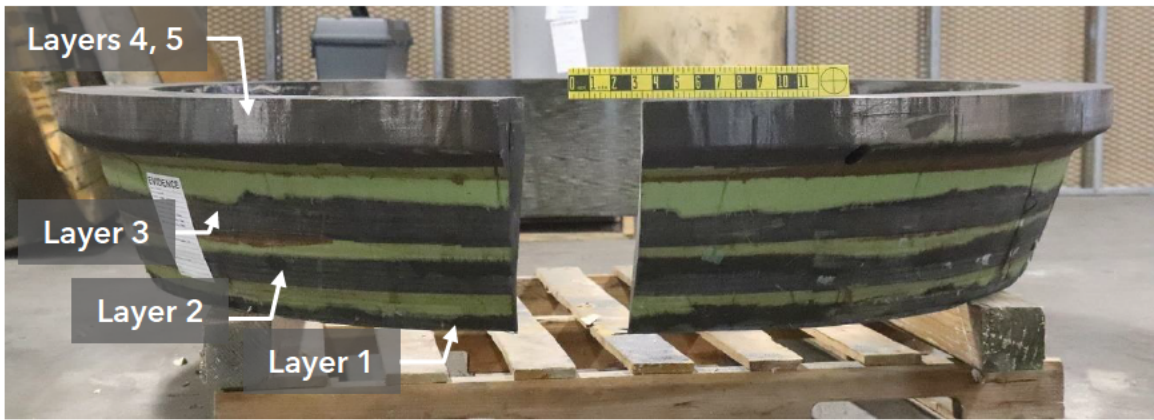
**Figure 27.** Images of trimmed end 'B' from the Titan hull; a) view of cut end face and b) side view.

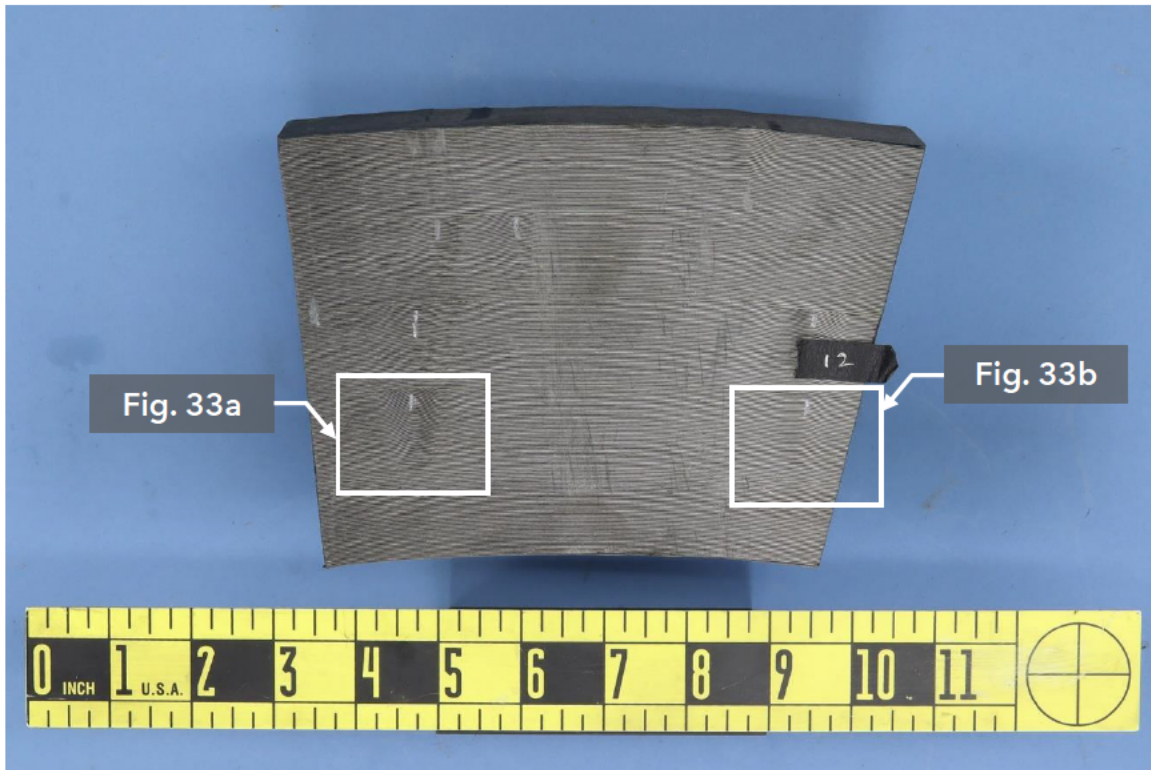
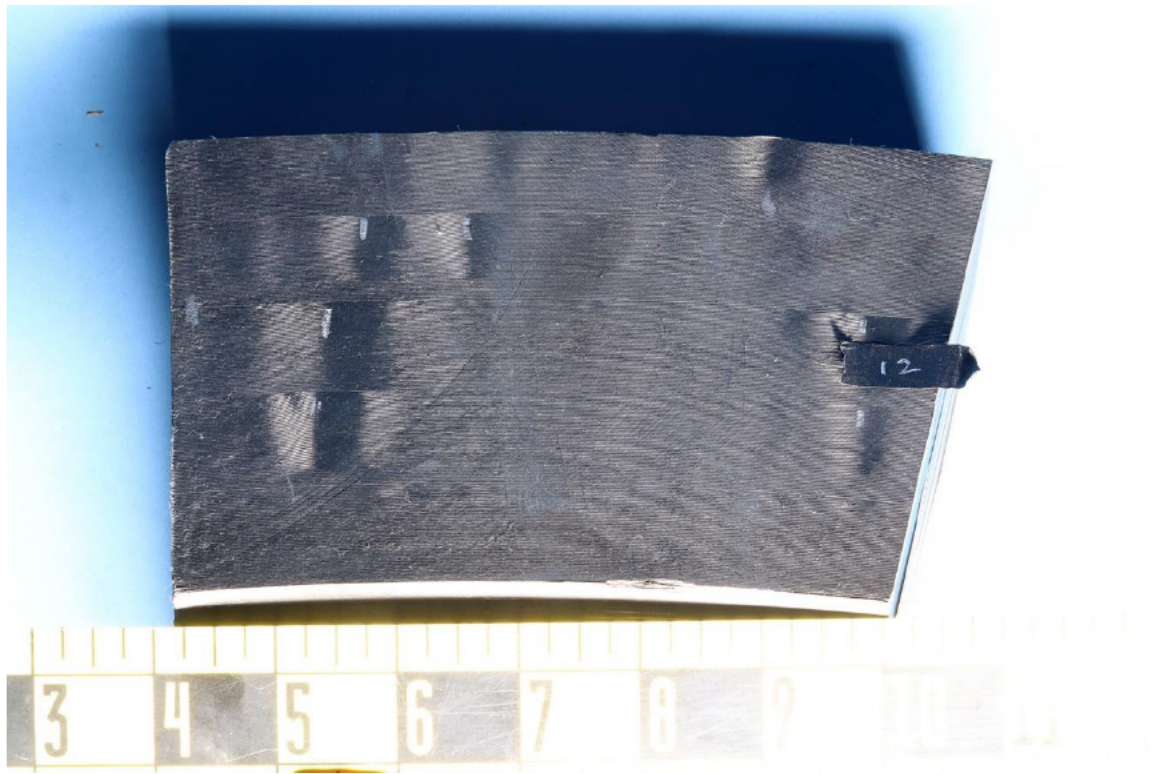
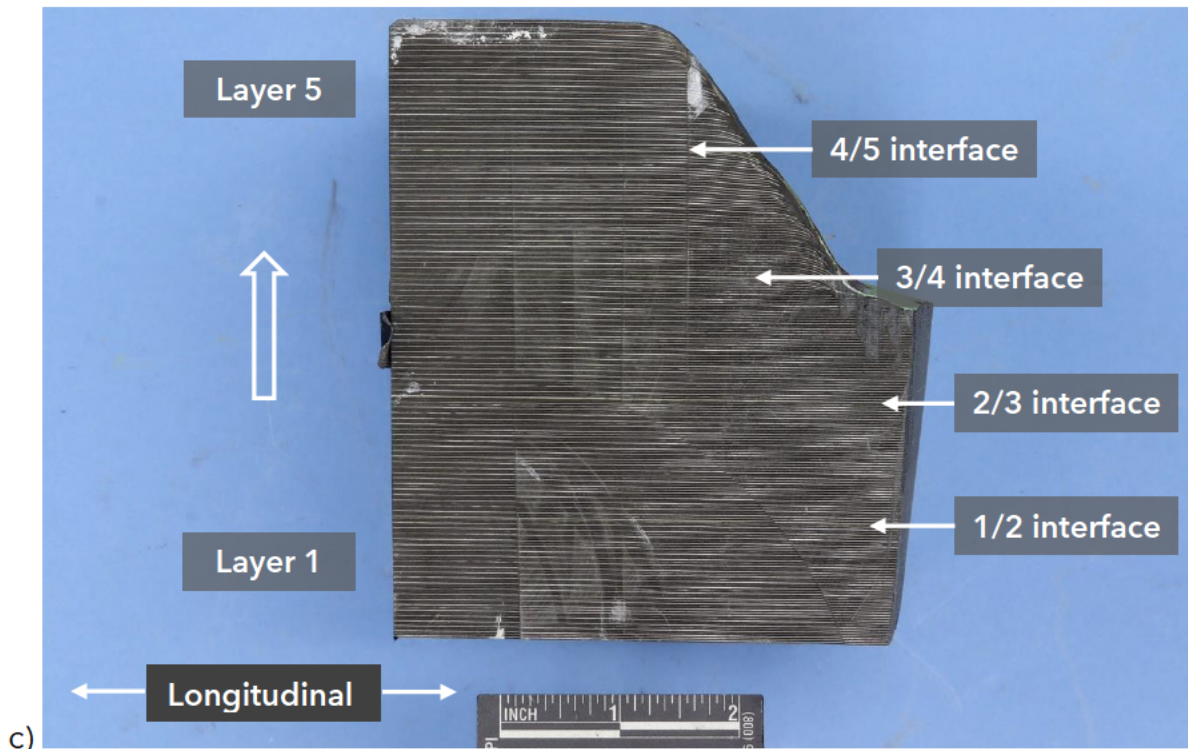
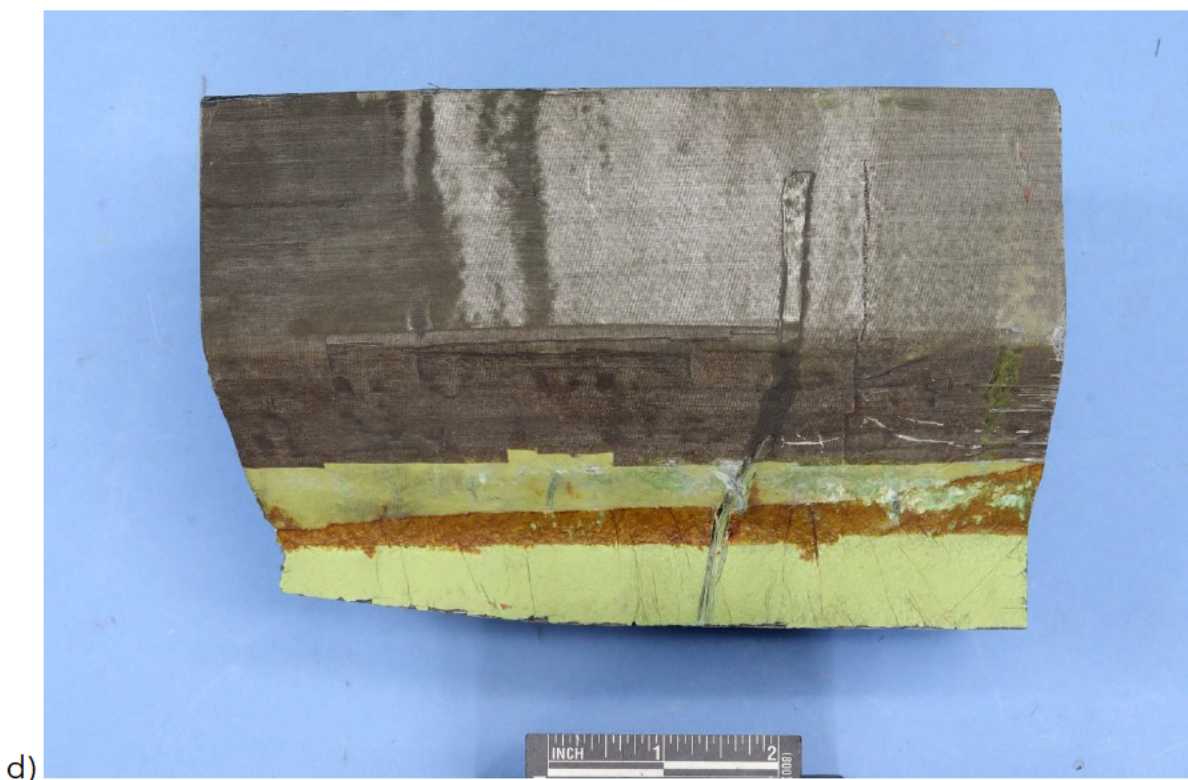
The locations of two notable wrinkle grinding features on the smaller end piece are indicated in figure 31a and shown in greater detail in figures 33a and b. A fiber bridging feature with voids in the adhesive on either side of the incipient wrinkle is indicated in figure 32 and shown in greater detail in figure 34. For the piece in figure 31, a total of 6 grinding features were observed. The number of ground plies for each of the features (from most to least) was 12, 10, 6, 5, 5, and 1.

**Figure 31.** Images of the smaller piece cut from trimmed end 'B': a) cut face under general lighting; b) cut face under oblique angle lighting, which highlights wrinkle features;

**Figure 31 (cont.).** c) longitudinal cross section with the layers and interfaces labelled; and d) outer surface of the piece viewed radially inward.

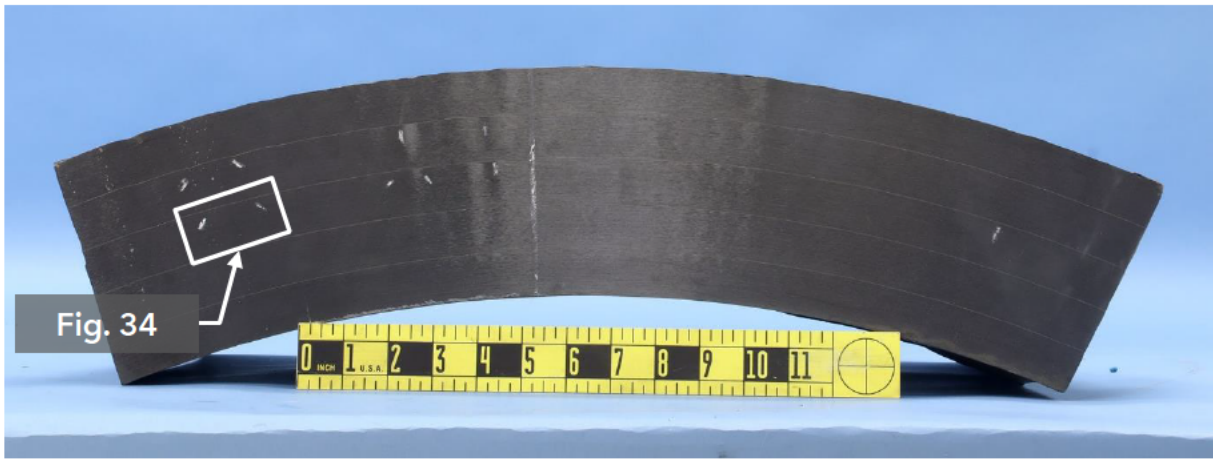
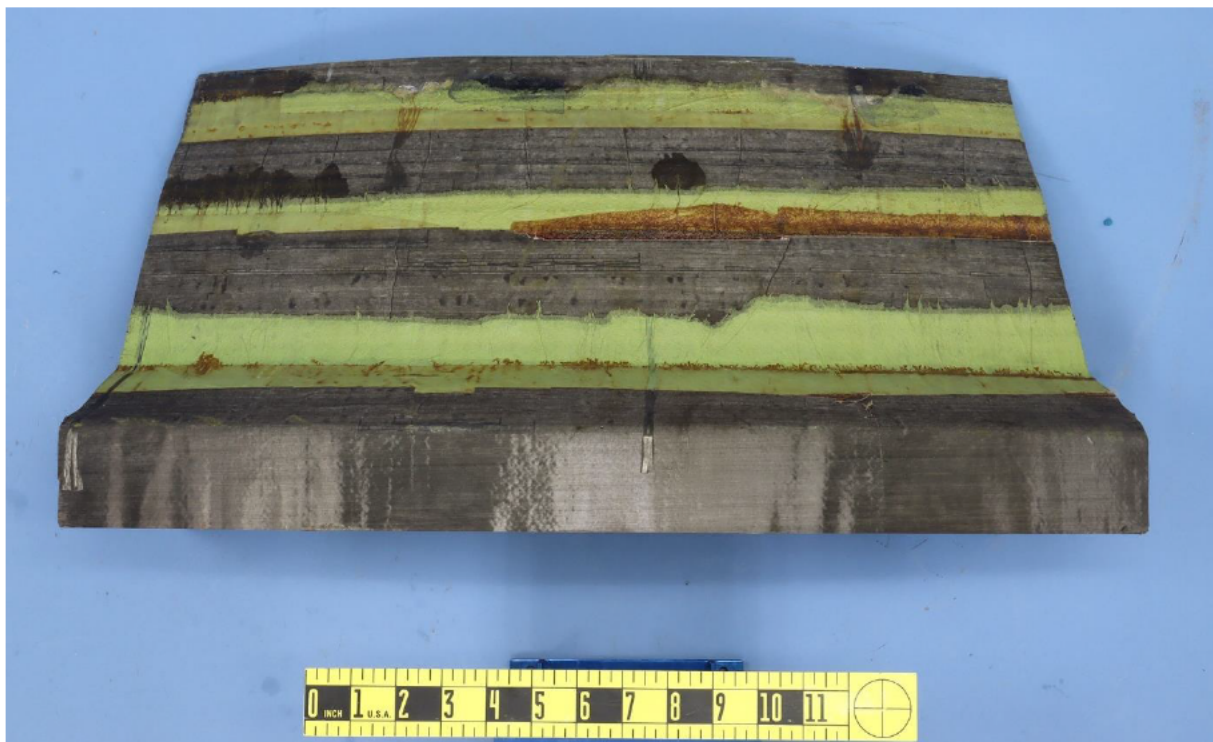
**Figure 32.** Image of the larger piece cut from end 'B'; a) viewed in the longitudinal direction and b) outer surface viewed radially inward.
