# National Transportation Safety Board

DCA23FM036

Factual Report 24-011

Location: Atlantic Ocean  
Date: June 18, 2023  
Vehicle: OceanGate Experimental Submersible Titan  
Investigator: Marcel Muise, MS-10

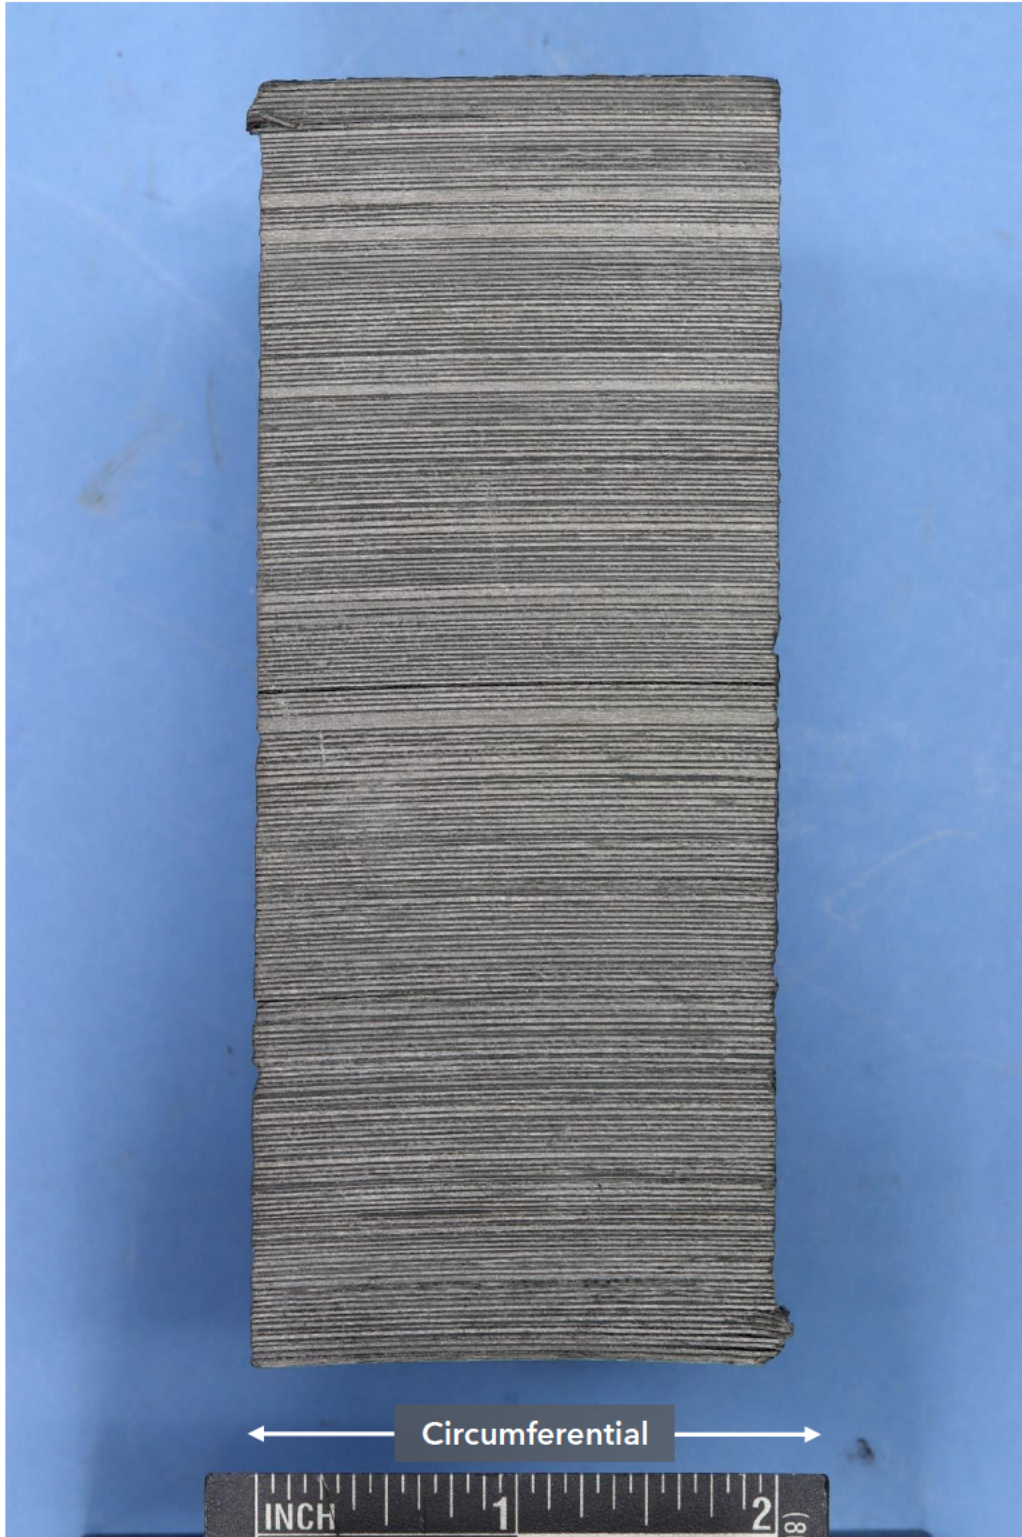
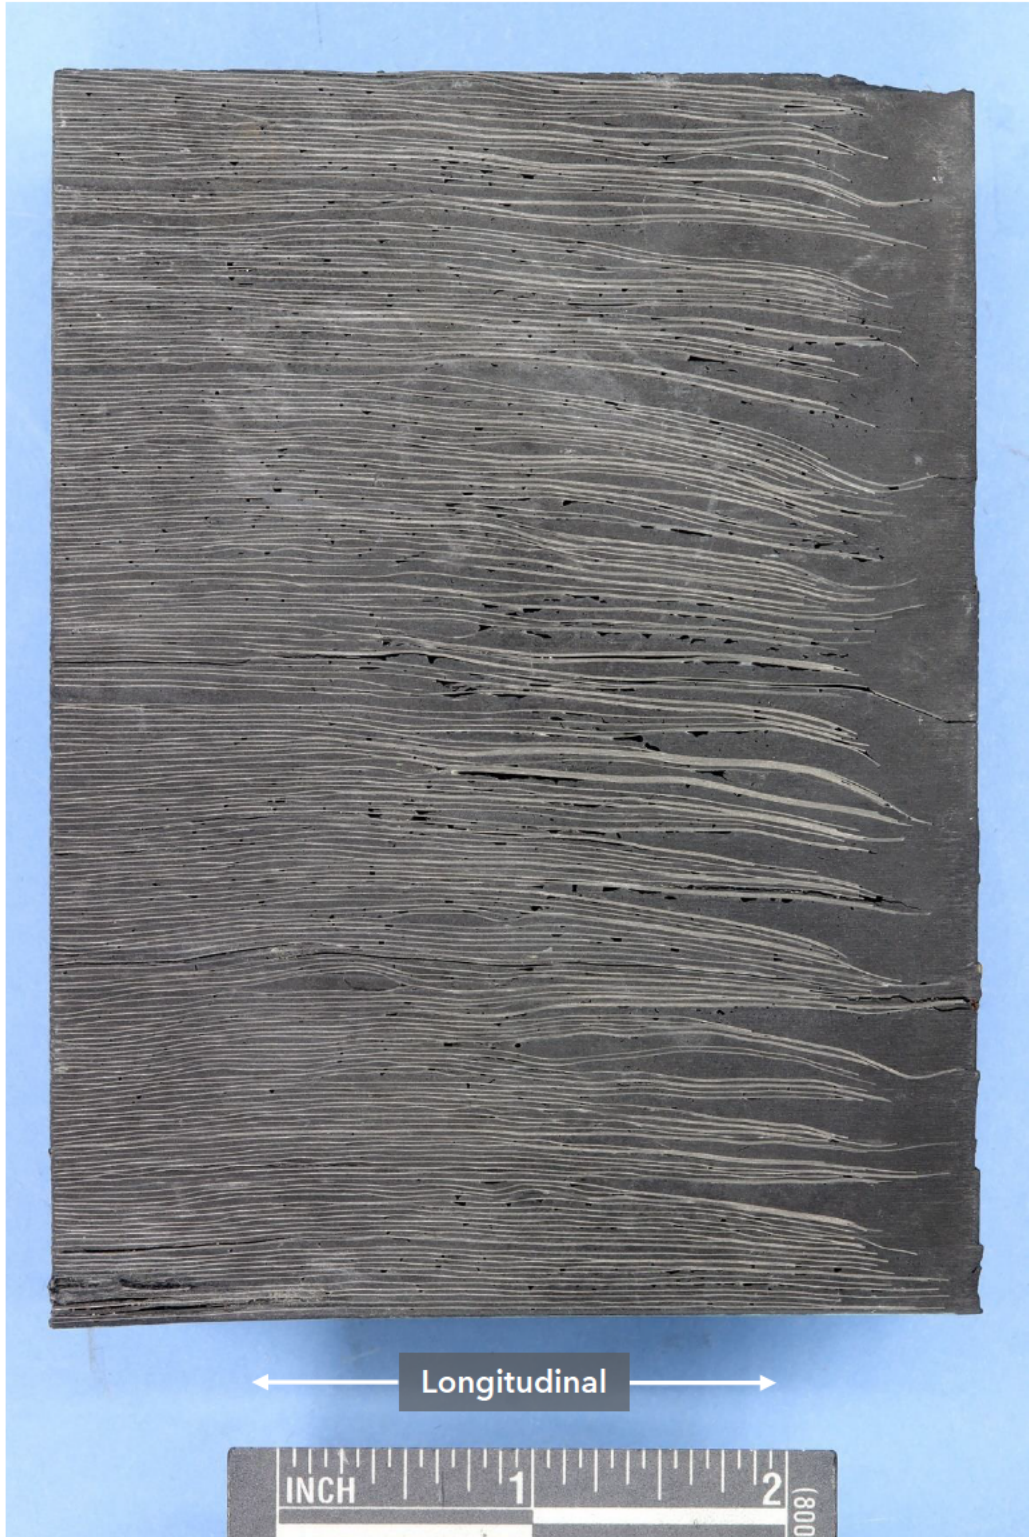
A block of trimmed end material from the first Titan hull is shown in figures 38a and b. The hull was manufactured in 2017 and retired from service in 2019. Measured by caliper, the thickness of the end piece was 4.974 inch. A visual comparison illustrating the difference in thickness between the first and second full-scale hull trimmed ends is shown in figure 39. The first-hull's trimmed end contained multiple delaminations and voids. Of particular note was a centerline delamination, near the mid-thickness of the piece, which is shown from two directions in figures 40a and b.

**Figure 38.** a) Circumferential cross section of the trimmed end piece from the first full scale Titan hull and

**Figure 38 (cont.).** b) longitudinal cross section of the trimmed end piece from the first full scale Titan hull.

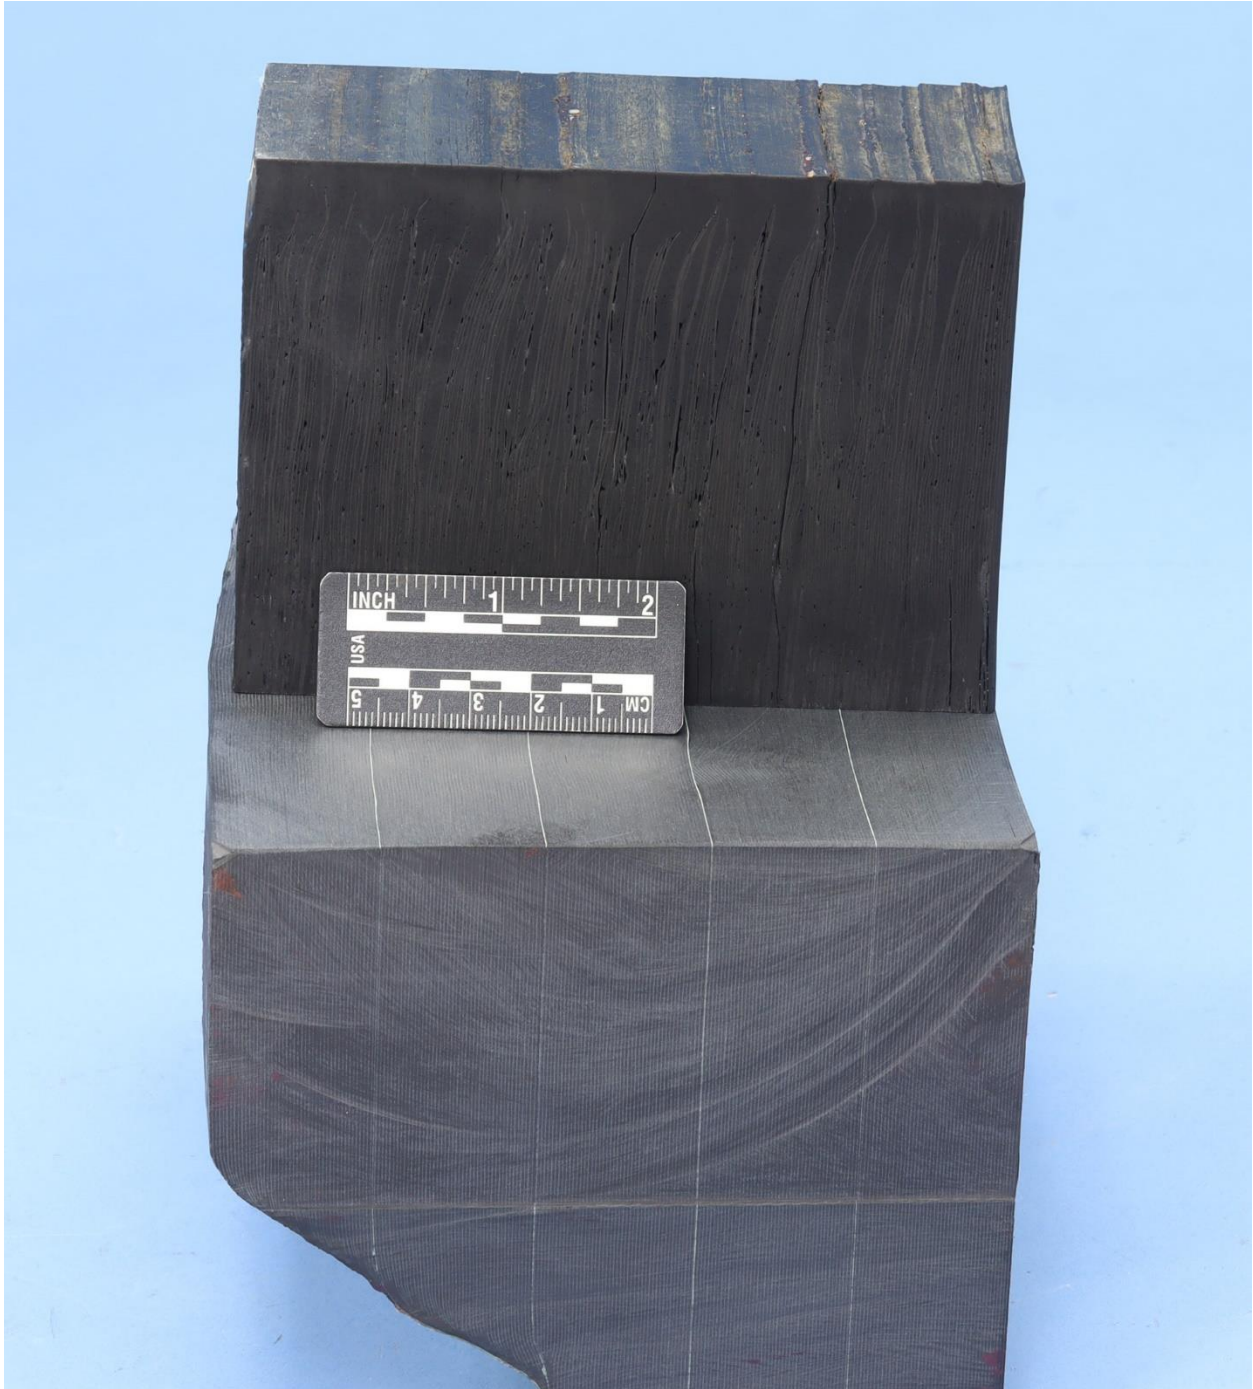
**Figure 39.** Visual comparison of the thickness of scrap end pieces from the first and second full-scale Titan hulls.

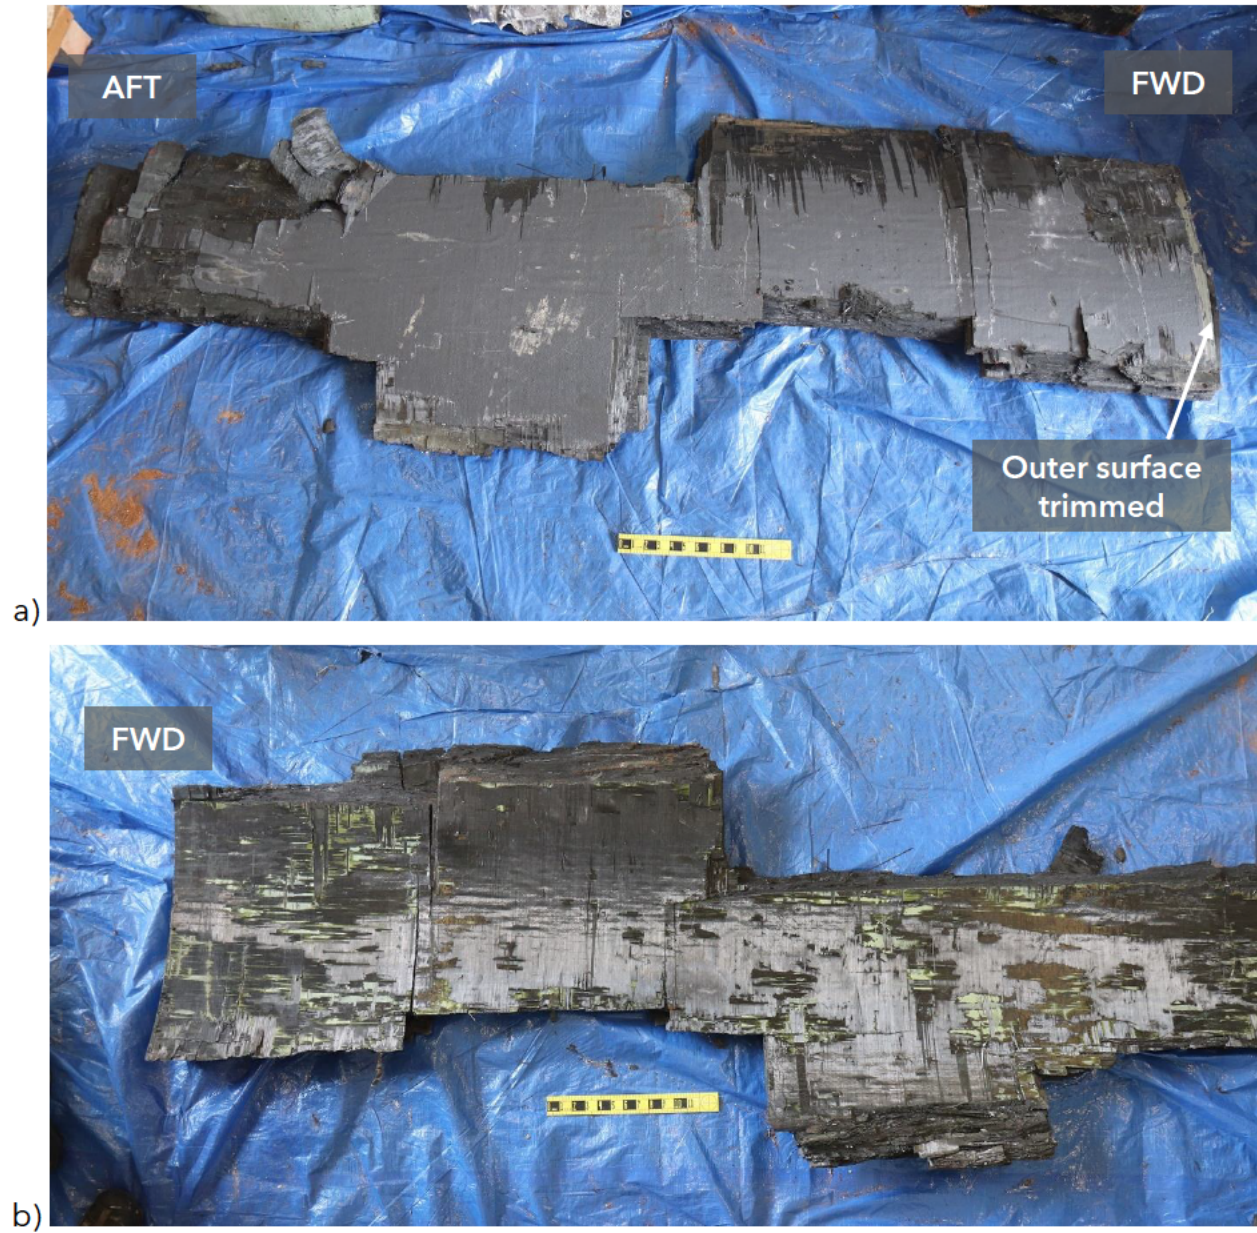
One additional large piece of carbon fiber hull material was recovered, as shown in figures 48a and b. The piece was approximately 2 inches (2 layers) thick and comprised layers 4 and 5. The outer surface was coated with a rubber material and the inner surface was delaminated adjacent to the layer 3/4 adhesive layer interface, as evidenced by occasionally visible adhesive. Based on video footage from the search and rescue mission (see Materials Laboratory Factual Report 24-012) the forward and aft ends were identified. The piece was approximately 97 inch long and was originally located near the top (12:00 position) of the vessel. The forward end was machined. The aft end was fractured and approximately 3 inches was missing. At the forward end, the outer surface had been visibly trimmed to facilitate insertion into the segment's C-channel for adhesive bonding. Portions of the outer surface had a wavy appearance, consistent with wrinkling of the composite plies as shown in the top image of Figure 49. A screen capture from an OceanGate video taken during the manufacturing process indicated that similar features were likely present around the entire surface of the hull as shown in the lower image of figure 49.

**Figure 48.** Images of large layer 4 and 5 hull piece: a) outer surface and b) inner surface.

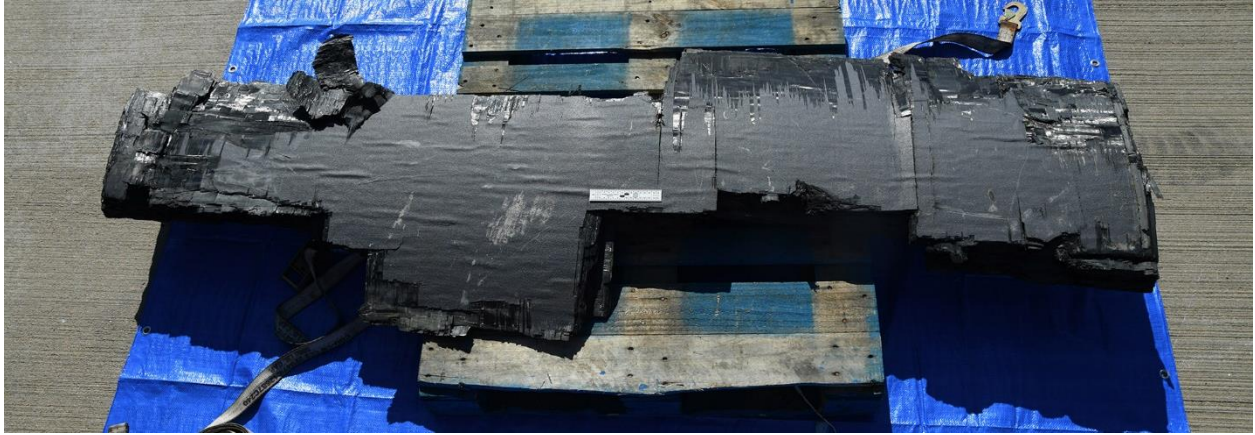
**Figure 49.** Images showing waviness on the outer surface of the hull: Upper image: retrieved hull piece. Lower image: Rough hull post-curing with mandrel removed.

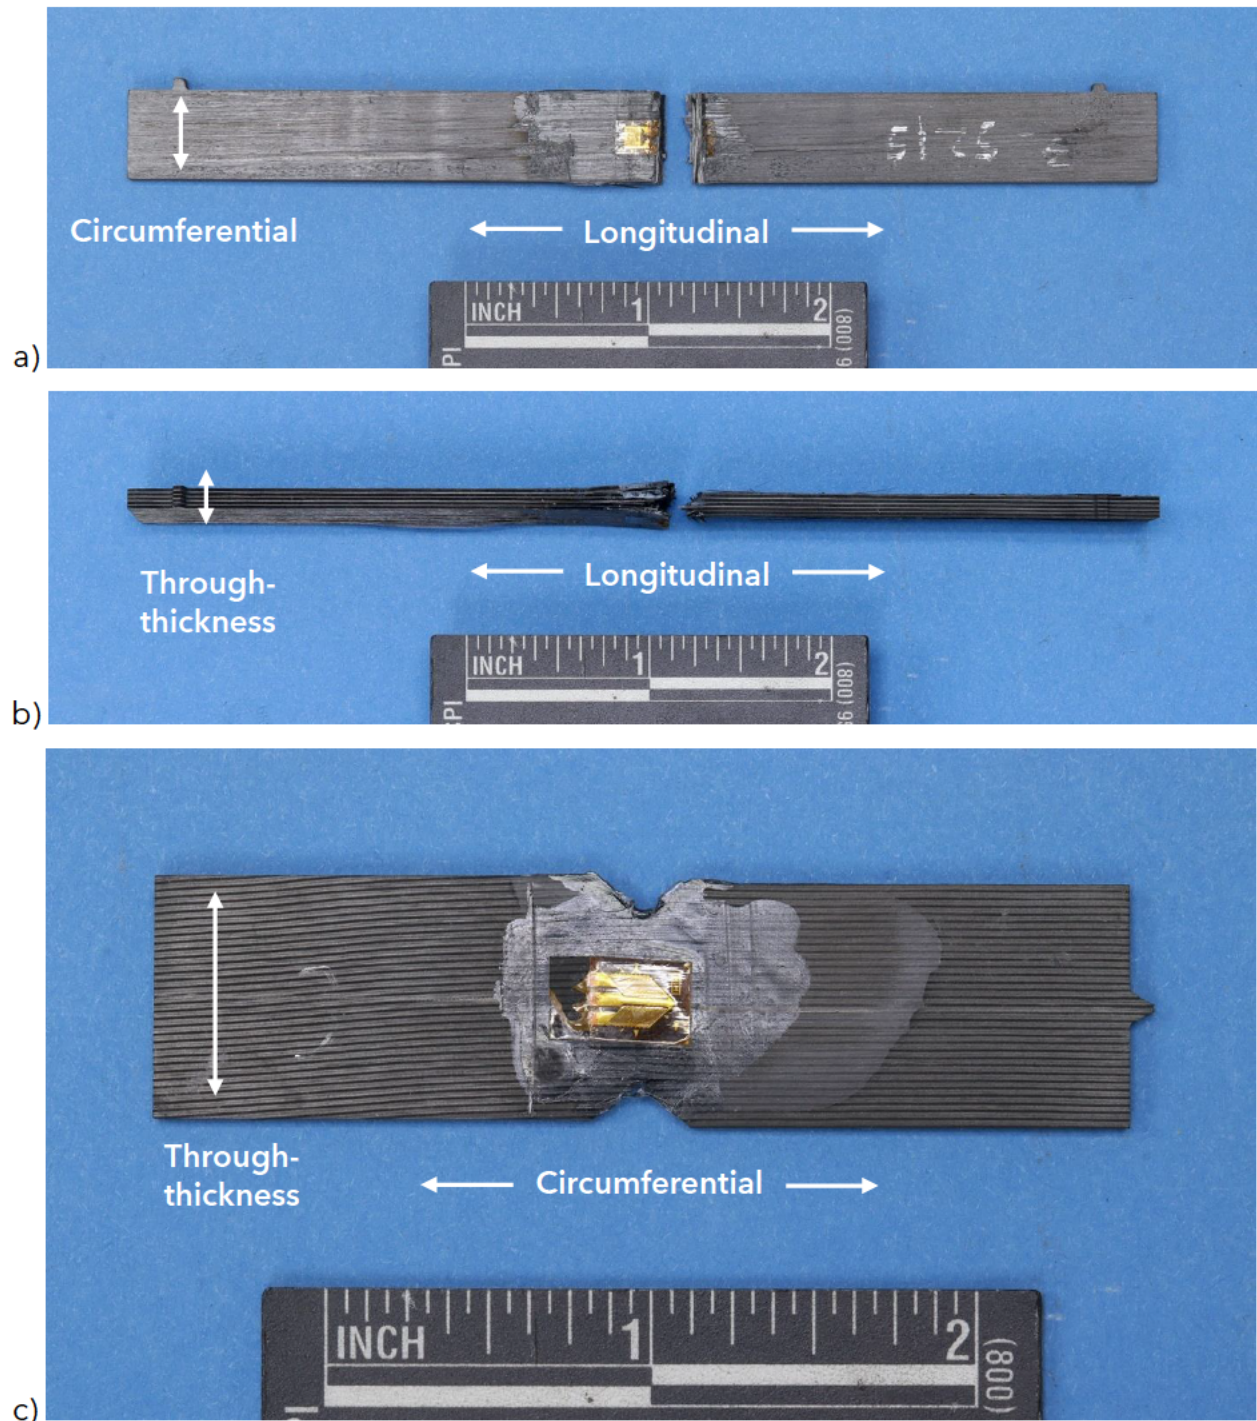
The V-notch shear specimens were cut from a through-thickness circumferential slice of the hull (figure 50c). The samples were nominally 0.5 inch wide and between 0.095 inch and 0.097 inch thick. The long side of the gage section was aligned with the through-thickness direction of the hull and the short side of the gage section was aligned with the longitudinal direction of the hull. The shear displacement was applied in the through-thickness direction, which resulted in a 1,3-type shear to the circumferential plies (1 equates to the V-notch shear plane being perpendicular to the principal fiber axis and 3 equates to the shear direction being perpendicular to the plies). The results are shown below in table 3. A report obtained by OceanGate reported a 1,3 shear strength for a unidirectional laminate of Toray P2362W-19L of 12,400 psi with a standard deviation of 500 psi.

**Figure 50.** Images of mechanical test coupons: a) long side of compression test specimen; b) short side of compression test specimen; and c) V-notch shear test specimen.
