National Transportation Safety Board

MATERIALS LABORATORY

Factual Report 24-012

Location: Atlantic Ocean
Date: June 18, 2023
Vehicle: OceanGate Experimental Submersible Titan
Investigator: Marcel Muise, MS-10

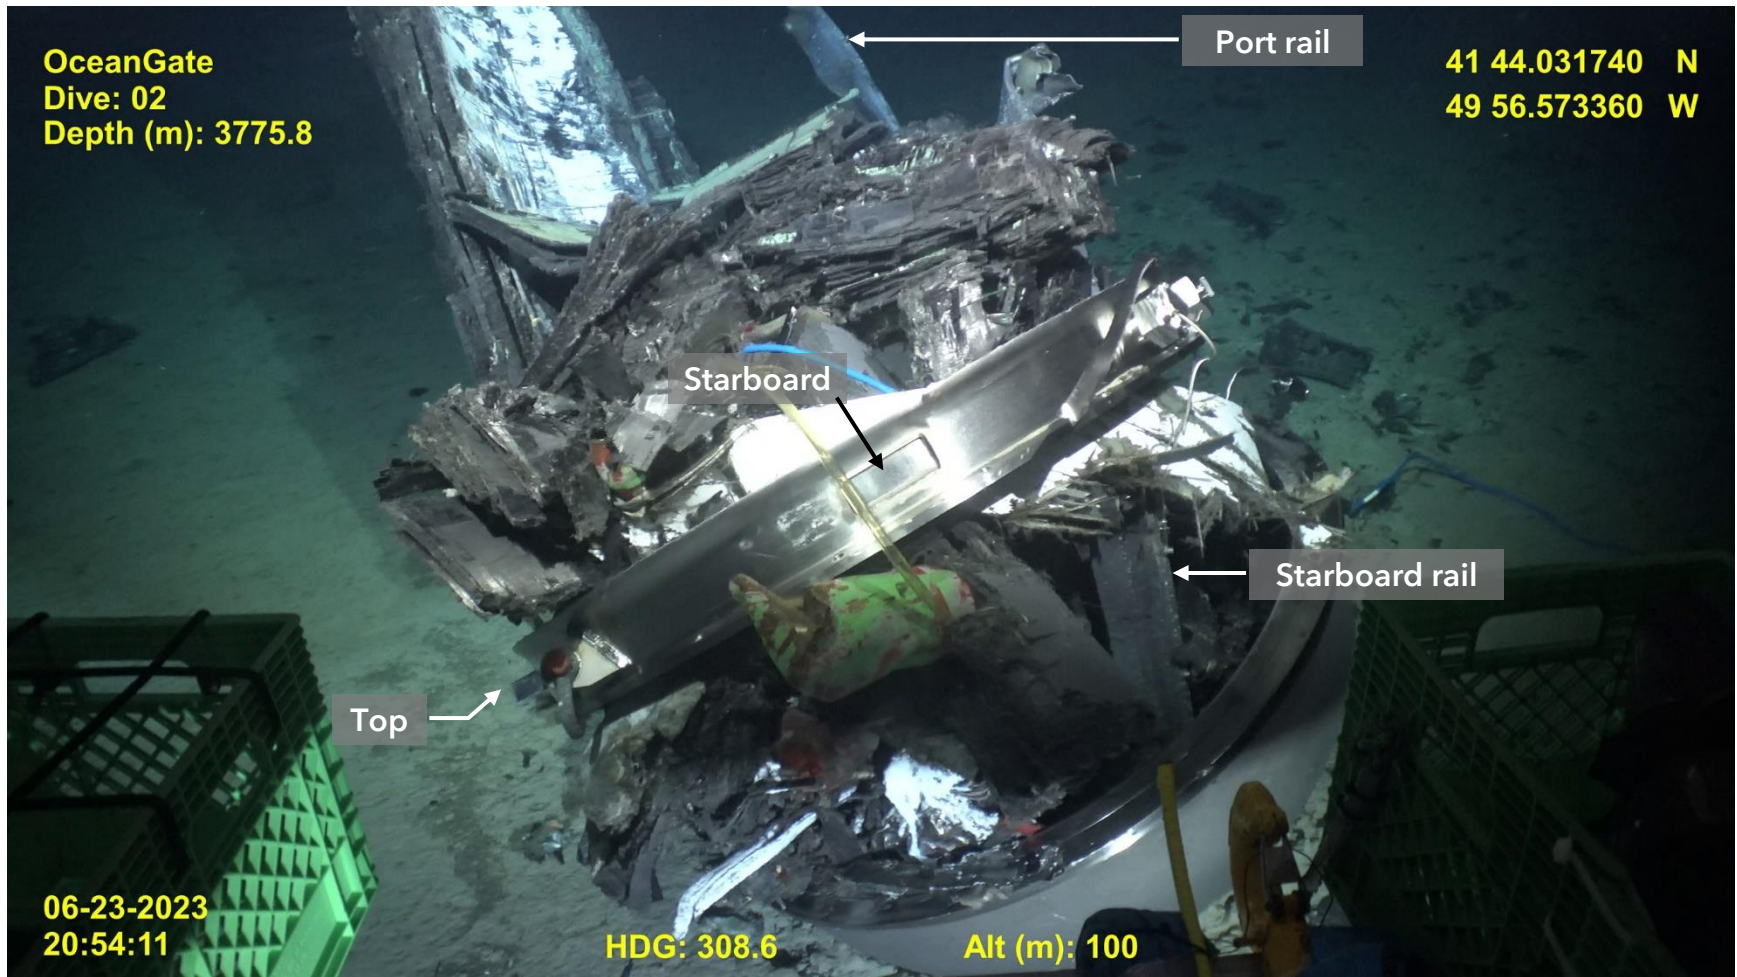
Figure 7. Main wreckage viewed starboard side.

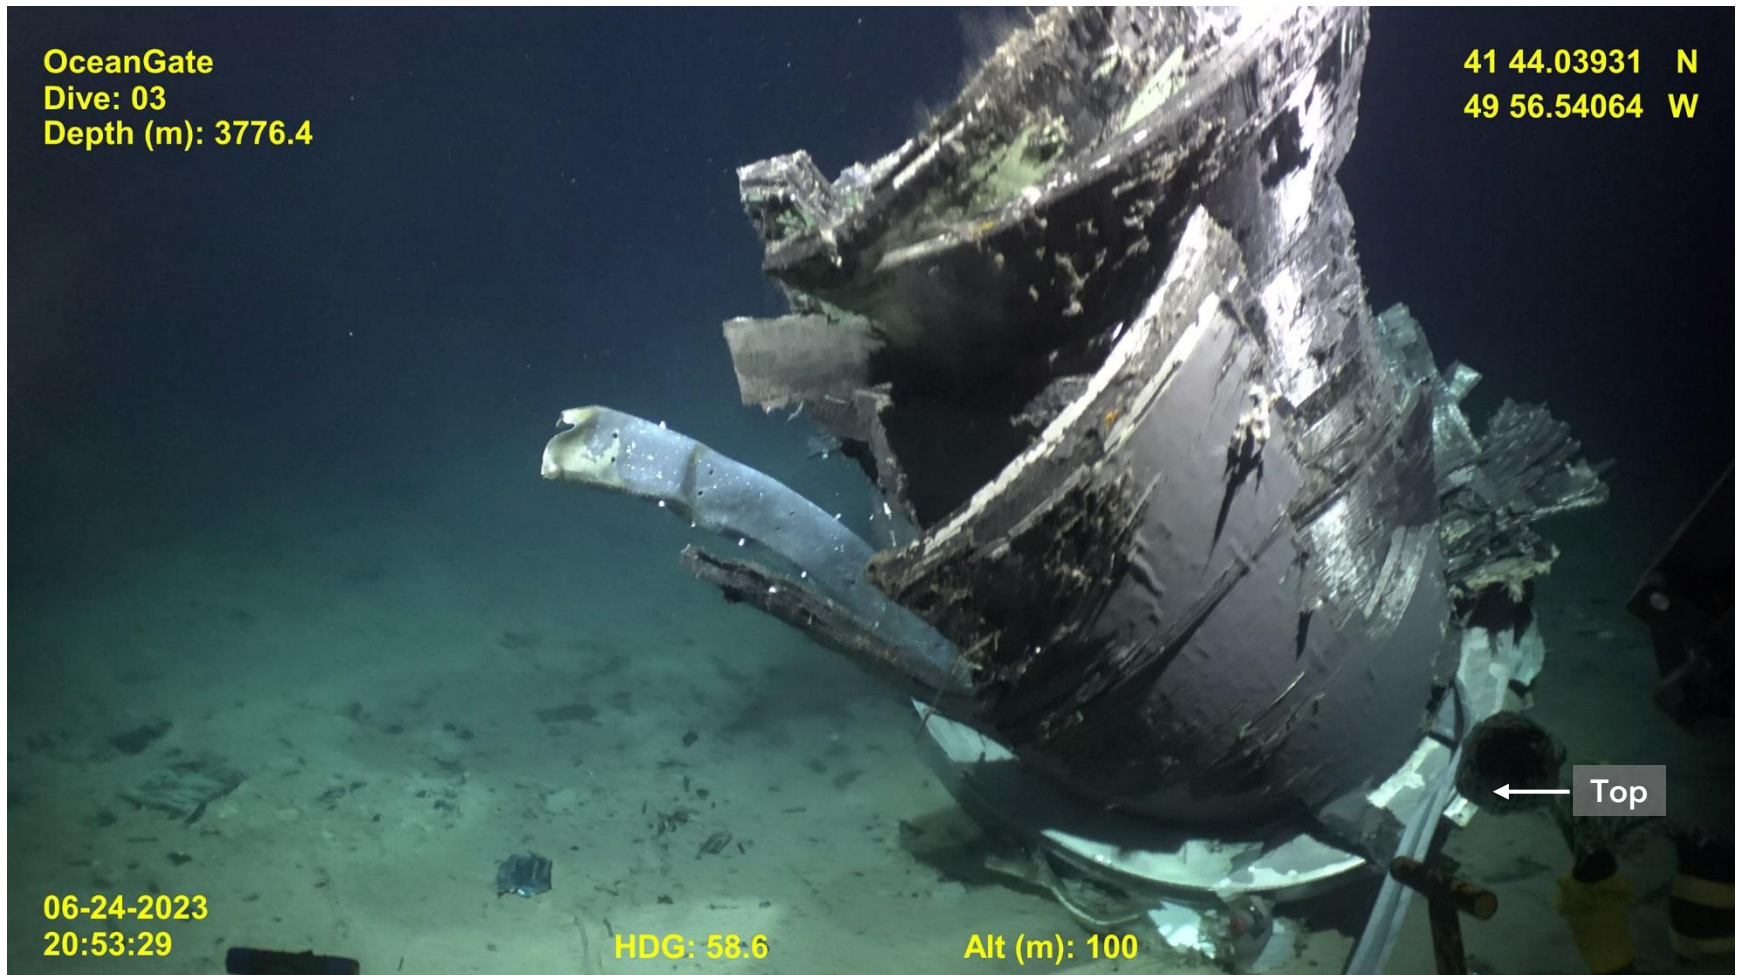
Figure 9. Main wreckage viewed from forward end and top side.

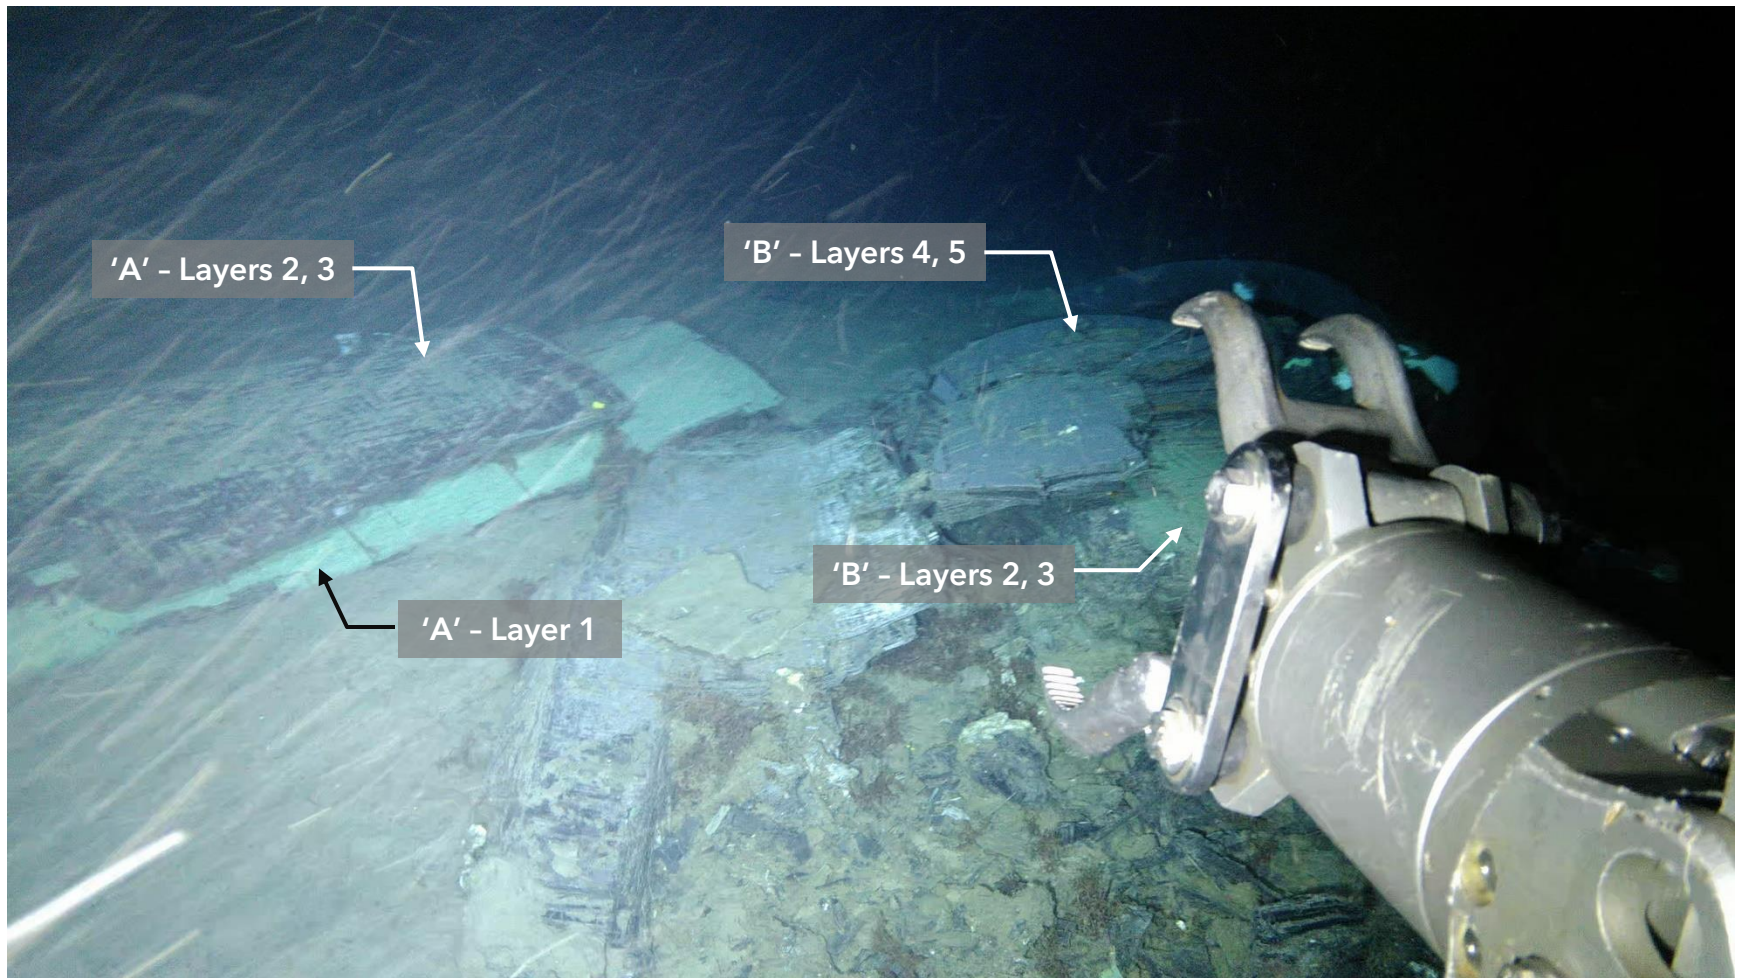
As found, piece 'B' was located on the port side of the wreckage (figure 5). Images of 'B' are shown in figures 13 and 15 - 21. The dimensions of the piece could not be precisely established but based on the size of 'A' it was likely between 60 inch and 72 inch long (between 5 and 6 feet), over half the length of the hull (full length is 100 inch). The aft end of the piece is labelled in figure 15. As with 'A', the piece had delaminated into multiple layers: layer 1, layers 2/3, and layers 4/5. The delamination at the layer 1/2 interface resided within the adhesive as did much of the delamination at the layer 3/4 interface.

Figure 16. Pieces 'A' and 'B' from a different point of view.

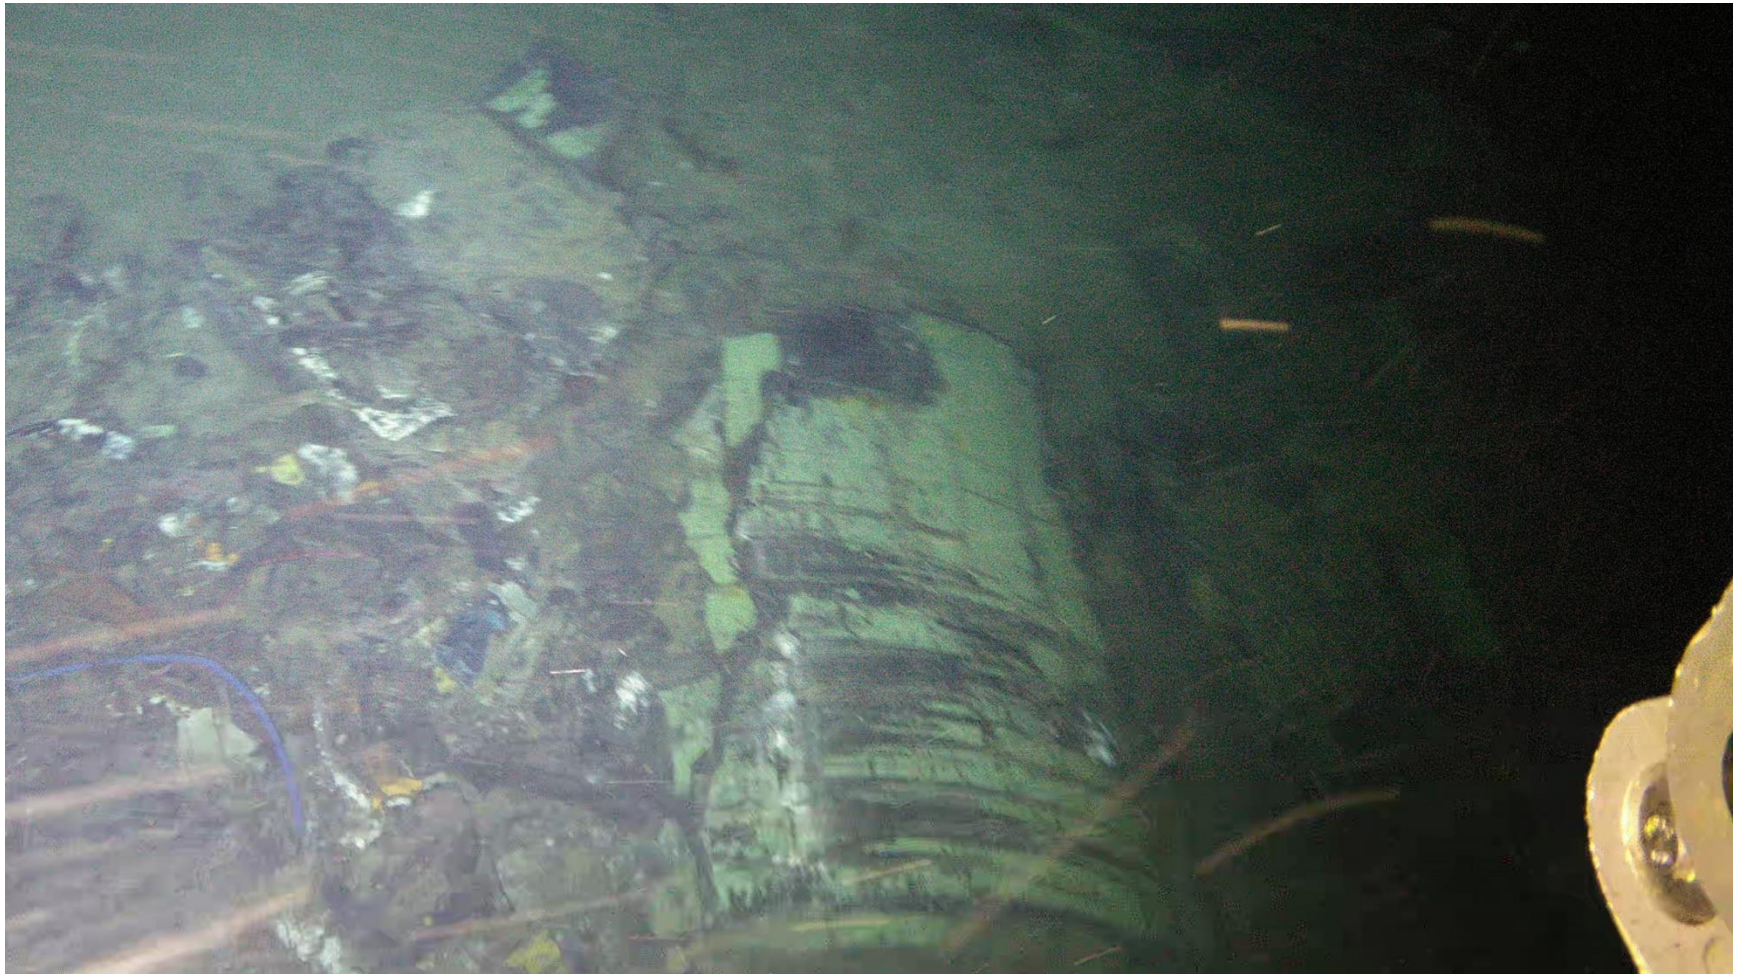
robotic arm (see figure 18), the underside exhibited multiple longitudinal cracks. The adhesive surface also exhibited a light/dark pattern, like that documented in Materials Laboratory Factual Report 24-011. Features consistent with voids were present on the surface of layer 1, but due to the layup sequence at the layer 3/4 interface, it could not be determined if some features at that interface were voids or longitudinal fiber fragments. The longitudinal through-thickness fracture on the clockwise (CW) edge of the piece appeared relatively straight, whereas the through-thickness fracture on the counterclockwise (CCW) edge was irregular (see figure 20).

Figure 21. Piece 'B' after removal of layers 4 and 5 from a different point of view.

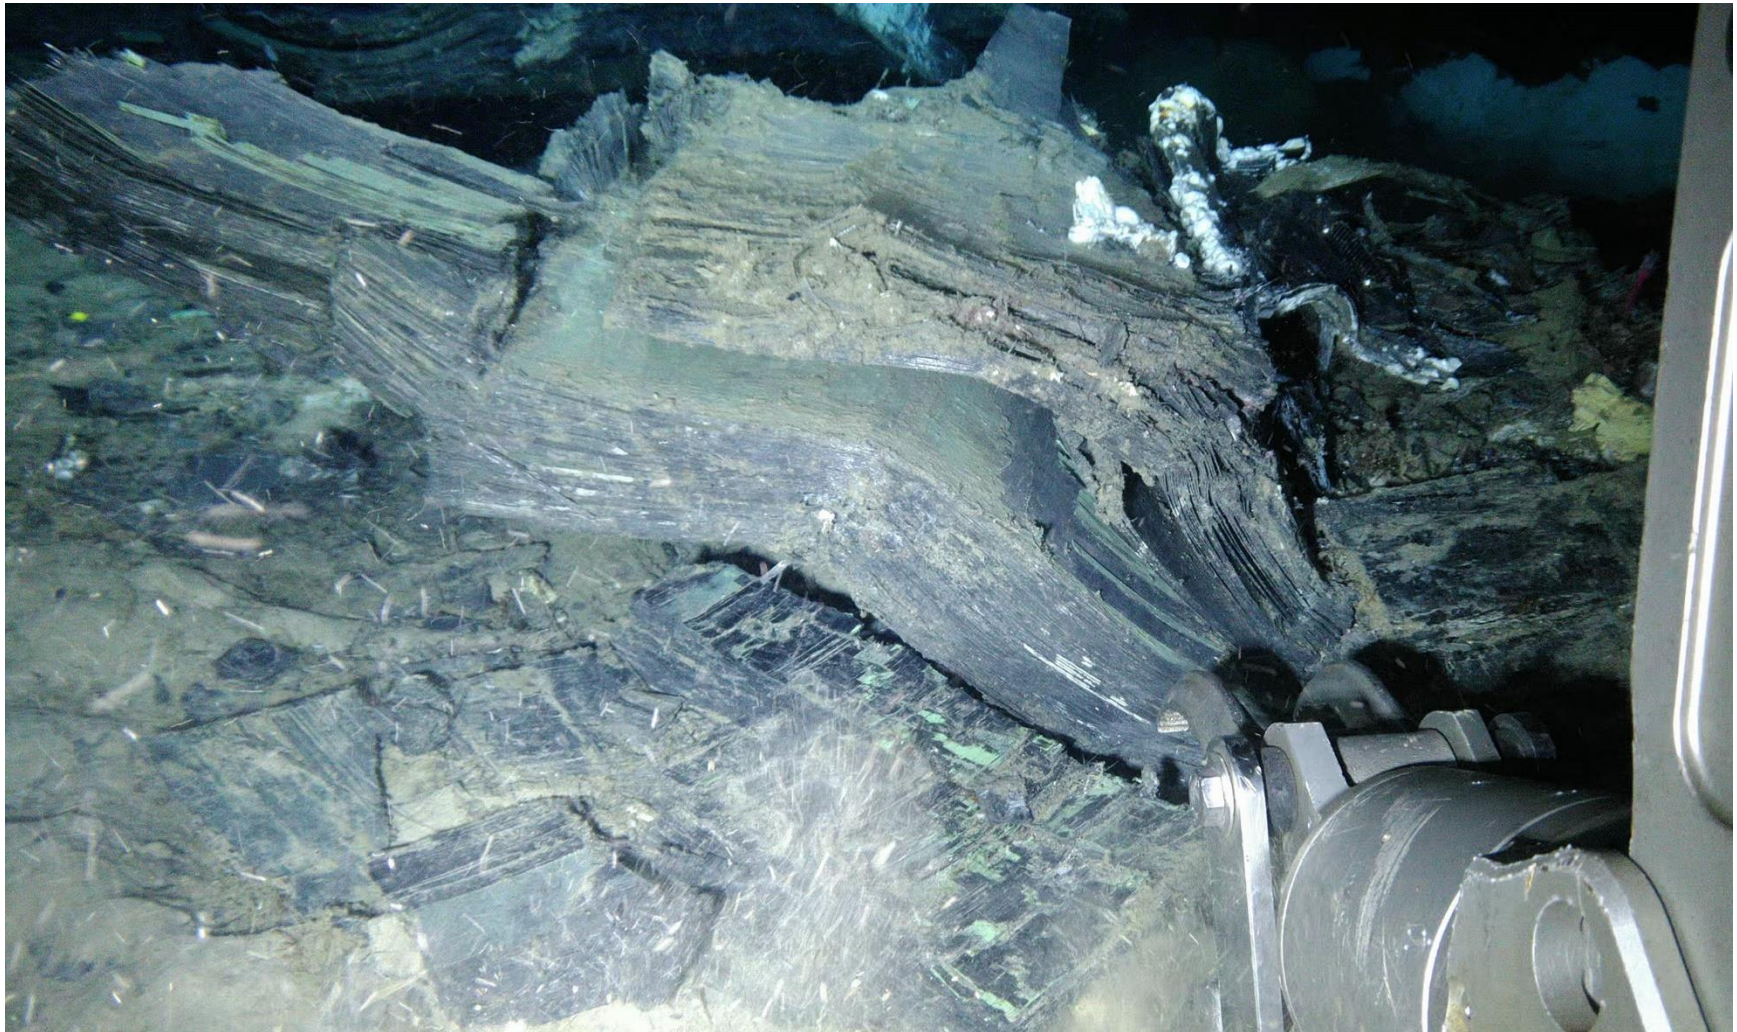
Piece 'D' was not originally visible from outside of the wreckage. The aft end of the piece was revealed after the segment was separated from the aft dome (figure 11). 'D' appeared to have been sandwiched between 'B' and 'C'. Additional photos are shown in figures 22 and 23. 'D' was a partial piece. Layer 1 was missing (the inner surface of the hull was painted white and no painted surface was seen). Along the CW side, the piece was delaminated through the adhesive. 'D' exhibited a sigmoidal buckle as indicated by the yellow dashed line in figure 22, with an inward bend and an adjacent outward bend. Between the bends, the separation within the adhesive layer transitioned into the adjoining composite material.

Figure 23. Piece 'D' from another point of view.

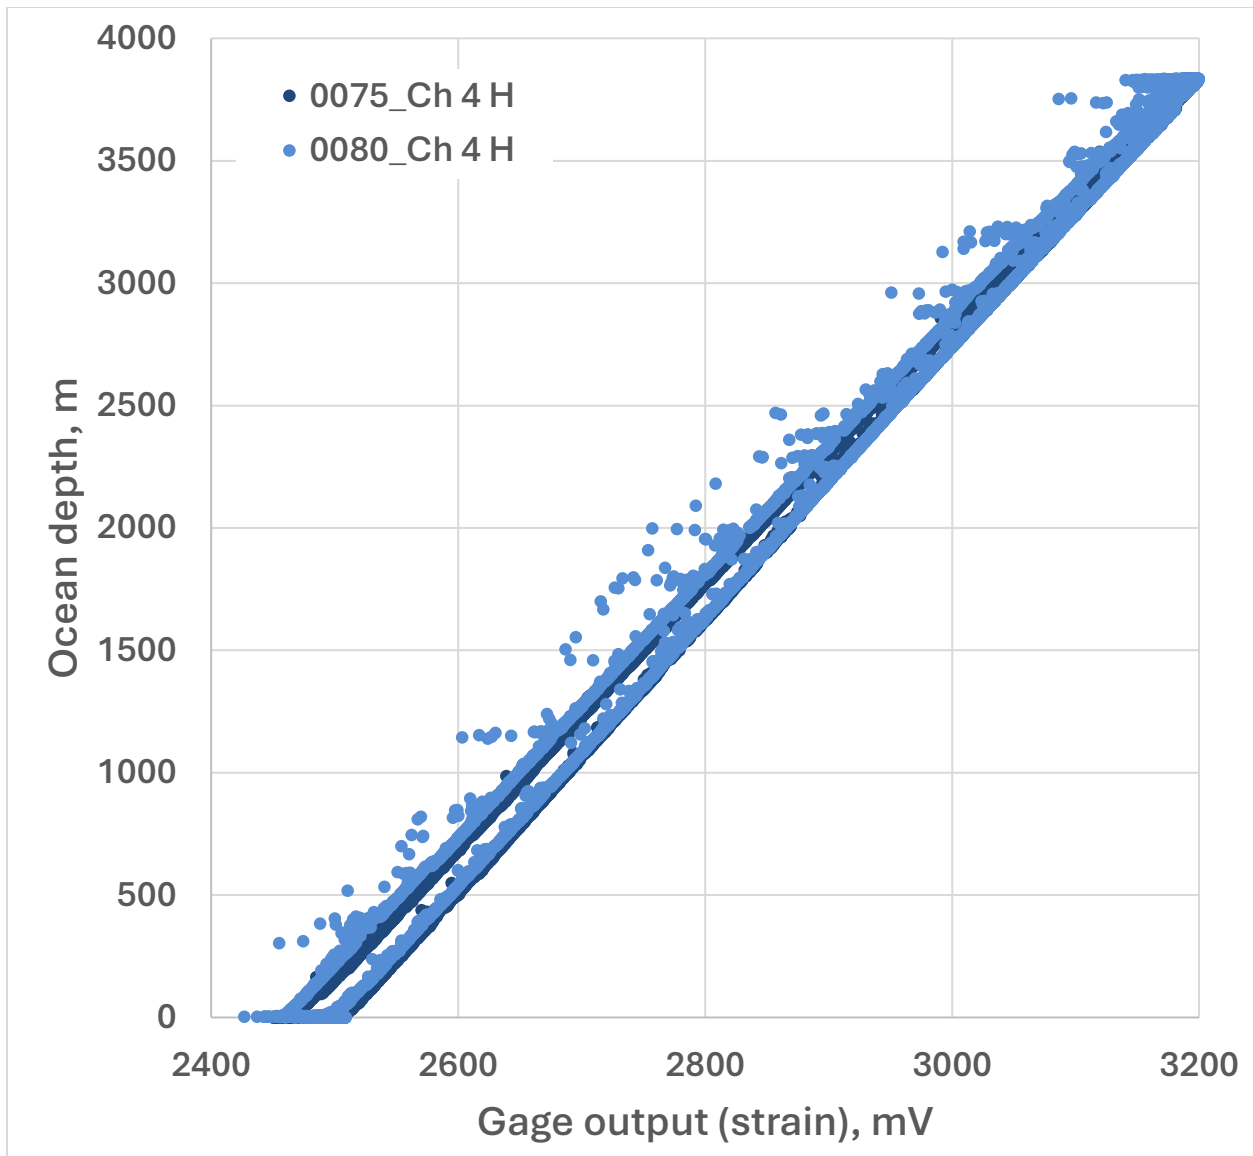
Figure 29. Plot of dive depth as a function of strain gage output for Dives 75 and 80 - Gage group 4 - hoop strain gage. The curves have been aligned using the linear portion of the descent phase of the trip.

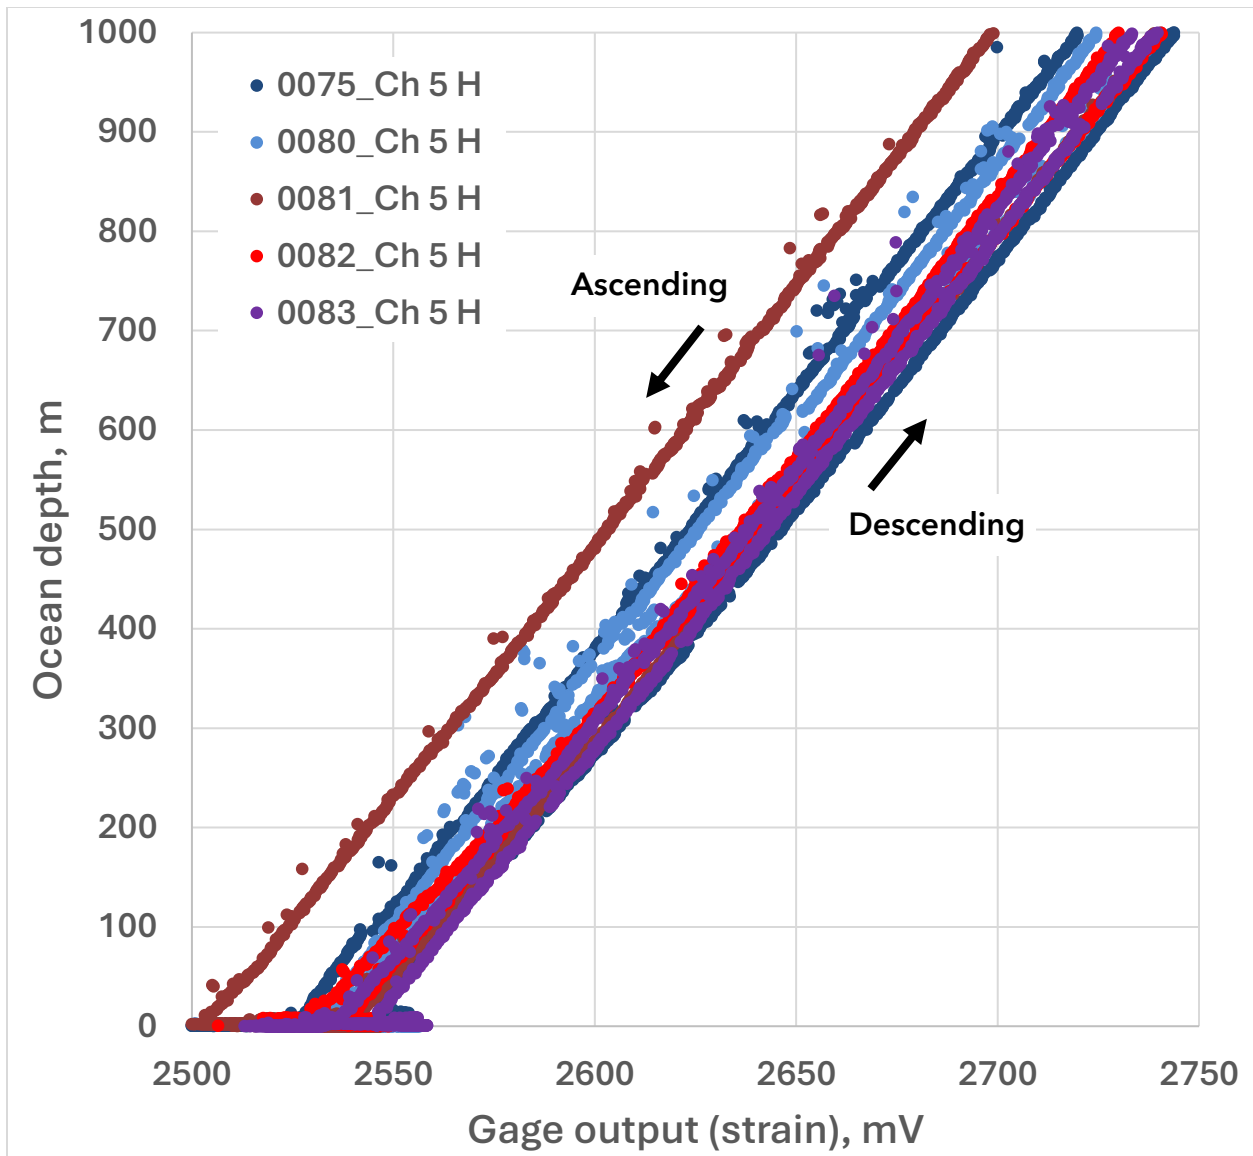
Figure 34. First and last 1000 m of dive depth for Dives 75 and 80 - 83 - Gage group 5 - hoop strain gage. The curves have been aligned using the linear portion of the descent phase of the trip.

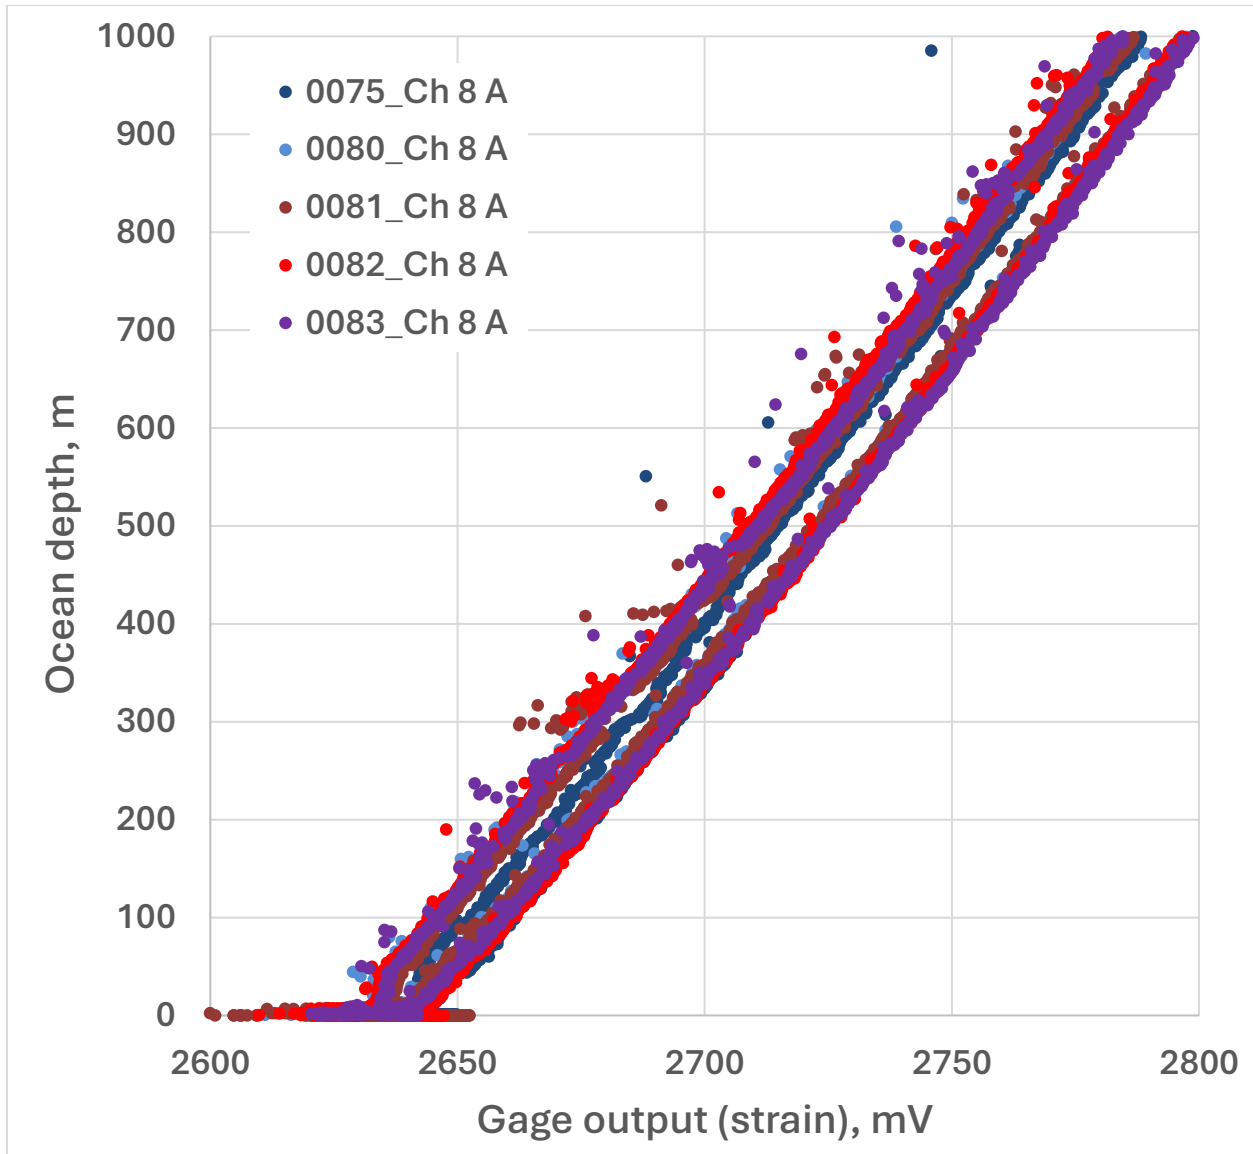
Figure 37. First and last 1000 m of dive depth for Dives 75 and 80 - 83 - Gage group 8 - longitudinal strain gage. The curves have been aligned using the linear portion of the descent phase of the trip.

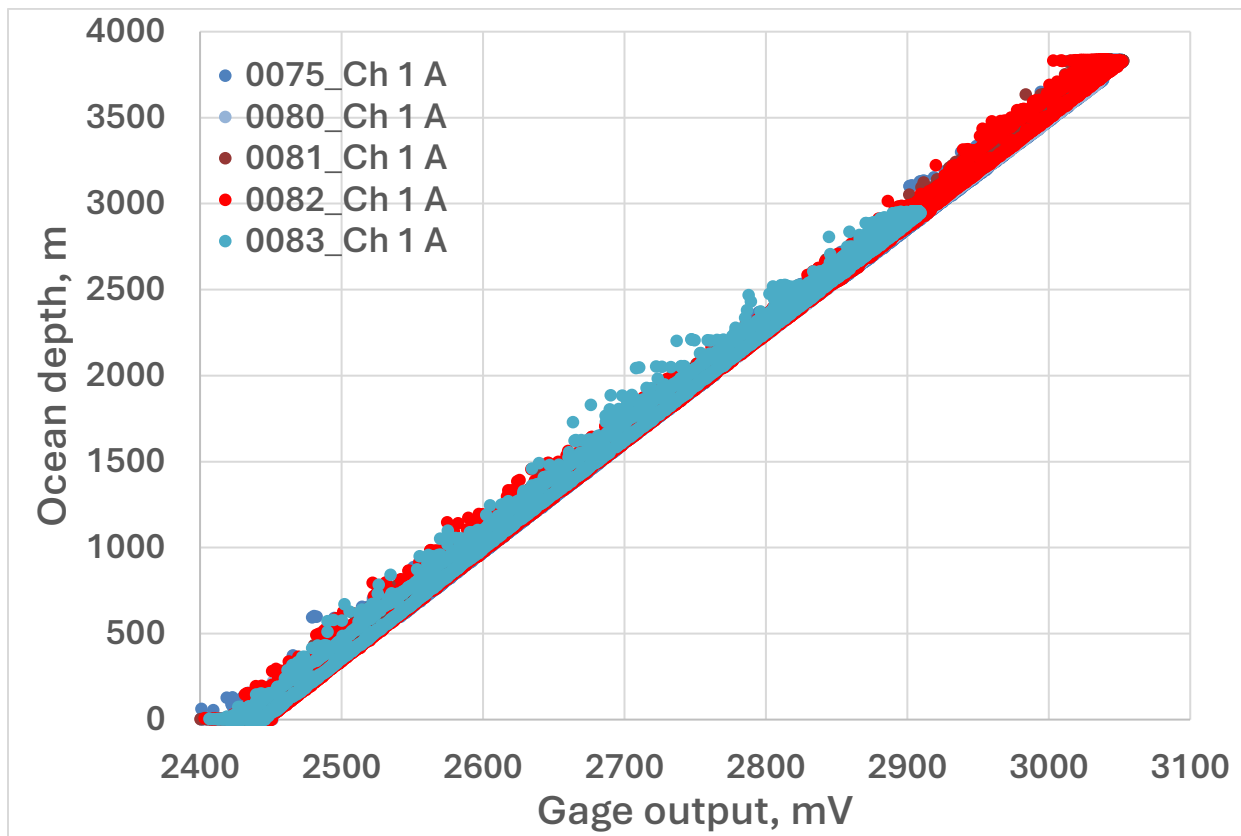
The strain response of the forward dome is shown in figure A1. The forward dome was originally equipped with four strain gages: two in the polar orientation and two in the azimuthal orientation. The gages were placed at or near a weld adjacent to the viewport, at a high-stress location. From at least Dive 75 onward, only one polar gage was operational.

Figure A1. Plot of dive depth as a function of strain gage output for Dives 75 and 80 through 83 - Gage group 1 - "A" strain gage in the polar orientation.
