National Transportation Safety Board

DCA22FM022

Fire Factual Report 22-101

Location: Norfolk, VA
Date: June 7, 2022
Vehicle: Spirit of Norfolk
Investigator: Michael Karr

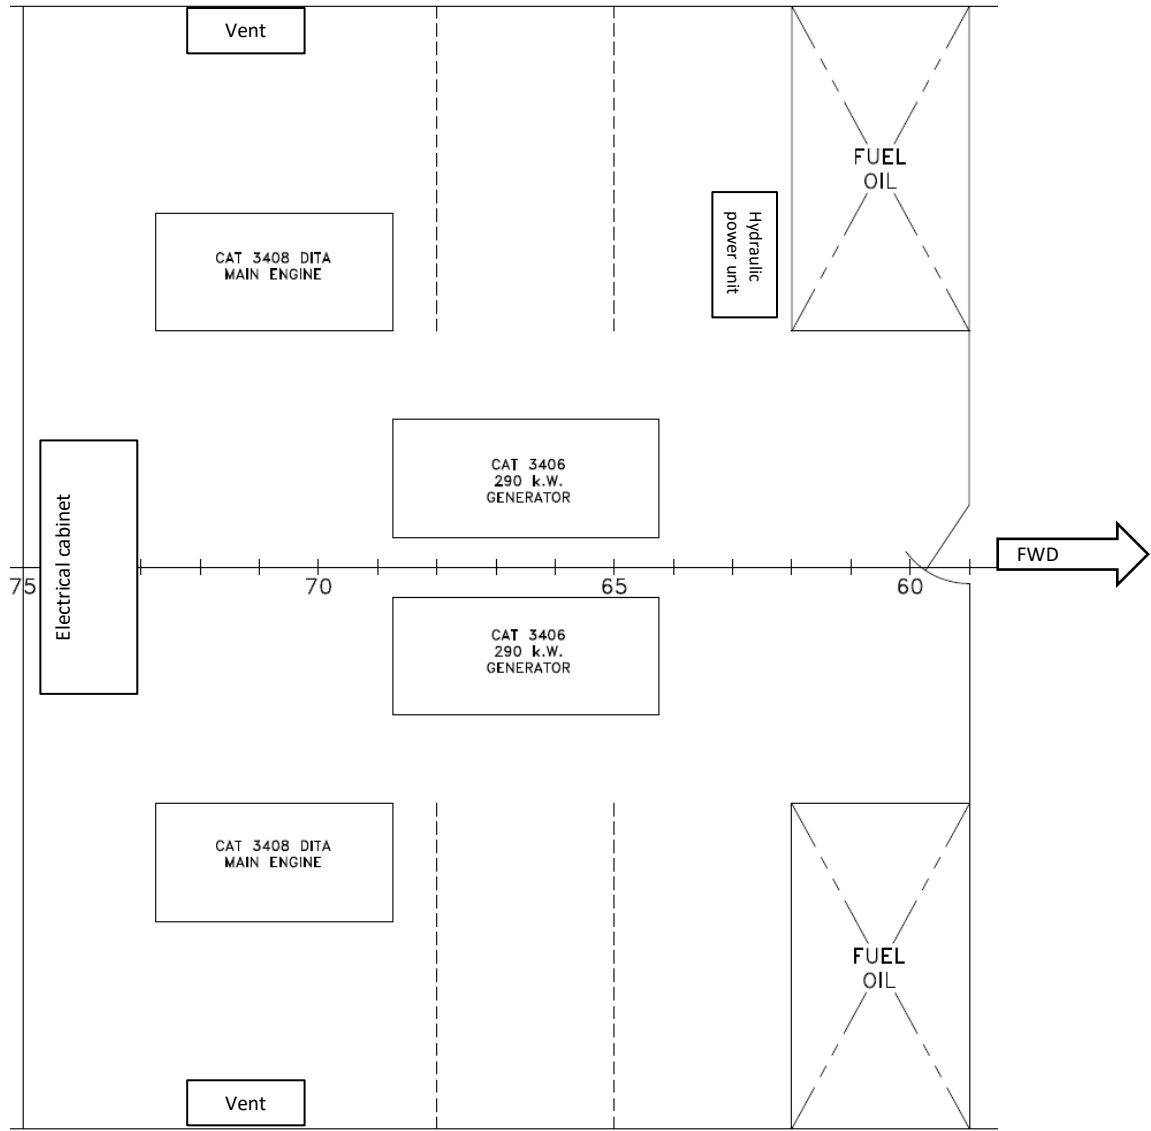
Figure 16. Engine room layout (not to scale).

sealing the exhaust vents beyond shutting down the powered ventilation. The interior of the engine room consisted of a mostly open compartment with two partial bulkheads extending perpendicularly from the exterior bulkheads towards the center of the compartment. These partial bulkheads created two alcoves closed on three sides with the open sides facing the generators at the center of the compartment. The exterior bulkheads and ceiling of the engine room were covered with thermal insulation. A diagram of the engine room layout is depicted in Figure 16. The engine room contained two propulsion engines in the aft portion of the compartment. One on the port side and one on the starboard side. Towards the middle of the engine room there were two engine generators with one on the port side and one starboard. A hydraulic power unit was located on the port side forward and outboard of the port side generator. The port and starboard fuel tanks were located in the two forward corners of the engine room.
