ATK 32050

The following defects were noted on the sleeper car that was positioned as the third car behind the two locomotive train consist remaining upright.

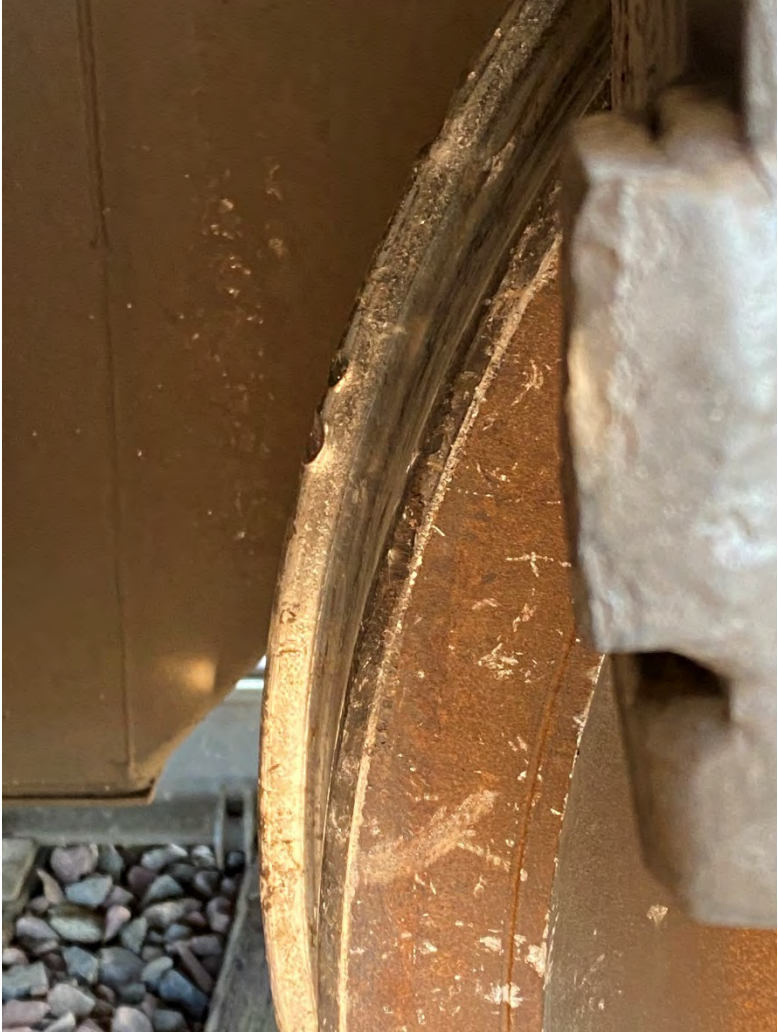
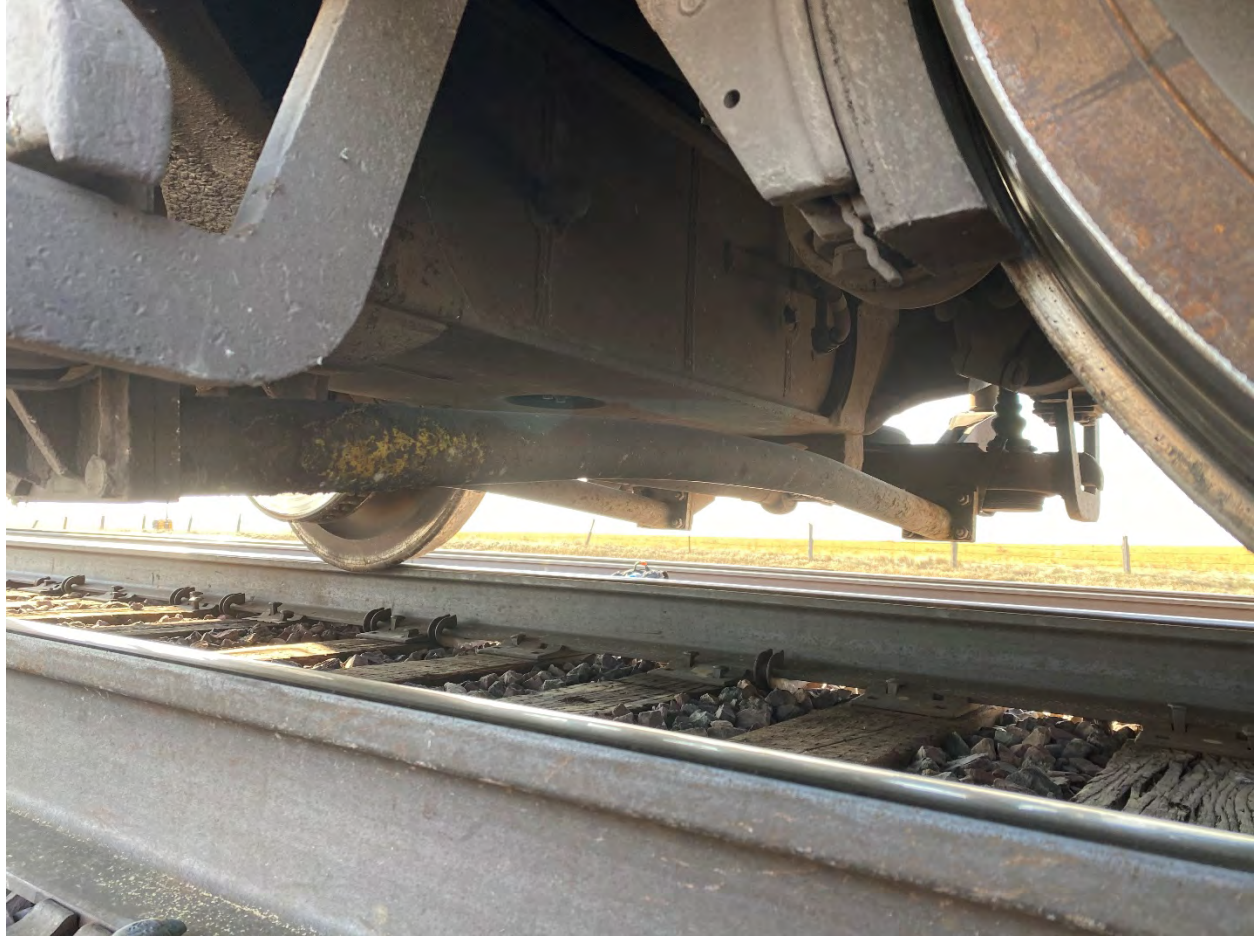
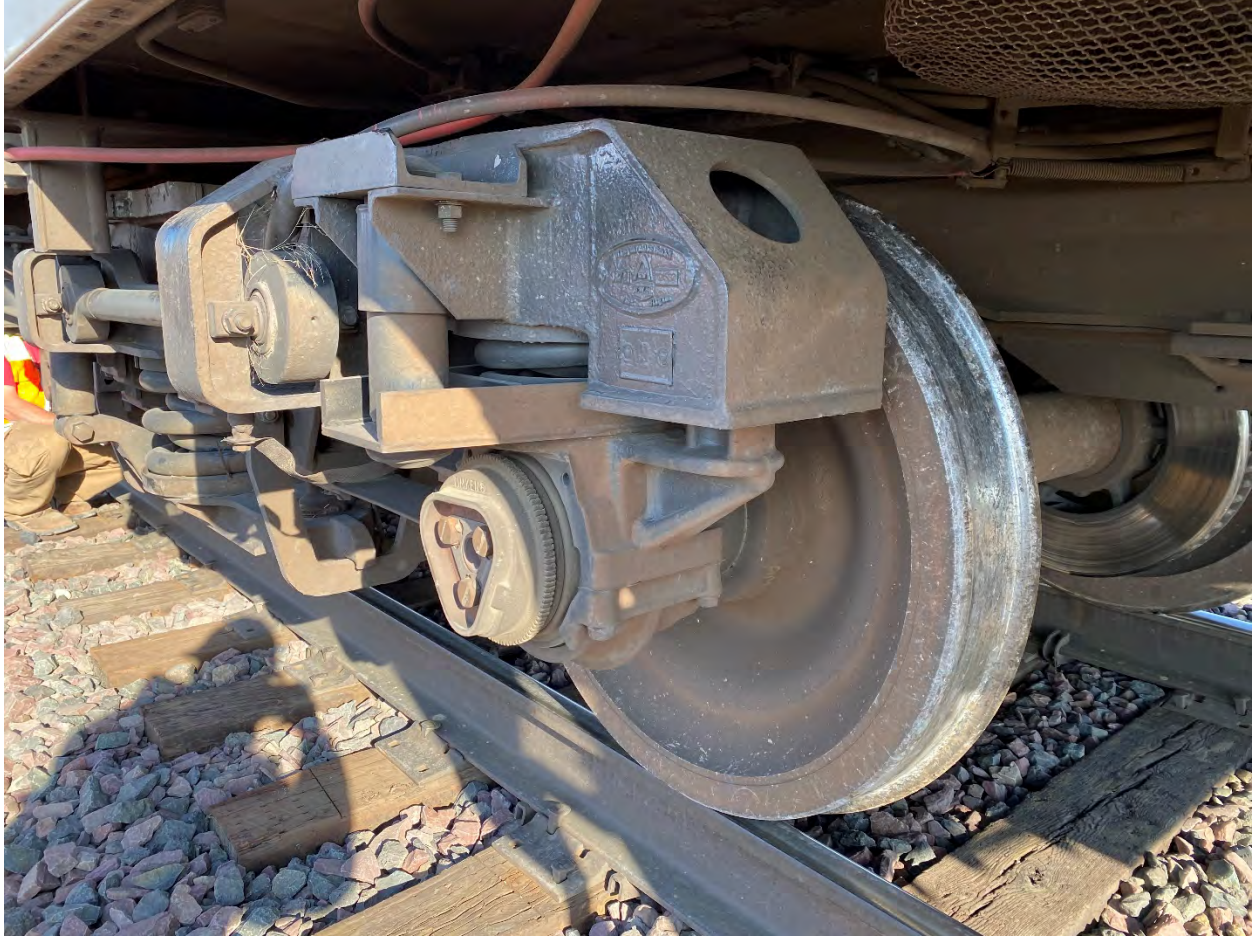
32050

The B-end of the passenger car rear trailing axle showed signs of all four wheels were off the rail. The left number two wheel had evidence of heavy impact marks on the wheel flange as noted in the photos. The left number one brake rotor showed evidence of dragging. The B-end stabilizer bars were bent and damaged. The B-end coupler right side bump stop was broken and impact marks on the top of the coupler shank from the buffer casting. The B-end right side truck frame had signs of dragging. The B-end right side spring saddle had signs of dragging.

The stateroom 13 door was off its track. The stateroom 11 window was missing. The interior A, B, and D room access doors were binding.

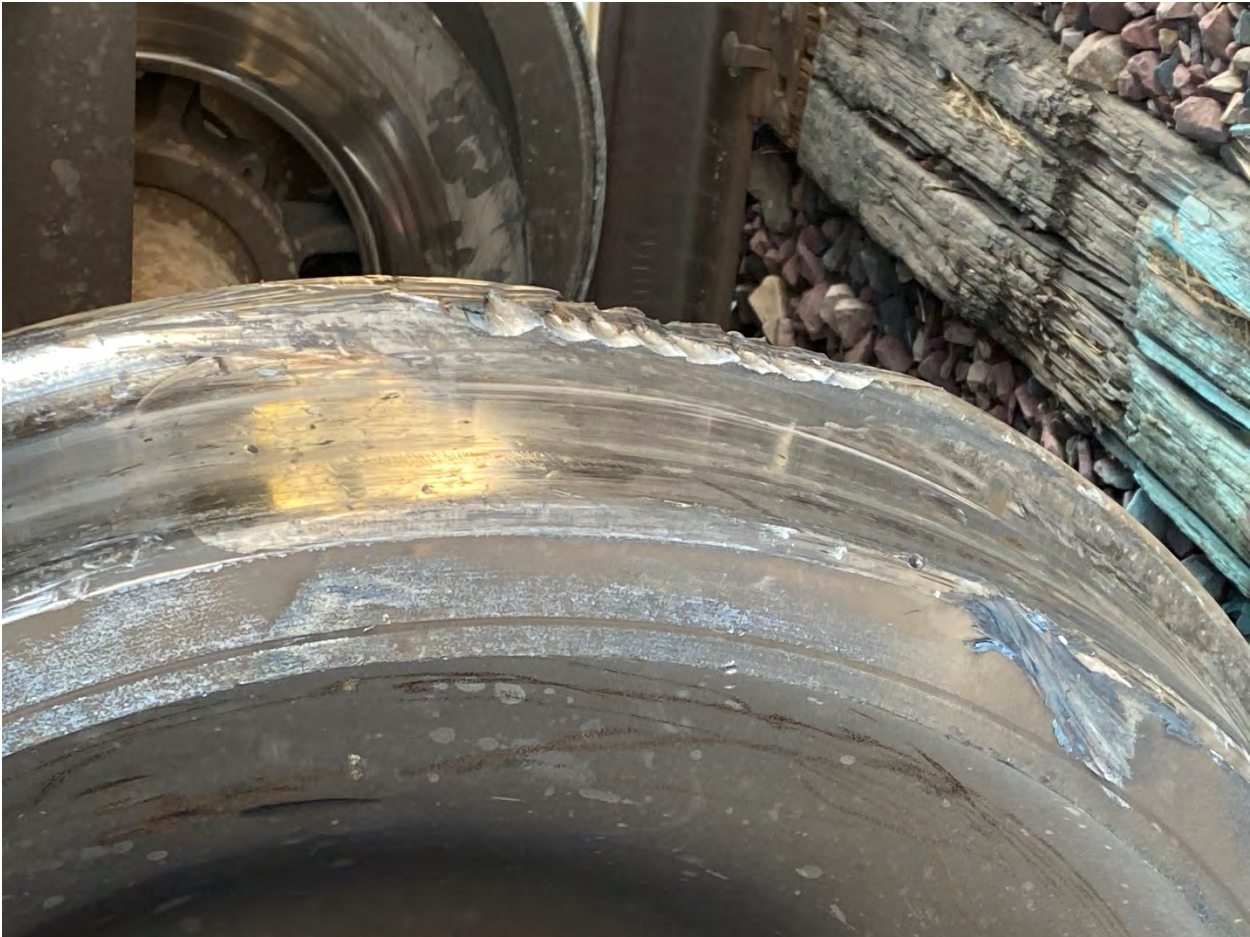
32085

All eight wheels were derailed. The L1 wheel was damaged extensively in a saw tooth pattern. . The R1, R3, R4, L1, and L2 wheel adapters missing. The R2 wheel adapter was out of place. The R3 and R4 truck springs missing. The L1 and L2 equalizer beams were missing. The R3 and R4 equalizer beams were out of position. The BL shock absorber was missing. The B end air brake top rod bent. The L3 tread brake unit broken. The AR side coupler bumper block missing.

The A end vestibule door dislodged from track. The B end vestibule door inoperable. The stateroom 7 bunk dislodged from safety latch.

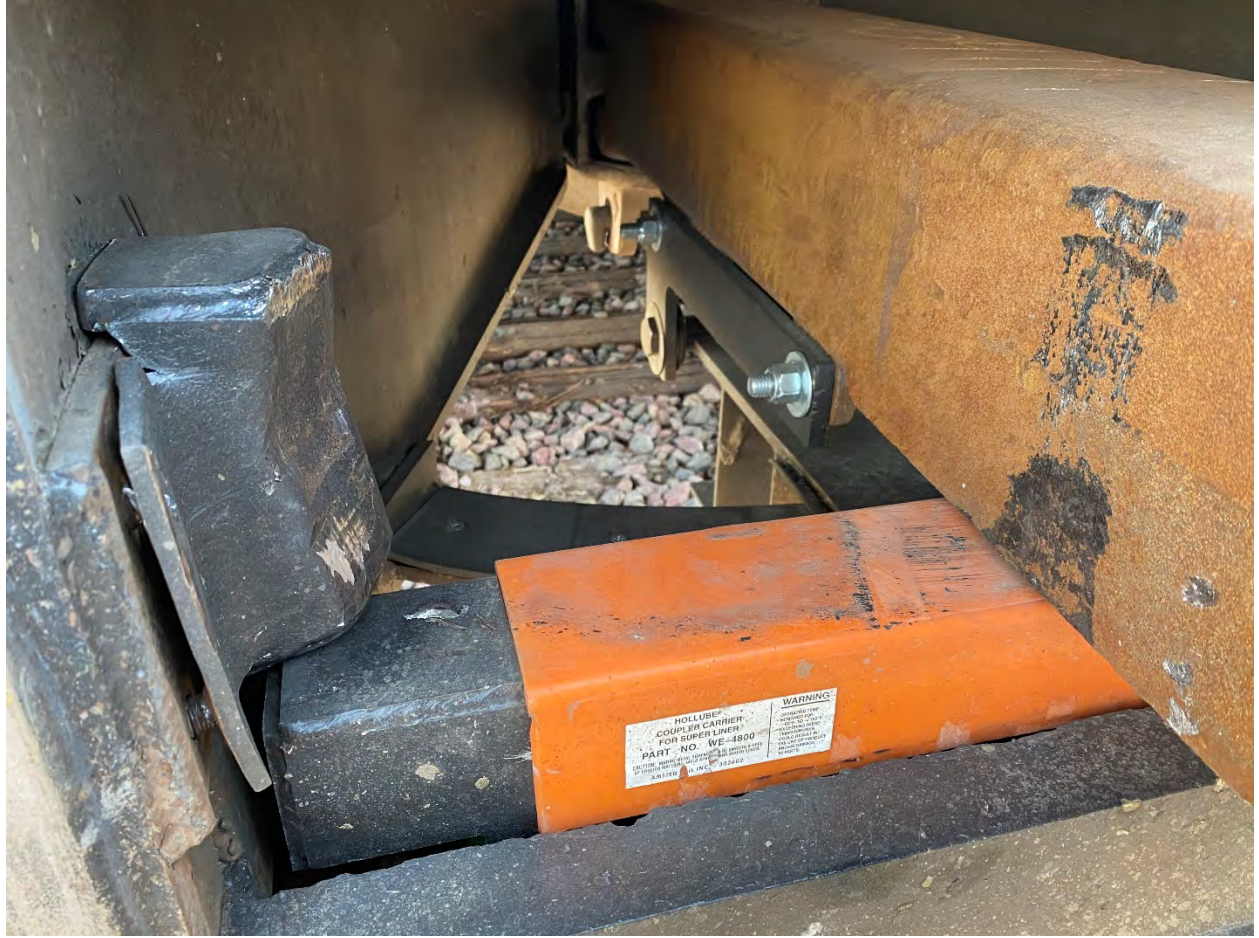
38058

All eight wheels were derailed with the car body remaining upright. The L1 and L2 wheels were damaged extensively with impact marks and rail burn. The L3, L4, and R4 wheel adapters out of position. The L1, L2 and L4 truck springs missing. The L3 truck spring was not in position. The L1 and L2 equalizer beams were not in position. The R3 and R4 outer equalizer beams were missing. The R3 and R4 shock absorbers damaged. The L1 and L2 truck tie bar plates missing. The A end brake pipe and cut out cock damaged. The B end coupler bumper stops missing. The A end bumper stops damaged.

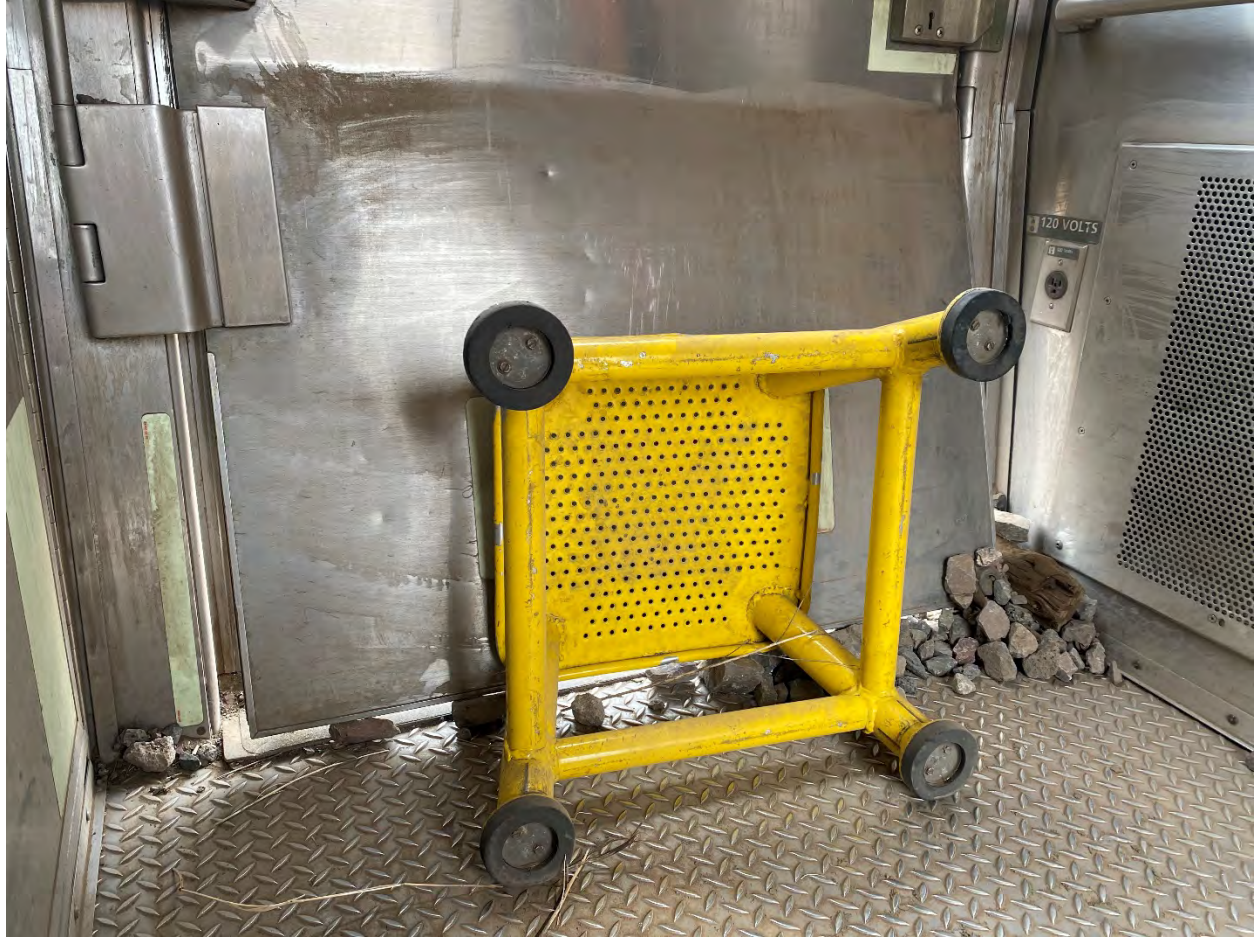
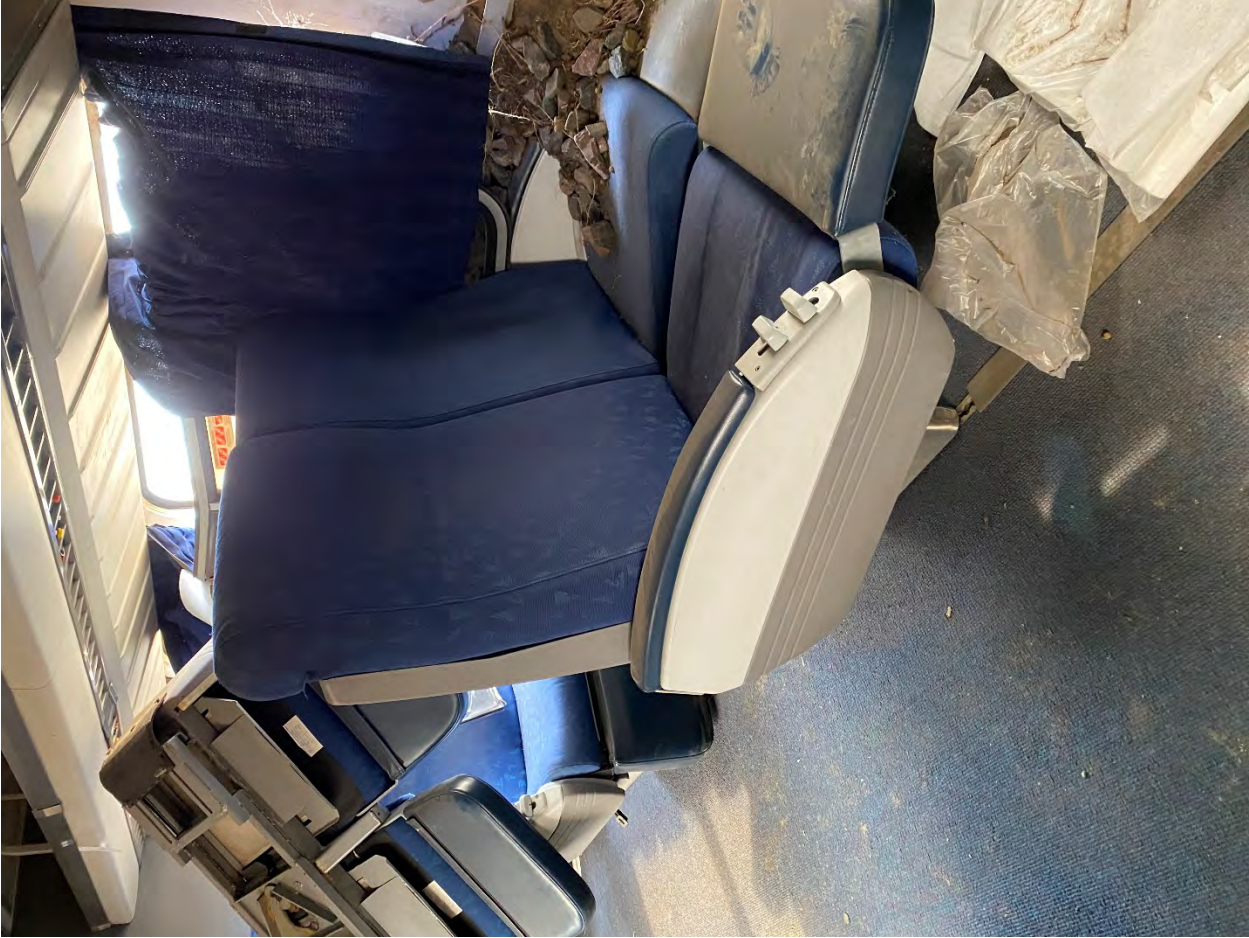
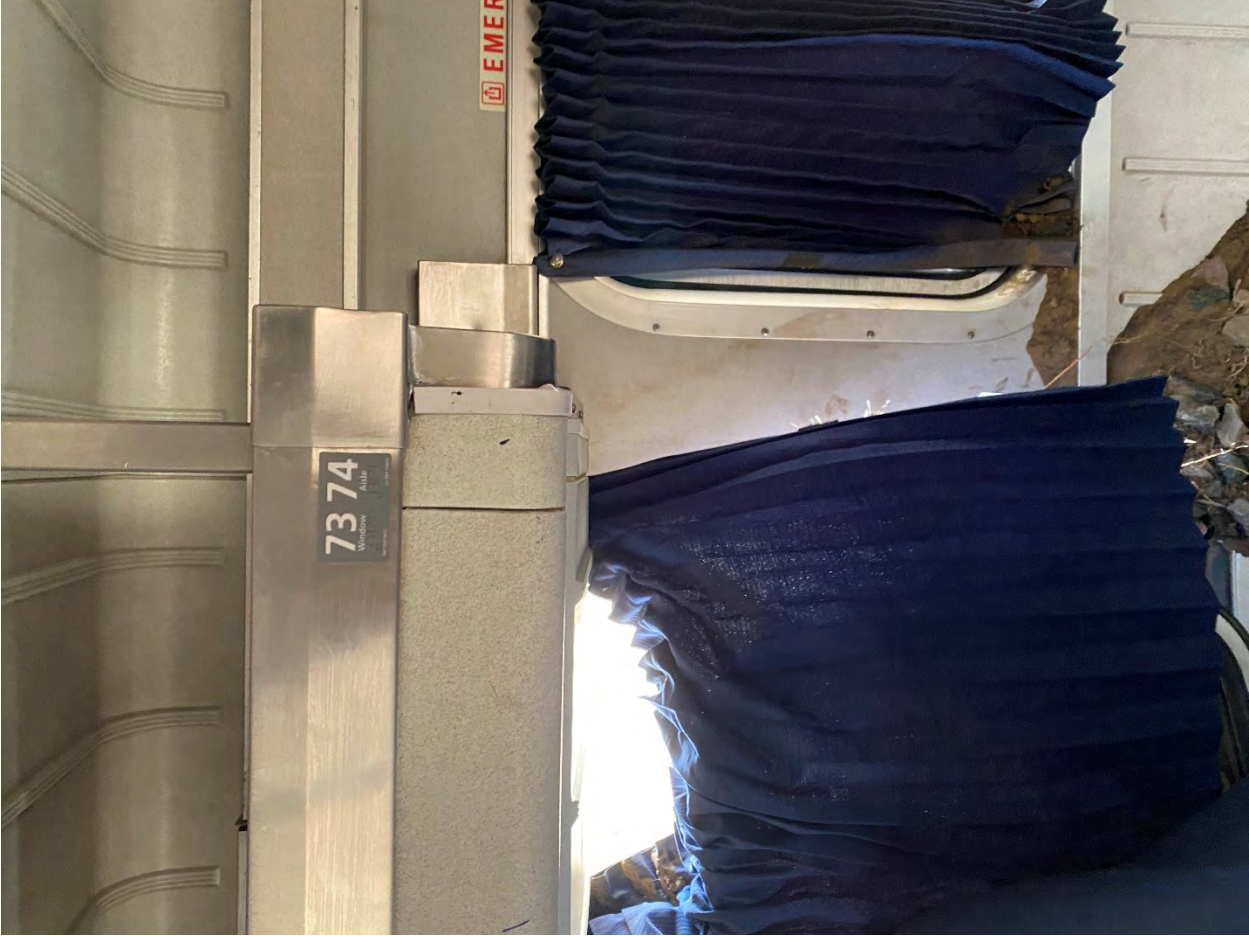
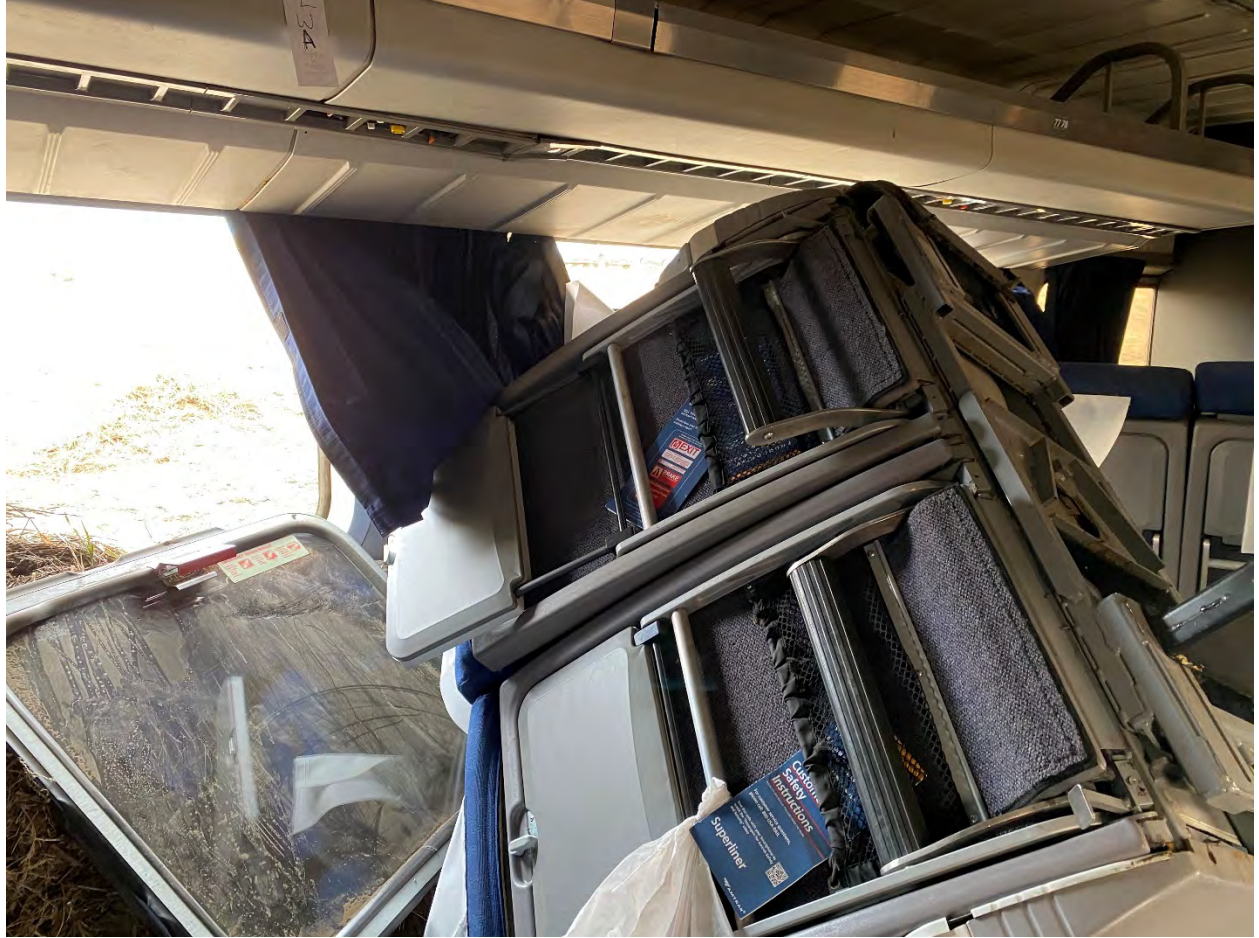
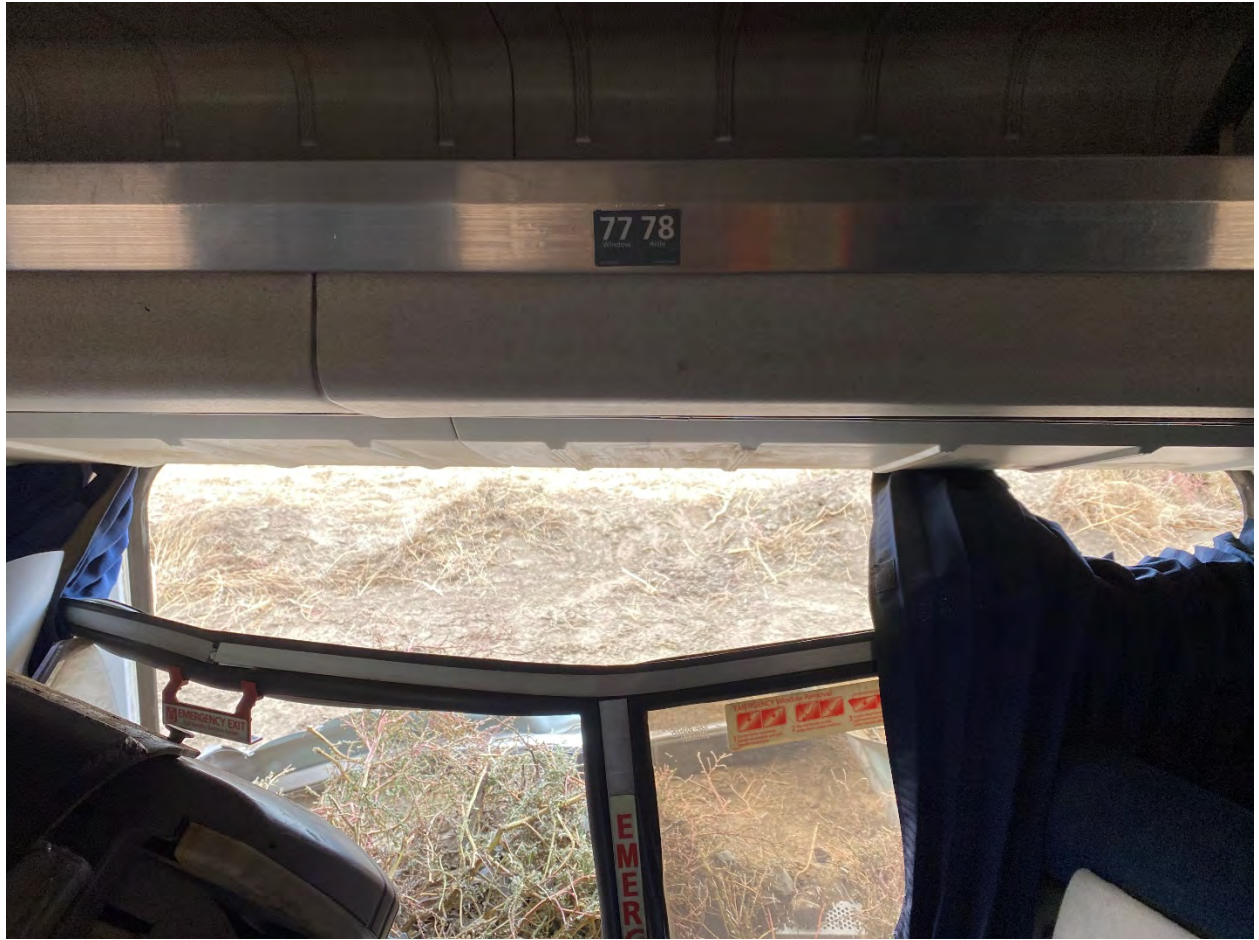
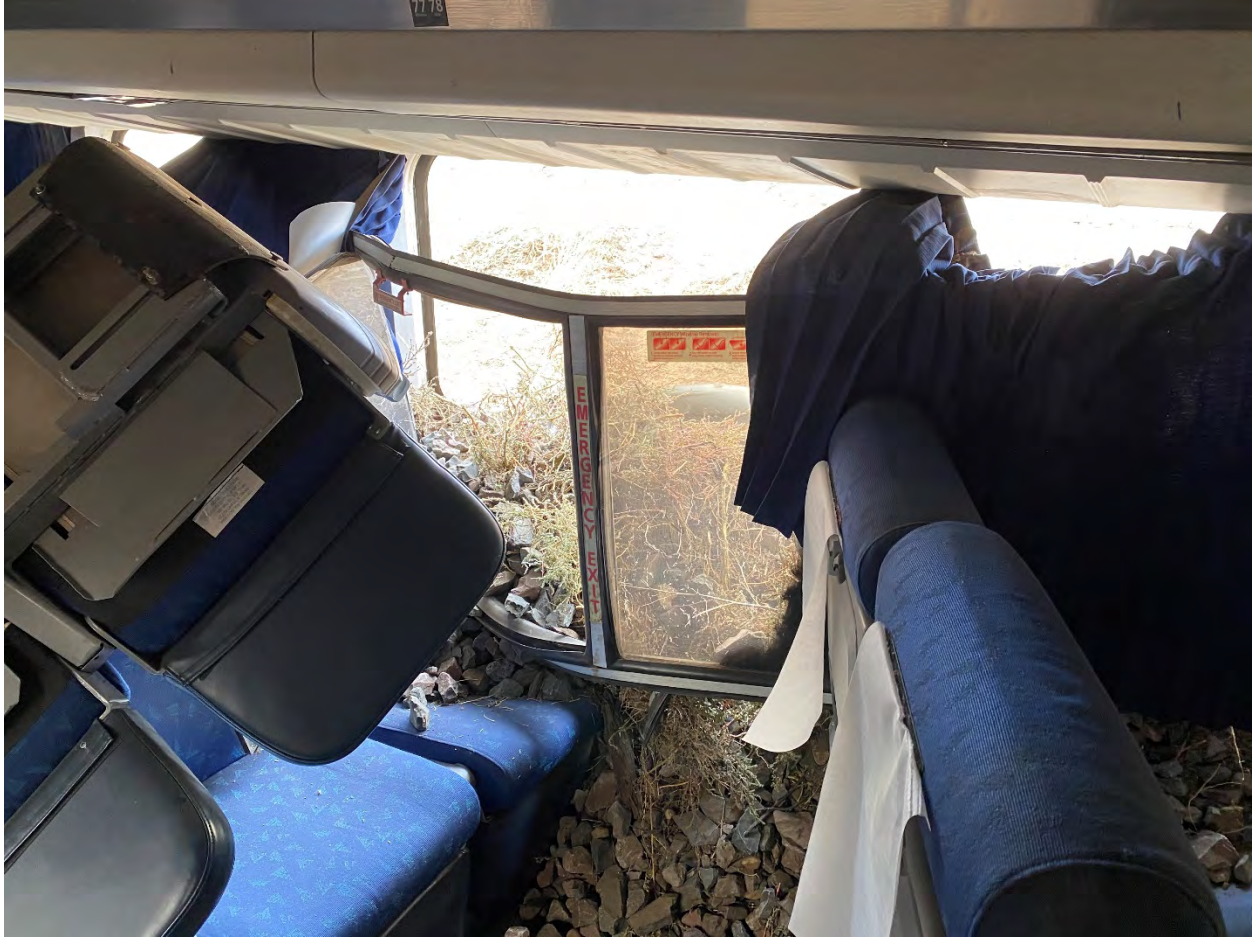
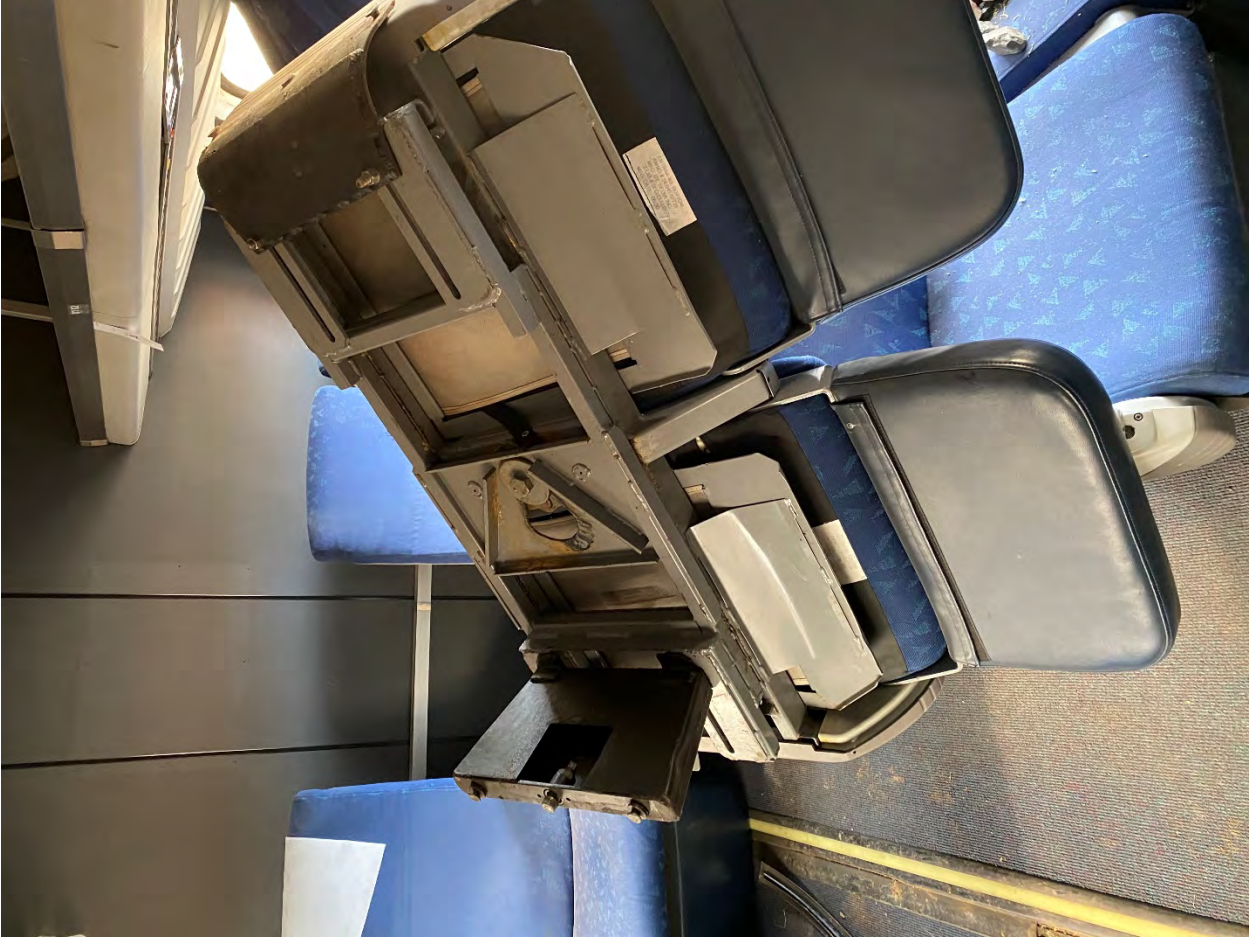
The following defects were noted on the coach car that was positioned as the sixth car behind the two locomotive train consist remaining upright.

The passenger car showed signs of all eight wheels were off the rail. The L1 wheel bearing cap bolt sheared off. The A and B end coupler bumper stops were damaged. The A end brake pipe and cut out cock damaged. The A end coupler buffer casting damaged. The BL side handhold broken.

The left and right-side entry doors were damaged. The end vestibule door diaphragm damaged. Top left side number one and two windows damaged. Seat 77, 78, 73, and 74 side windows dislodged. The seats 1, 2, 5, 6, 17, 18, 25, 26, 29, 30, 33, 34, 79 and 80 were dislodged.
