ATK 32050

The following defects were noted on the sleeper car that was positioned as the third car behind the two locomotive train consist remaining upright.

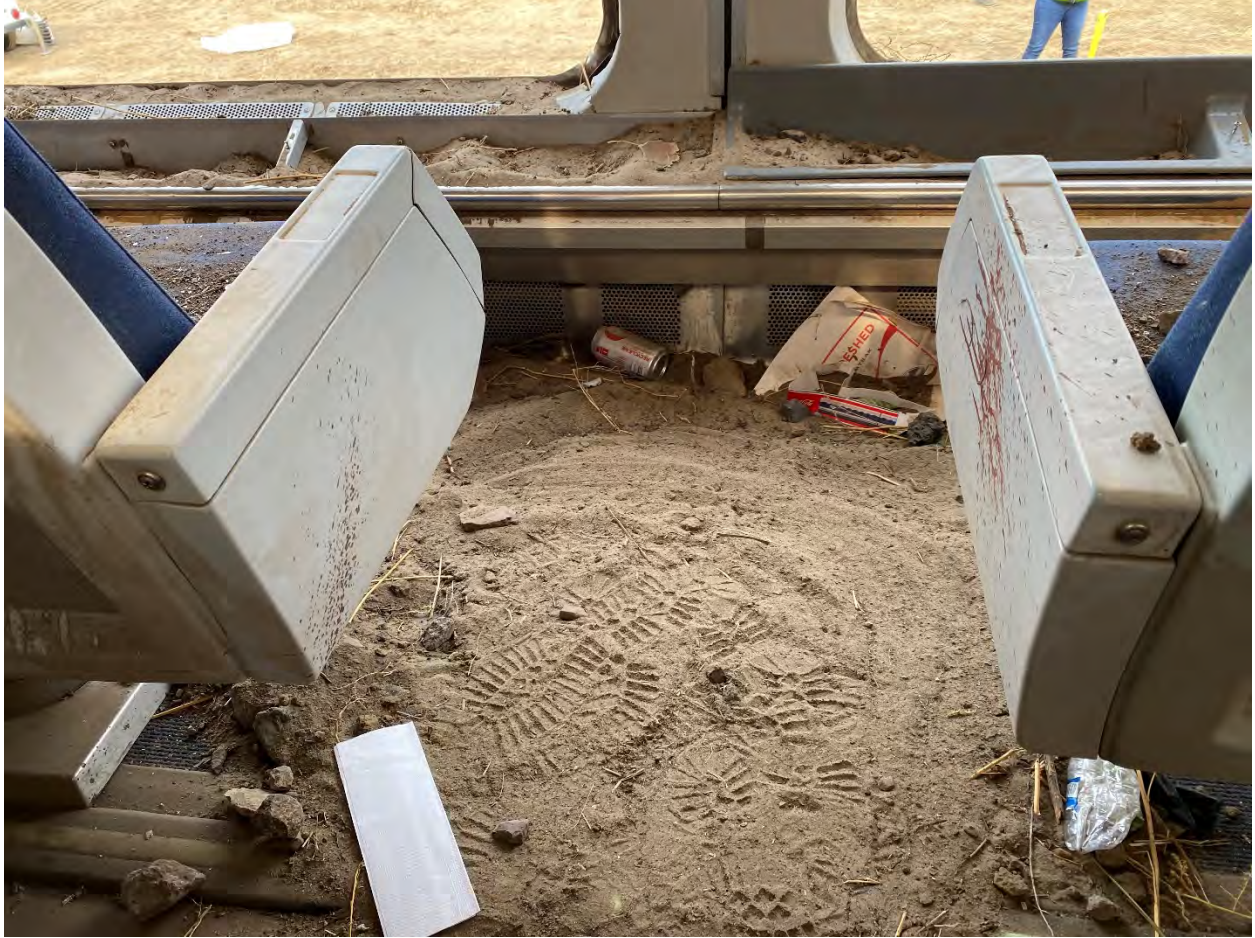
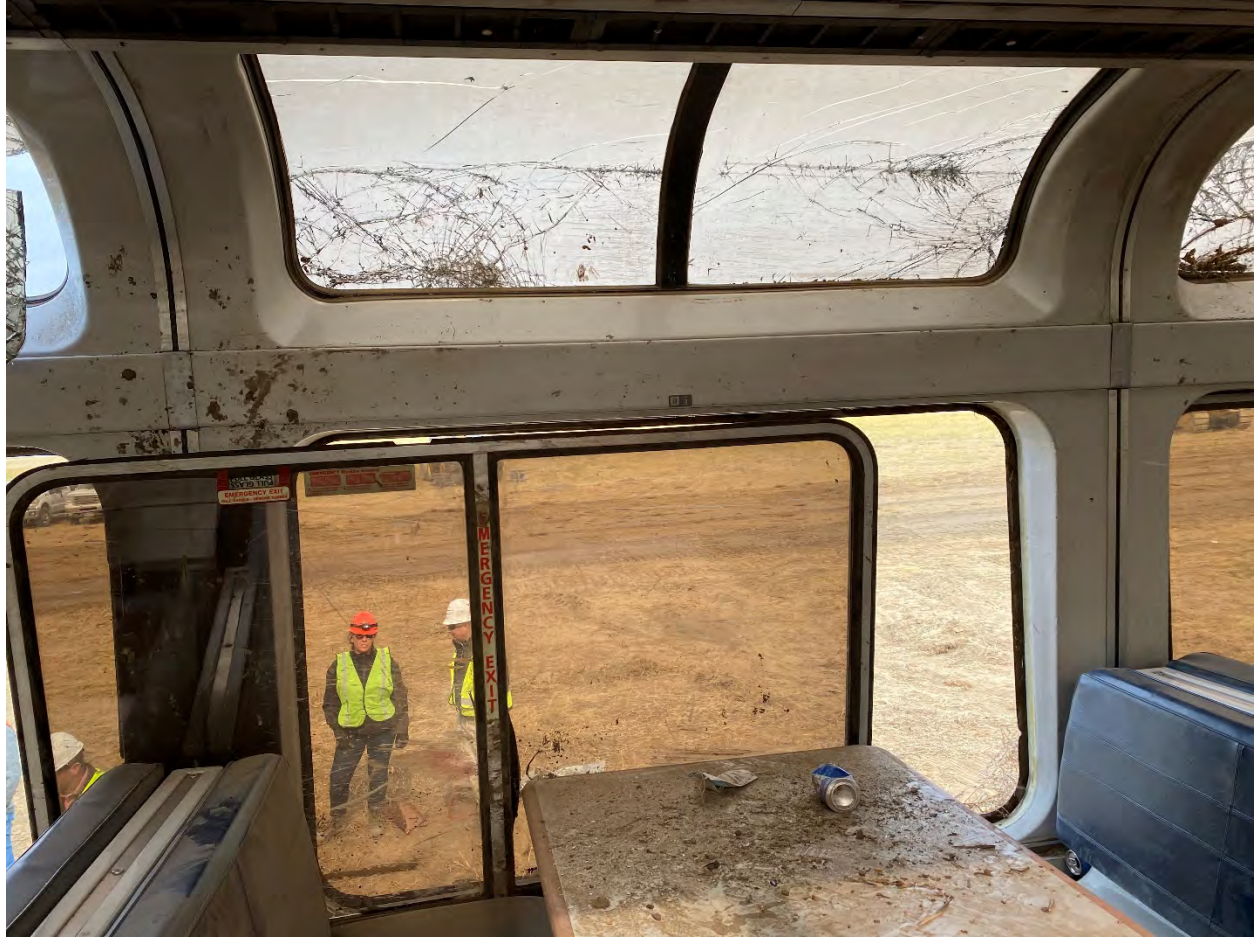
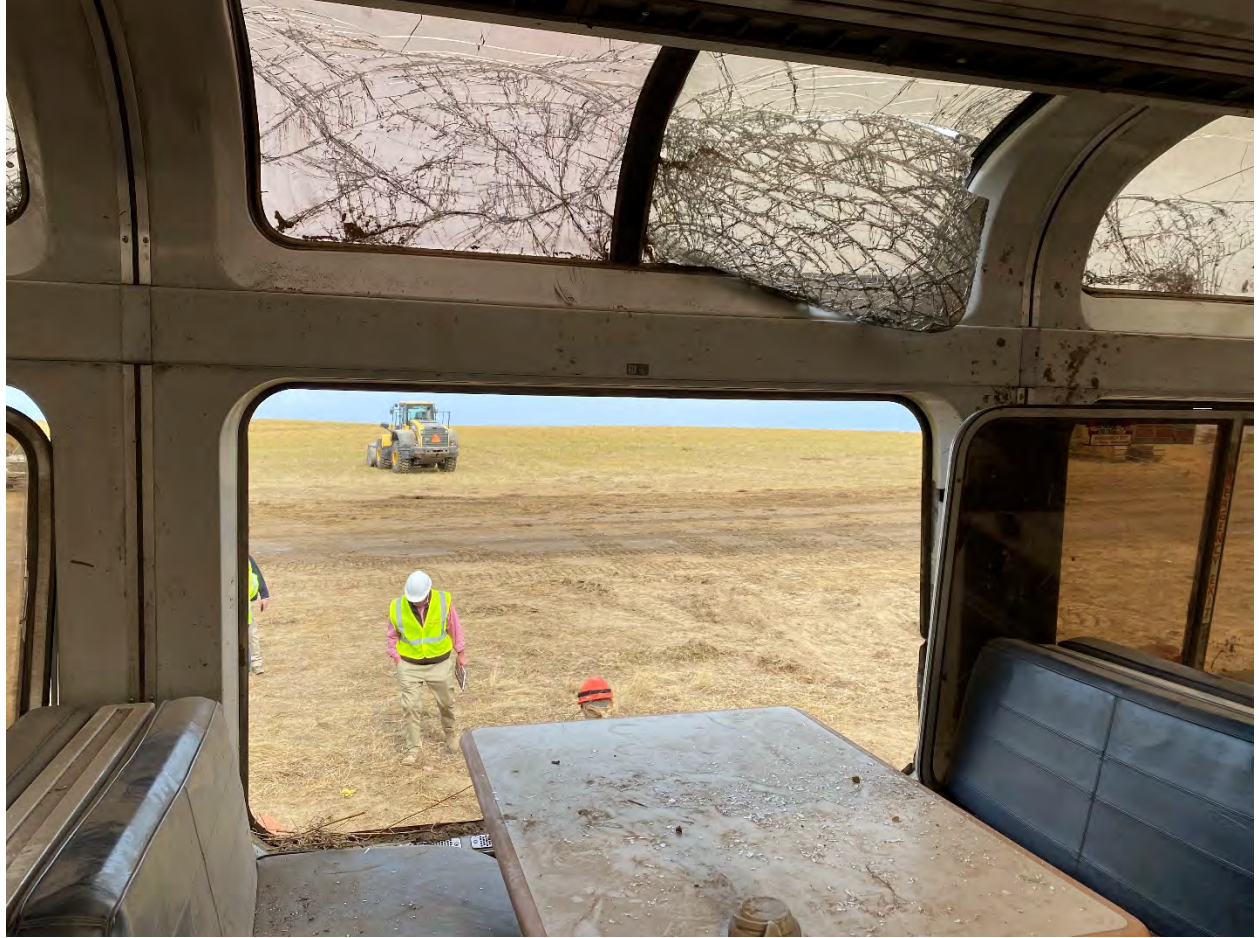
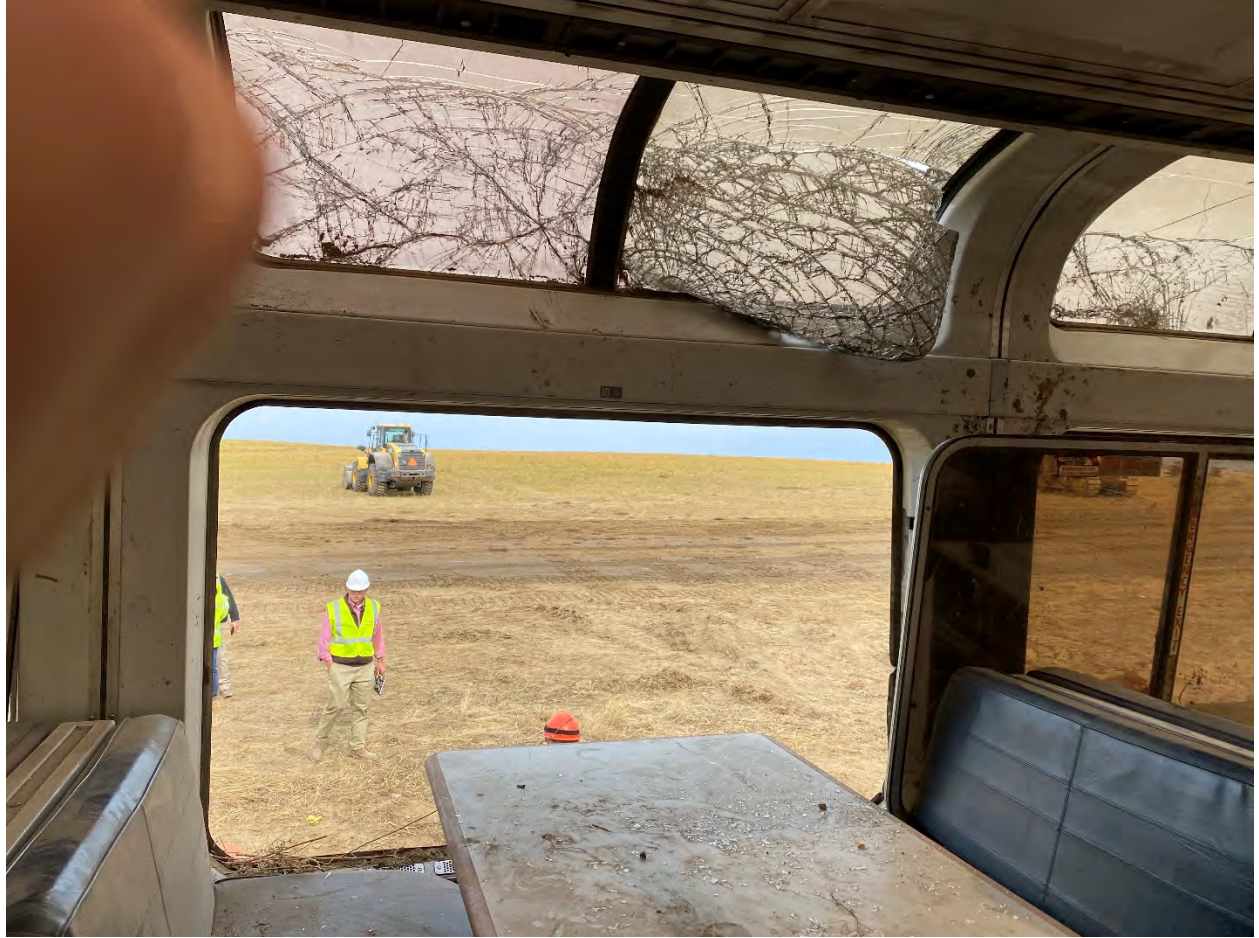
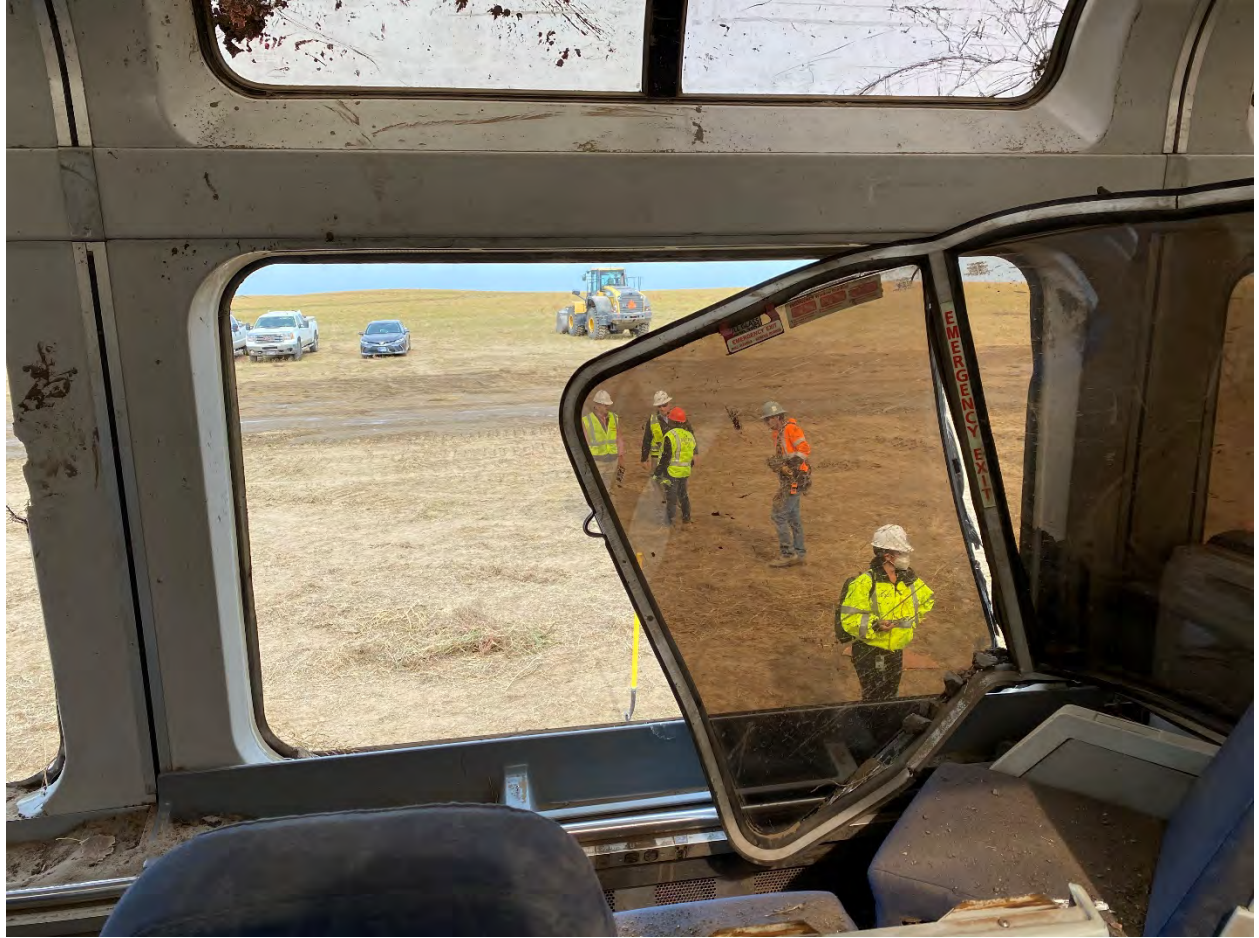
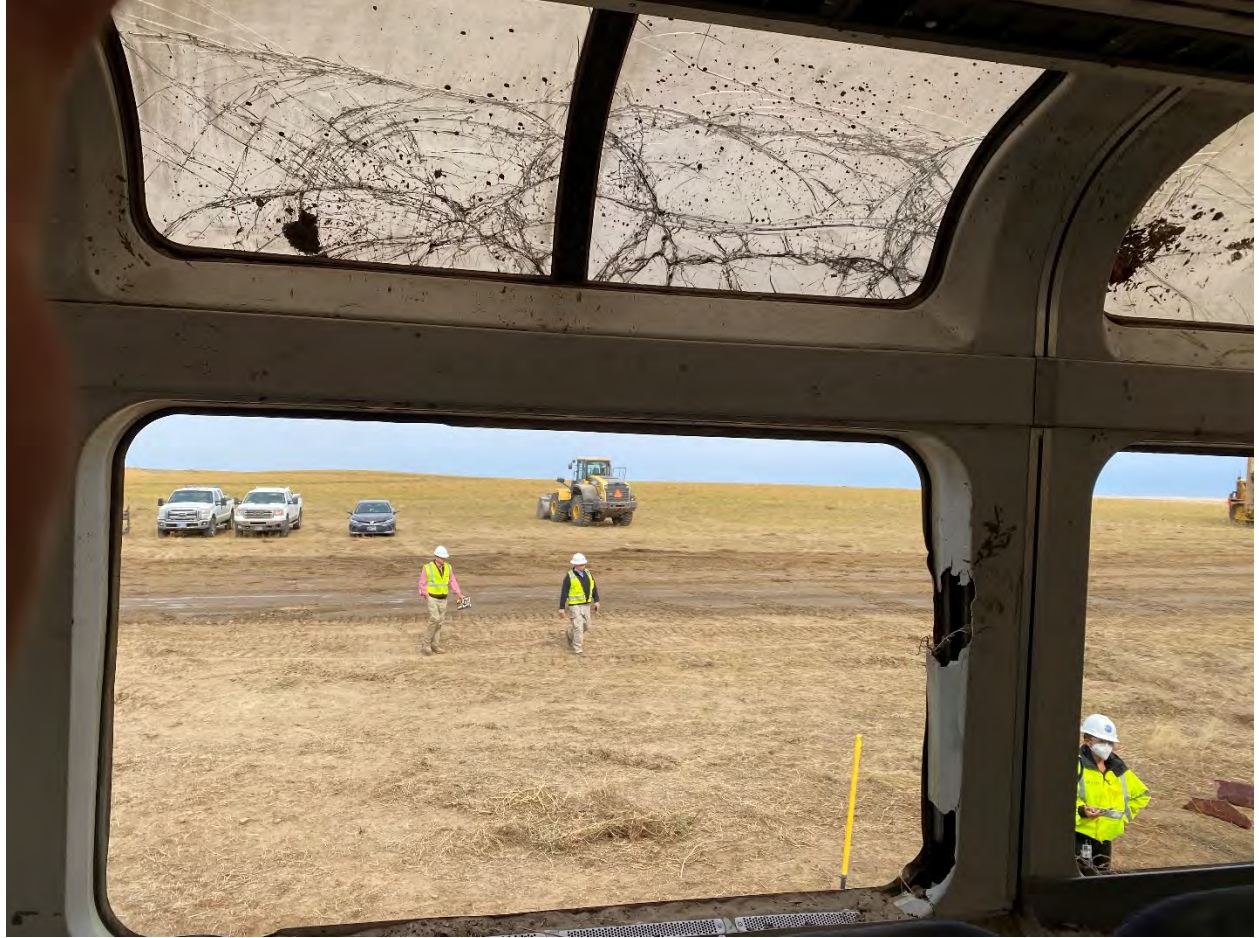
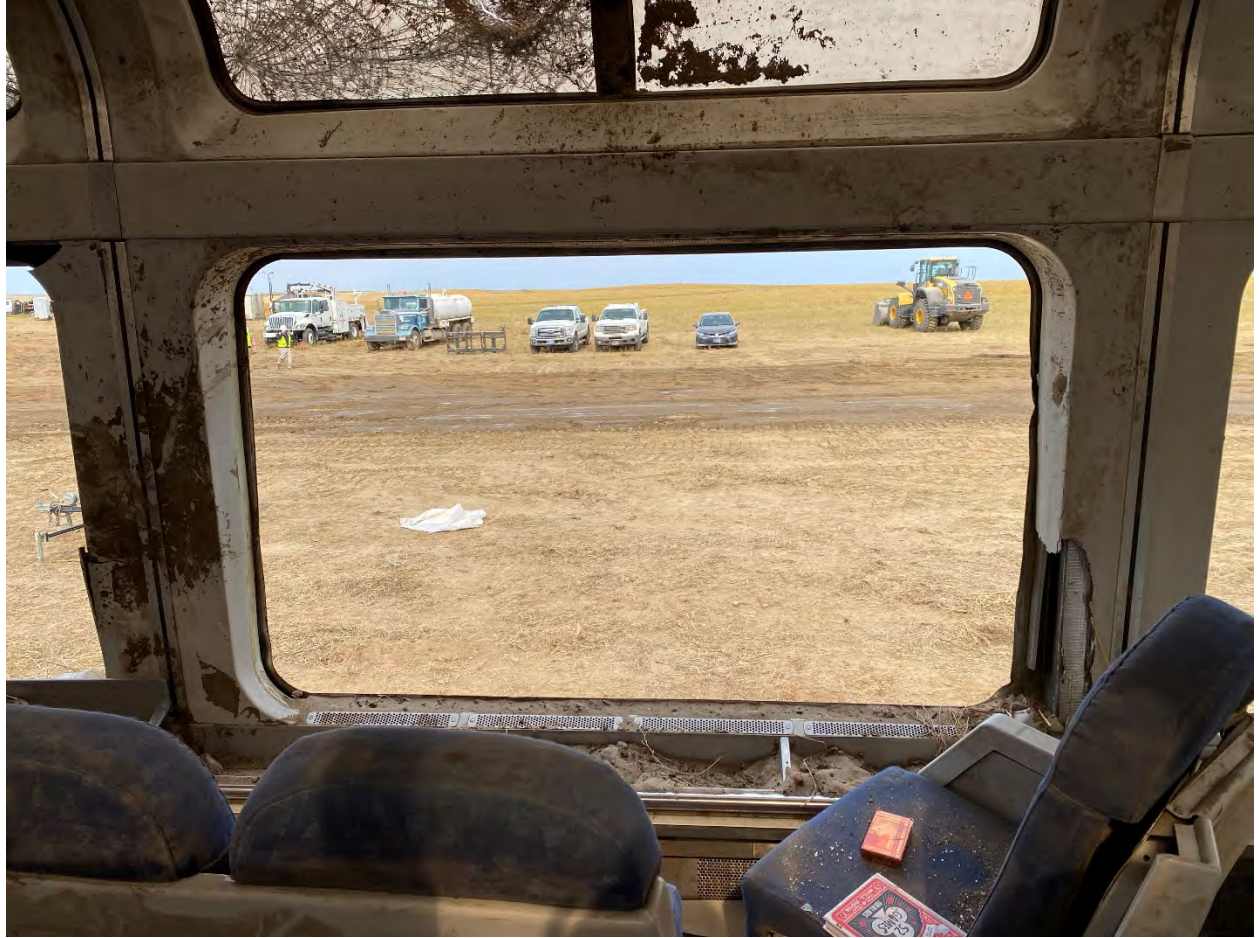
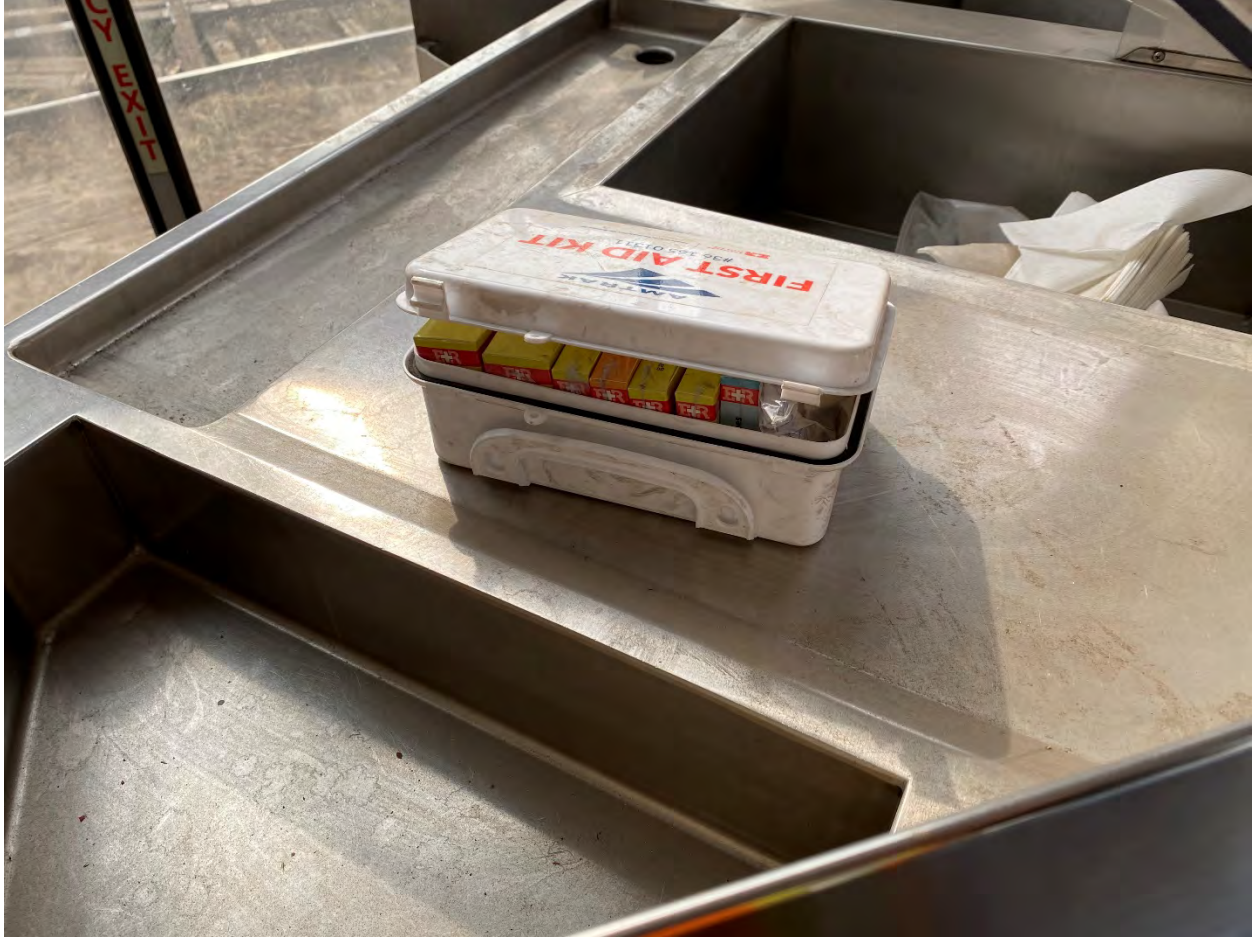
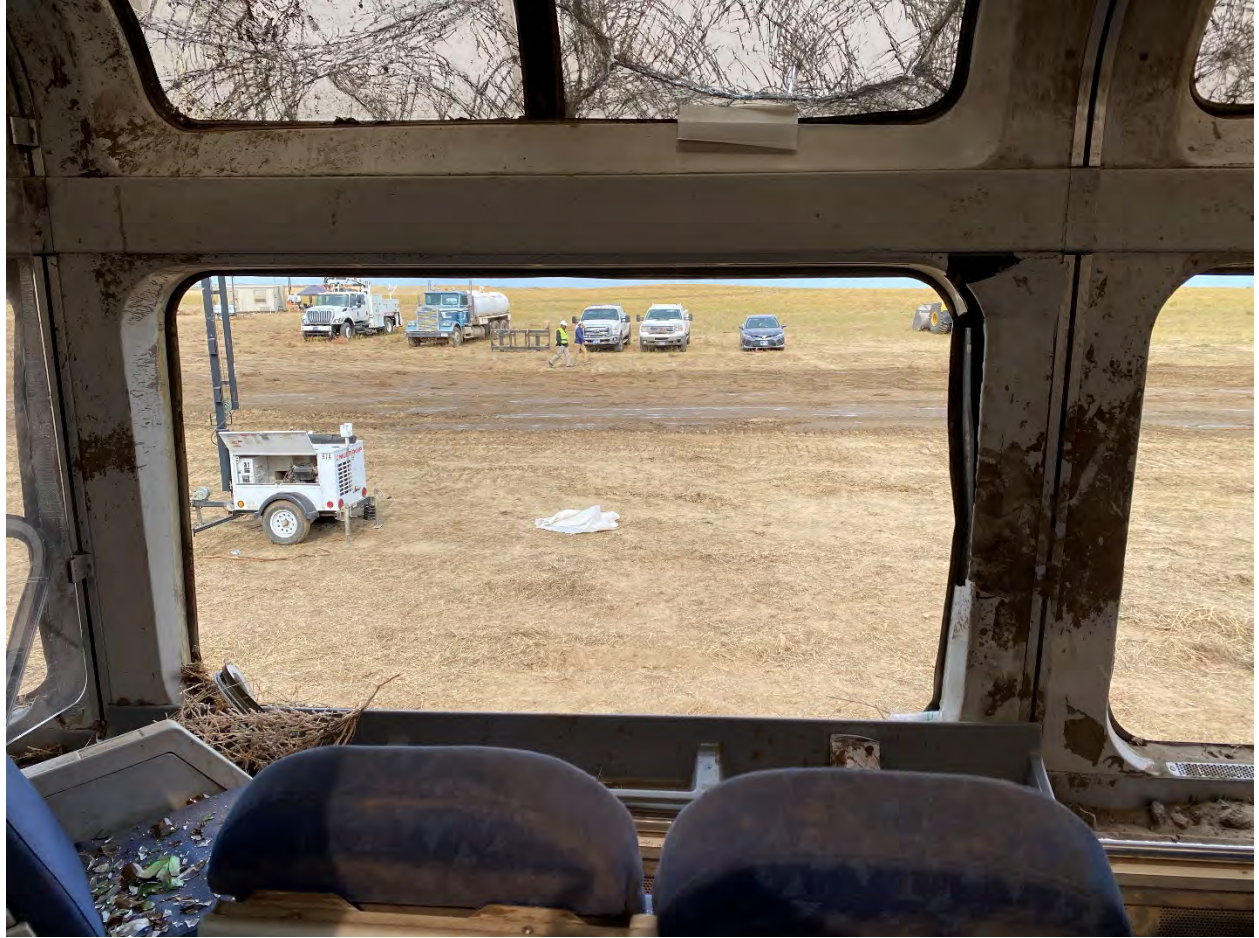
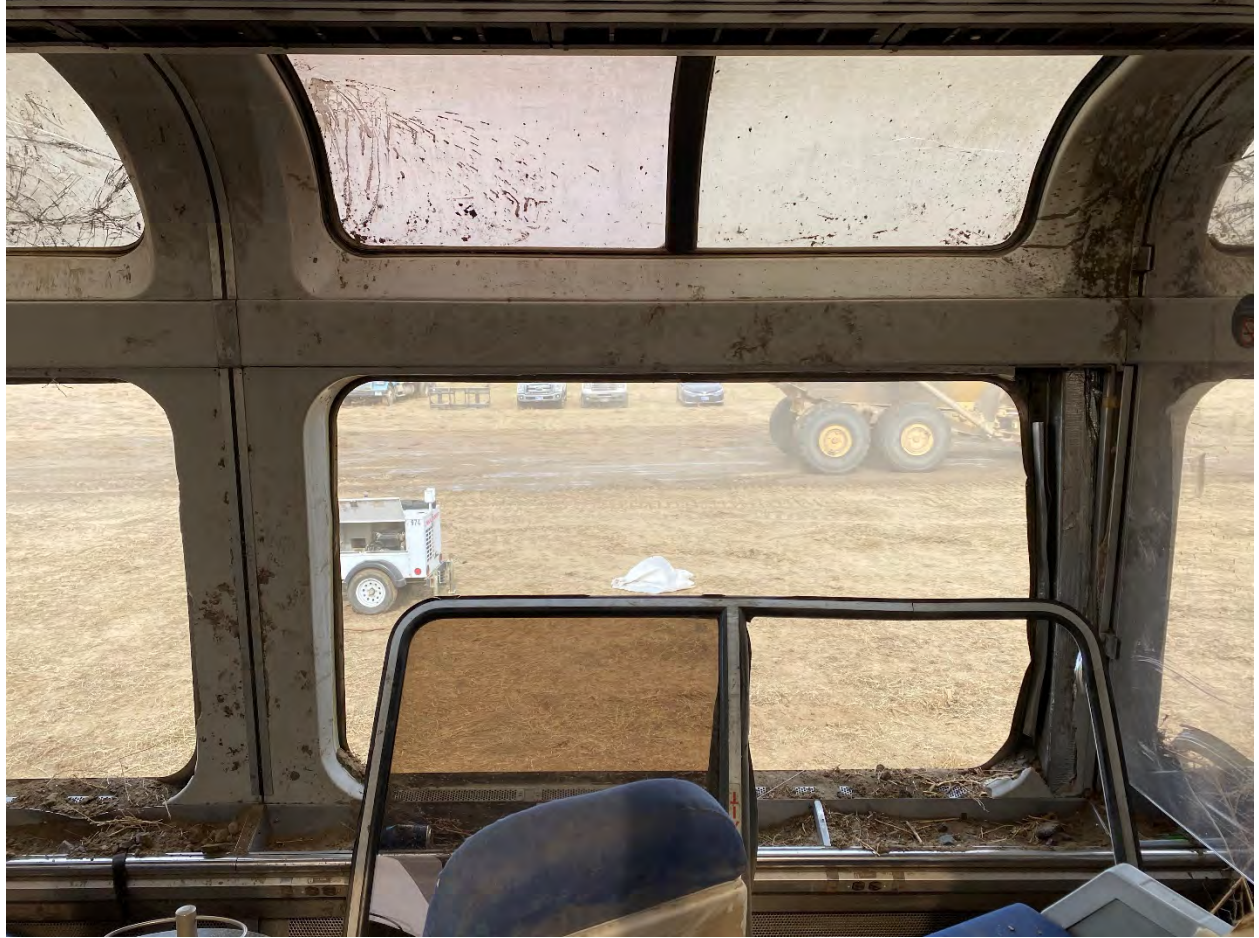
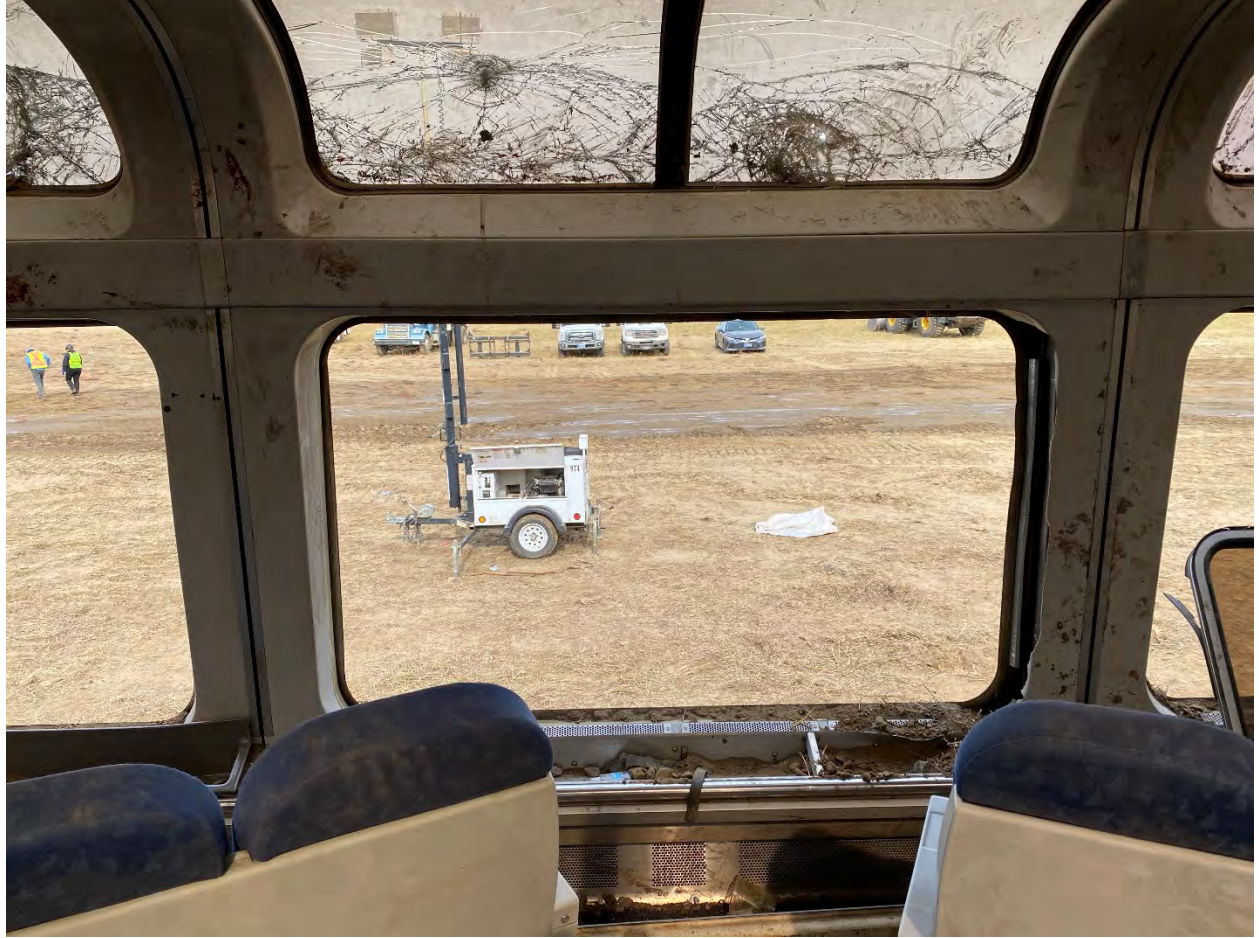
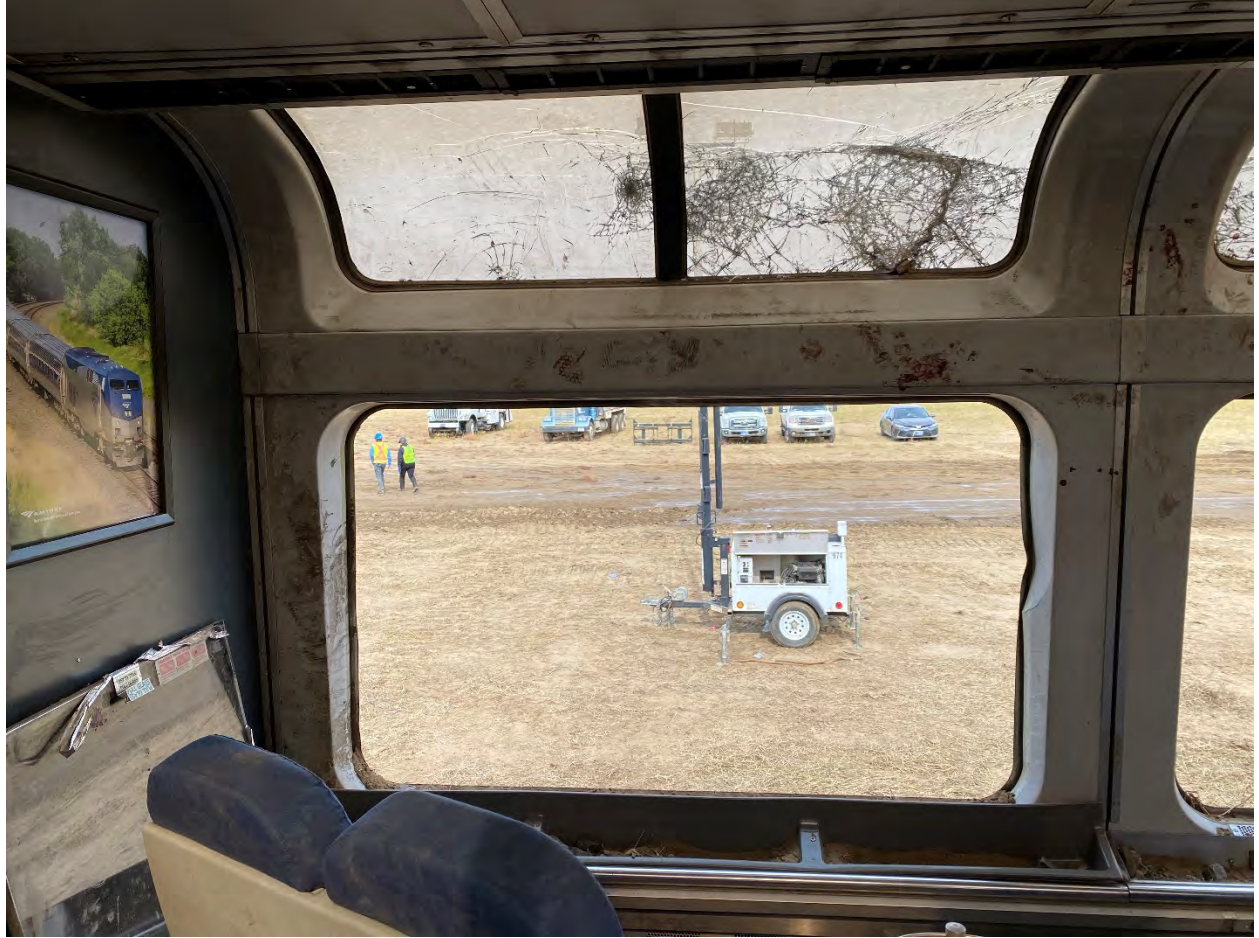
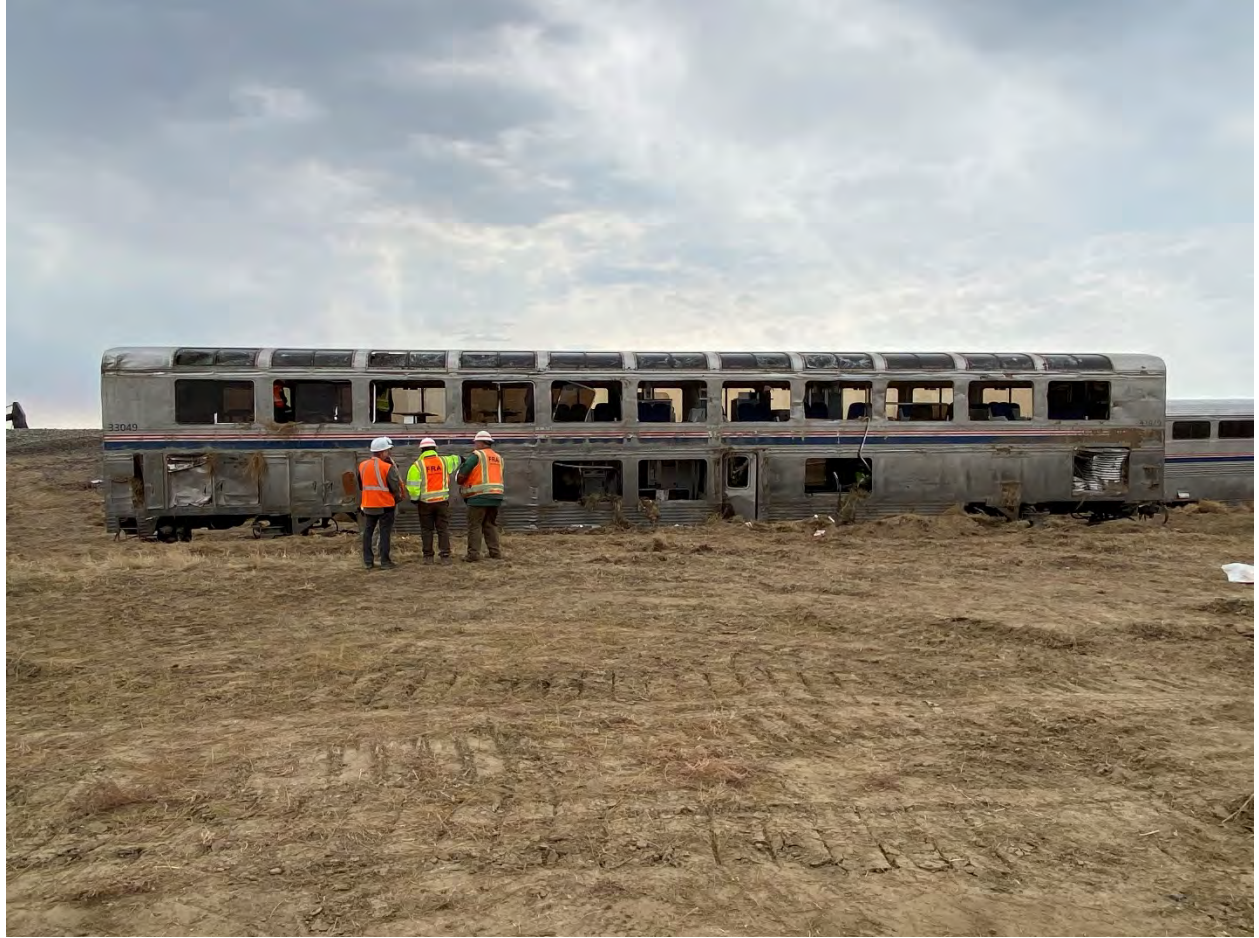
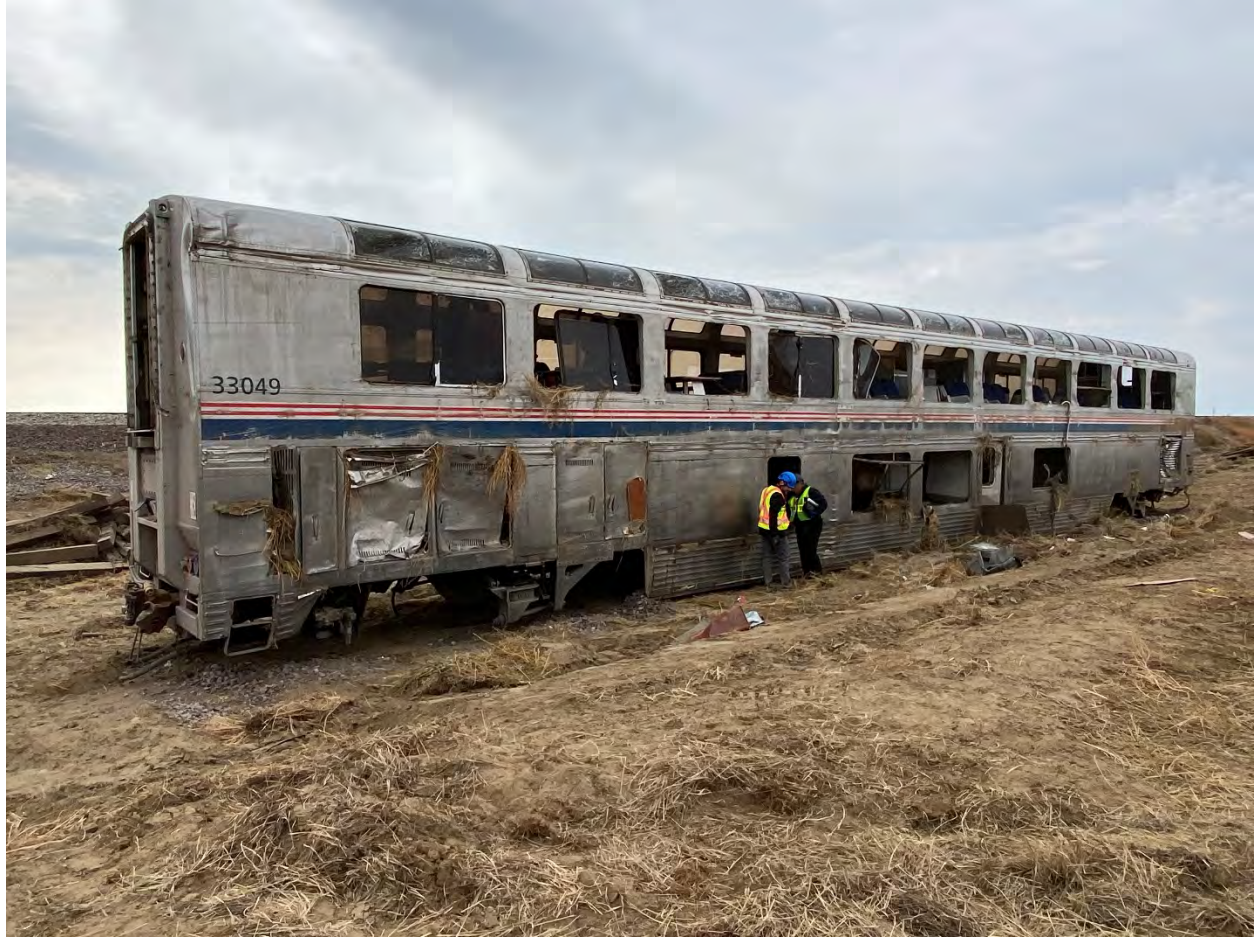
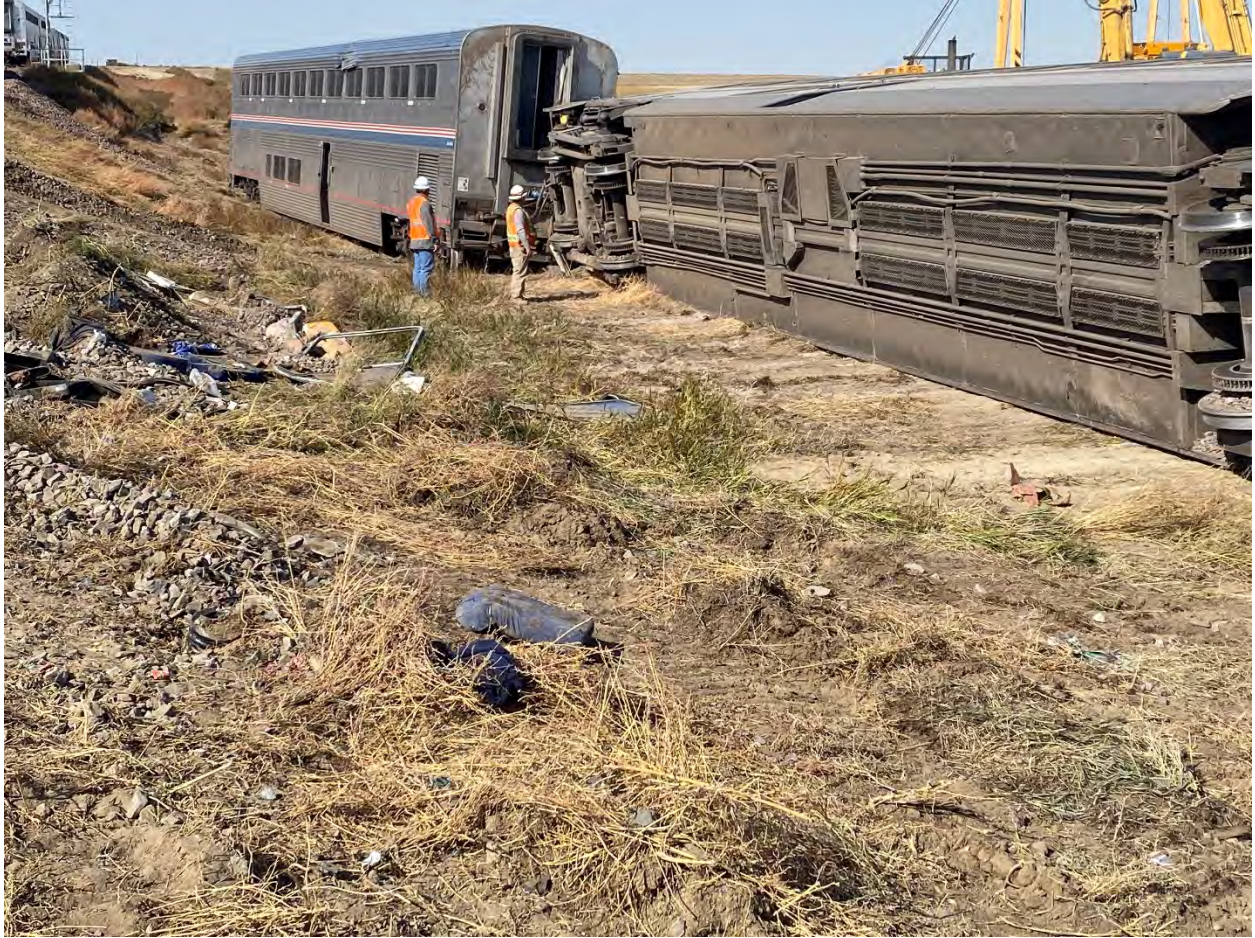
ATK 33049

The following defects were noted on the lounge/observation car that was positioned as the seventh car behind the two locomotive train consist laying on its side.

The passenger car showed signs of all eight wheels were off the rail. The B end coupler knuckle broken. B end coupler shank twisted.

The B end vestibule door diaphragm damaged. The cab windows on upper lower decks on the right side were missing except for one. The fire extinguisher was missing.
