ATK 32050

The following defects were noted on the sleeper car that was positioned as the third car behind the two locomotive train consist remaining upright.

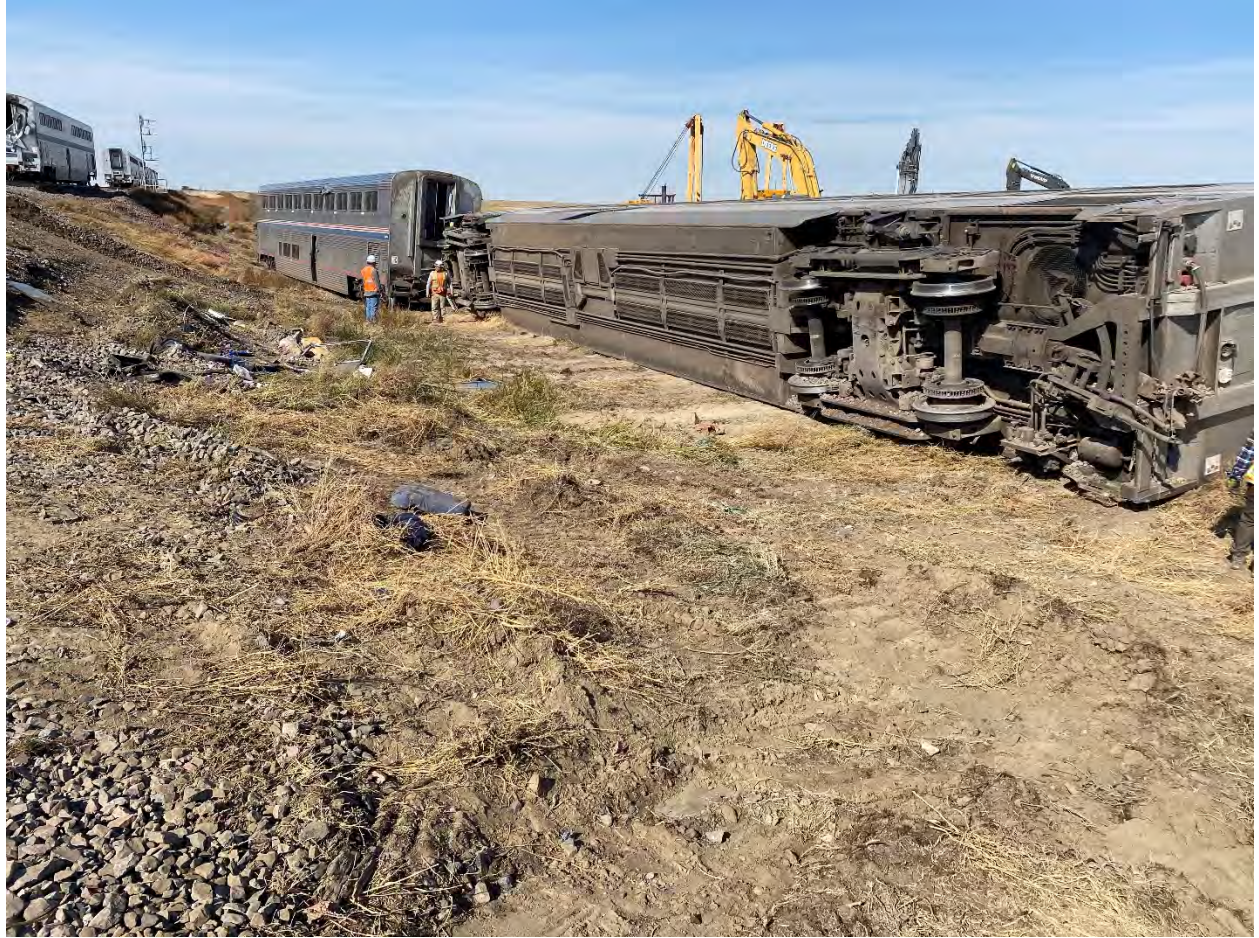
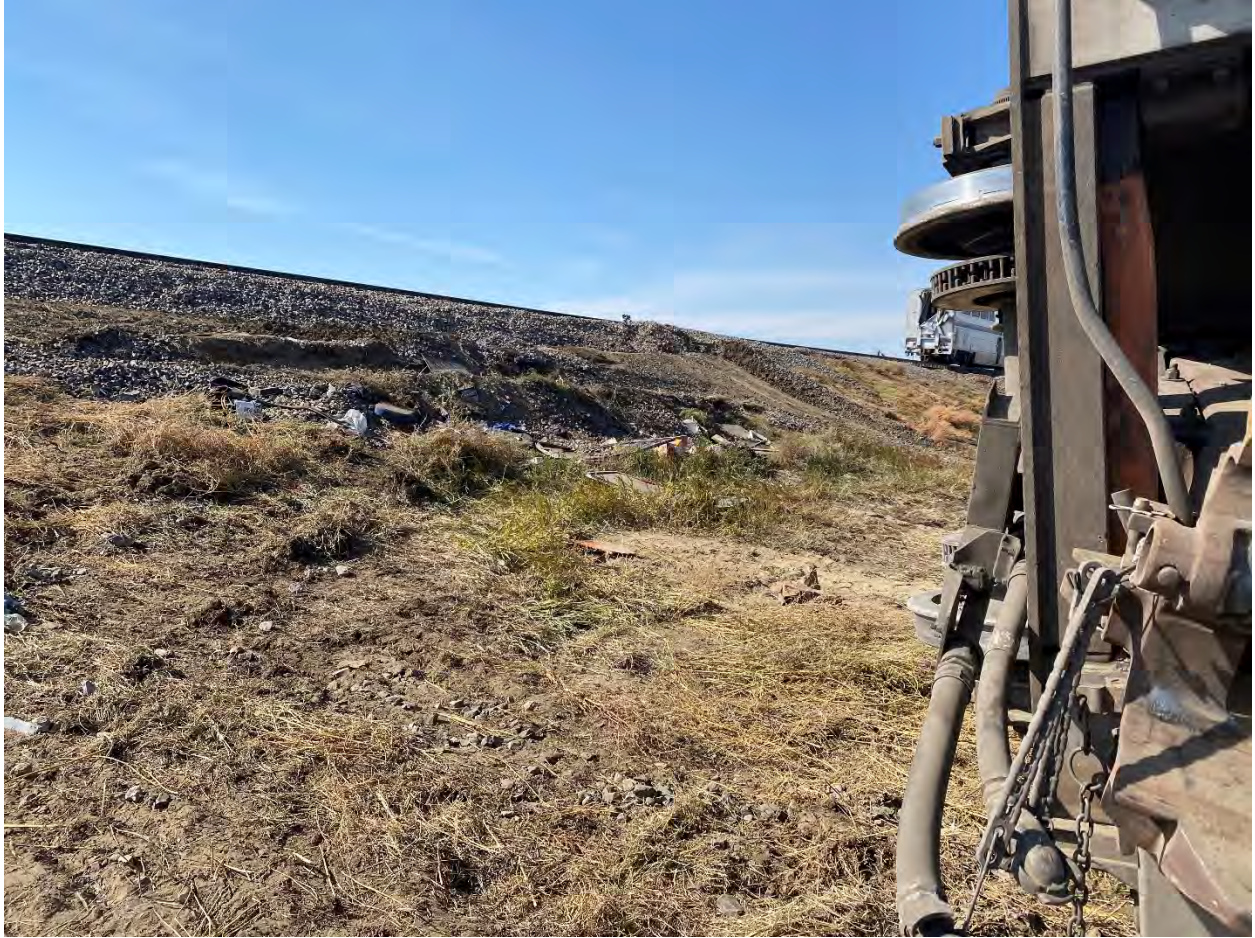
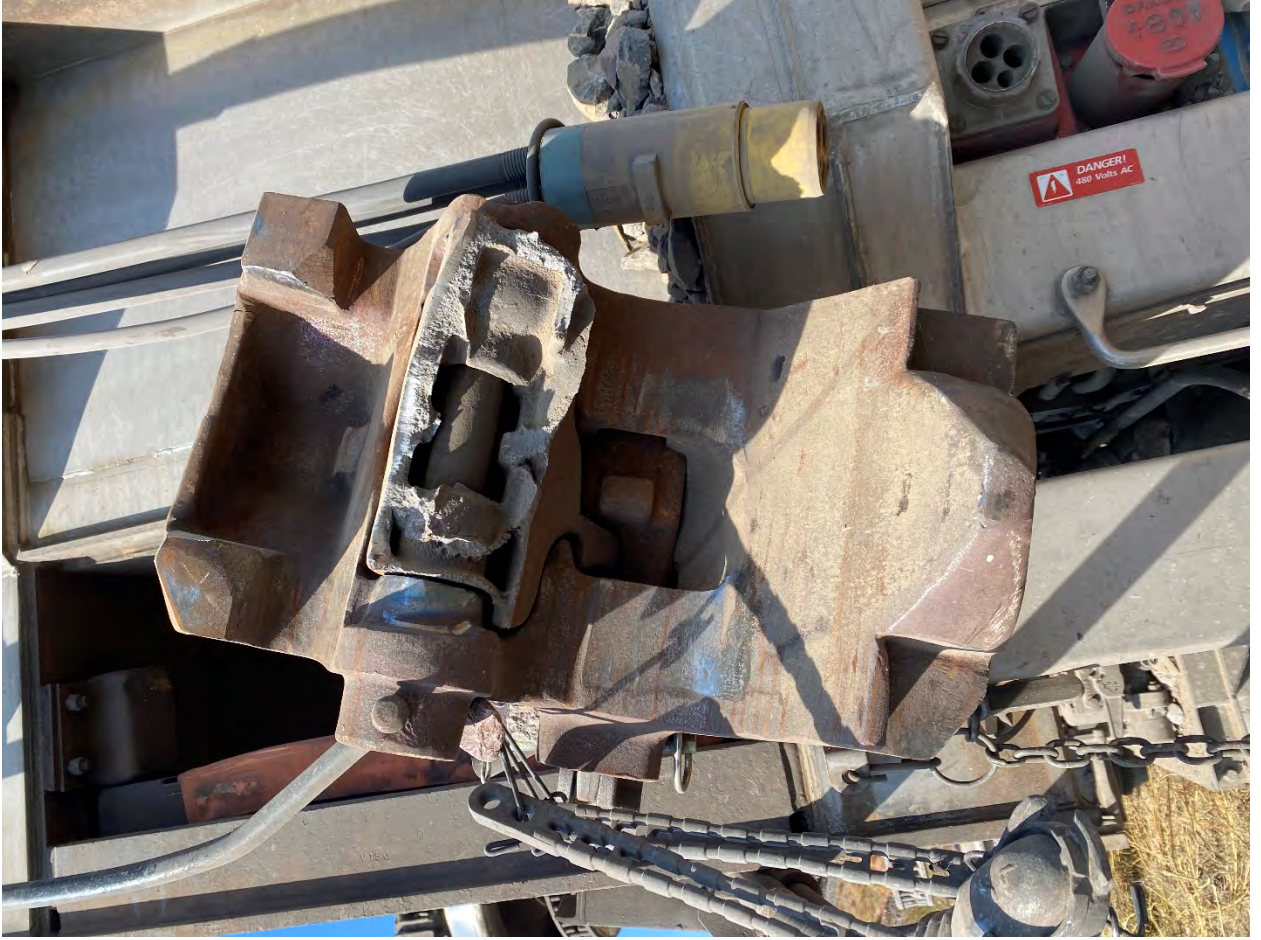
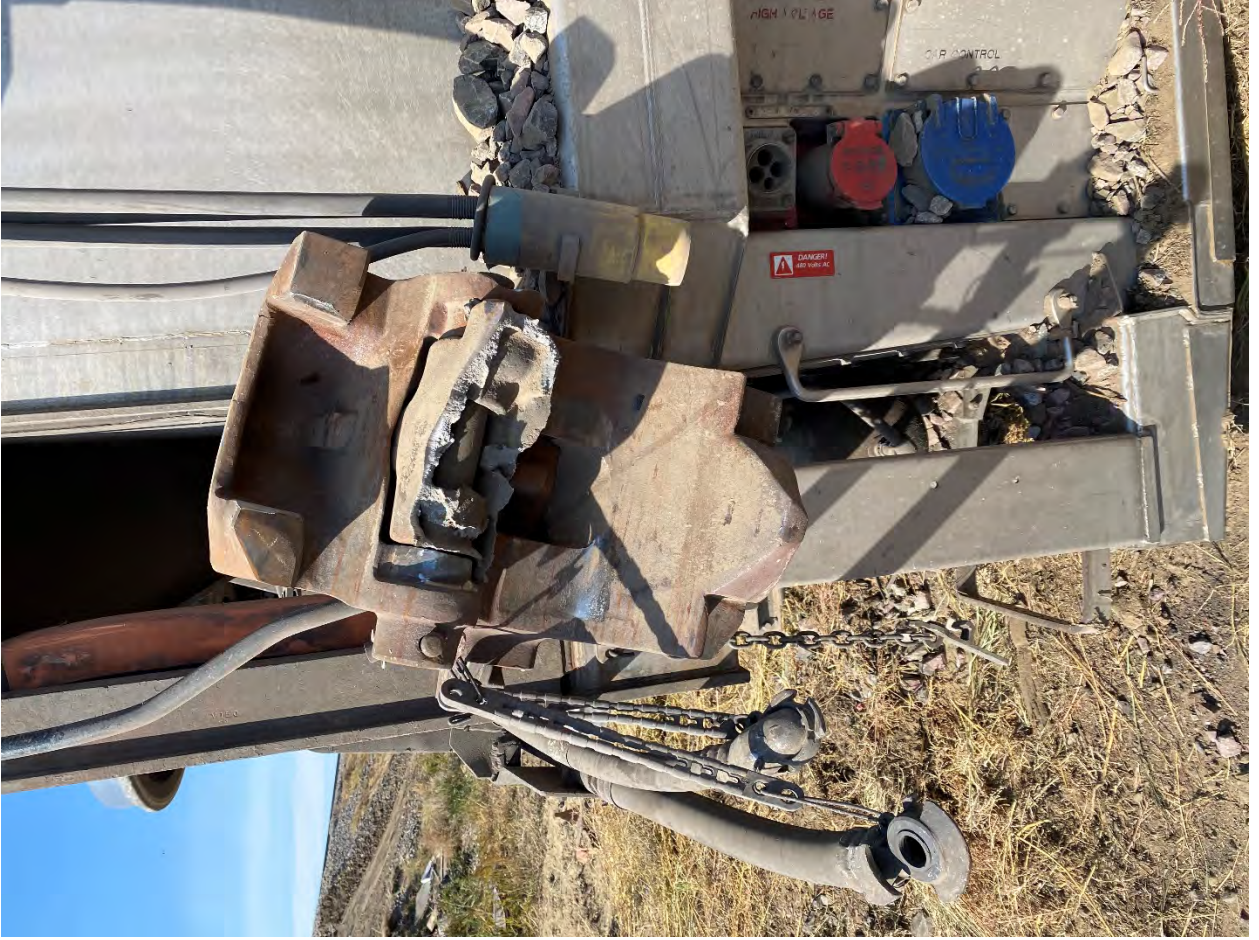
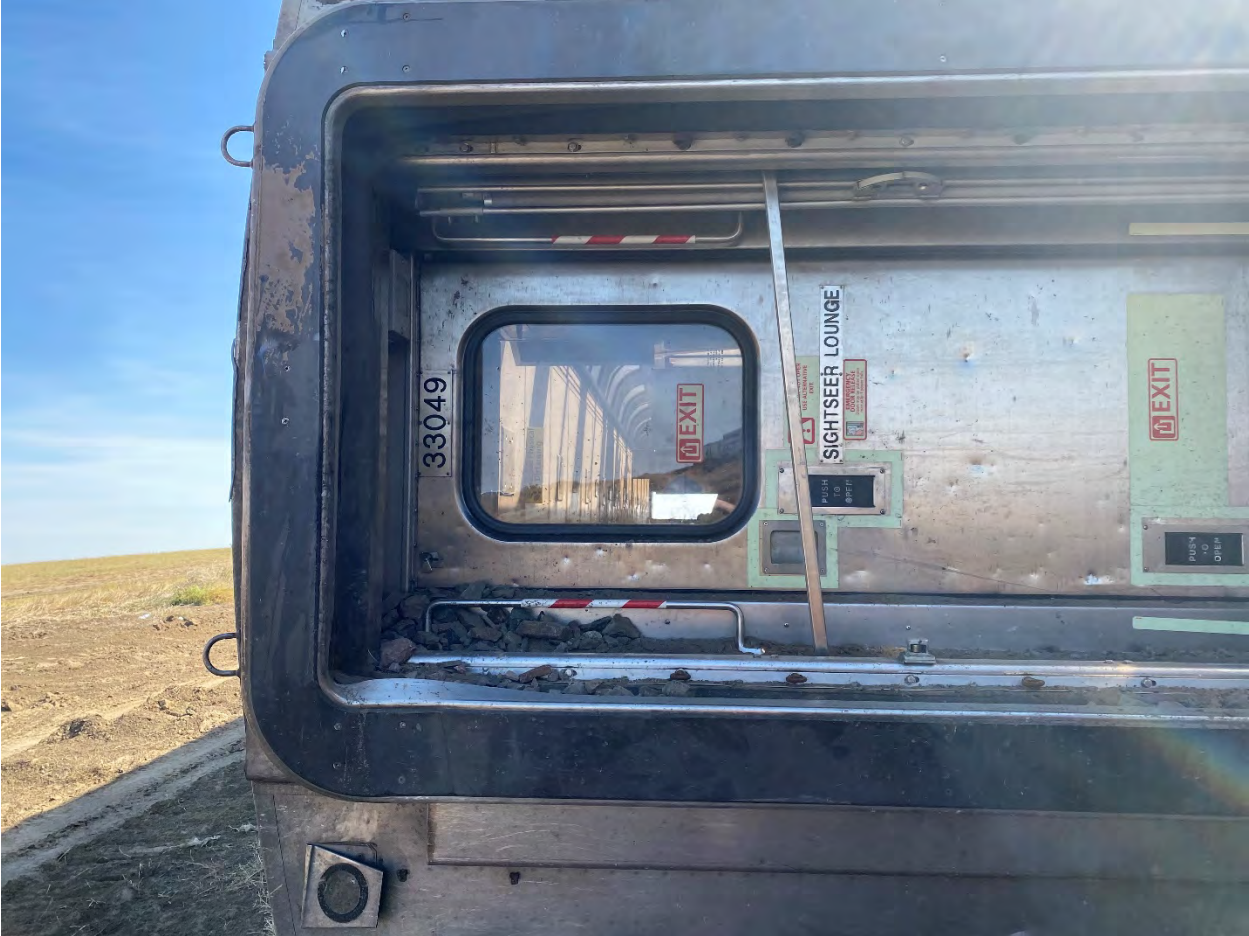
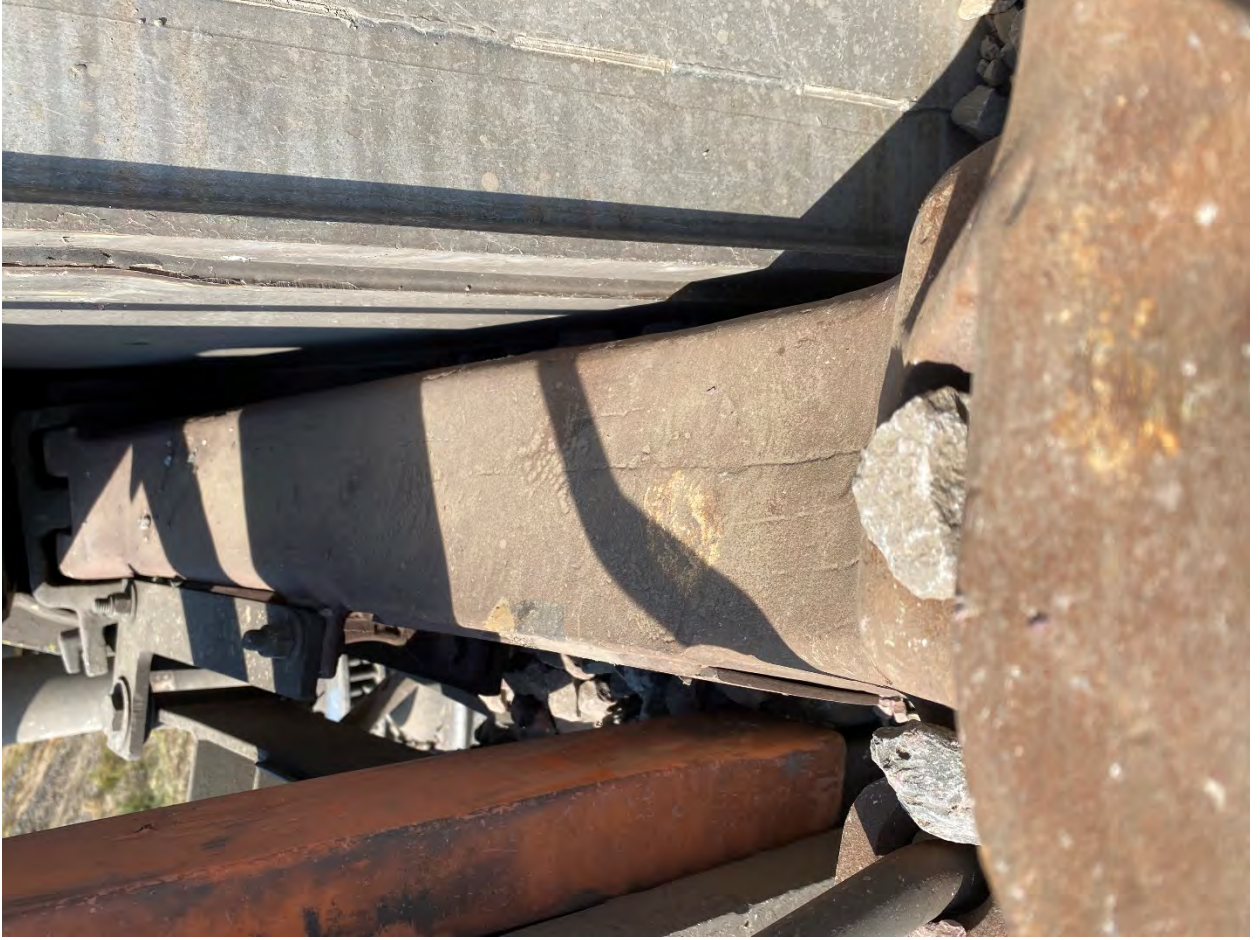
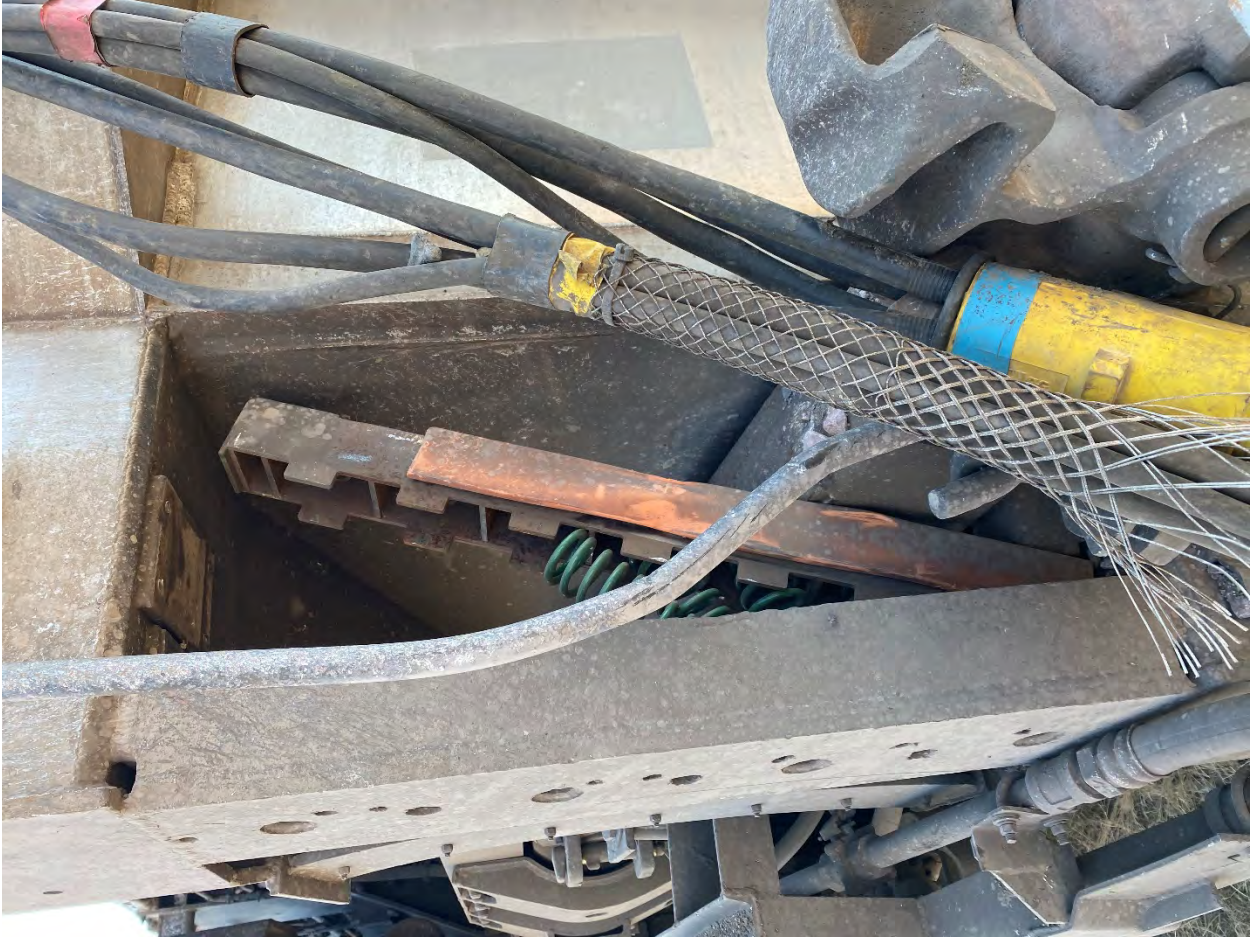
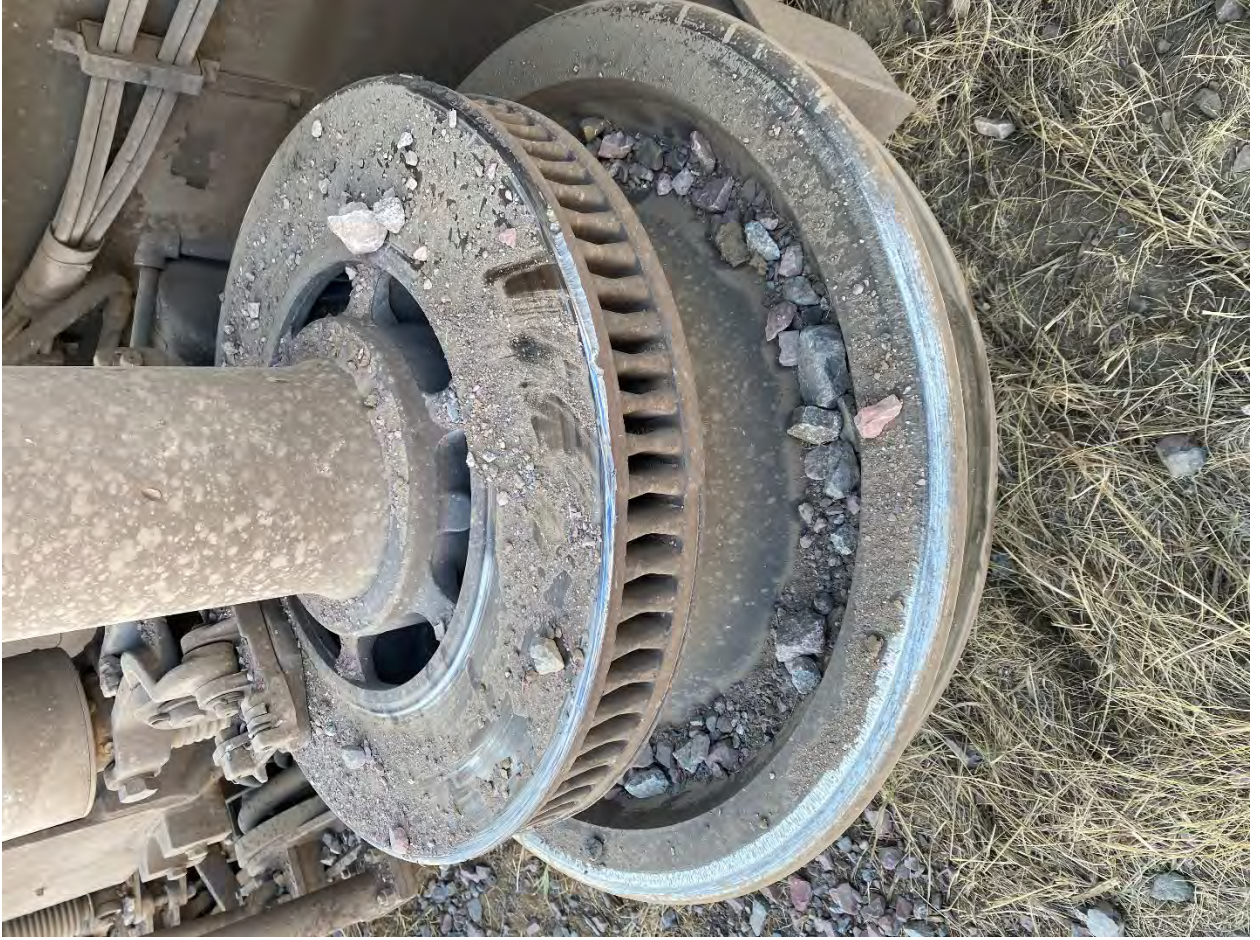
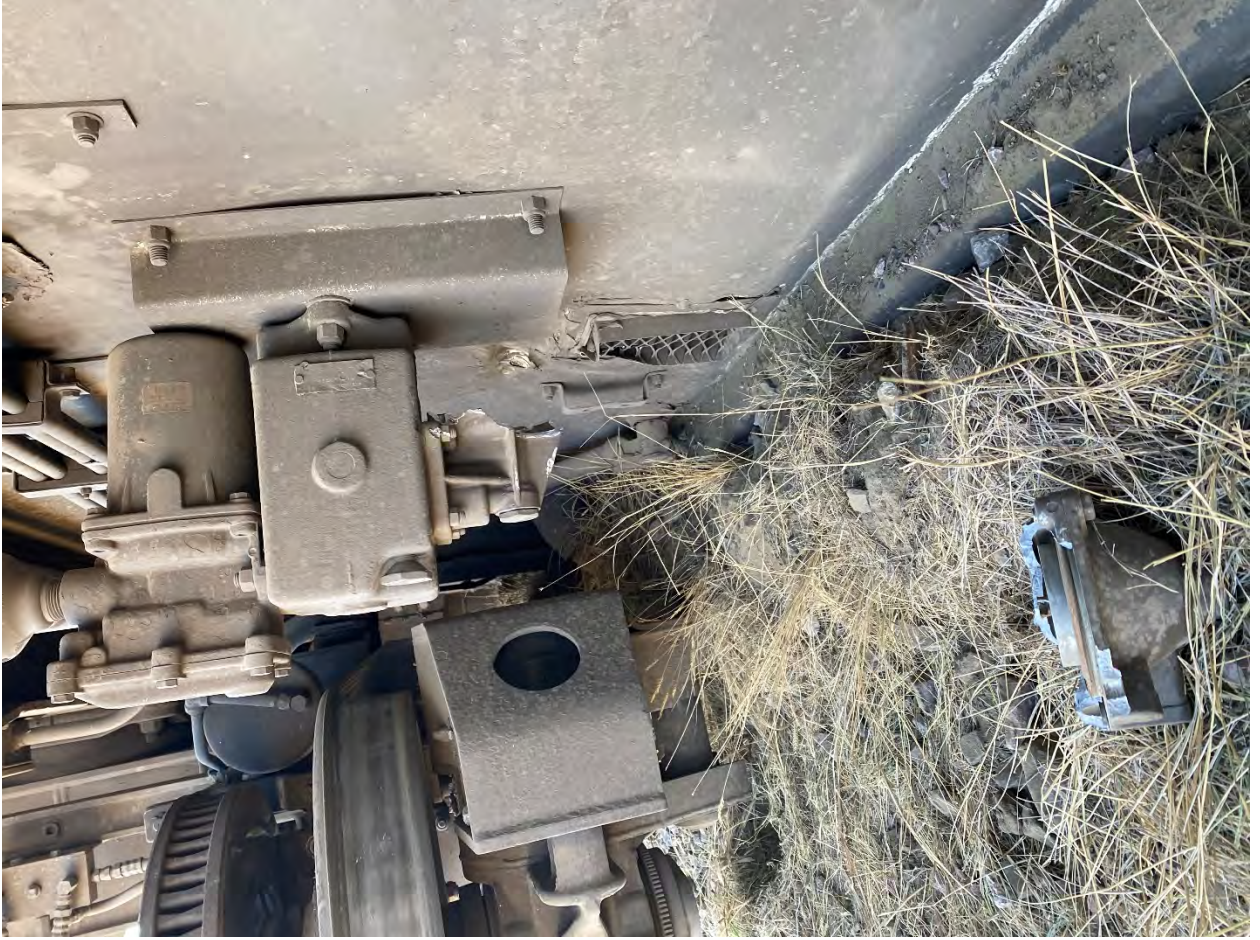
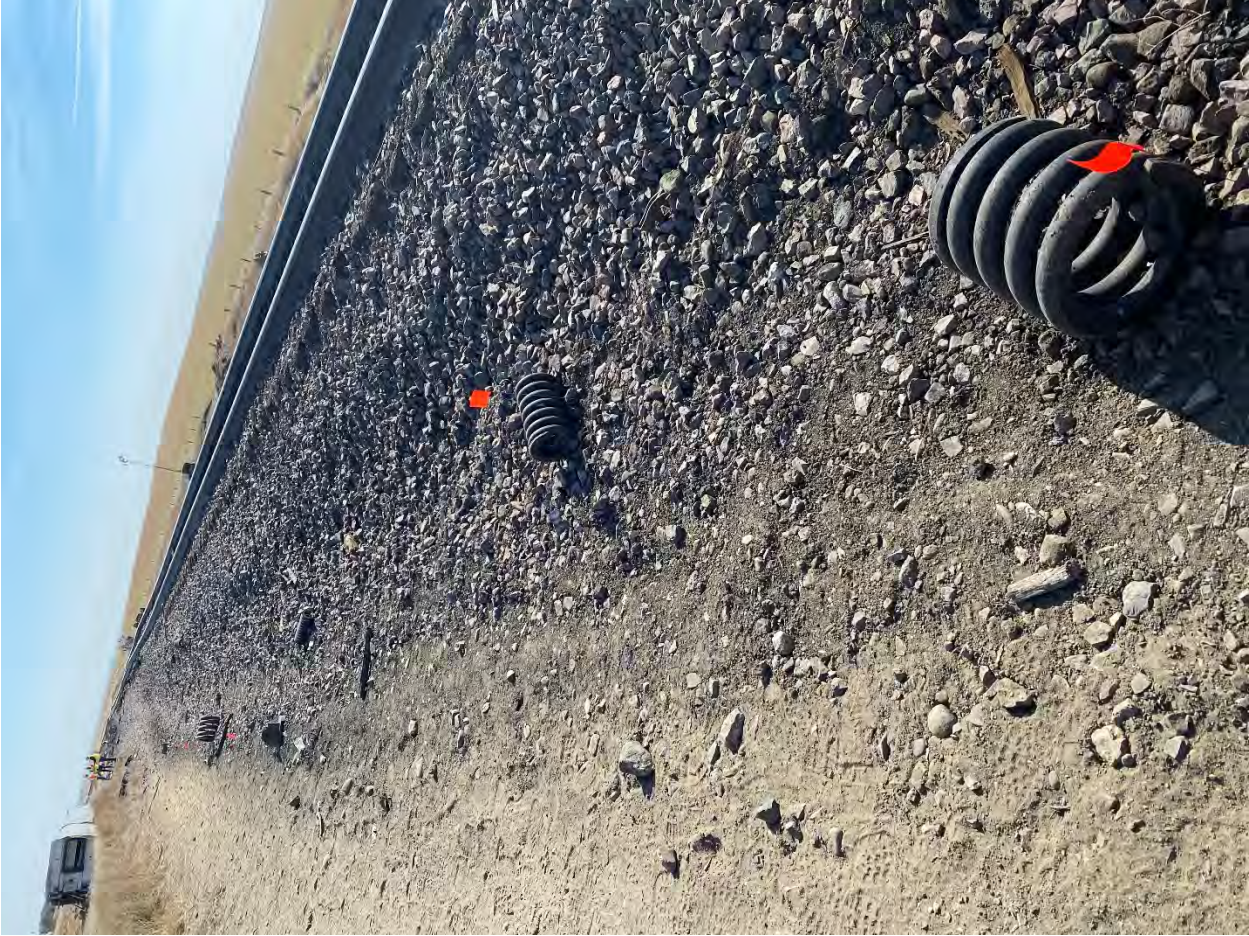
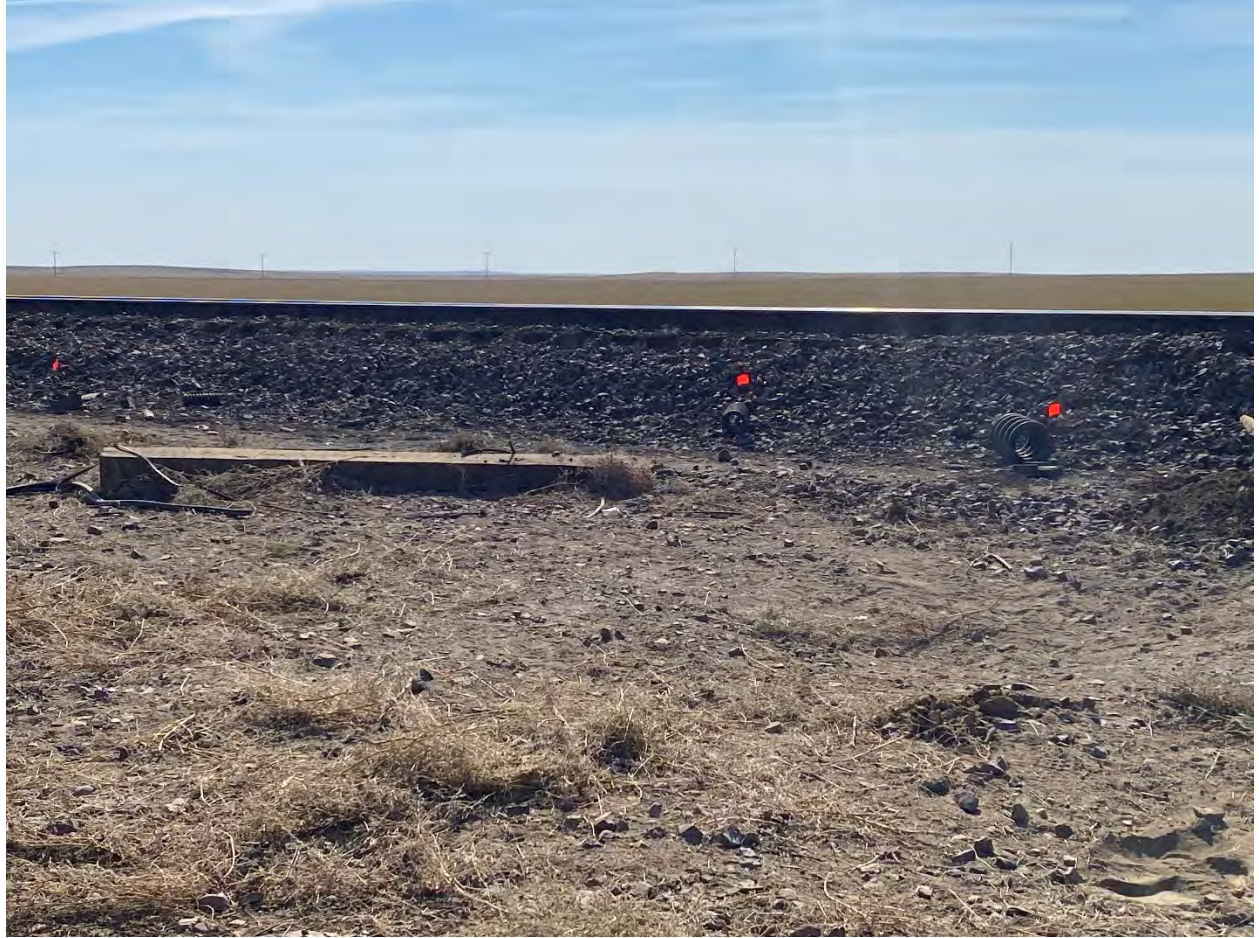
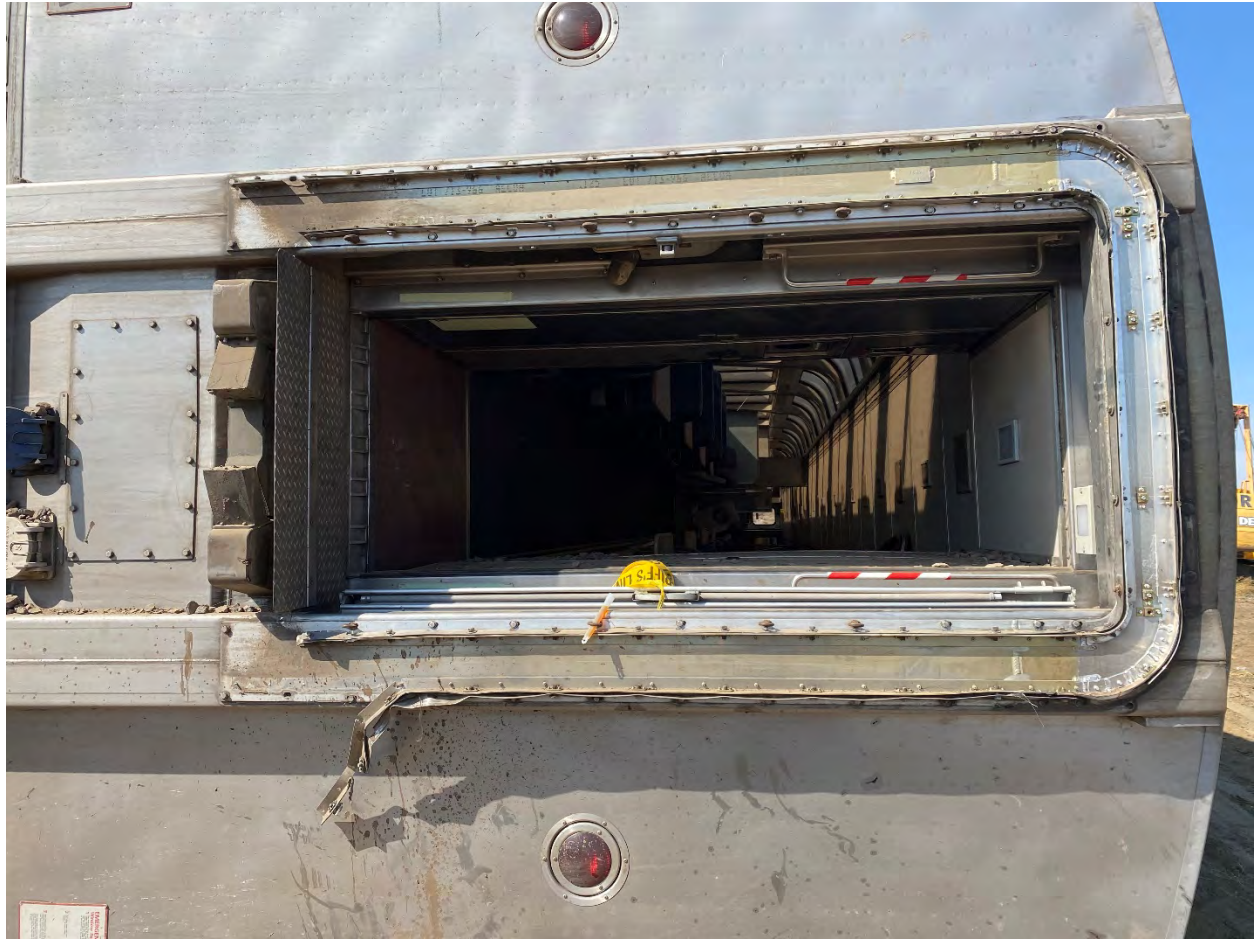
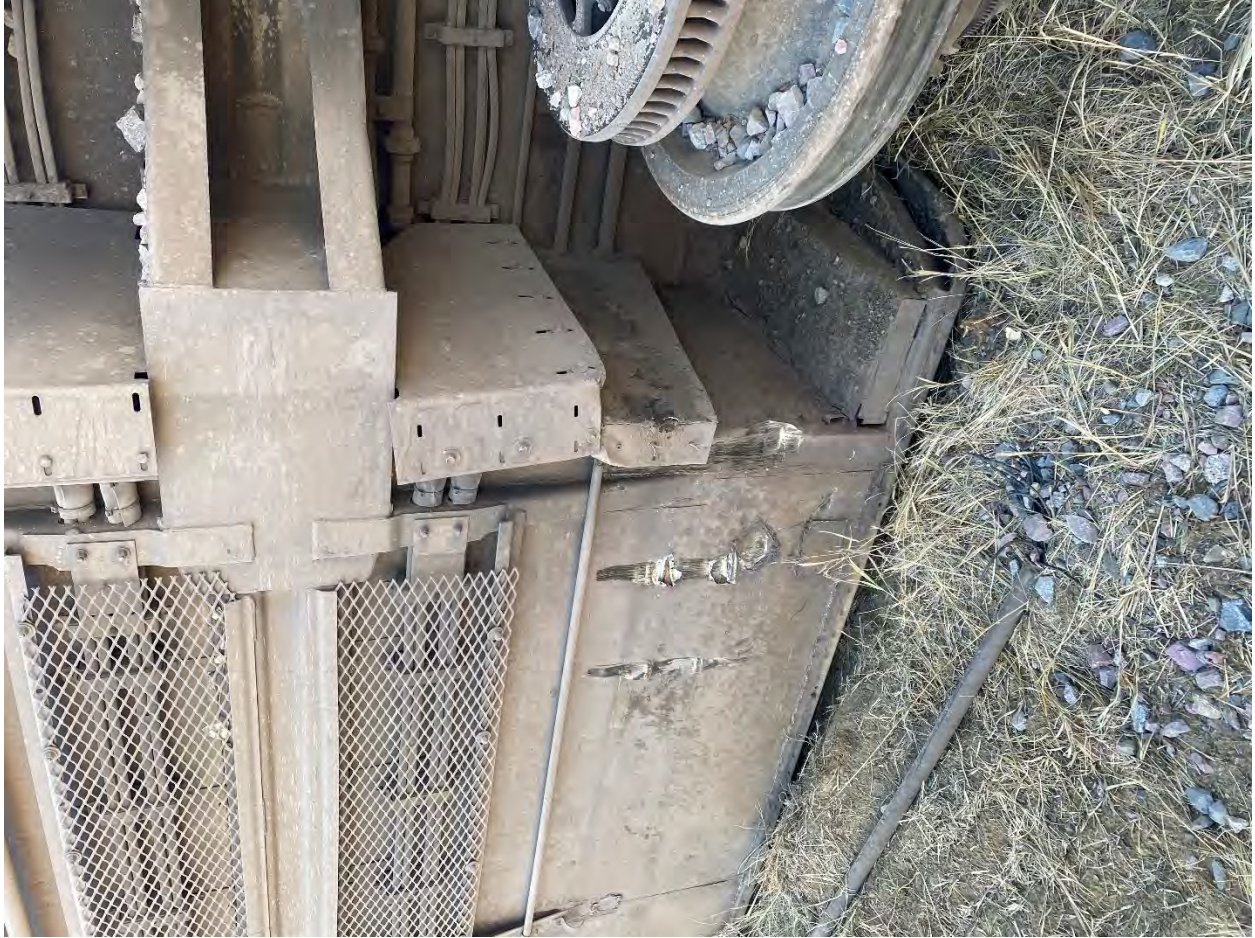
The passenger car showed signs of all eight wheels were off the rail. The B end coupler knuckle broken. B end coupler shank twisted.

The B end vestibule door diaphragm damaged. The cab windows on upper lower decks on the right side were missing except for one. The fire extinguisher was missing.

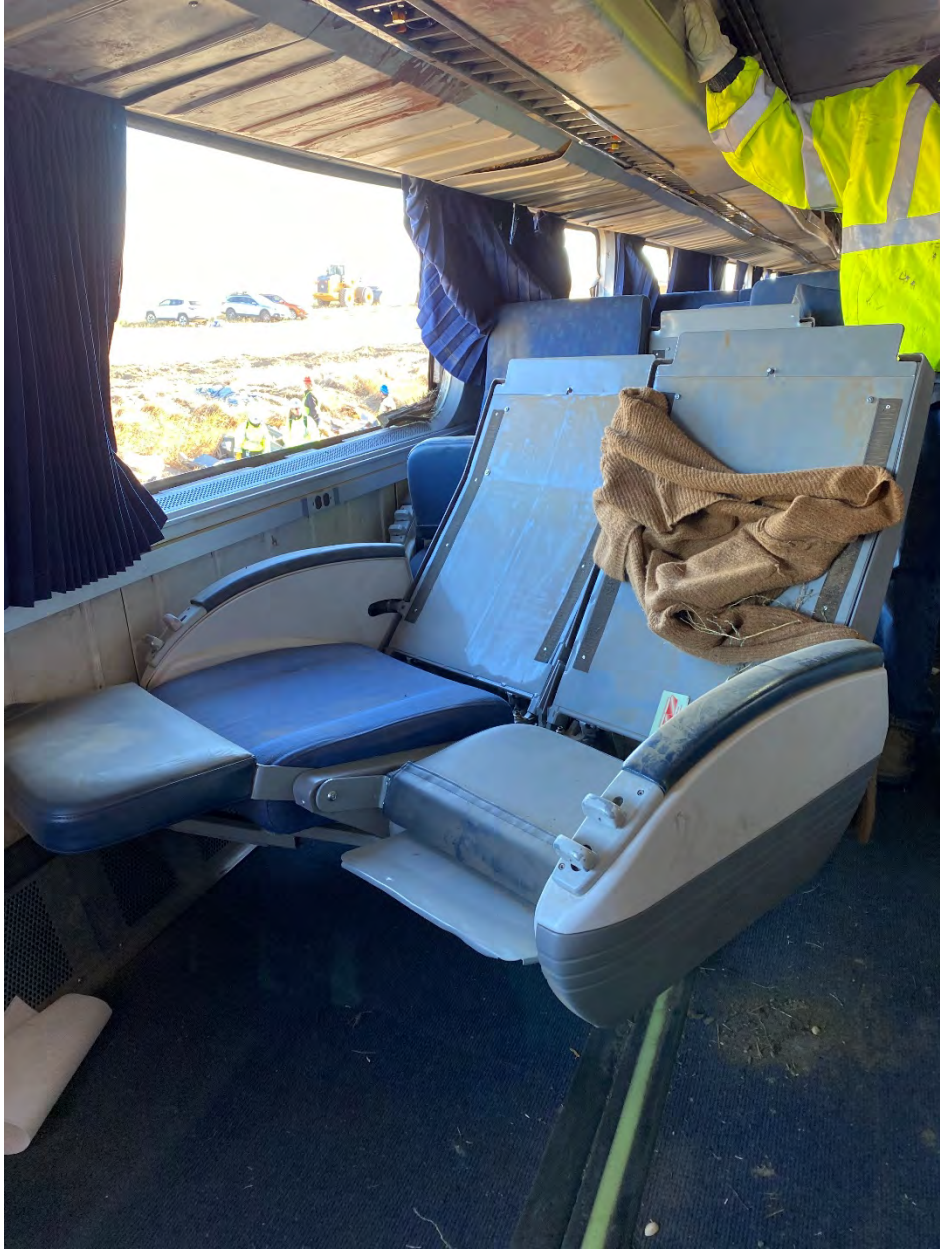
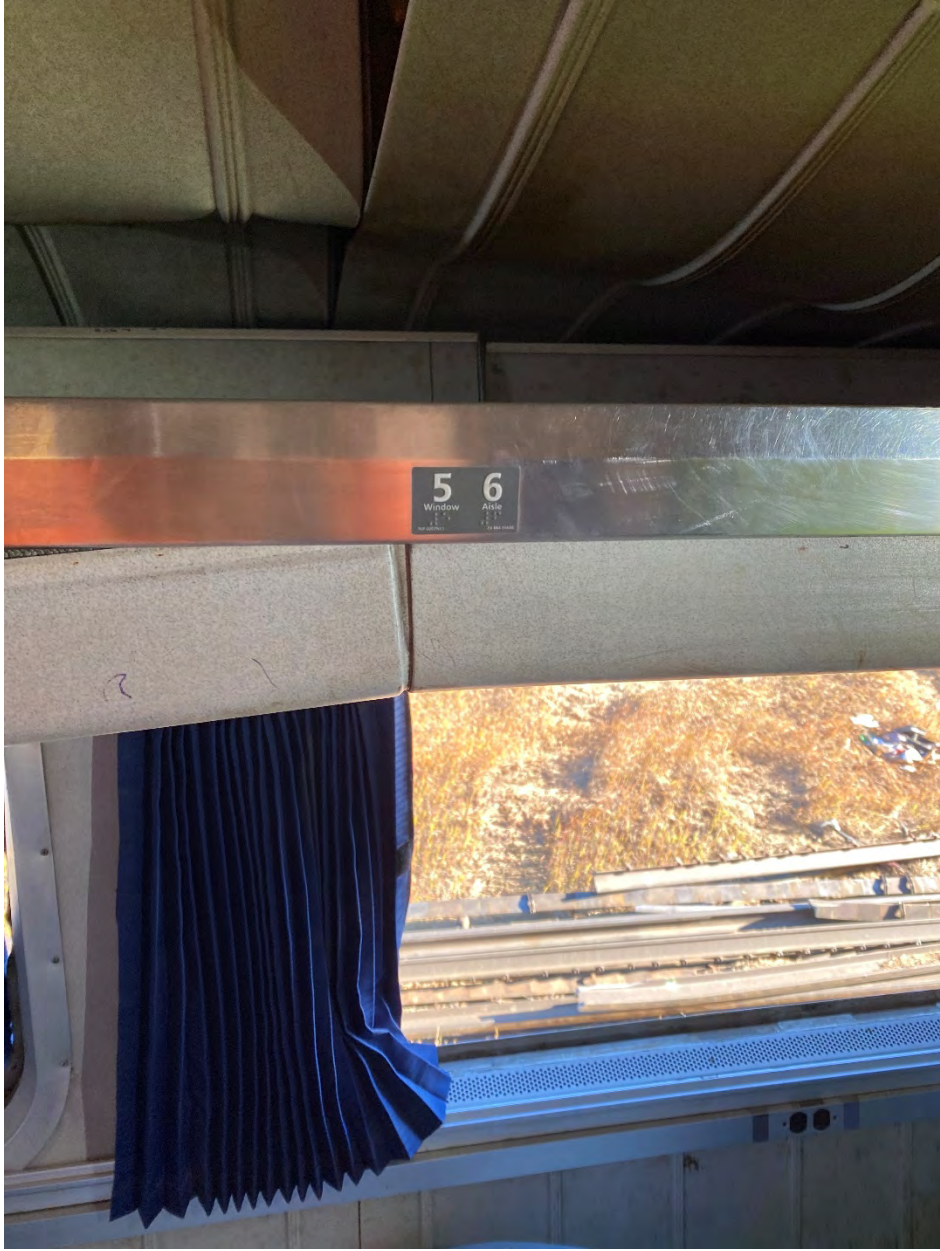
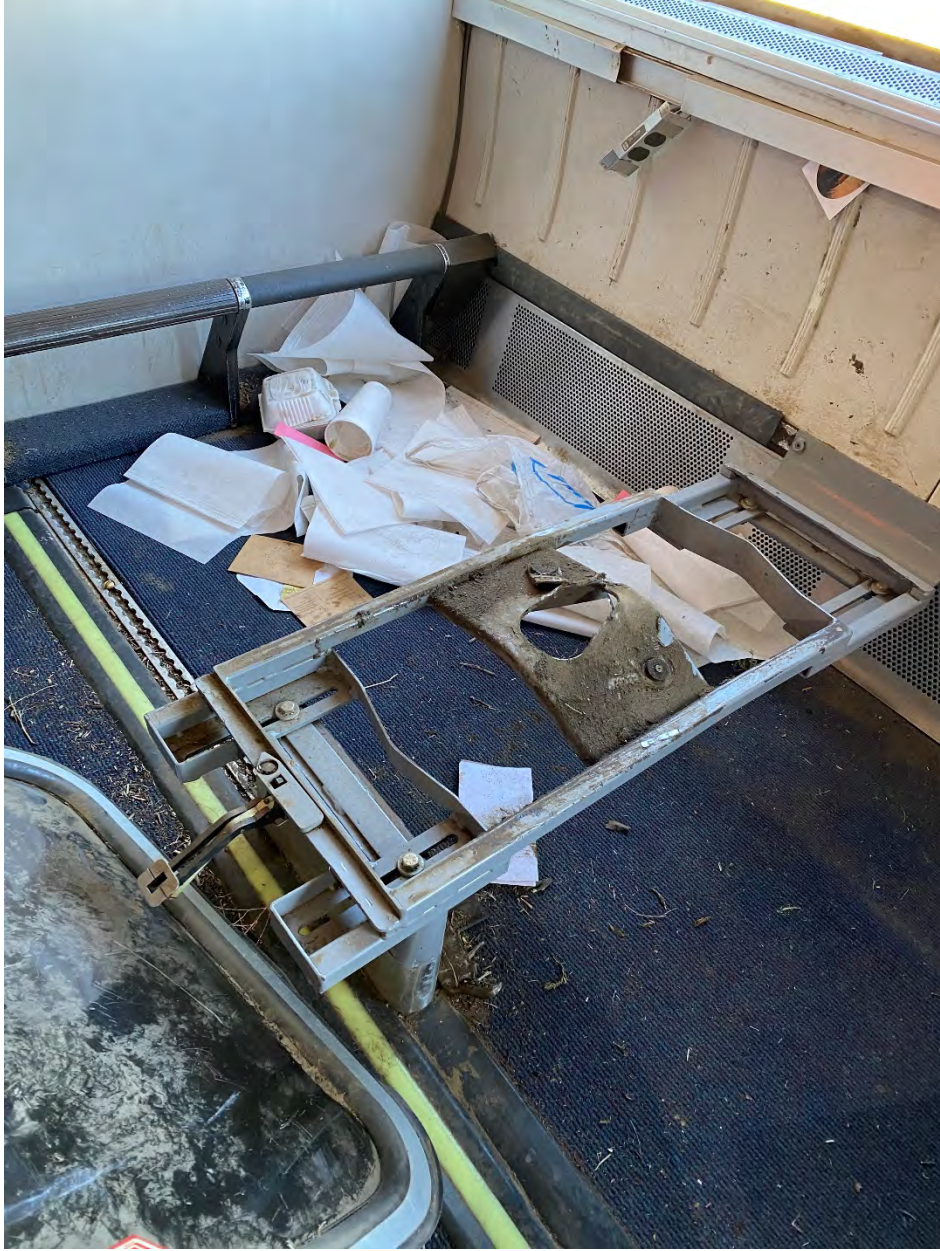
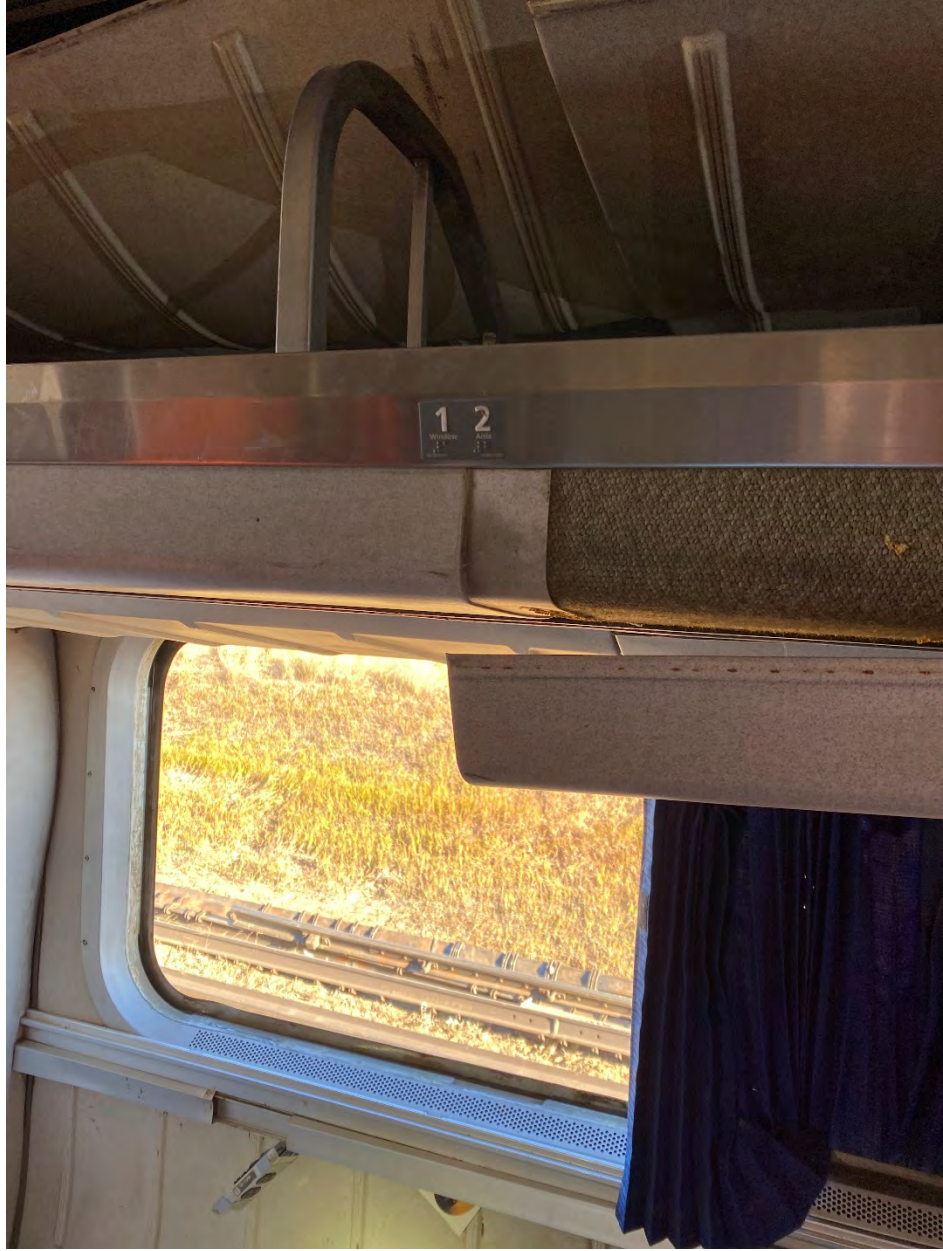
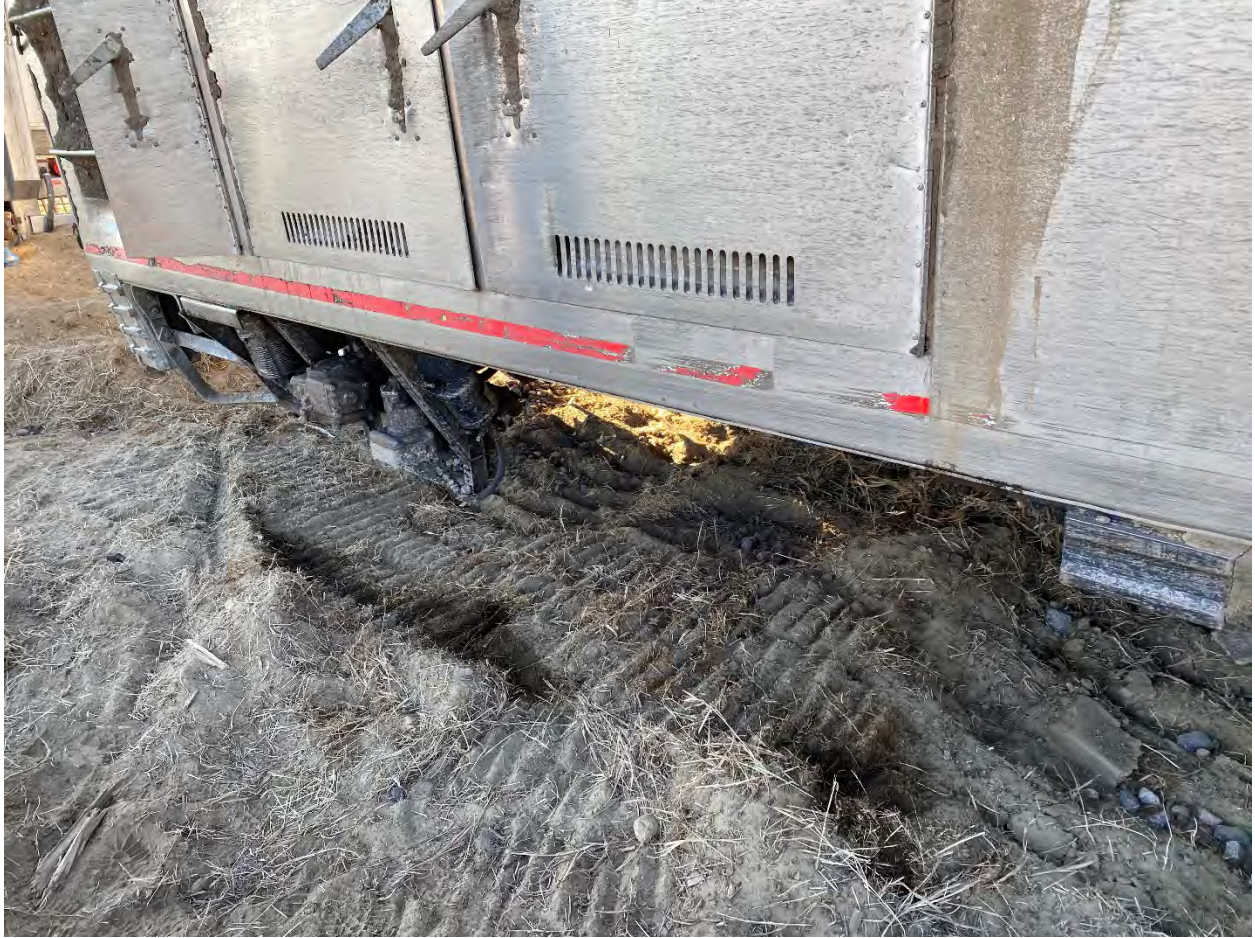
ATK 34077

The B end coupler horn broken, but still attached. The AR coupler bumper block missing. The B end coupler bumper blocks missing. The A1 air brake reduction replay missing.

The right-side batteries leaking acid. The seat positions 1, 2, 5, and 6 dislodged. Top lever water cooler fell out of the cabinet.
