ATK 32050

The following defects were noted on the sleeper car that was positioned as the third car behind the two locomotive train consist remaining upright.

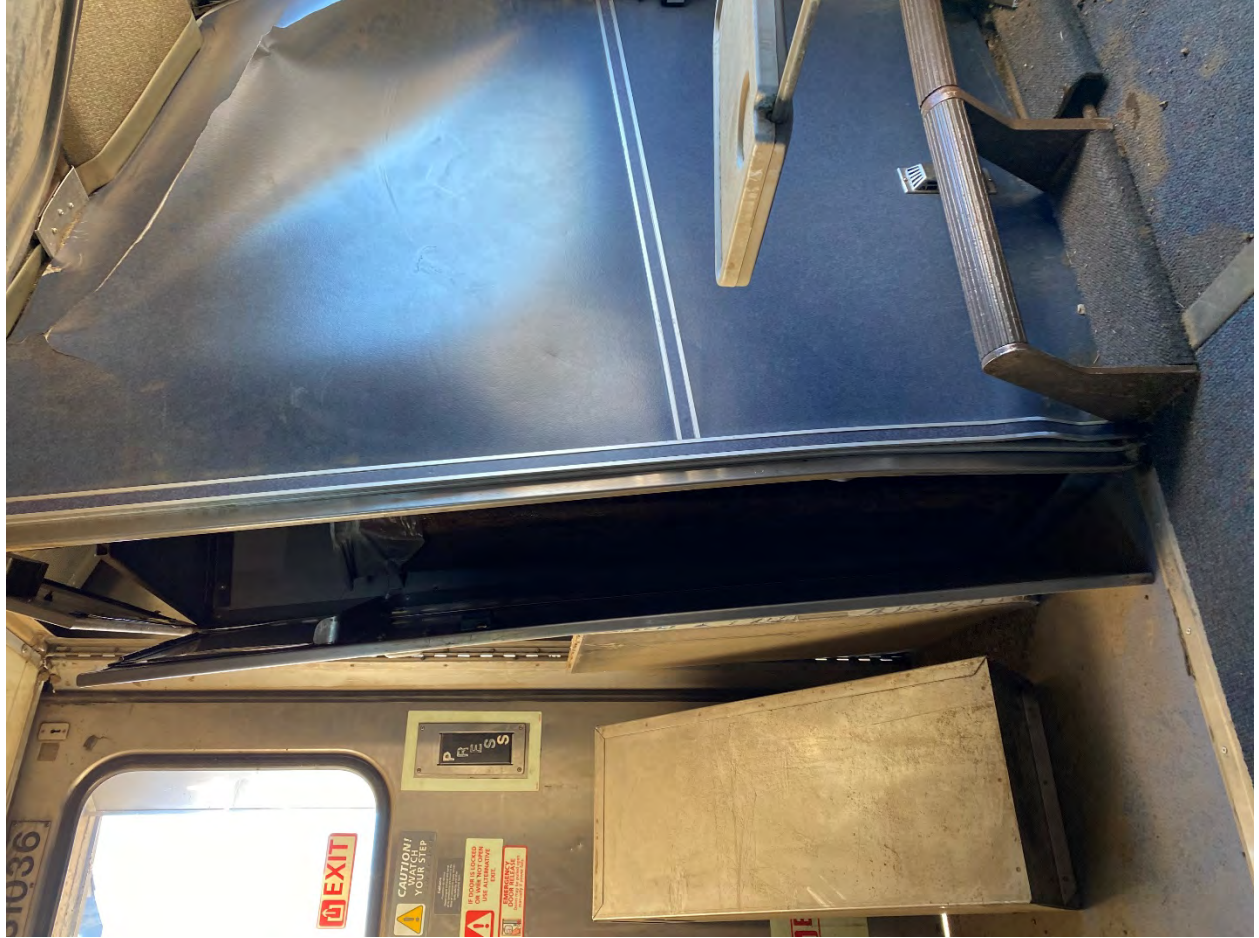
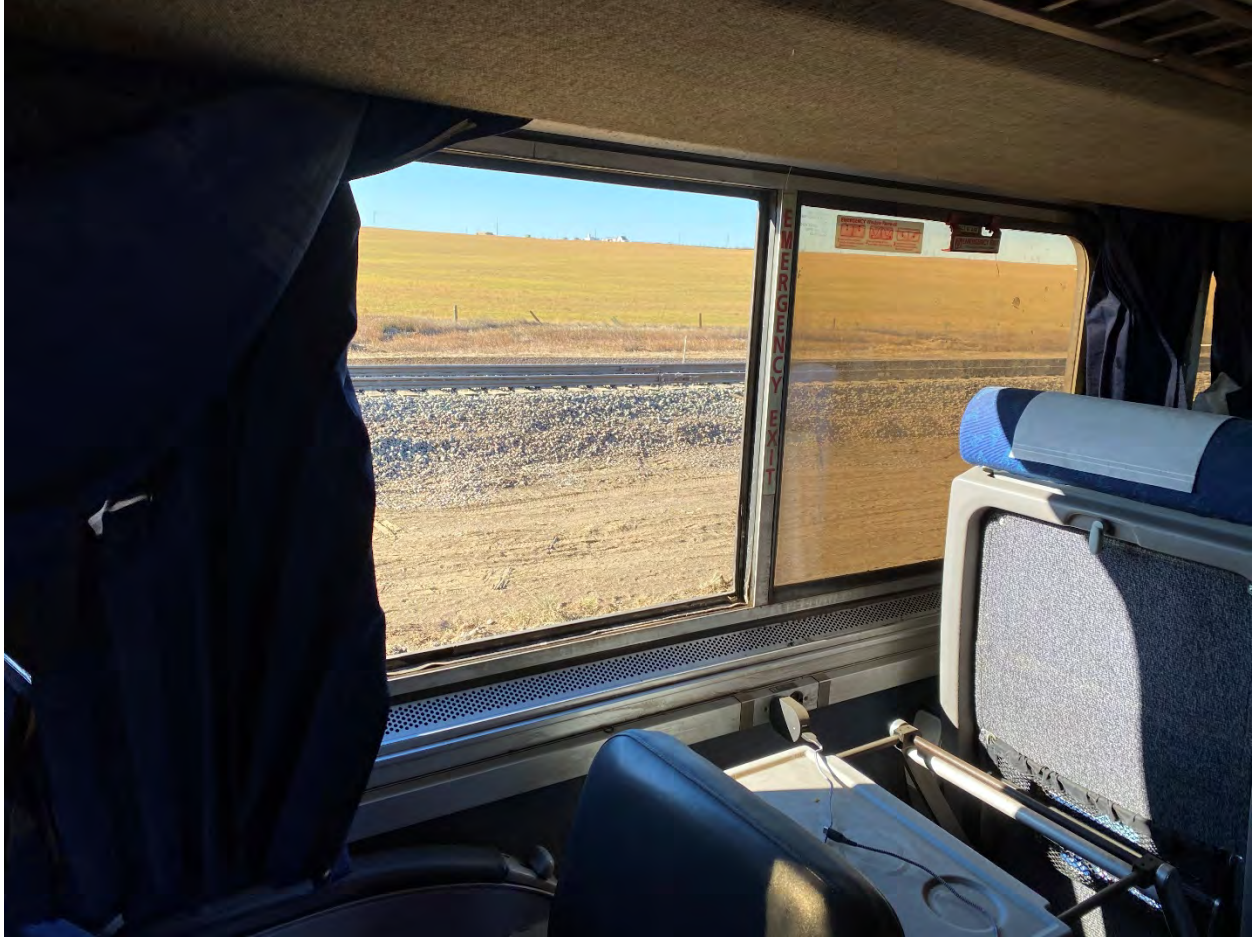
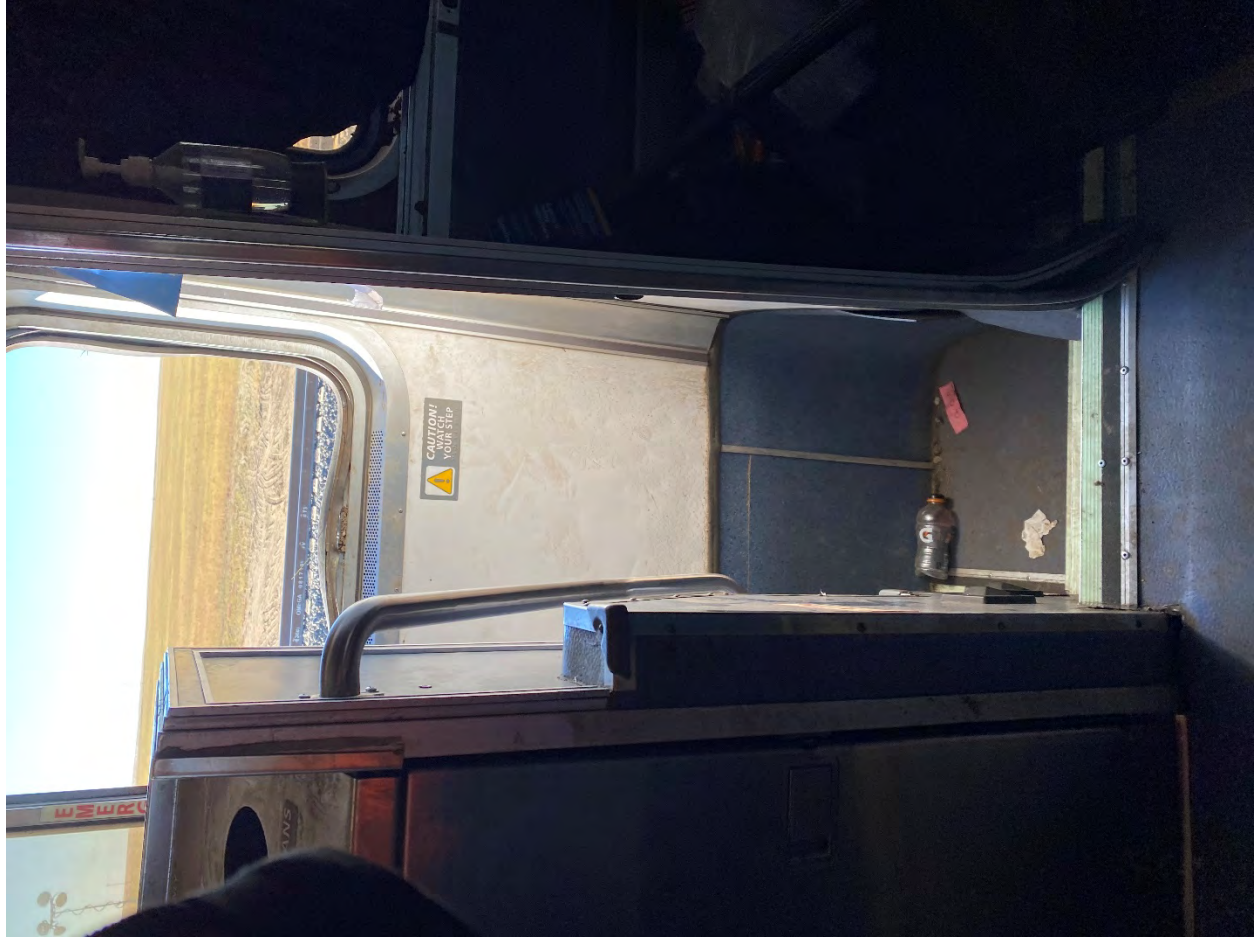
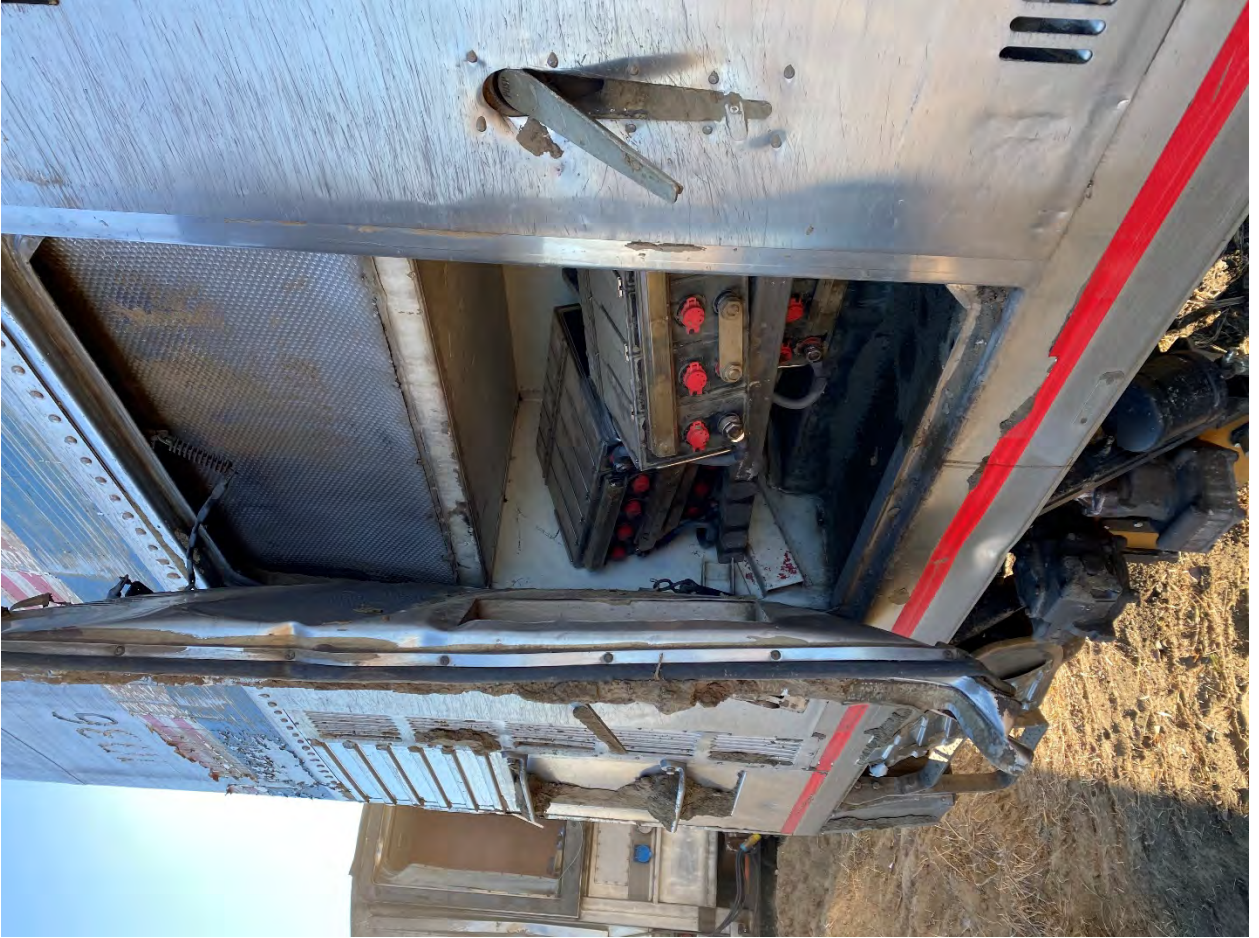
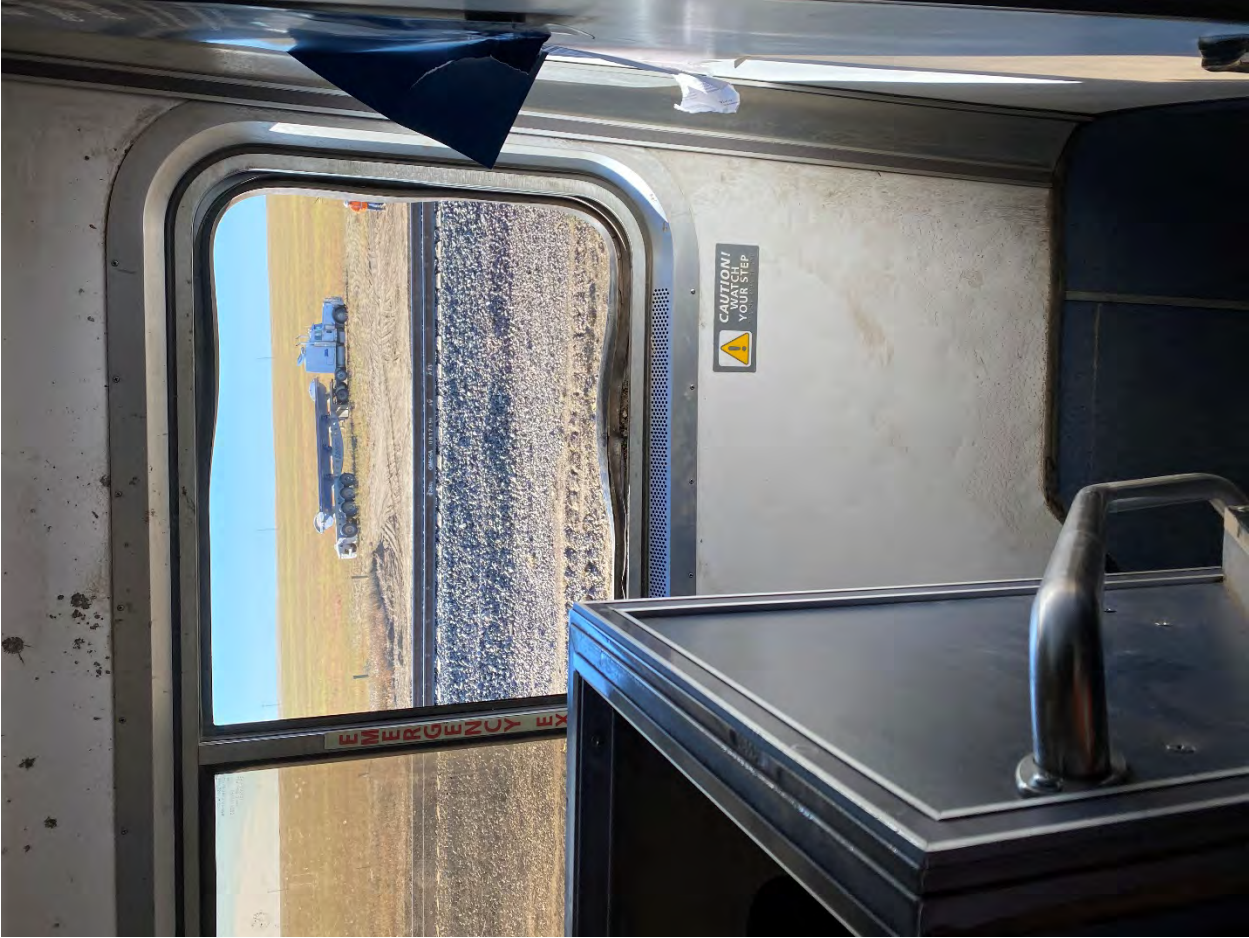
The A end coupler blocks missing. The B end bumper blocks damaged. The L4 brake rotor bent.

The A end vestibule door diaphragm damaged. The bottom floor entry fire extinguisher dislodged from bracket. Between the seats 9, 10, 11, and 12 the cab roof was breached. The windows on seats 67 and 68 were gone. The B end right side batteries dislodged.

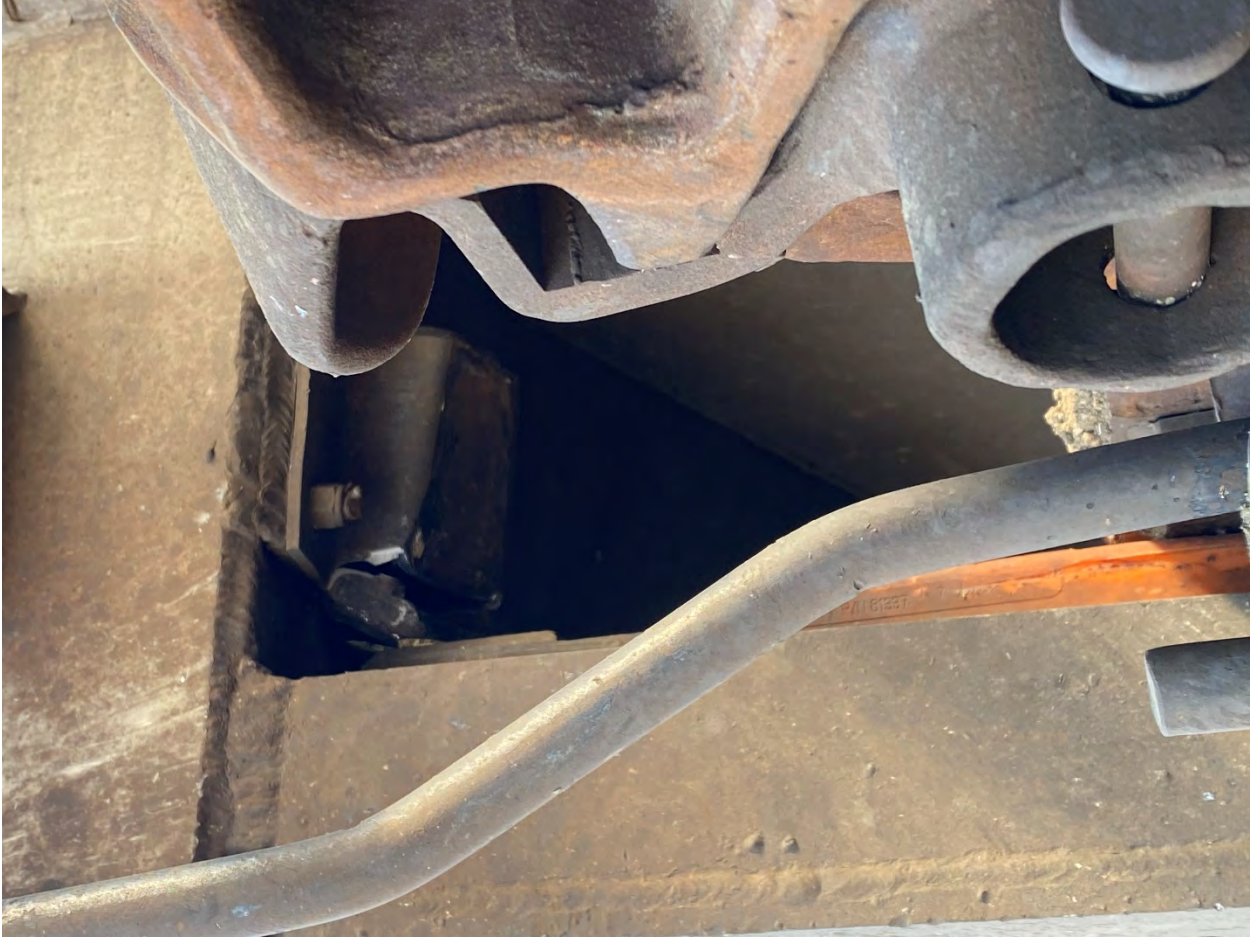
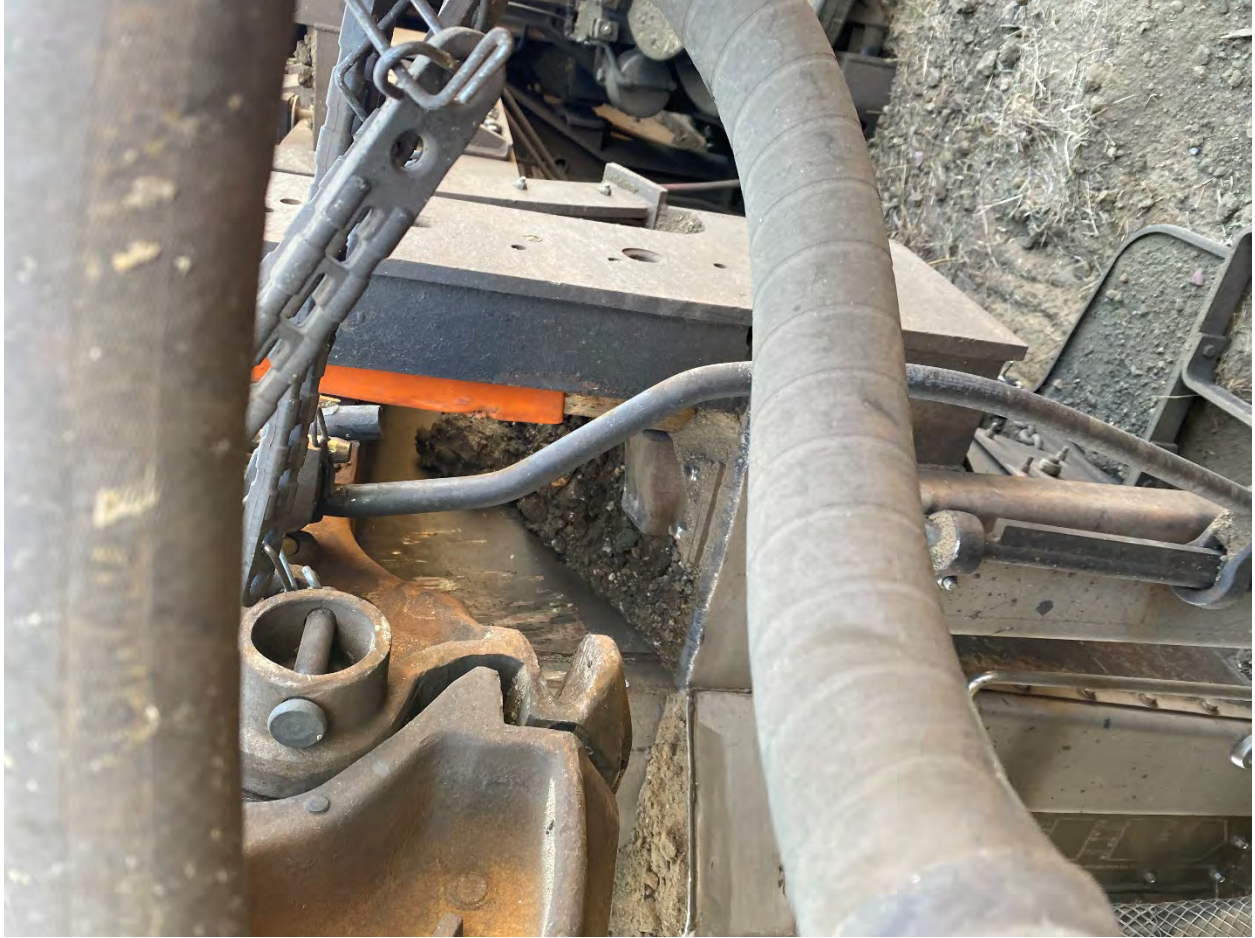
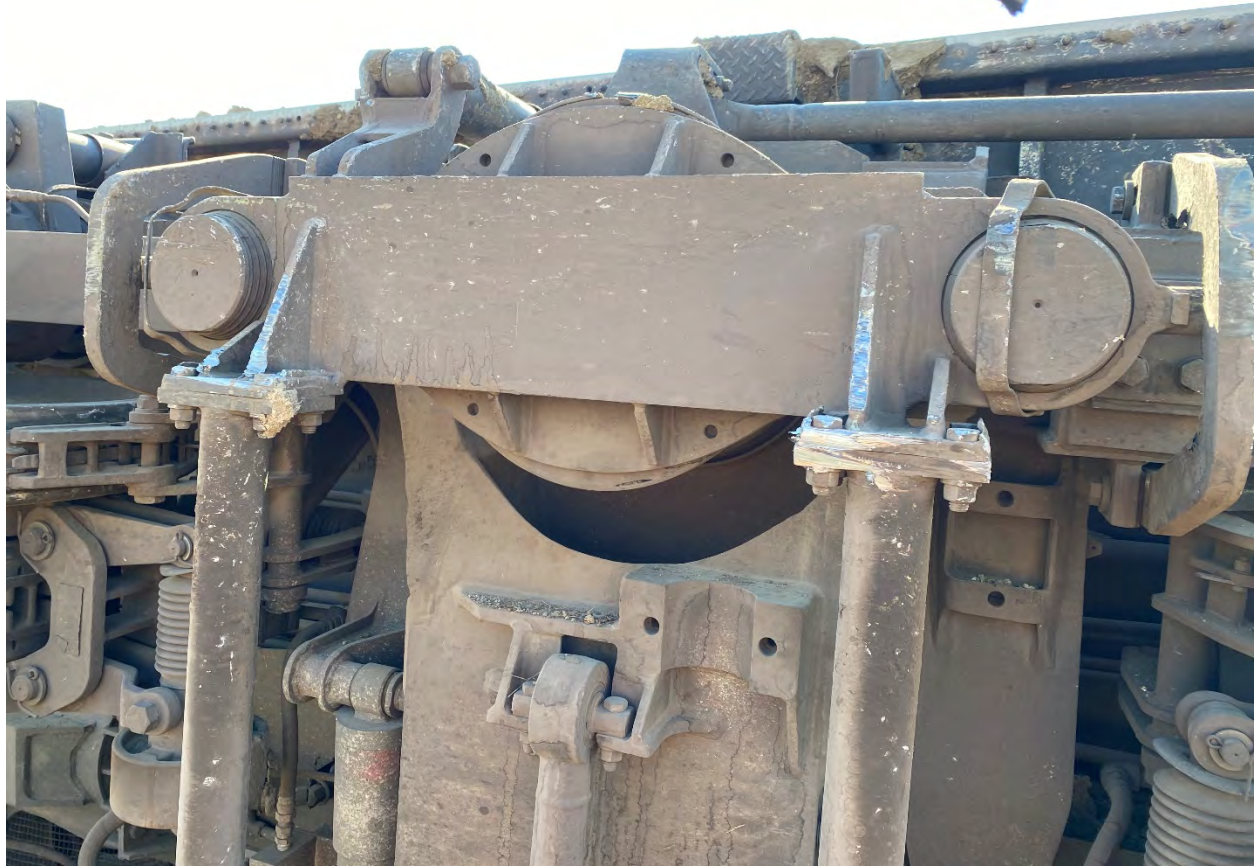
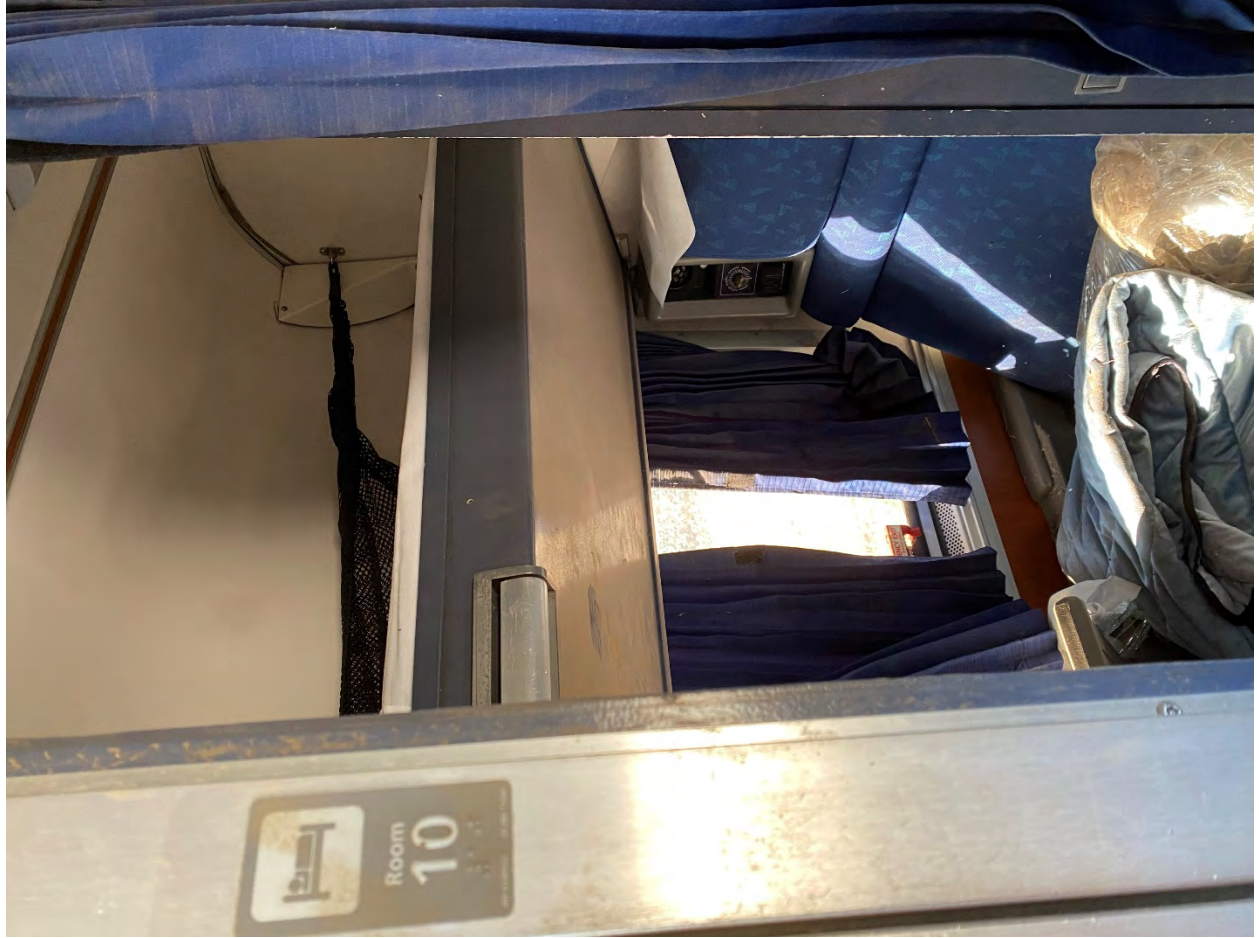
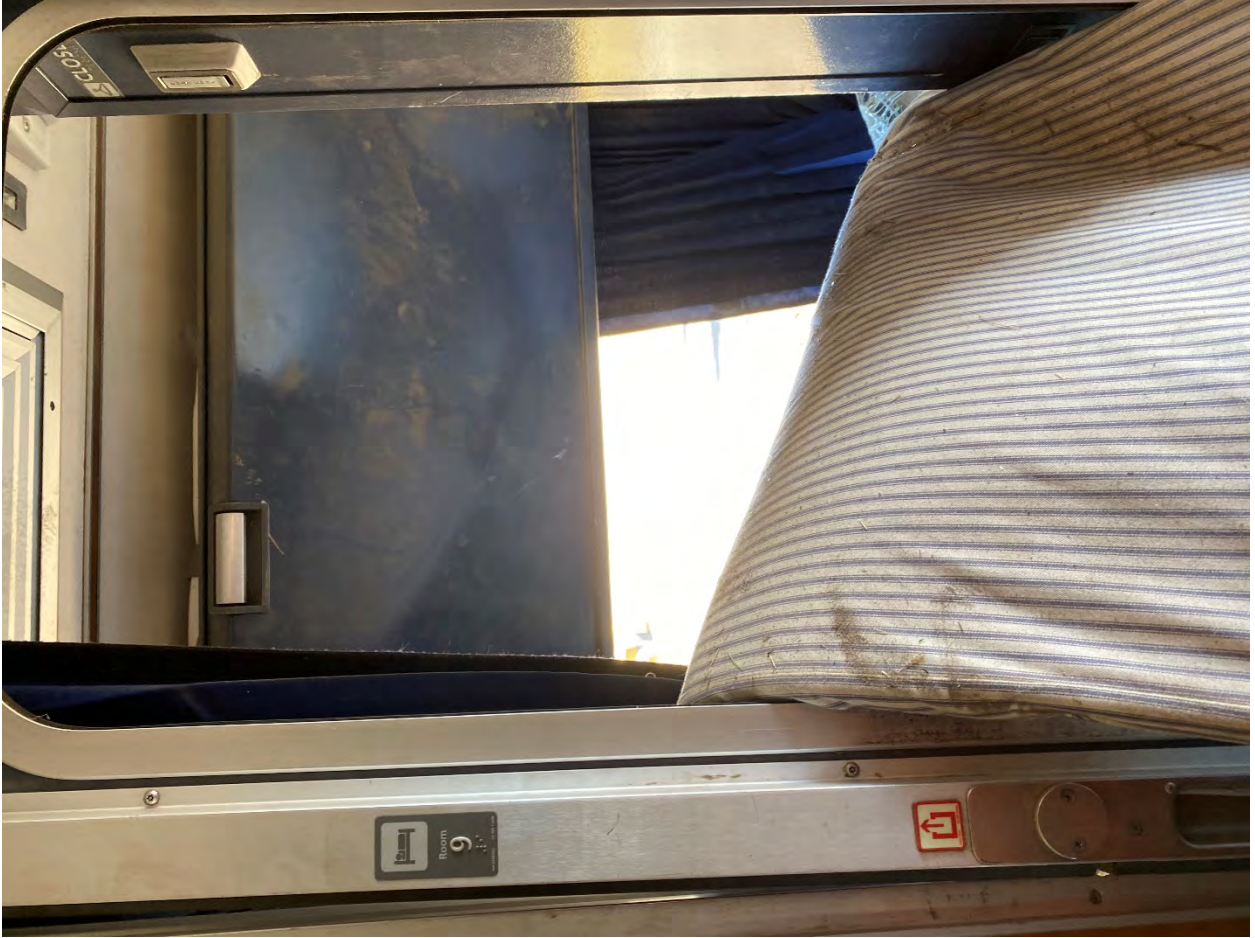
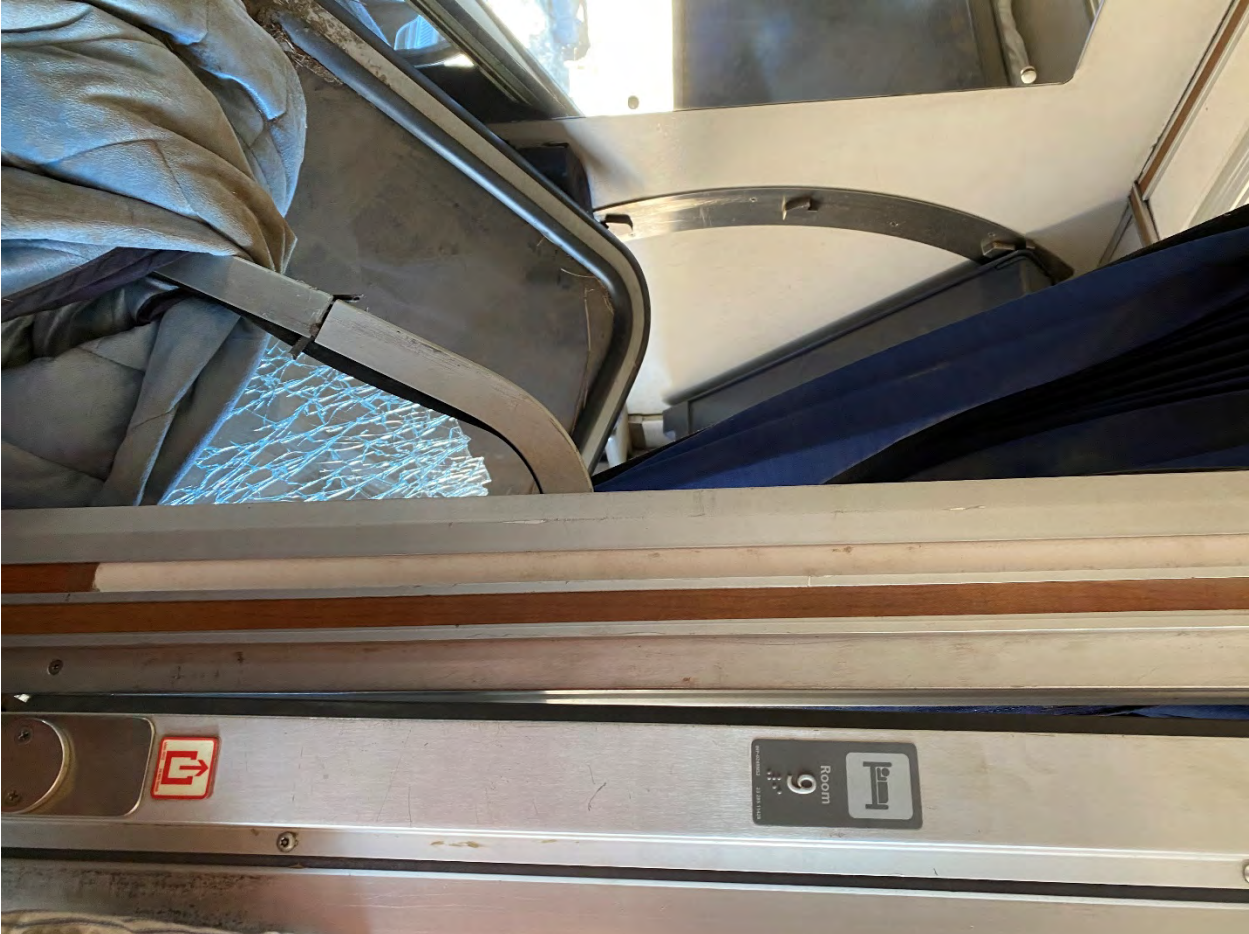
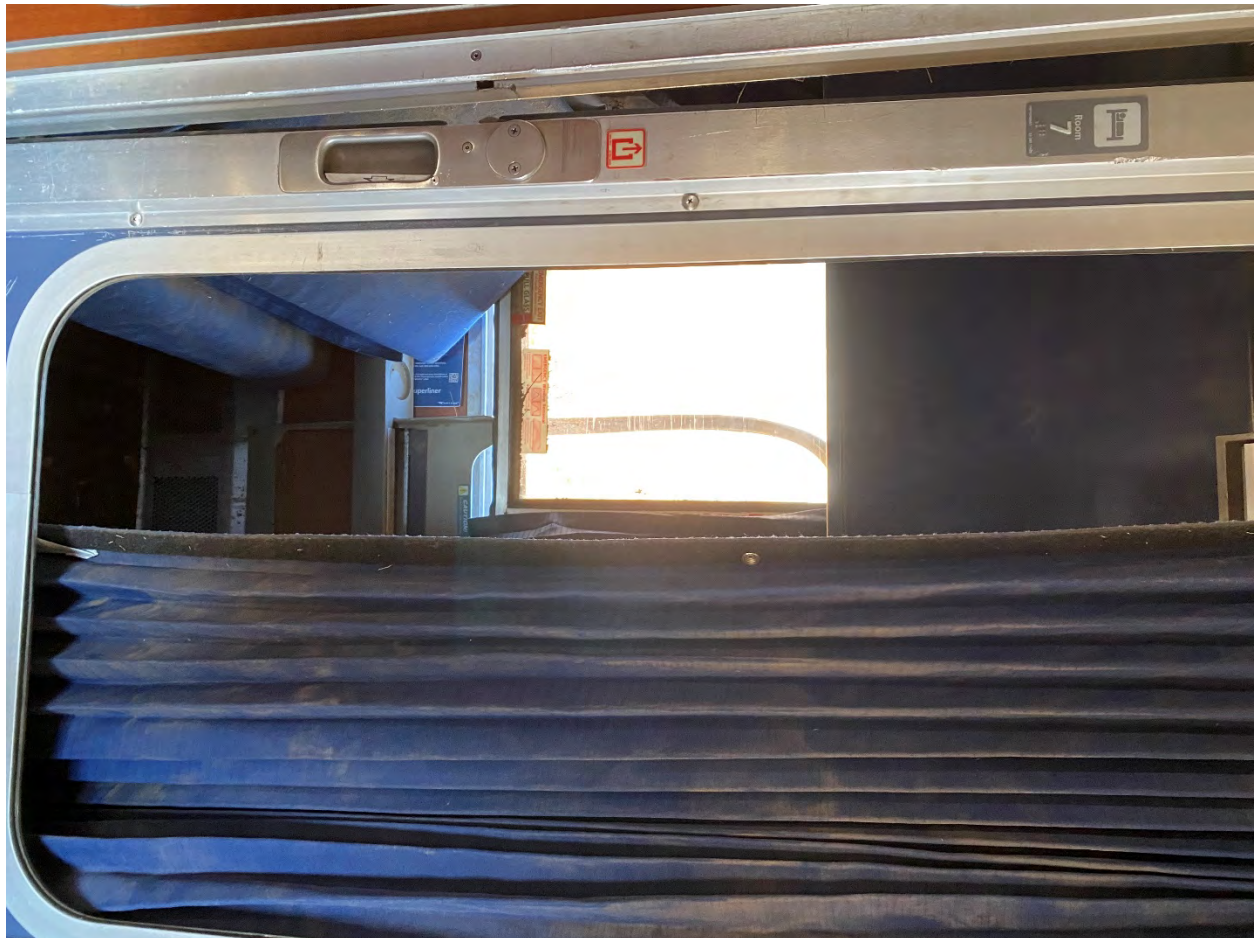
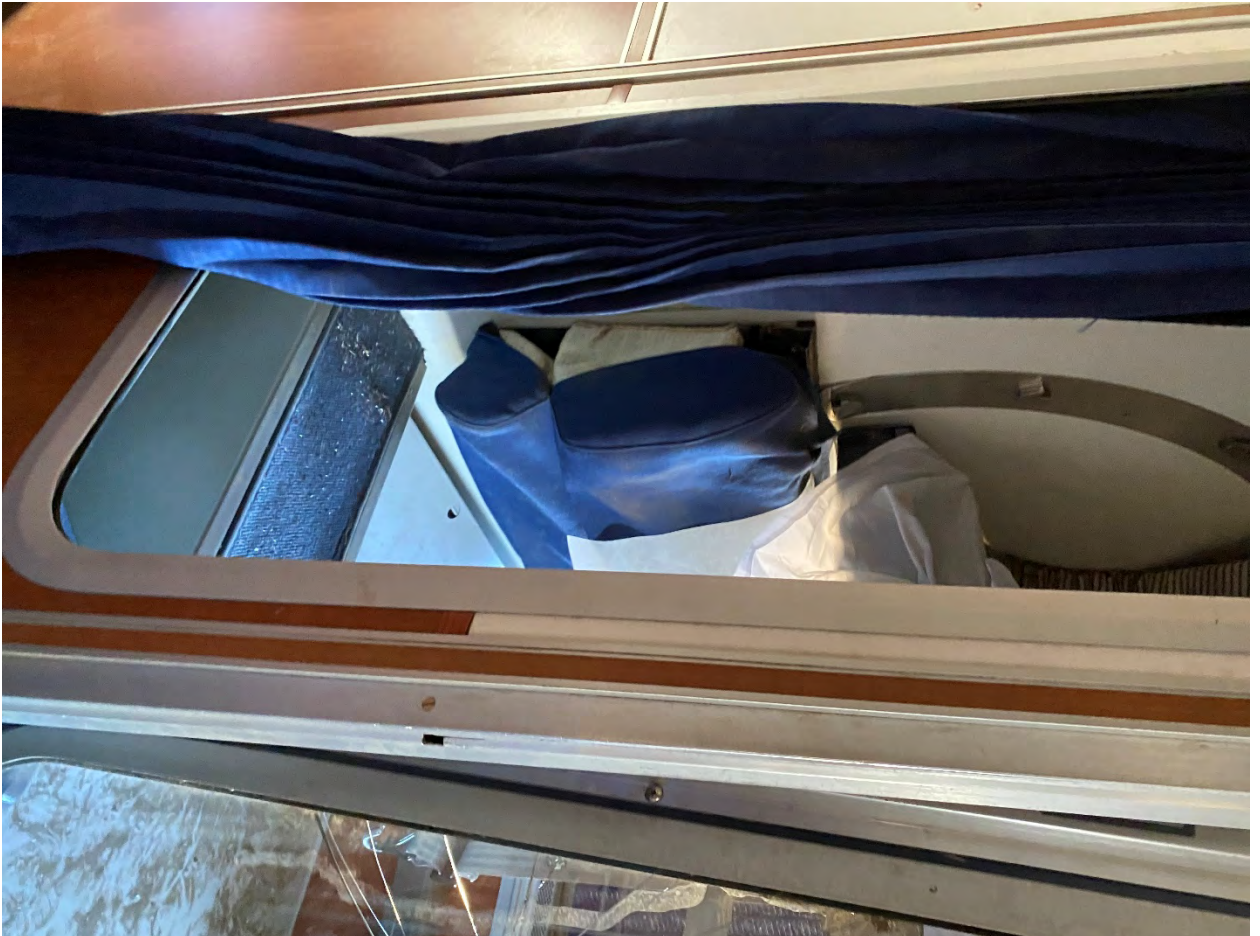
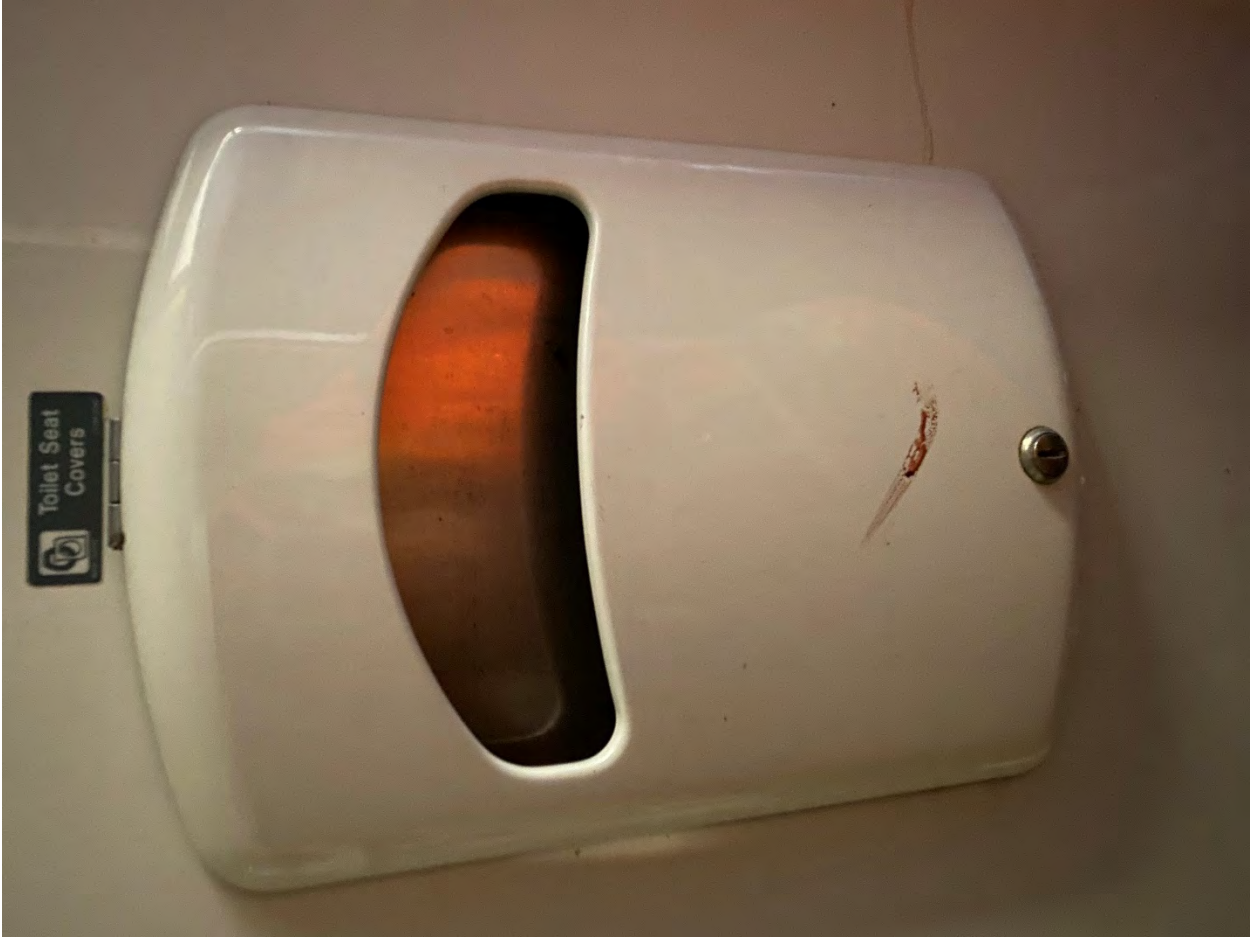
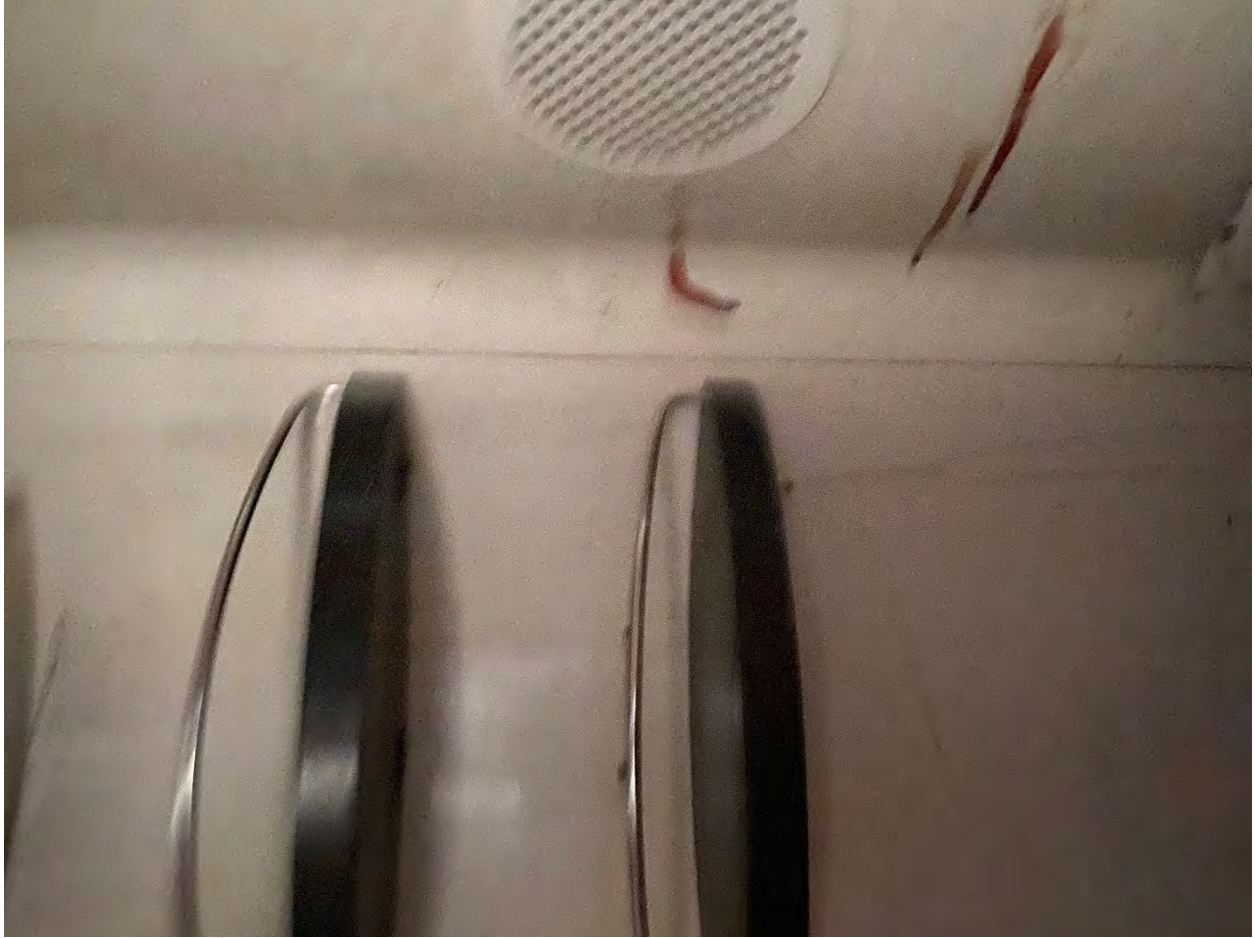
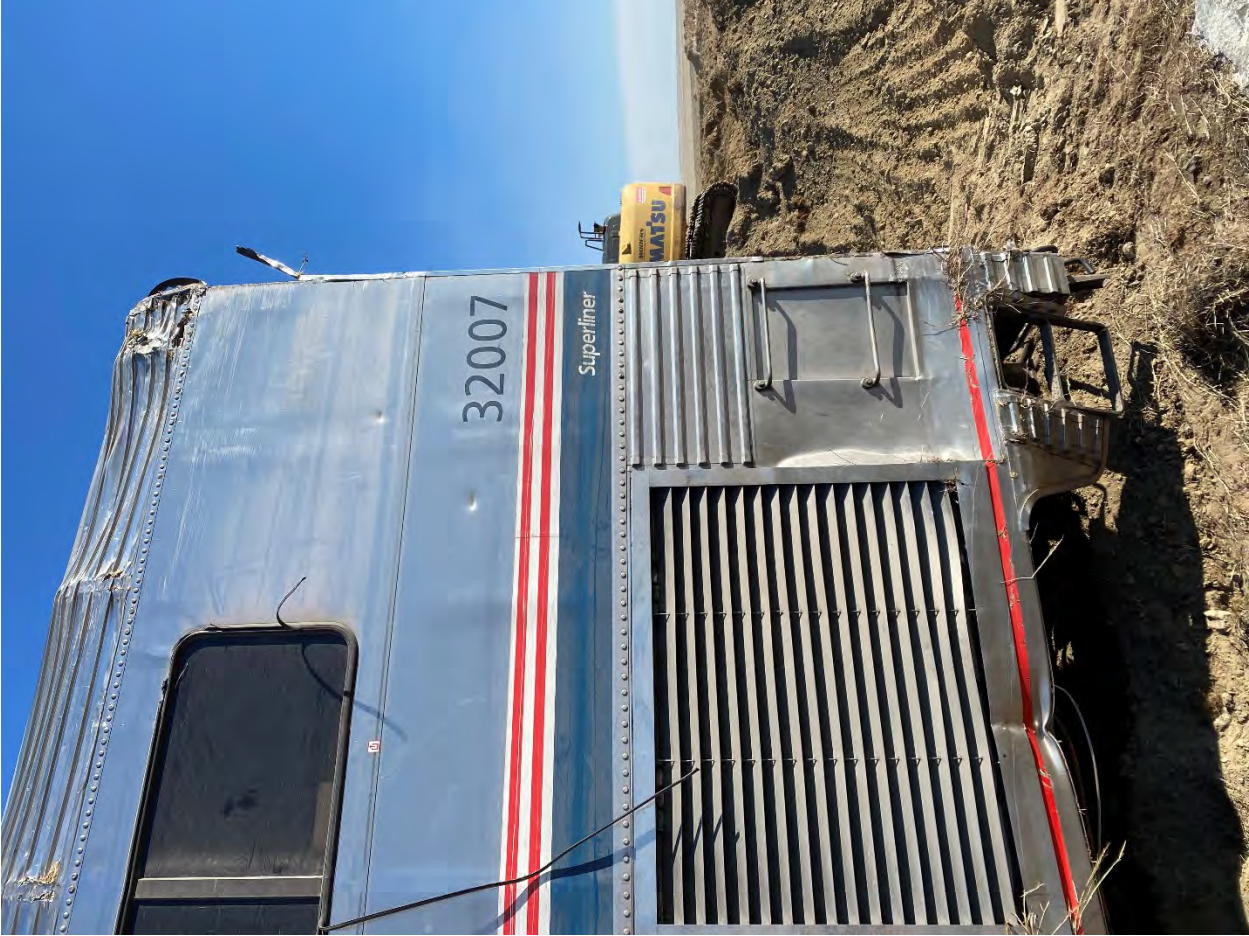
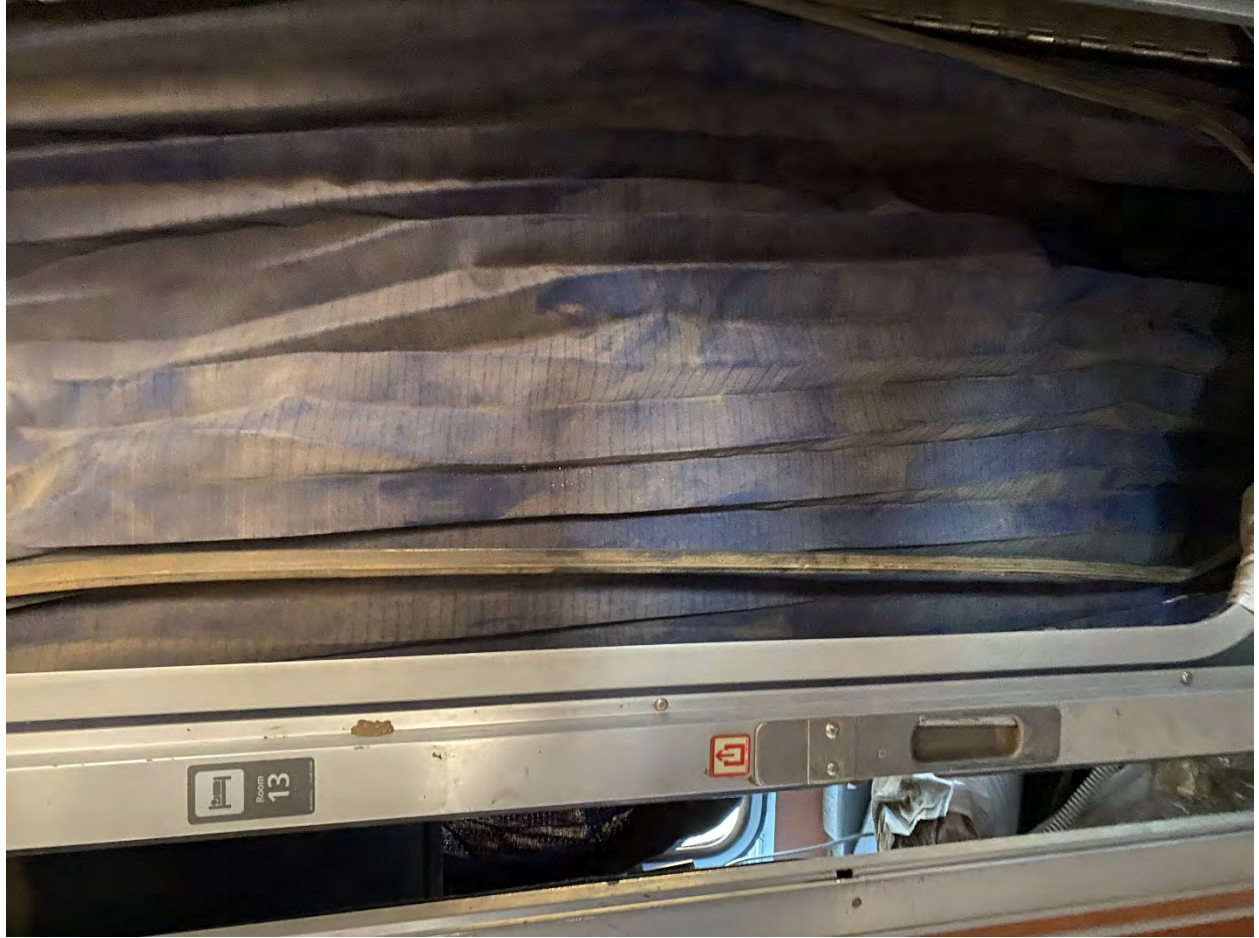
ATK 32007

The AL coupler bumper stop damaged. The R4 brake rotor damaged.

Room 3 wall glass and sliding door glass broken, laying inside and out of room.

Room 7 sliding door glass missing, pushed out.

Room 10 door glass missing, laying inside and outside of room.

Room 13 door glass missing, inside of room.
