National Transportation Safety Board
Office of Railroad, Pipeline and Hazardous Materials Investigations
Washington, D.C. 20594

Union Pacific – Rear End Collision
Granite Canyon, Wyoming
October 4, 2018
Mechanical Group Factual Report

NTSB Accident Number: RRD19FR001
Date of Accident: October 4, 2018
Time of Accident: 7:38 p.m. (MDT)
Type of Trains: Freight
Railroad Owner: Union Pacific
Train Operator: Union Pacific
Fatalities: 2
Location of Accident: Granite Canyon, WY

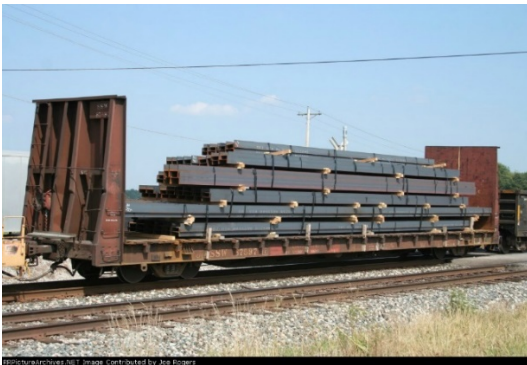
The end hose arrangements, to include a small portion of the brake pipe, secondary hoses, intermediate hoses, angle cocks, EOC trainline brackets, and end hoses were retained from both ends of the SSW 87597 and shipped to the Strato laboratory in New Jersey for testing.

Figure 6 SSW 87597 shown years prior to the accident.

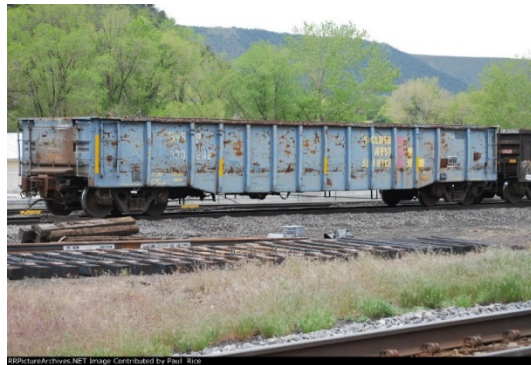
Figure 7 SP 338282 shown years prior to the accident.

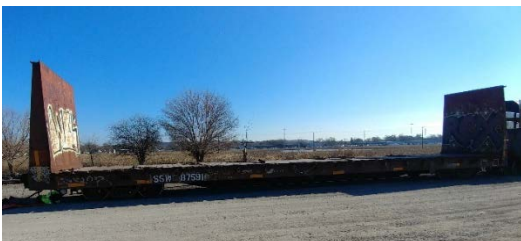
Figure 8 SSW 87591 in Council Bluffs on November 15, 2018.

It was noted that exemplar Car SSW 87591 (bulkhead flat) had a few notable differences from the accident car. First, both ends of the exemplar car had end hose arrangements that did not utilize the S-4021 bracket, whereas the accident car did have a S-4021 bracket on both ends. This means that the exemplar car did not utilize a secondary hose and the angle cock was located under the coupler as opposed to on the end sill. The Strato representative explained that historically, brackets were welded to the cushioning device to support trainline angle cocks. However, because dissimilar metals were used, and because welding practices varied, cracks often developed in these areas leading to undesired emergencies and equipment not secured properly. Therefore, AAR changed the standards (Field Manual Rule 6) and required a coupler mounted bracket or other mechanical securement to be used in lieu of welding. When a CMB was used, the location of the angle cock had to be changed. The change in standards over time has led to variations between cars, and often between ends of the same car.

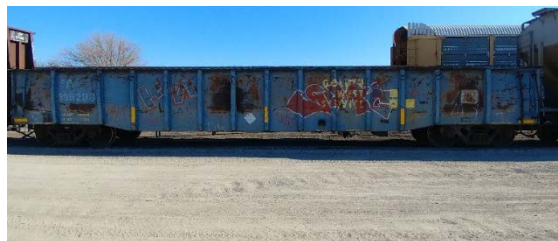
Figure 9 SP 338286 in Council Bluffs on November 15, 2018.

Car No. SP 338286 had a few differences as well. The B-end of the car had a S-4021 bracket, whereas the accident car did not. The A-end of the exemplar car had a bracket which is similar to the accident car. Secondly, it was noted that the B-end intermediate hose had an observable kink in a vertical direction. There was wear on the hose where it had contacted the center sill and/or cushioning unit. While this is different than the sister gondola car, it is similar to what the bulkhead flat car SSW 87597 was found with post-accident. Also, the B-end arrangement appeared to be installed improperly, with missing components replaced with a cotter key and a large water trap (low spot in the hose) formed in the intermediate hose.

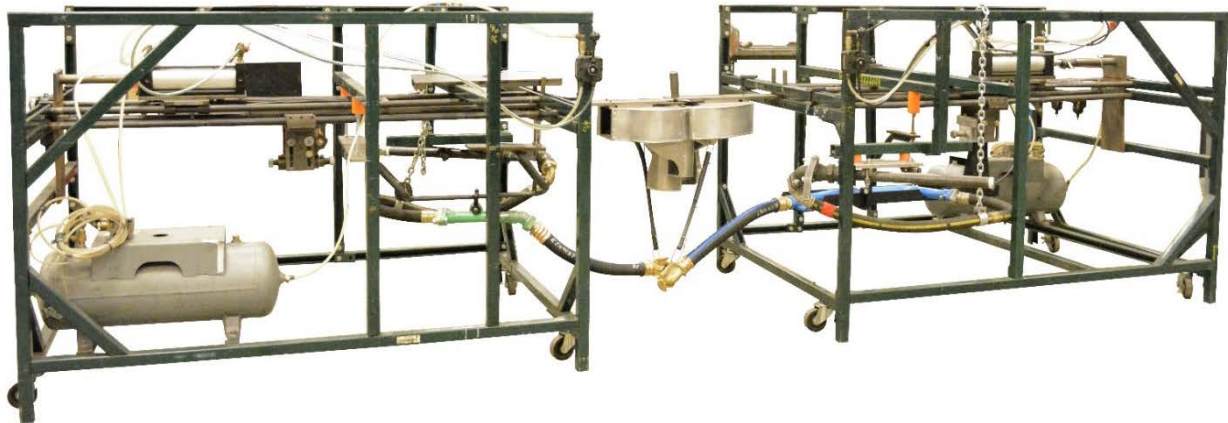
Figure 12 Test rig example at Strato.

Based on the measurements of the sister cars in Council Bluffs, the car did not have any components that would have caused hose interference or obstruction, however the group recreated obstructed flow scenarios by putting the test rig in different buff and draft positions and placing the hose support in different locations in a manner to induce kinking. An air flow meter was connected to the rig to observe any air flow fluctuations while conducting these tests. The pressure in the hose was 90 psi and the flow was reduced to approximately 24 CFM. Initial event recorder data shows that previous to the incident, air flow readings were recorded between 20 to 27 CFM. Based on that data, investigators agreed to conduct testing at 24 CFM.

Investigators observed no changes in the air flow on the subject hoses from car SSW 87597 or on new hoses tested in multiple scenarios in an attempt to kink them. It was also observed that flow through the subject hoses was possible in nearly any configuration due to the material's tendency to form a figure eight (8) shape variance when kinked or compressed. (See figure 14) Investigators were unable to kink any hoses while pressurized to reduce the flow to 0 CFM.
