NATIONAL TRANSPORTATION SAFETY BOARD

MECHANICAL GROUP FACTUAL REPORT

CSXT Railroad, Derailment with Hazardous Materials Release and Fire

NTSB Accident Number: DCA17FR011
Date of Accident: August 02, 2017
Time of Accident: 4:54 a.m. (EDT)
Railroad Owner: CSXT
Train Operator: CSXT
Type of Train and No: Q38831 (Mixed Freight/Hazmat)
Crew Members: 1 Engineer, 1 Conductor
Location of Accident: Hyndman, PA

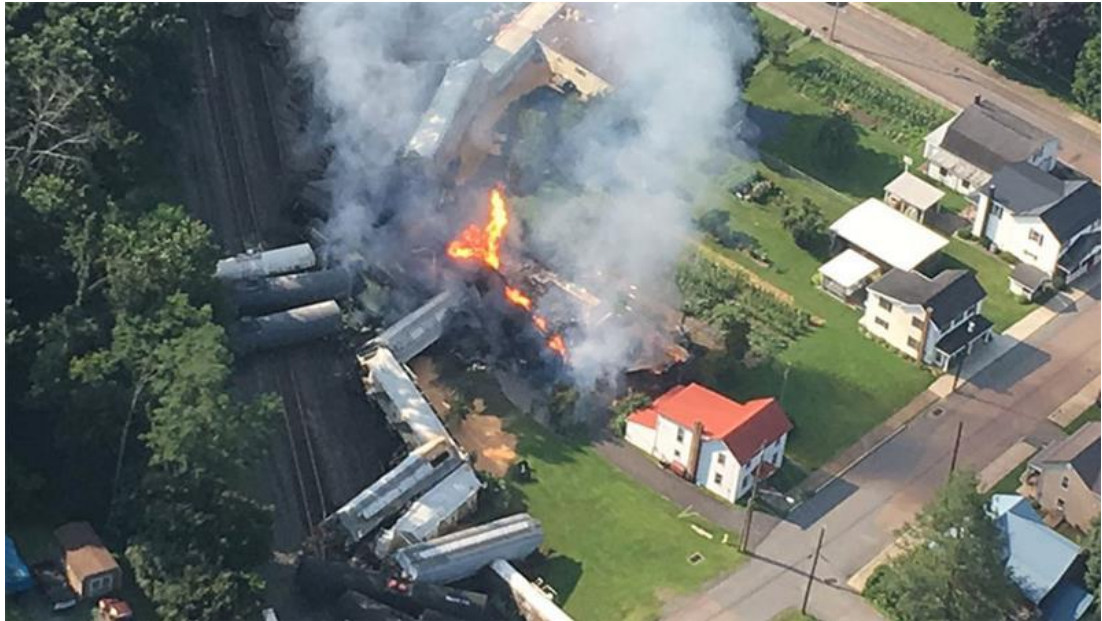
4
5 **Figure 1. Aerial view of accident location. Several houses are seen within the**
6 **photograph. Near the center are several derailed railcars and a fire with smoke**
7 **rising from the site.**

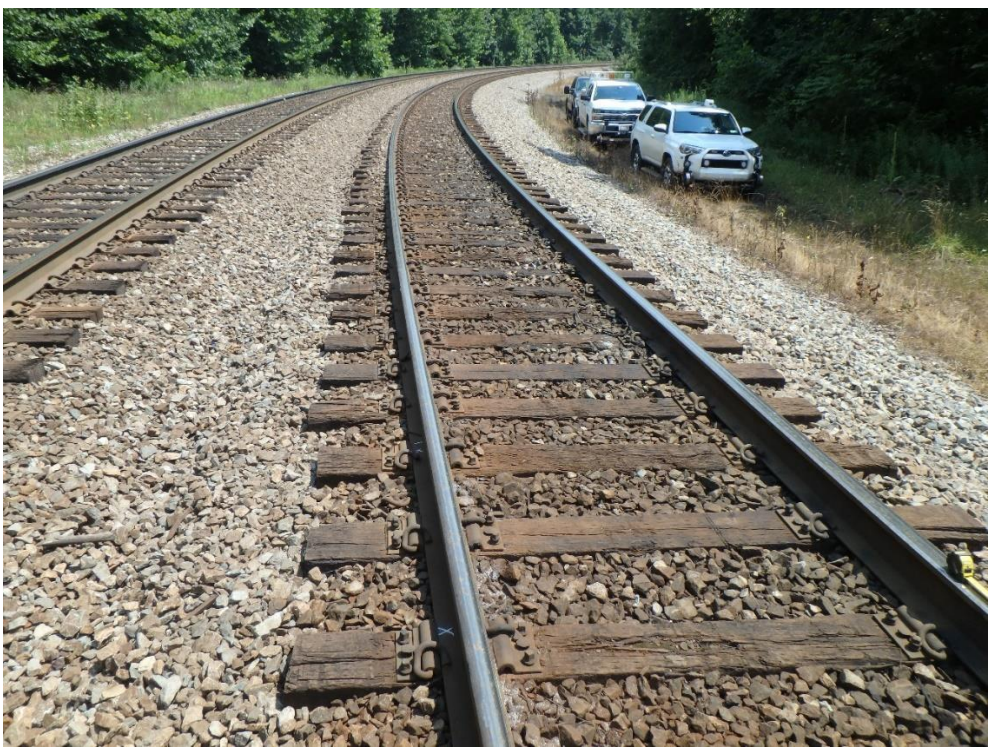
14 **Figure 2. This photograph, facing east and the direction of travel, shows two sets of tracks with the**
15 **accident track and curve on the right side of the photograph.**
