MEMORANDUM FOR RECORD

Date: November 23, 2021
Subject: Oil Sending Units and Wiring Harnesses
NTSB Case Number: CEN21FA130

On November 23, 2021, the oil sending units from the accident airplane (N13VT) along with their associated wiring harnesses were examined and tested at Velocity Inc., Sebastian, Florida.

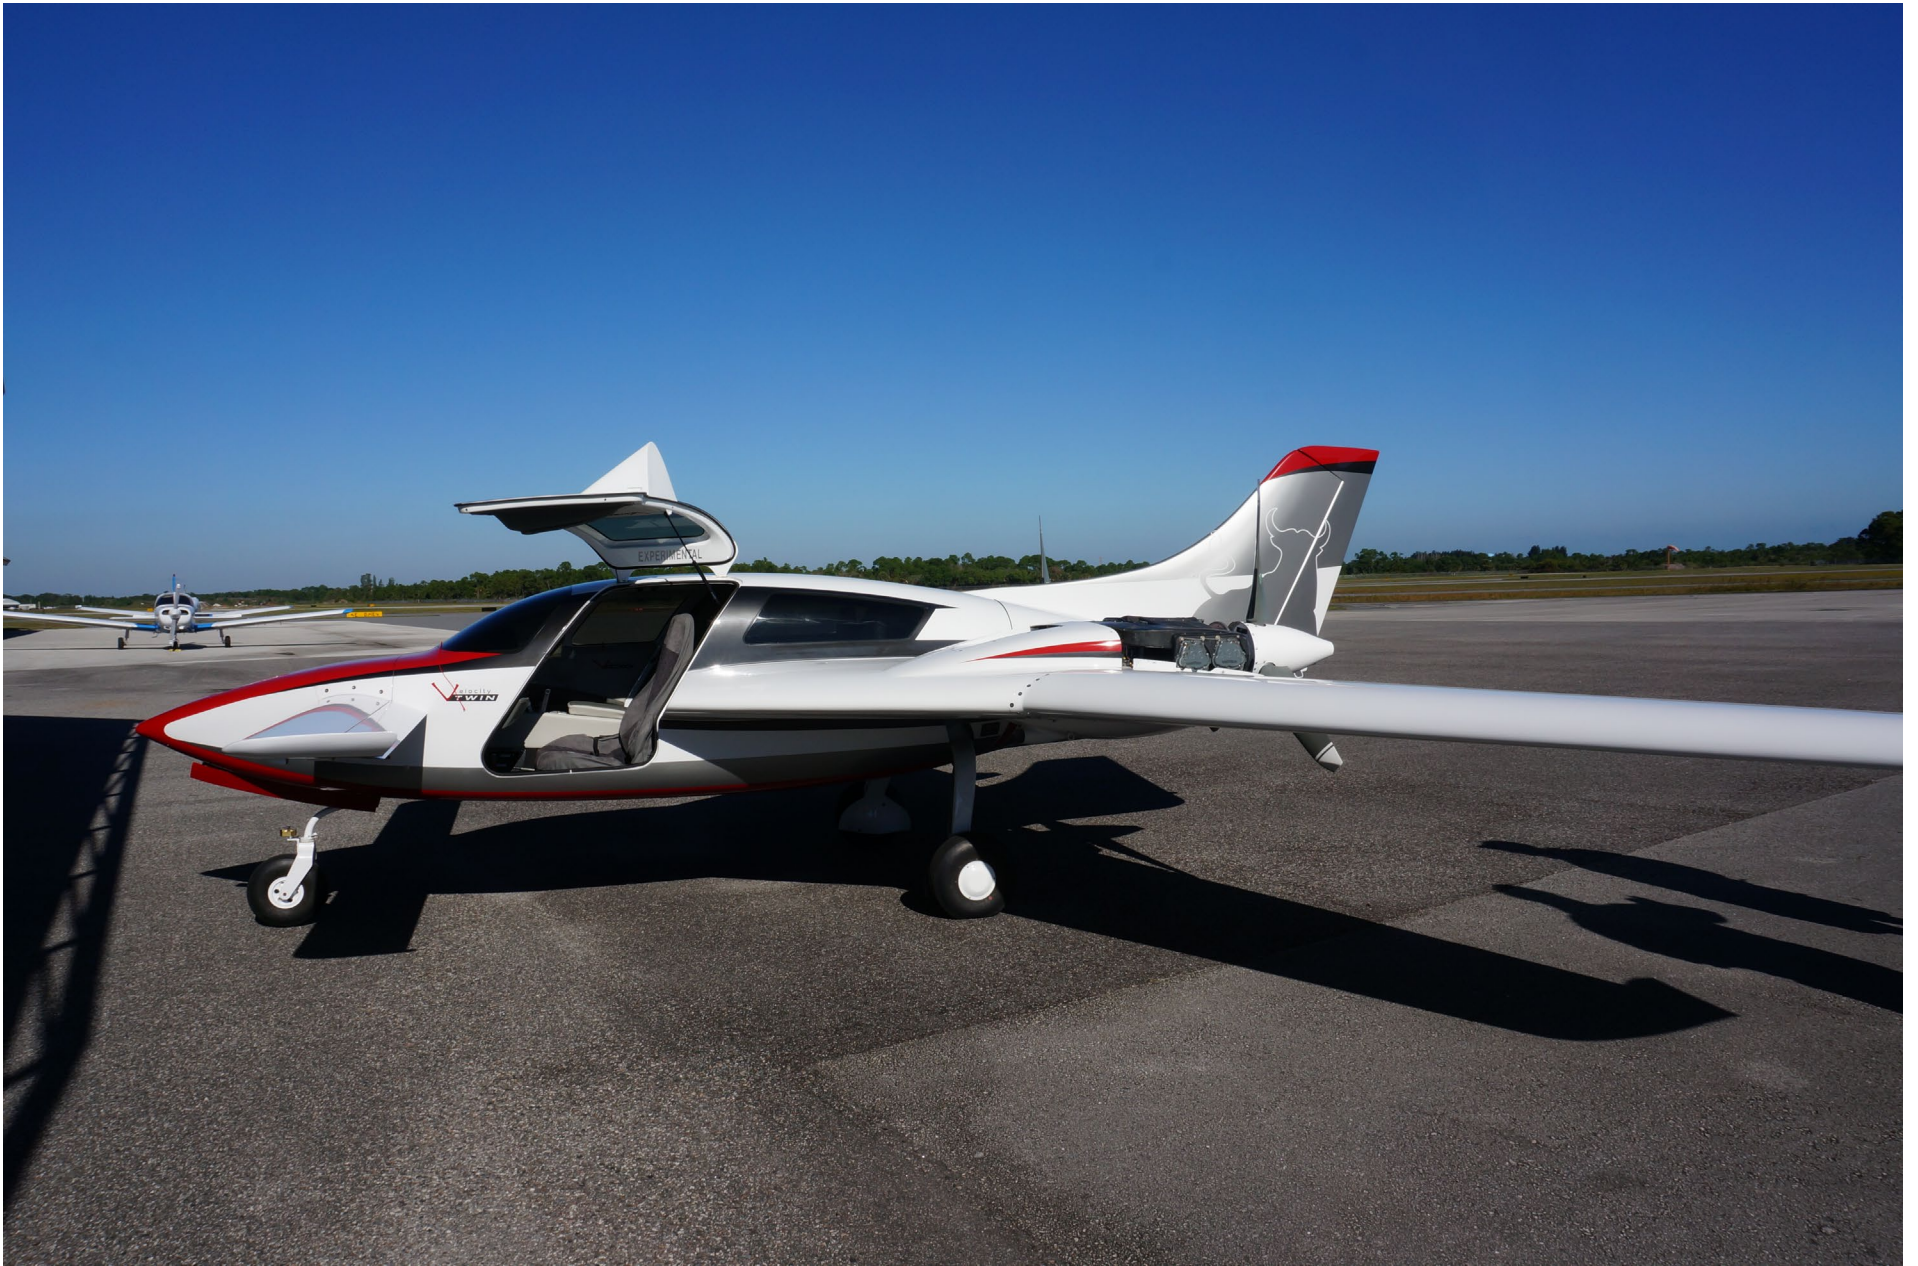
Photo 5 – Exemplar Velocity VTwin

Testing of the left and right oil pressure sensors was accomplished on an exemplar Velocity VTwin utilizing the left engine's oil system:
