NATIONAL TRANSPORTATION SAFETY BOARD

SYSTEMS AND STRUCTURES GROUP CHAIRMAN'S FACTUAL REPORT

A. ACCIDENT: WPR19MA177
LOCATION: Dillingham Airfield, Mokuleia, Hawaii
DATE: June 21, 2019, at 1822 Hawaii-Aleutian standard time
AIRCRAFT: 1967 Beechcraft 65-A90 King Air, N256TA, (LJ-256)
Operated by Oahu Parachute Center

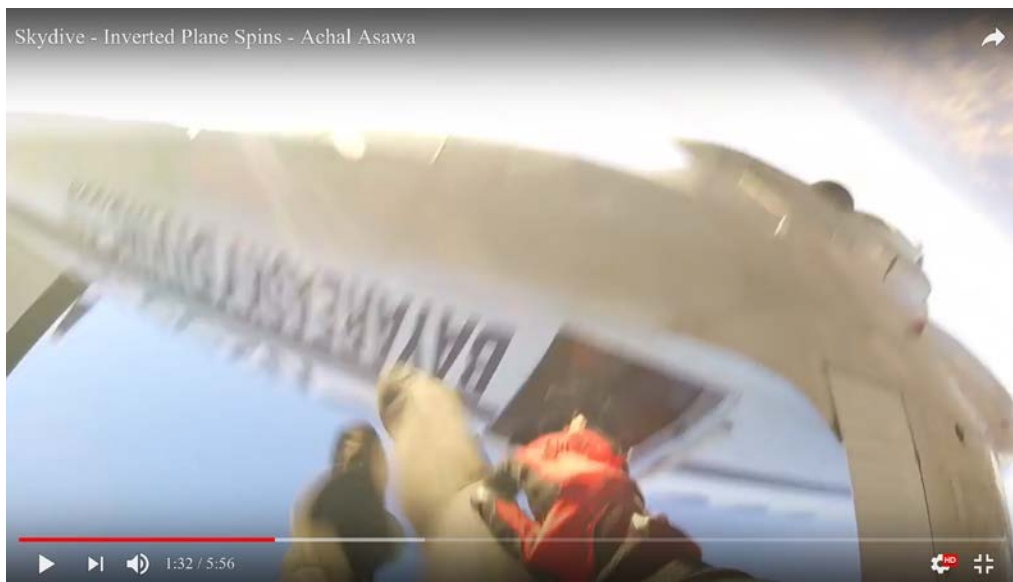
The right horizontal stabilizer and elevator separated during flight on July 23, 2016 and the event was partially recorded by one of the skydivers.¹ (See Figures 1- 3)

Figure 1. Still image from skydiver Achal Asawa 2016 video while he departed the airplane shows a lack of right horizontal stabilizer and elevator assembly.

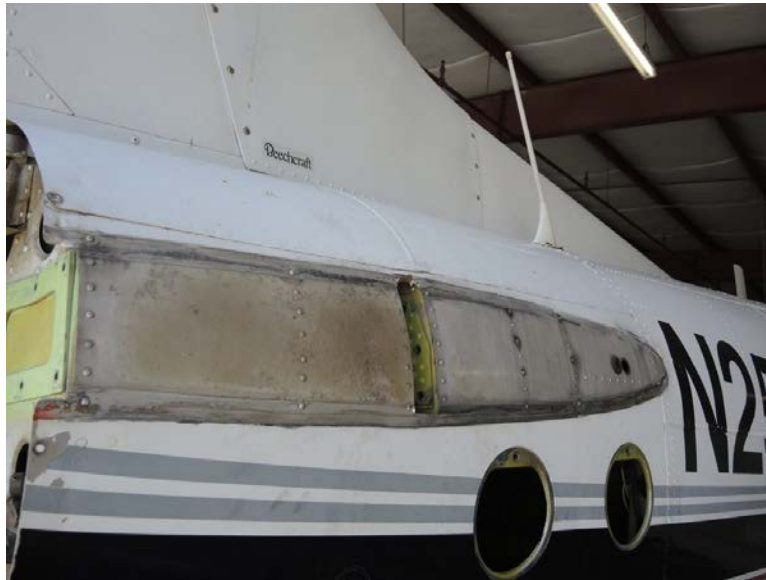
Photos were taken during the examination of the airplane after loss of the right horizontal stabilizer (HSTAB). The rear bulkhead on the right was found damaged where the horizontal stabilizer spar stub had attached. The fuselage skin and forward bulkhead also had damage. (See Figures 4 - 7)

Figure 5. The right rear fuselage with a bend in the bulkhead which the right HSTAB attached to. (Photo from: Textron Report ASI-16-CF, taken August 11, 2016)

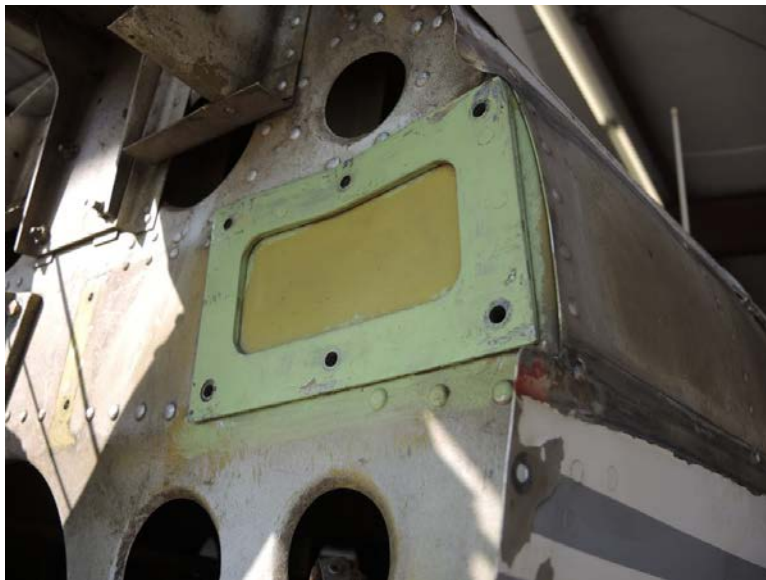
Figure 6. Closer view of the bent attachment which the right HSTAB attached to. (Photo from: Textron Report ASI-16-CF, taken August 11, 2016)

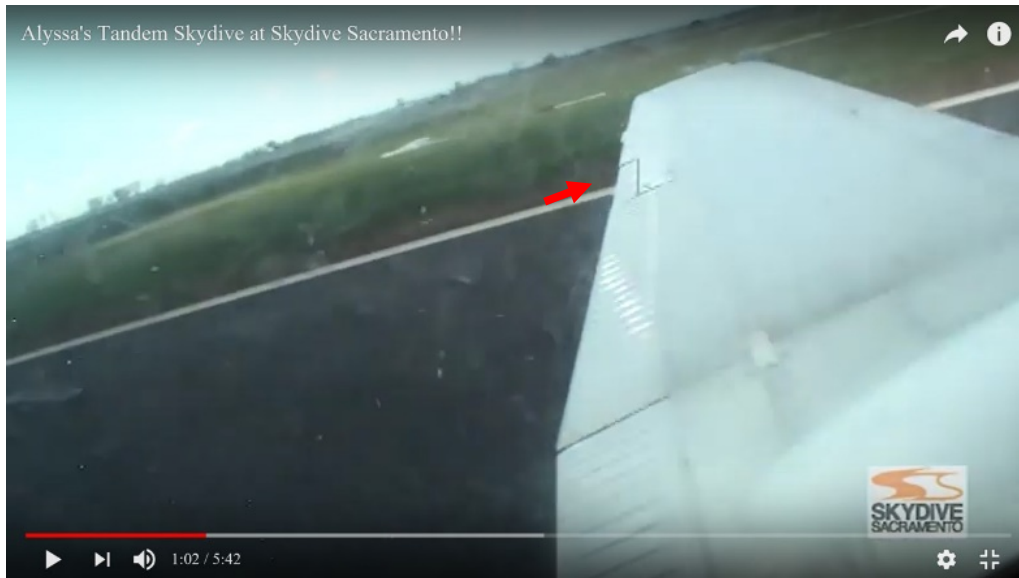
Videos and photographs of the airplane from prior to the 2016 accident were found on parachute jumping websites. The left wing appeared to be undamaged, without wrinkles and the trim tab on the left aileron was close to the faired position. (See Figures 10 and 11)

Figure 10. This 2011 photo is an example of pre-2016 accident photos that show the aileron trim tab faired to the aileron. (Still image from video posted to: www.Gurustunts.com)

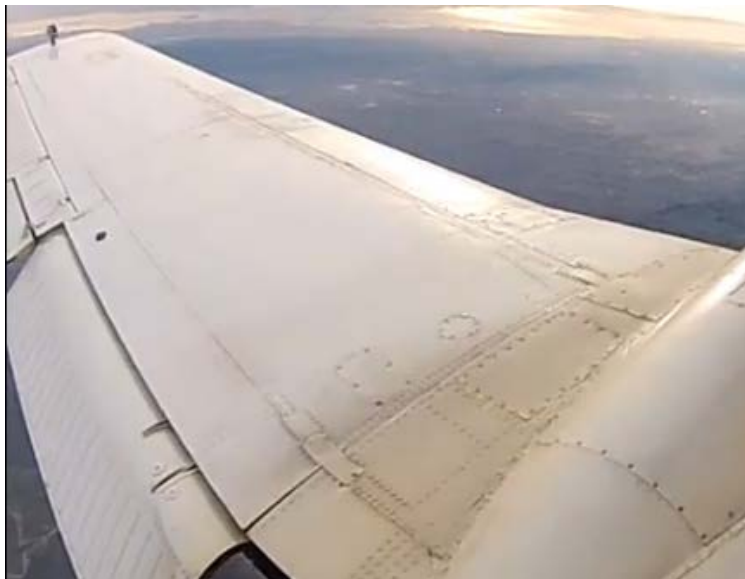
Figure 11. Pre-2016 accident photo showing lack of wrinkles and smooth transition across the outboard section of the forward wing spar. (Still image from video posted to: www.Gurustunts.com)

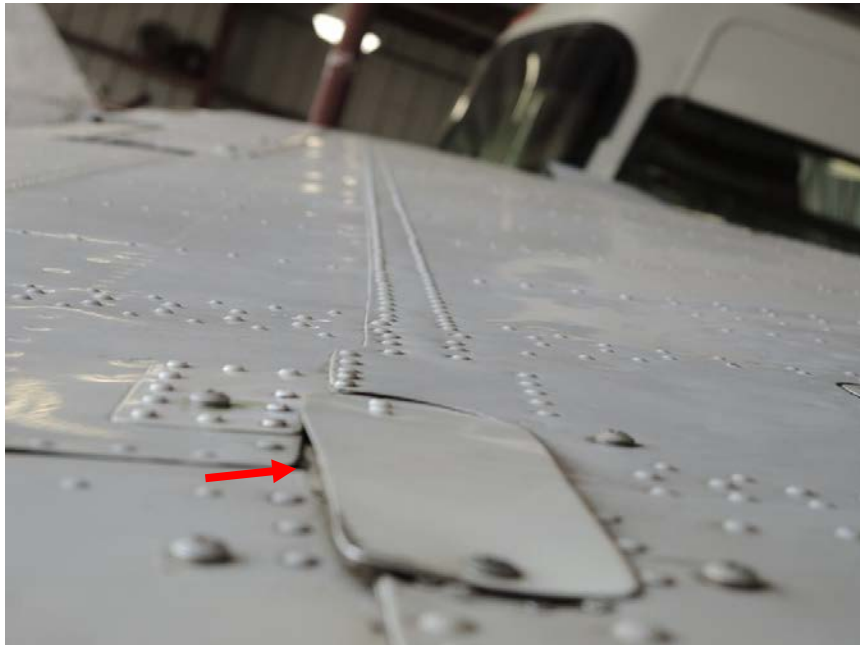
Figure 14. Compression buckle of thin aluminum fairing over rear wing attach fitting. (Photo from: Textron Report ASI-16-CF, taken August 11, 2016)

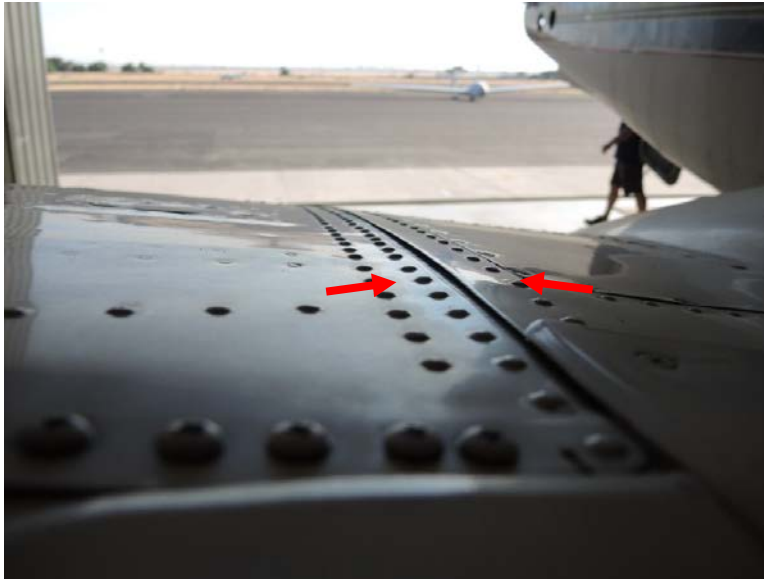
The upper wing surface of the right wing was not a single smooth continuous plane across the joint of the outboard wing panel. (See Figure 15)

Figure 15. The right wing root joint not in plane with the surface of the outer panel, immediately outboard of the right engine. (Photo from: Textron Report ASI-16-CF, taken August 11, 2016)

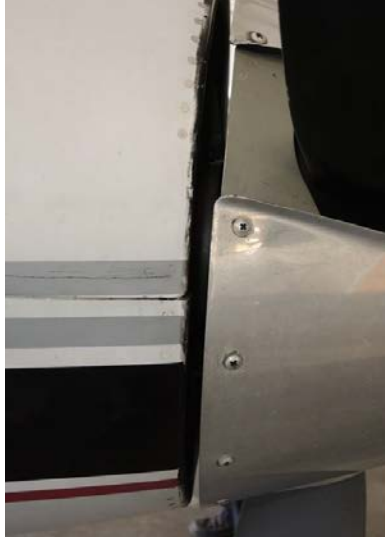
A difference existed in the gaps between the engine cowlings to the left and right propeller spinners. The gap for the left propeller was not parallel and the propeller appeared to be oriented slightly downward. (See Figures 16A and 16B)

Figure 16A. Gap between left spinner and cowl, showing edges not parallel with propeller oriented downward. (Photo from: Textron Report ASI-16-CF, taken August 11, 2016)

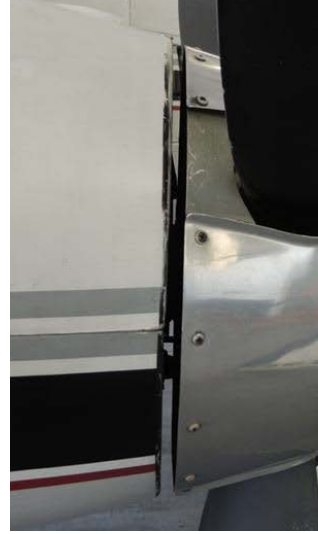
Figure 16B. Gap between right spinner and cowl, showing parallel edges. (Photo from: Textron Report ASI-16-CF, taken August 11, 2016)

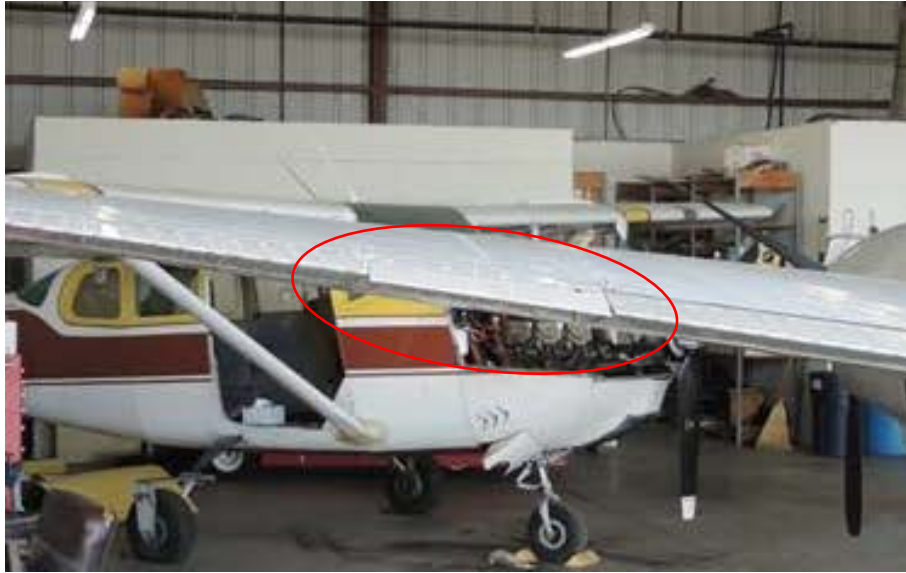
A difference existed between the photos before the 2016 accident and those taken after. The photos from immediately after the 2016 accident show the left aileron trim tab with a further downward deflection (see Figure 17 and 18) than photos taken before the horizontal stabilizer separation (see Figure 10).

Figure 17. Deflection of aileron trim tab on left wing photographed during inspection after 2016 loss of horizontal stabilizer. (Photo from: Textron Report ASI-16-CF, taken August 11, 2016)

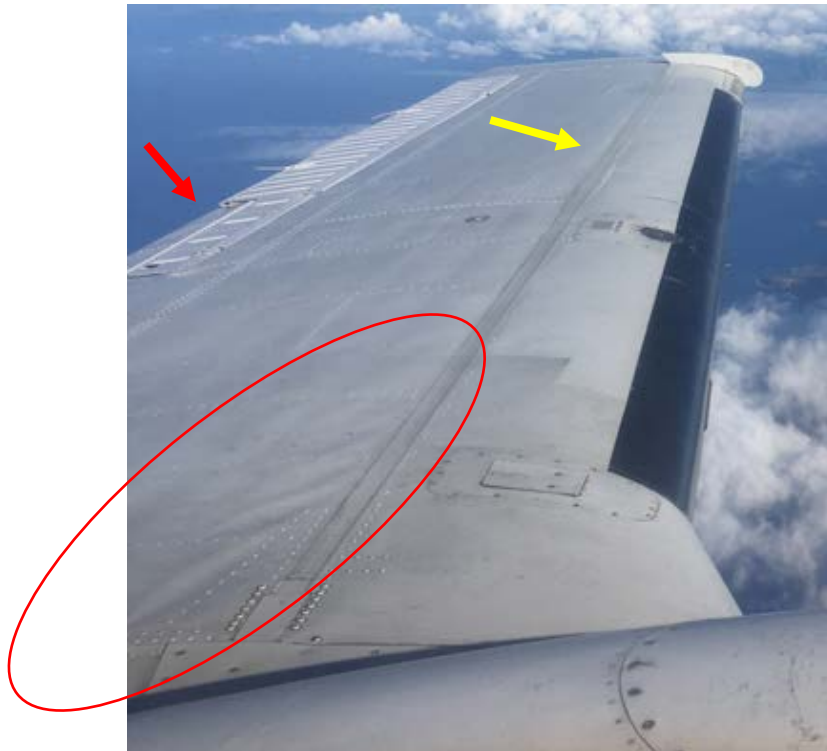
Figure 18. Inflight during 2017 delivery to Hawaii, the left/red arrow shows the trim tab deflection. The right/yellow arrow shows the non-smooth skin transition aft of the outboard section of the forward wing spar and the oval shows the wrinkled upper wing skin. (Photo from: Adam Townley Wren)

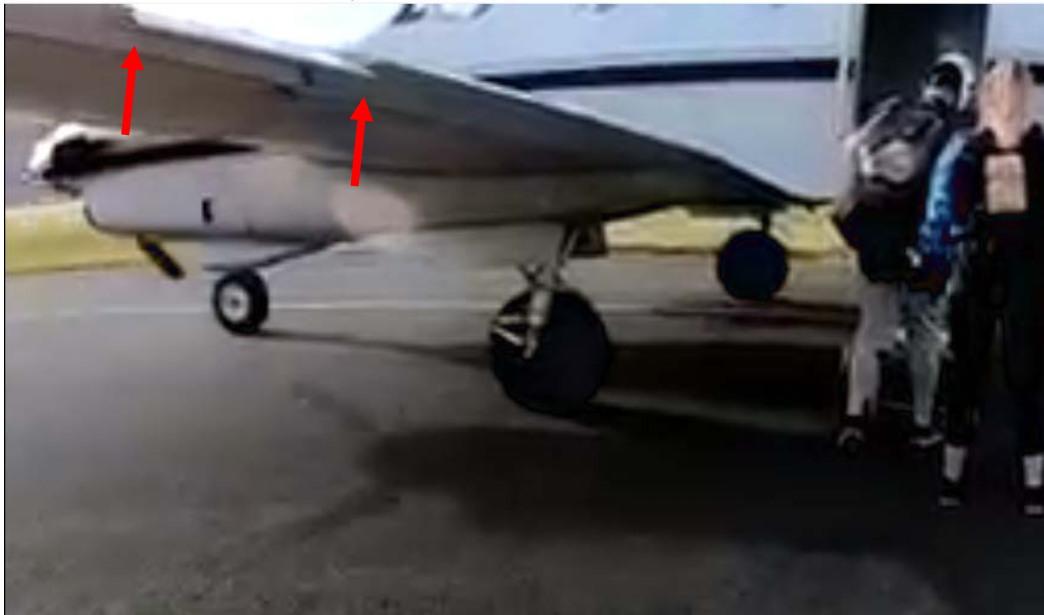
Responding to the NTSB request for images from the public, the following email transmitted a video. A still image from the video shows the deflection of the trim tab on the left aileron at a time that was reported to be just prior to the accident flight. (See Figure 19)

Figure 19. The extent of left aileron trim tab deflection is clearly visible between the arrows while loading for the flight prior to the accident. (Video from: Public)

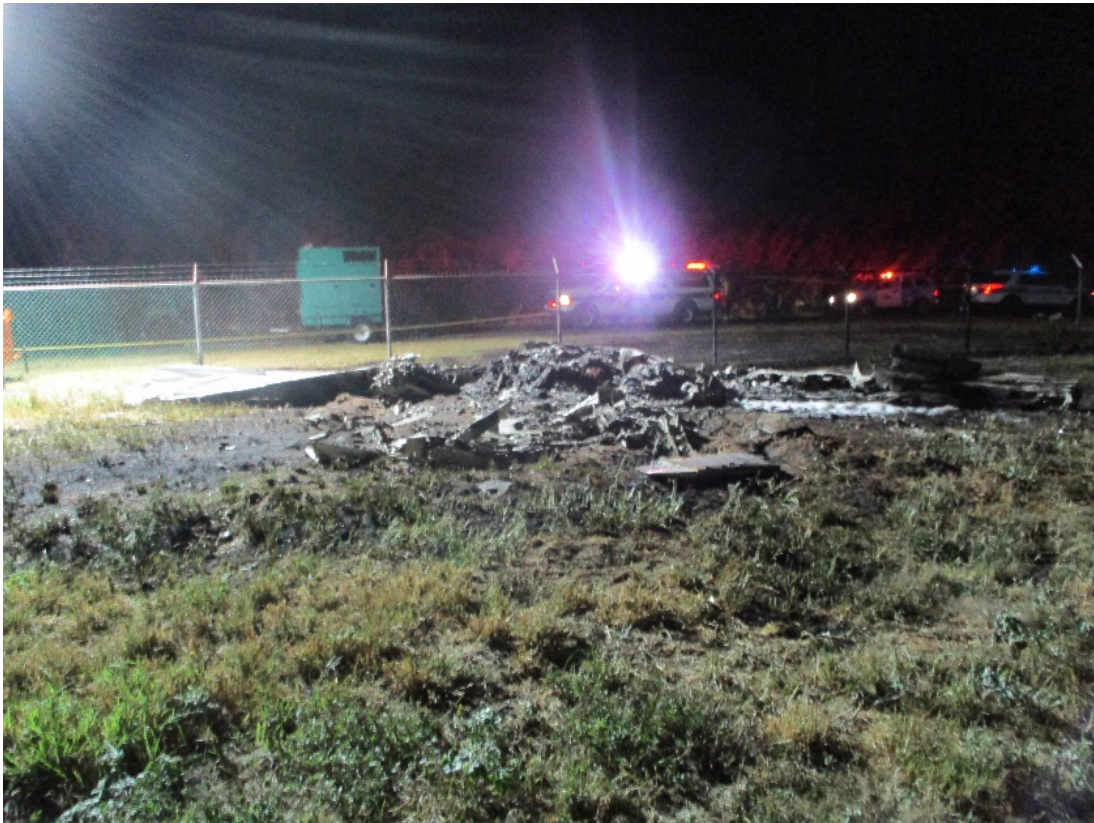
Figure 22. First known photo of accident site, taken prior to victim recovery. The orientation is roughly in the direction of travel of the airplane. Note mound of debris in the middle area which had been pulled apart and distributed by the time the daylight photos were taken later. (Photo from: FAA)

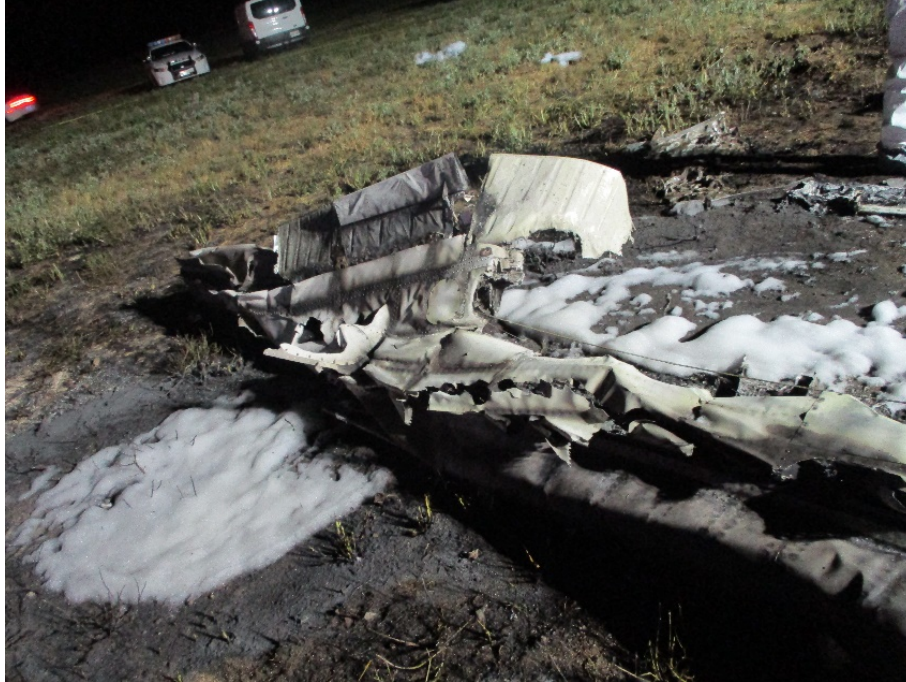
Figure 23. Left outboard wing, leading edge down. (Photo from: FAA)

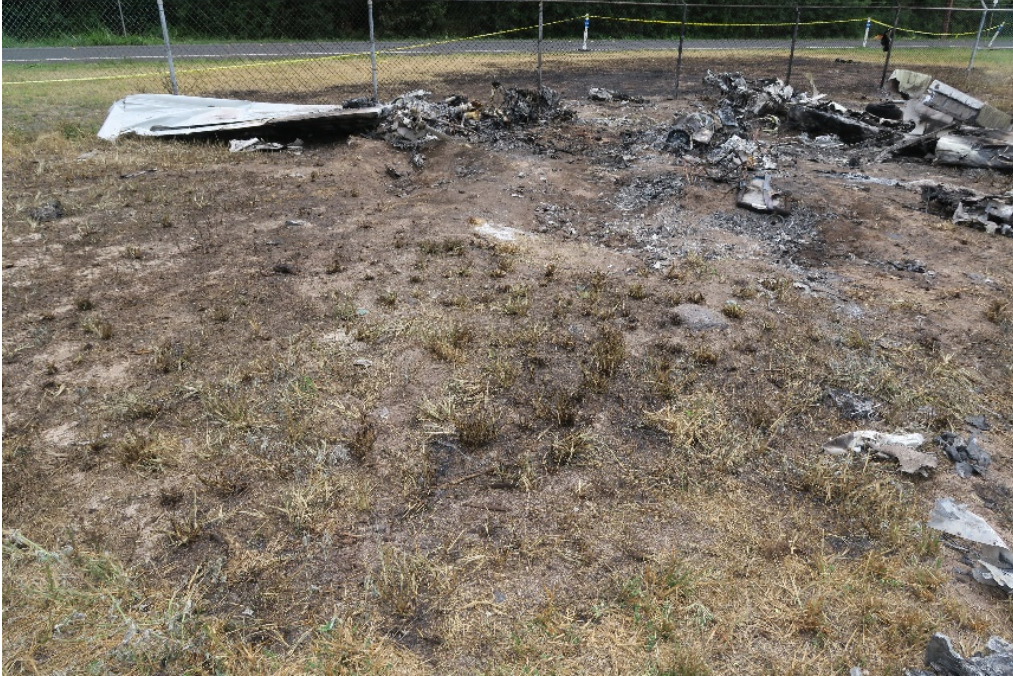
The impact was nose down on a magnetic heading of 011 degrees at GPS position of N21.5807000 and W-158.188611, where fragments of windshield were found with an initial ground cut corresponding to the top of the vertical stabilizer. The path of the general disturbance to the ground slightly pivoted around the initial contact of the left wing on the right side of the travel path. For example, although the vertical stabilizer and rudder were found in the daylight far from the fence, the ground cut of the vertical stabilizer continued in a curving path consistent with rotation around the left wing. The fence posts were spaced 10 feet apart which indicated that nearly all debris was within about 40 feet along the fence and within about 40 feet of the fence. (See Figures 24 and 25)

Figure 24. Initial daylight view of impact site in direction of travel, prior to placement of tarps on fence. Right wing is against fence in upper left of photo with the right nacelle and engine to the right of it. The left wing is at upper right, with nacelle and cockpit area closest to fence. Note mound of debris has been pulled apart for victim recovery. (Photo from: Textron)

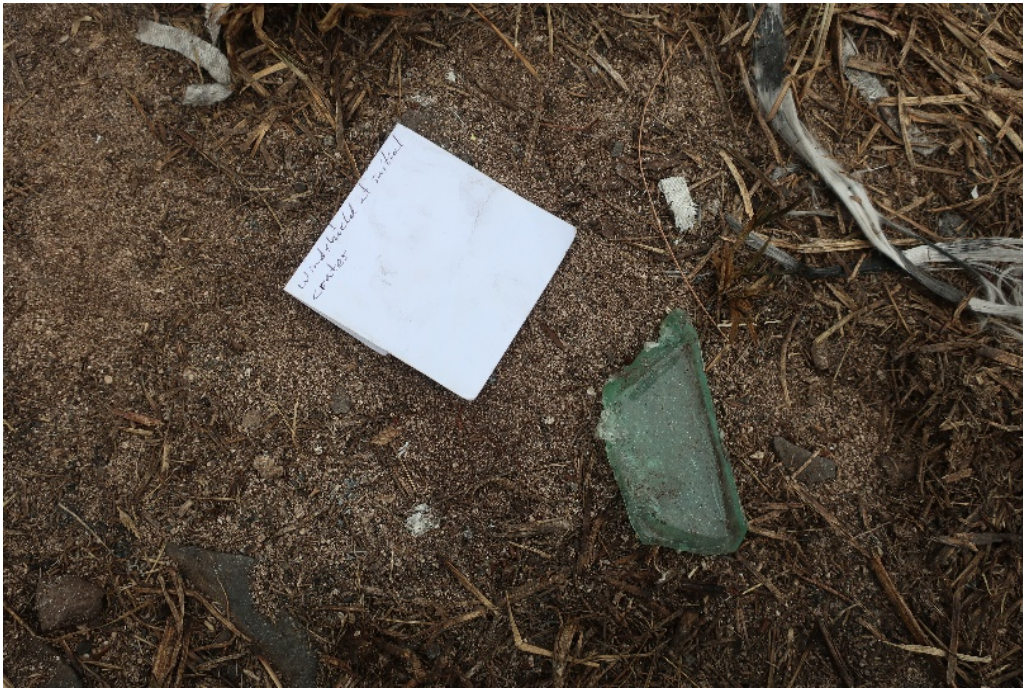
Figure 25. Windshield fragment at initial impact location. (Photo from: Swaim)

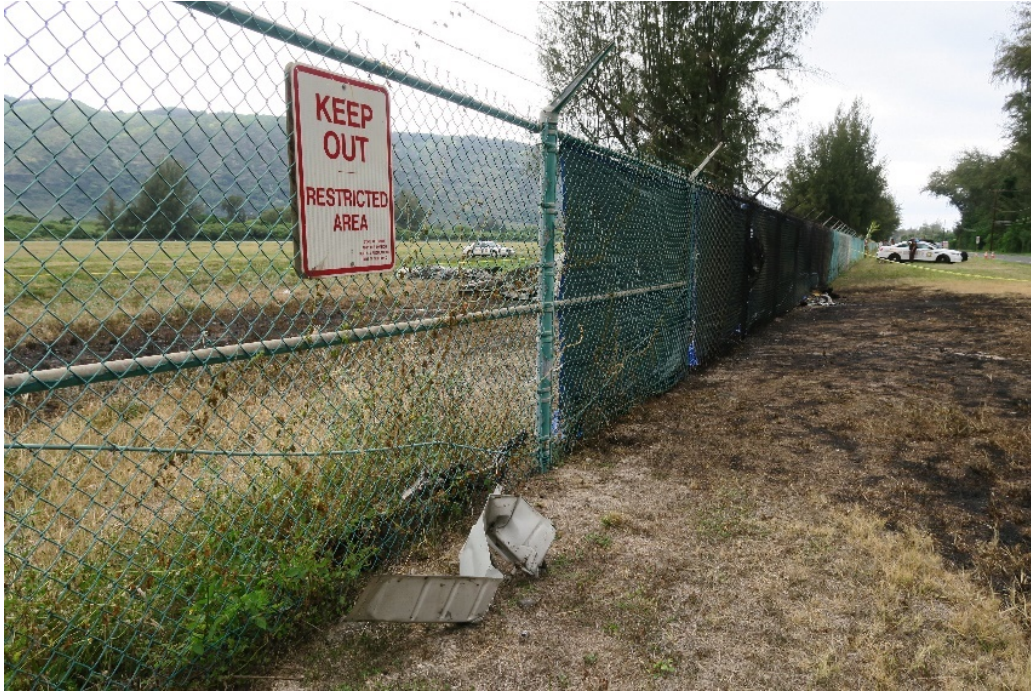
Due to the extent of how much of the airframe had been consumed by the post-crash fire and disrupted by victim recovery, only small fragments of the fuselage were identifiable. The nose landing gear and a gear door were the largest of what was found from forward of the cockpit. An unburned nose landing gear door was found with several other light fragments on the other side of the perimeter fence. (See Figure 26)

Figure 26. The unburned nose landing gear door was found on the street side of airport perimeter fence, visible beneath the KEEP OUT sign. A heat exchanger, portion of a main landing gear, and other debris is visible in background, farther away from the photographer. (Photo from: Textron)

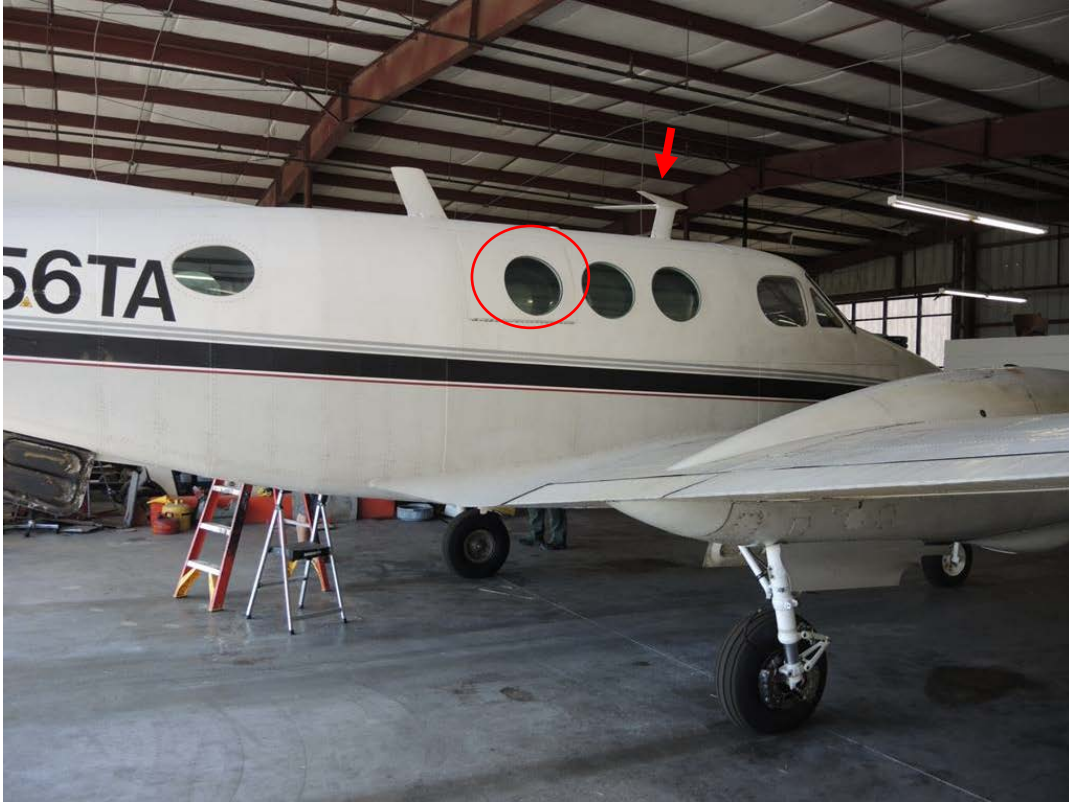
Nearly the entire fuselage was consumed by fire. One of the largest sections of fuselage was an eight-foot-long by five-foot-wide roof section from above and forward of the emergency exit.⁶ It was identified by the remaining antennas and unique frame of the exit door. This top of the cabin had been accordion folded with scrapes on the exterior surface. (See Figures 27 and 28)

Figure 27. Arrow points to antenna shown in following photo. Oval denotes emergency exit. (Photo from: Textron Report ASI-16-CF, taken August 11, 2016)

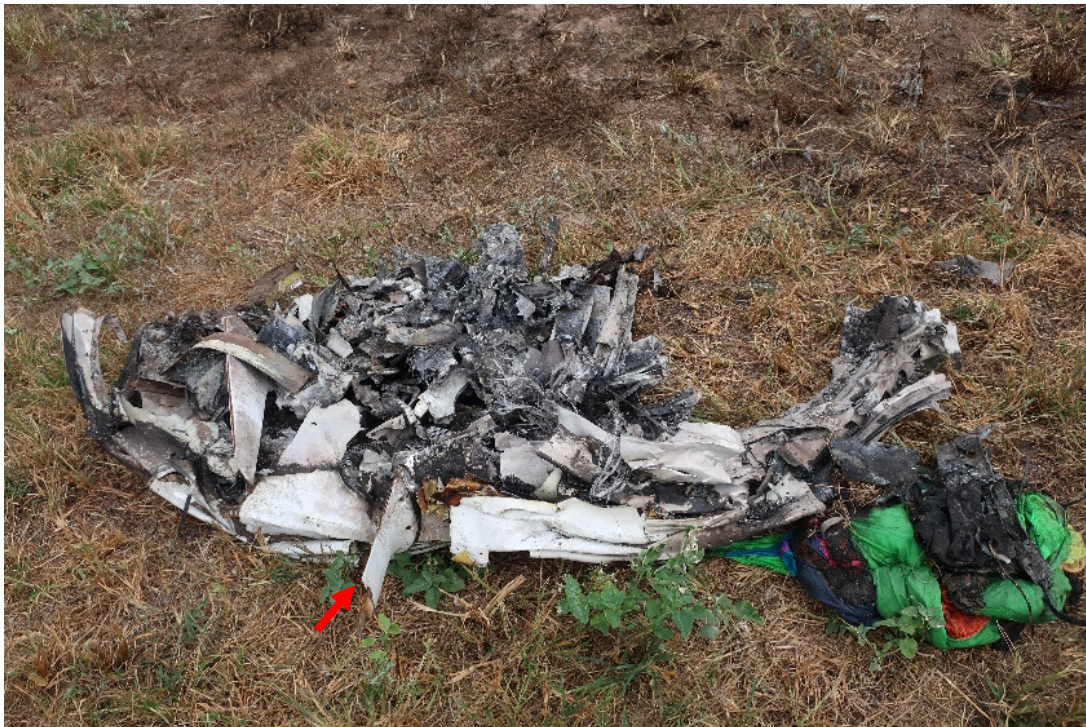
Figure 28. Arrow points to base of antenna shown in previous photo. (Green item is a parachute.)

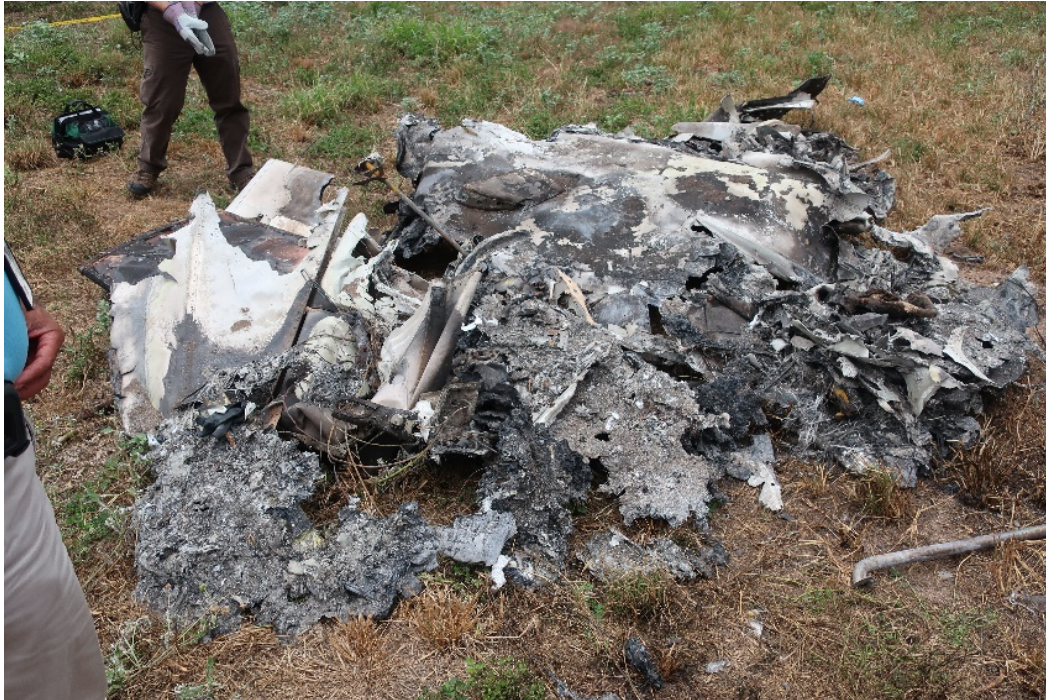
The other largest piece of fuselage was from beneath the cockpit and wing center section and was approximately five feet long by the width of the fuselage. This large fragment did not have the accordion folding found to the top of the cabin. (See Figure 29)

Figure 29. Fuselage from bottom of airplane.

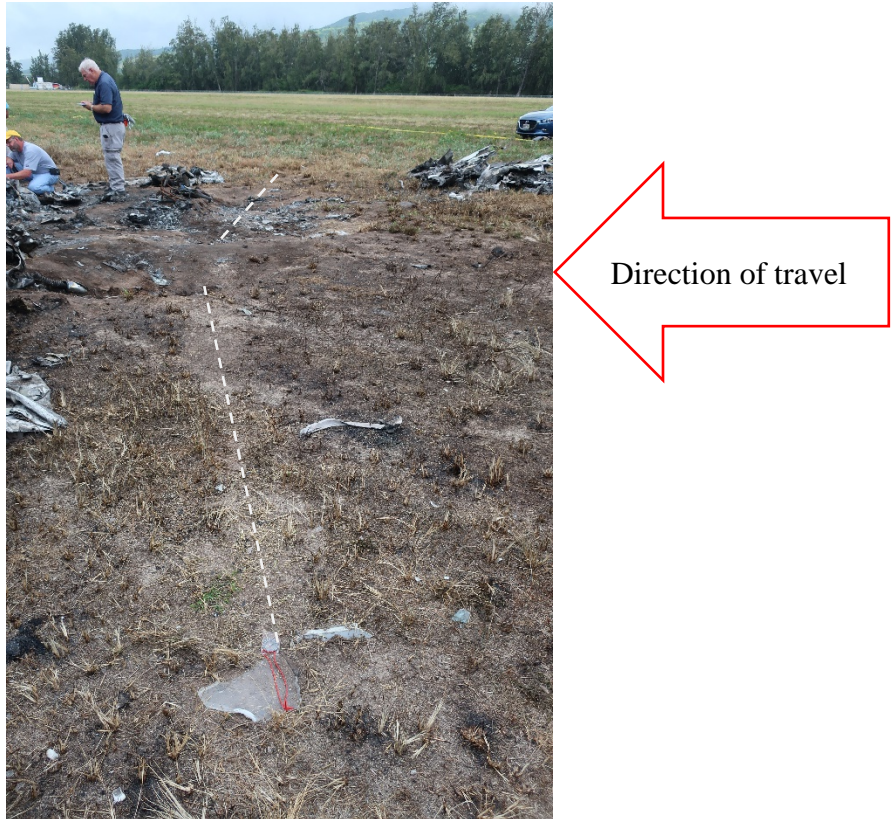
The complete span of the wings was identified in broken sections. The attachment points were found for the upper and lower forward spar fragments on both sides. The left wing tip contacted the ground before the right tip, and to the right of the path of movement. A line between wingtip impacts was measured to be 136/316 magnetic degrees. (See Figure 30)

Figure 30. The dashed lines show the ground scars of the wing leading edges as viewed from impact point of right wing tip toward the left. The center of the V created by dihedral is in the direction of movement, consistent with an inverted airplane attitude at contact. The airplane arrived from the runway, to the right of this photo, traveling toward the left. (Photo from: Swaim)

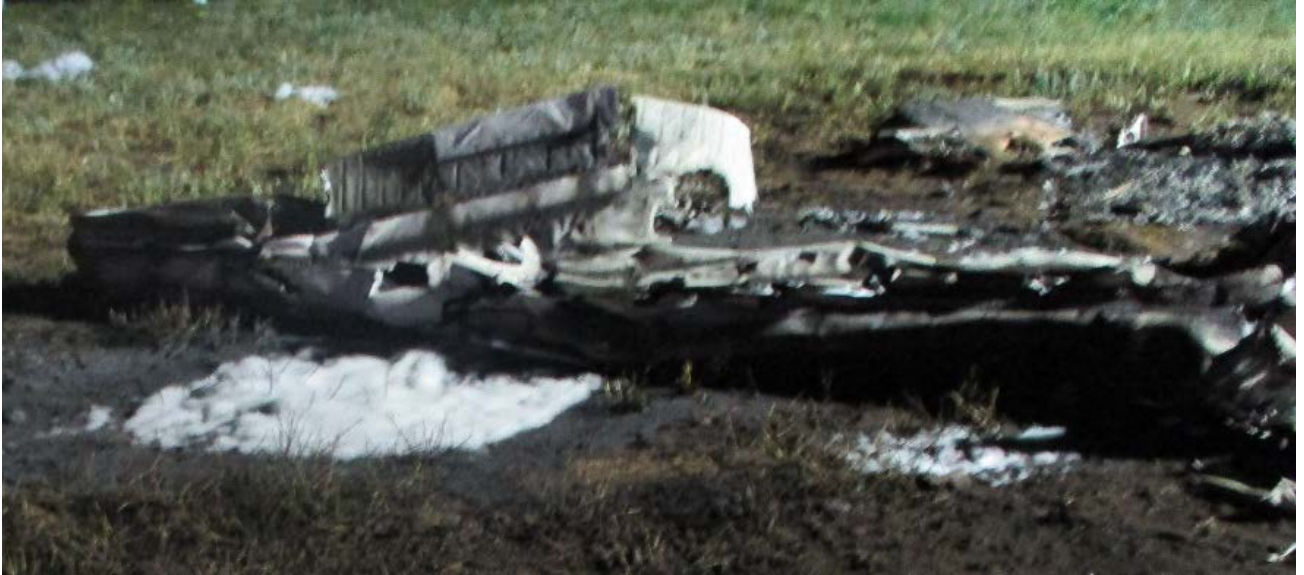
The left wing tip was away (South) from the fence with the leading edge down in initial night and subsequent daylight photos. The wing remnants outboard of the left engine pylon twisted so that the outboard end was on a diagonal with the leading edge down. The outboard portion of the wing had been extensively crushed along the chord line (fore/aft). The accordion-pleated end of the outboard wing measured 14 inches from the leading edge to rear spar. The wing outboard of the fuel tank and flap and the inboard half of the aileron were accounted for. The left wingtip was found separated in a pile of loose debris with crush and fire damage but was essentially complete. (See Figures 31 - 34)

Figure 31. Left wing in initial night photo, seen oriented with the leading edge downward prior to victim recovery. (Photo from: FAA)

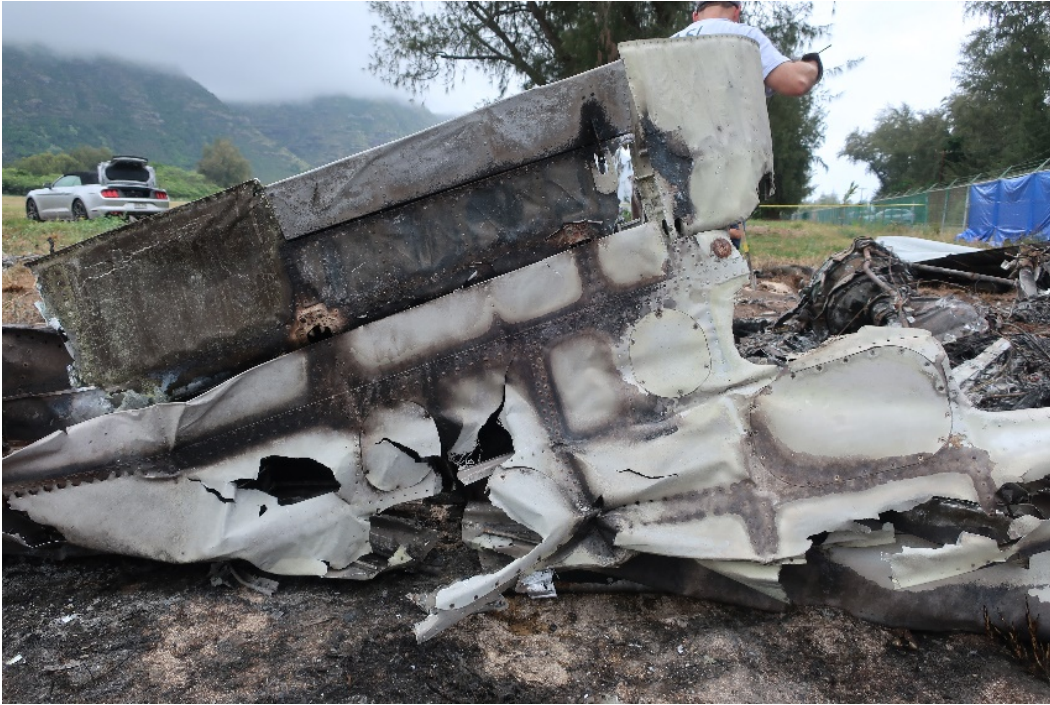
Figure 33. Bottom surface of remaining left aileron and wing. (Photo from: Swaim)

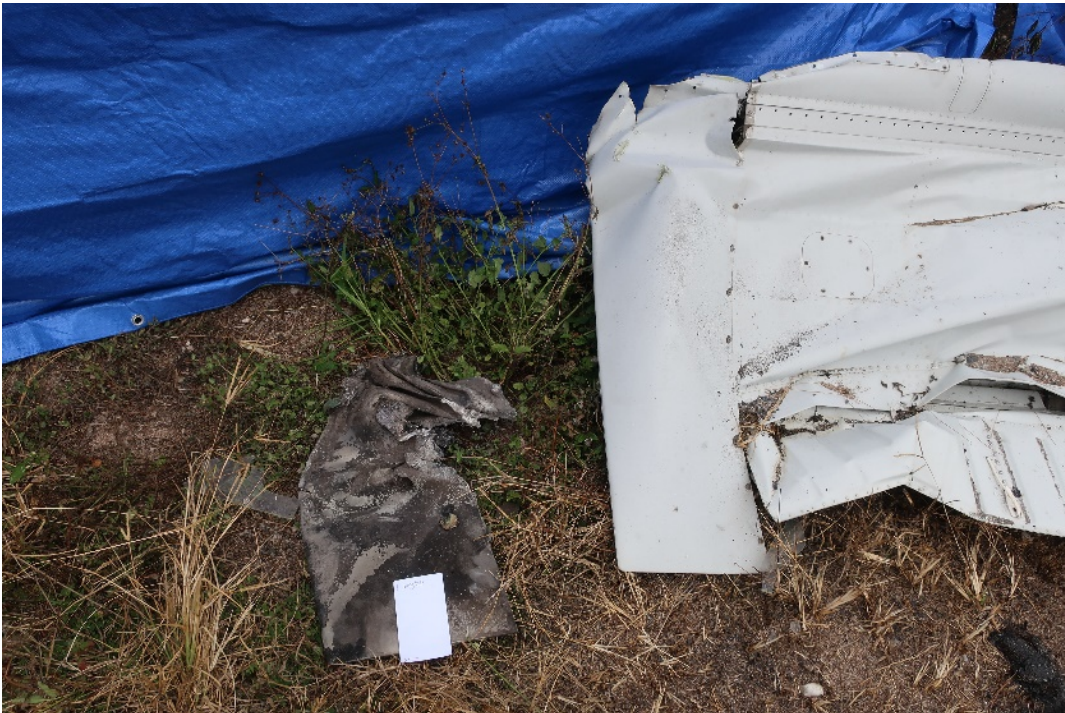
Figure 34. Burned and crushed left wing tip placed next to the tip of the right wing. (Photo from: Swaim)

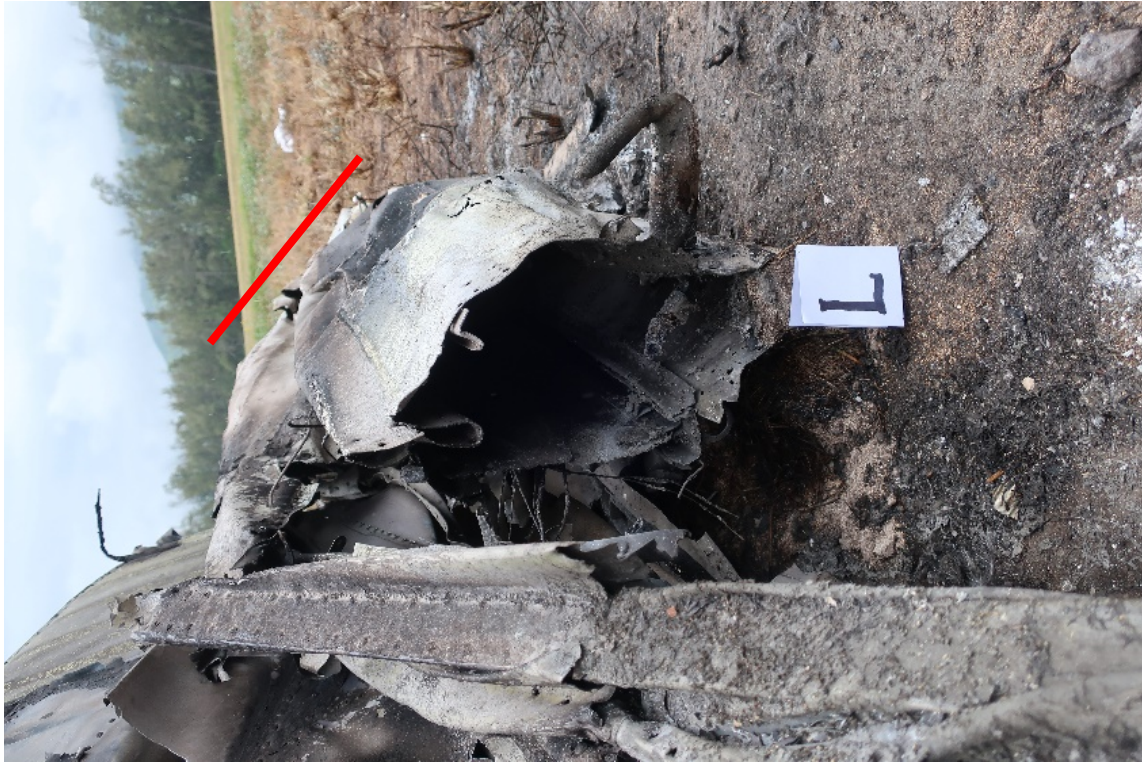
The pitot tube on the bottom of the leading edge was found intact with a slight bend toward the wing. (See Figure 35) The flattened area of left wing crush

Figure 35. Pitot tube on bottom of outboard wing leading edge. The flat surface denoted by the red line is approximately the same as the upper line in next photo. (Photo from: Swaim)

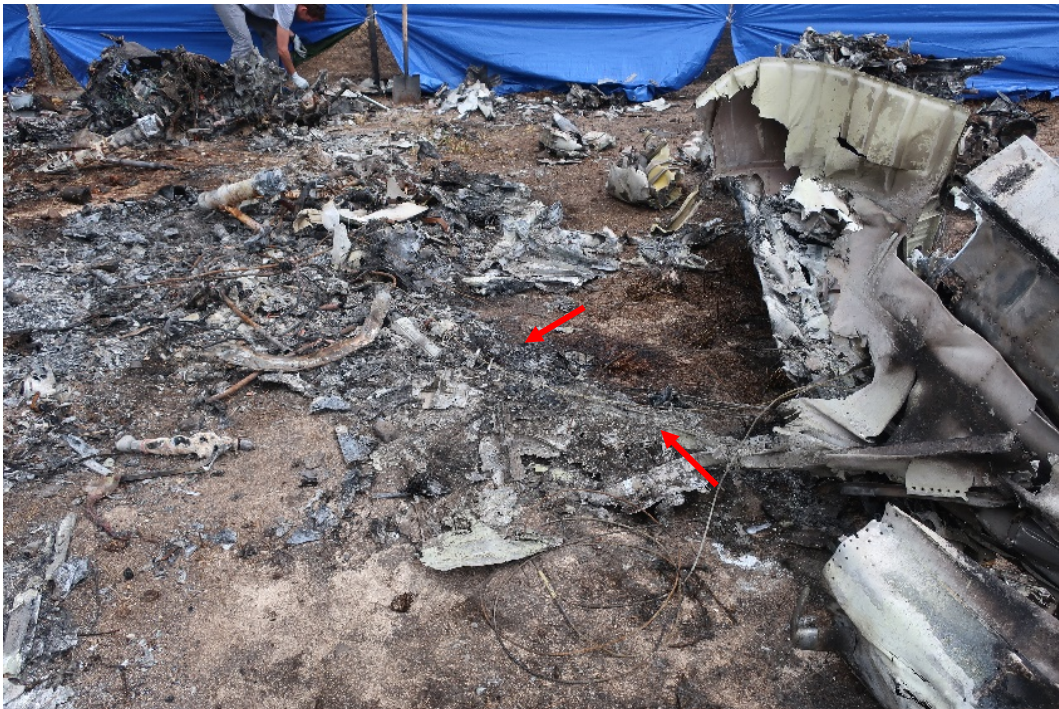
The structure between the left aileron and nacelle had been almost completely consumed by fire aft of the wing spar. Inboard of the engine pylon was more extensively fire damaged and little remained. The area of the engine pylon and outboard fuel tank had been consumed by fire, with remnants of the rear spar and surface stretched toward the location of the left engine. (See Figures 37 - 39)

Figure 38. Arrows show remnants of left wing rear spar between wing at right and nacelle at upper left, where engine was found. (Photo from: Swaim)

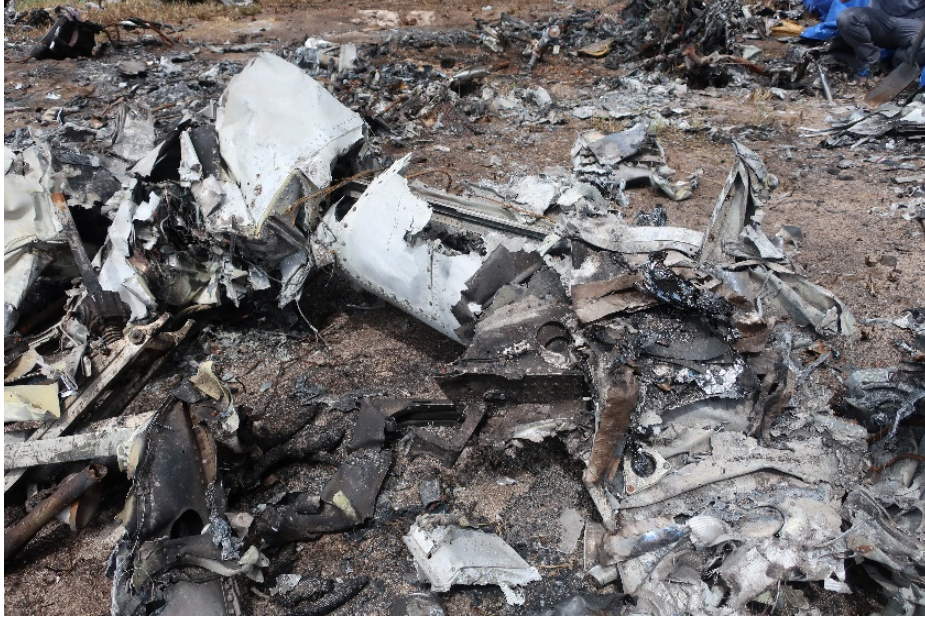
Figure 39. The remaining portion of the inboard left wing leading edge, from between the nacelle and fuselage. (Photo from: Swaim)

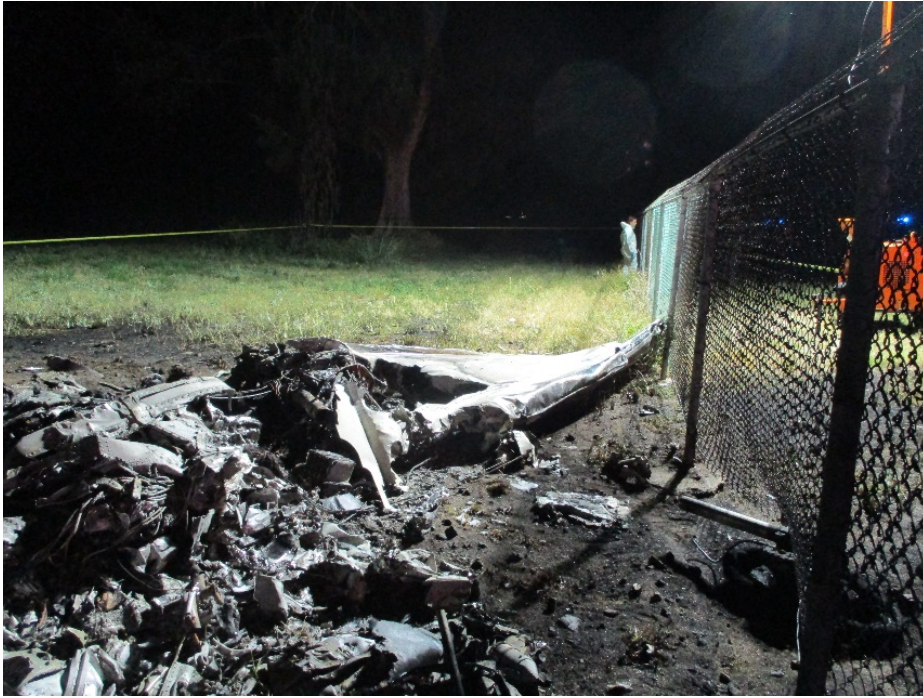
The right wing outboard of the pylon was found relatively intact on the top surface with the leading edge at the airport perimeter fence. A crush line of about 30 ° at the tip and leading edge was further along the top surface than the crush features observed on the left wing. (See Figures 40 - 42)

Figure 40. Right outboard wing laying inverted at airport perimeter fence, prior to victim recovery. At left edge of photo are the nacelle remnants. A main landing gear is partially under fence. Compare with the initial daylight photo below.
(Photo from: FAA)

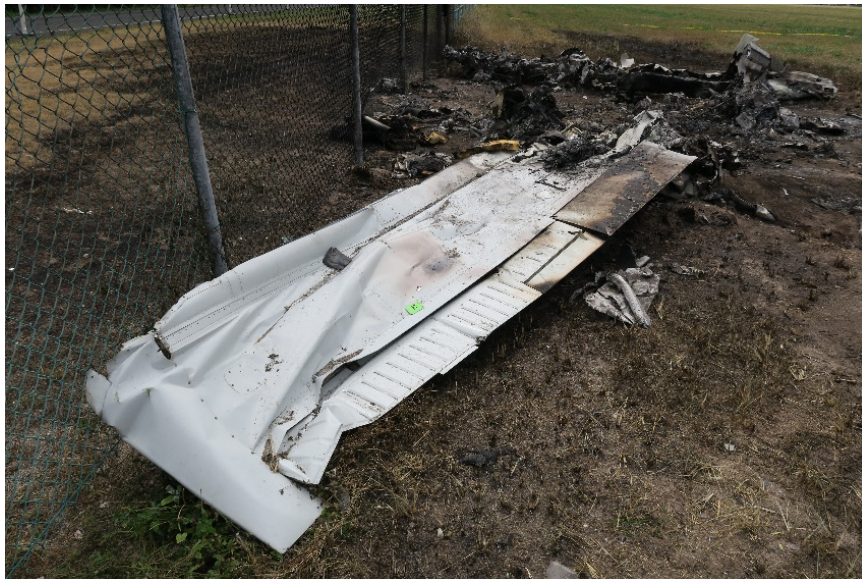
Figure 41. Right wing bottom surface prior to erecting tarps on the fence. Note the complete aileron, servo tab, and outboard flap. (Photo from: Textron)

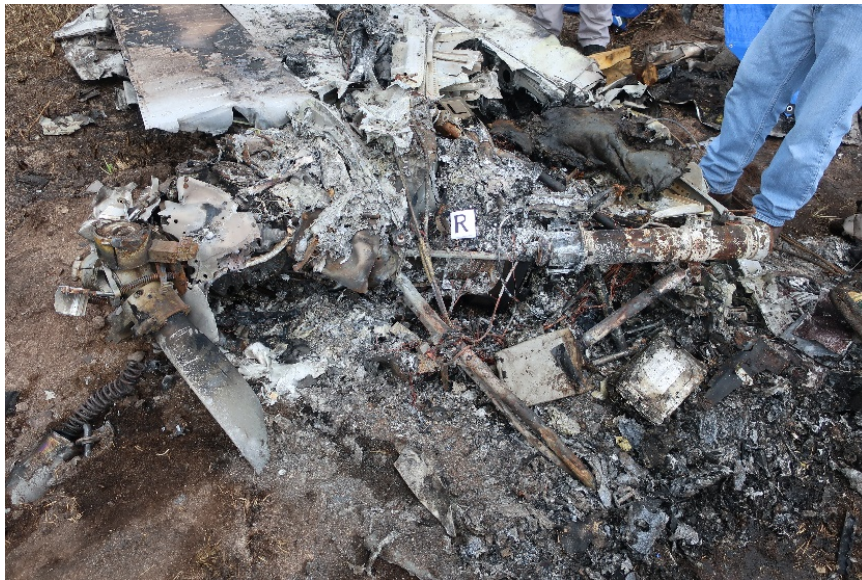
The inboard end of the outboard right wing panel remained loosely next to the nacelle, with much of the material consumed by fire. (See Figure 43) The wing panel was moved away from the nacelle to flip the wing over and further examine components in each. (See Figures 44 - 46)

Figure 43. Right nacelle with outboard wing panel beyond. The main landing gear strut cylinder is the horizontal tube extending from the “R” to the person’s foot. The inner portion of the landing gear strut with the tire was partially beneath the airport perimeter fence. (Photo from: Swaim)
