NATIONAL TRANSPORTATION SAFETY BOARD

SYSTEMS AND STRUCTURES GROUP CHAIRMAN'S FACTUAL REPORT

A. ACCIDENT: WPR19MA177
LOCATION: Dillingham Airfield, Mokuleia, Hawaii
DATE: June 21, 2019, at 1822 Hawaii-Aleutian standard time
AIRCRAFT: 1967 Beechcraft 65-A90 King Air, N256TA, (LJ-256)
Operated by Oahu Parachute Center

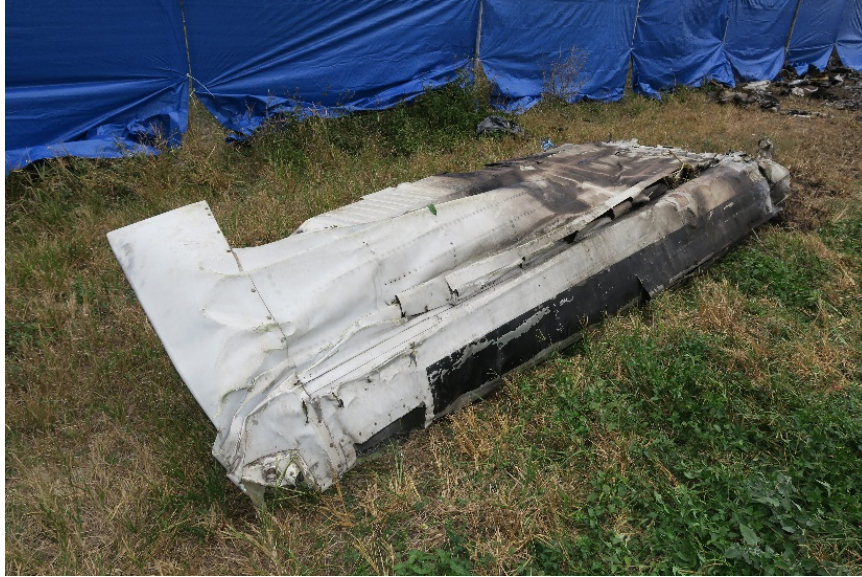
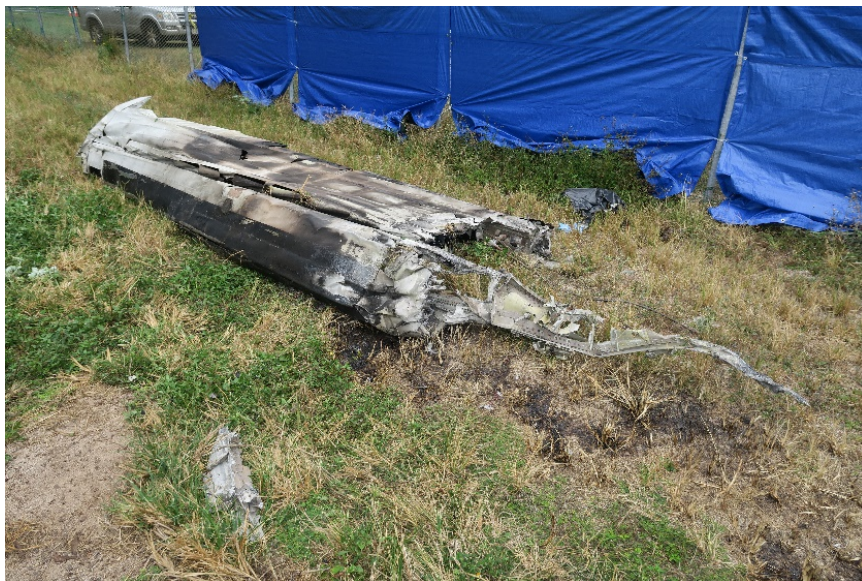
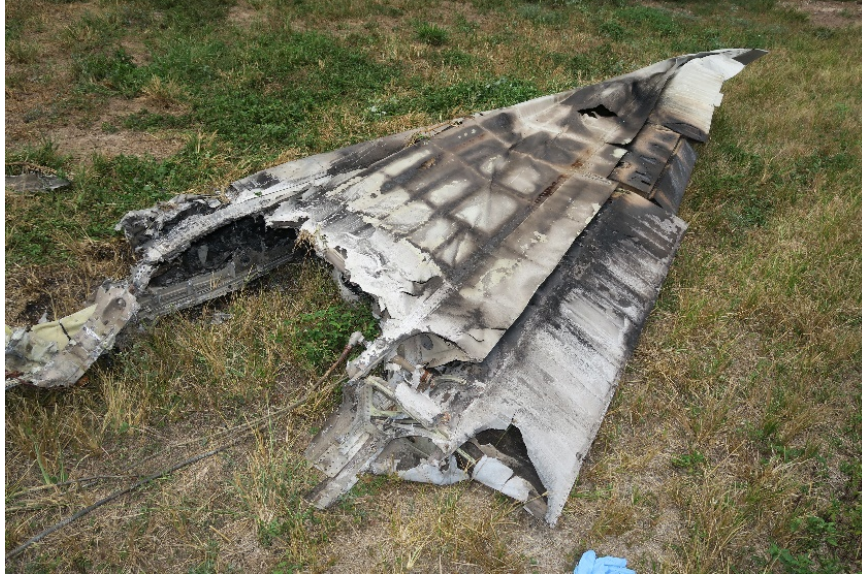
The inboard end of the outboard right wing panel remained loosely next to the nacelle, with much of the material consumed by fire. (See Figure 43) The wing panel was moved away from the nacelle to flip the wing over and further examine components in each. (See Figures 44 - 46)

Figure 44. Right wing top surface. (Photo from: Textron)

Figure 45. Right wing top surface. (Photo from: Textron)

Figure 46. Right wing top surface. (Photo from: Textron)

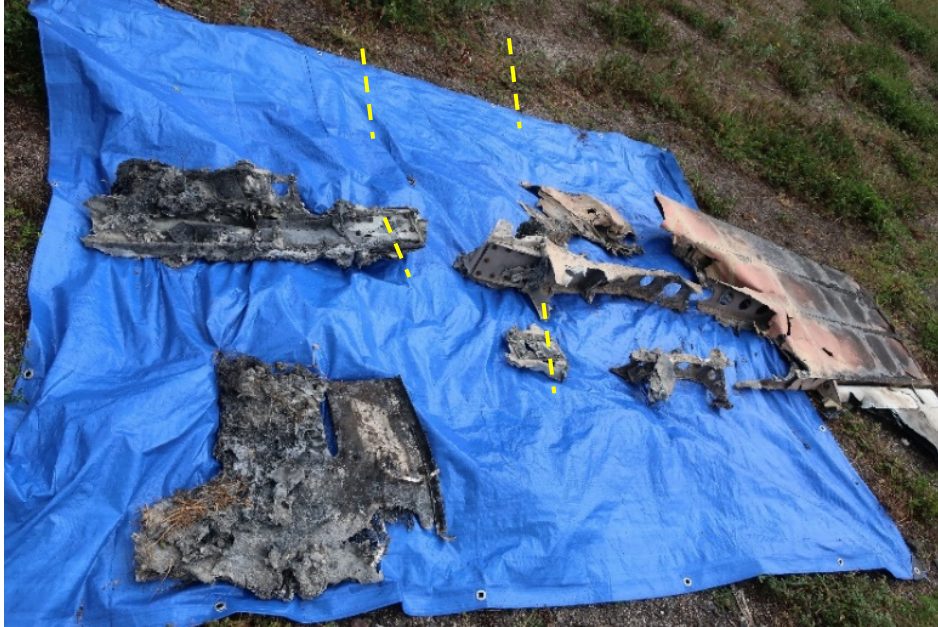
Portions of both horizontal stabilizers and elevators were found at the site of the accident. The left horizontal stabilizer had been folded upward about mid-span.⁷ The left side was extensively more consumed by fire than the right had been. The outboard right elevator remained with the horizontal stabilizer and most of the inboard right elevator had been consumed by fire. An extensively burned and relatively small section of material which resembled the inboard portion of an elevator was found. Because a right elevator remnant already had a portion which was similar, elimination was used to place the burned fragment on the left side of the reconstruction. (See Figures 47 and 48)

Figure 47. Partial reconstruction of horizontal stabilizers and elevators, with left toward the left and right toward the right. The yellow lines denote the relative sides of the fuselage. The aft left spar stub fragment (Figure 50) is not in this photo. (Photo from: Swaim)

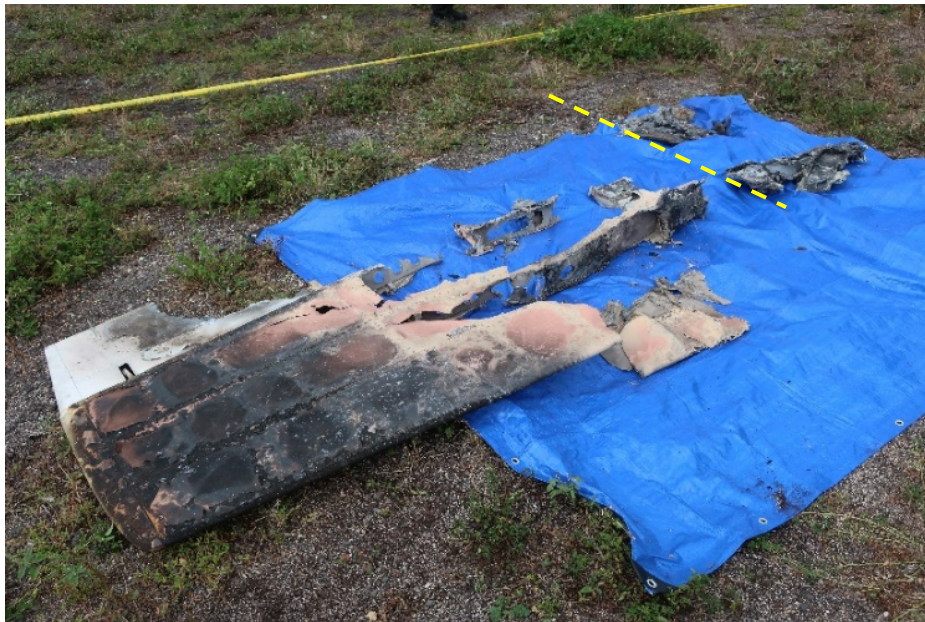
Figure 48. Partial reconstruction as seen from the front right. The yellow line denotes the centerline of the tail of the fuselage. The aft left spar stub fragment (Figure 50) is not in this photo. (Photo from: Swaim)

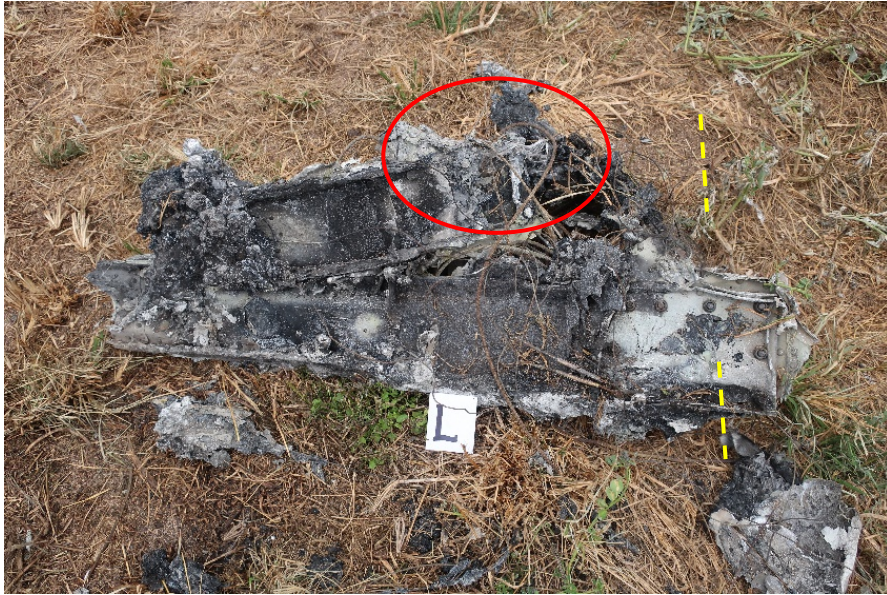
The horizontal stabilizers had been attached to the rear two bulkheads in the tail cone of the fuselage. Remnants for three of the four attachment points extended from inside the fuselage into the remnants of the horizontal stabilizers. Both the left front and left rear horizontal stabilizer spar fragments

remained bolted to fragments of their respective fuselage bulkheads, as did the forward right horizontal spar fragment. (See Figures 49 - 51)

Figure 49. Left horizontal stabilizer bent in half with the oval denoting the forward spar stub bolted to a remnant of the aft fuselage bulkhead. The yellow lines denote the side of the aft fuselage, showing small amounts of the bulkhead remaining attached to the spar stub. (Photo from: Swaim)

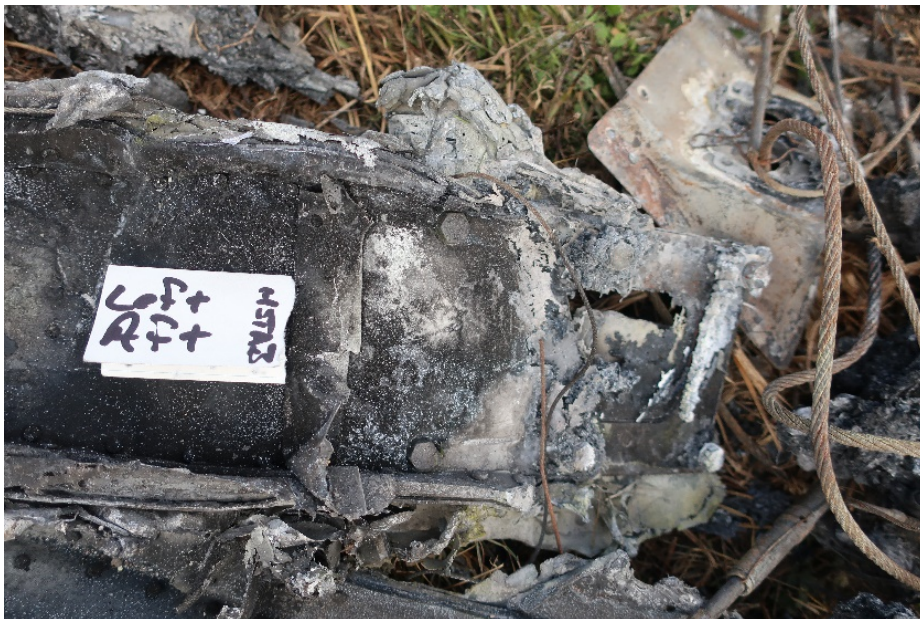
Figure 50. Left horizontal stabilizer aft spar stub remnant bolts which remained attached to a fragment of the bulkhead. (Photo from: Swaim)

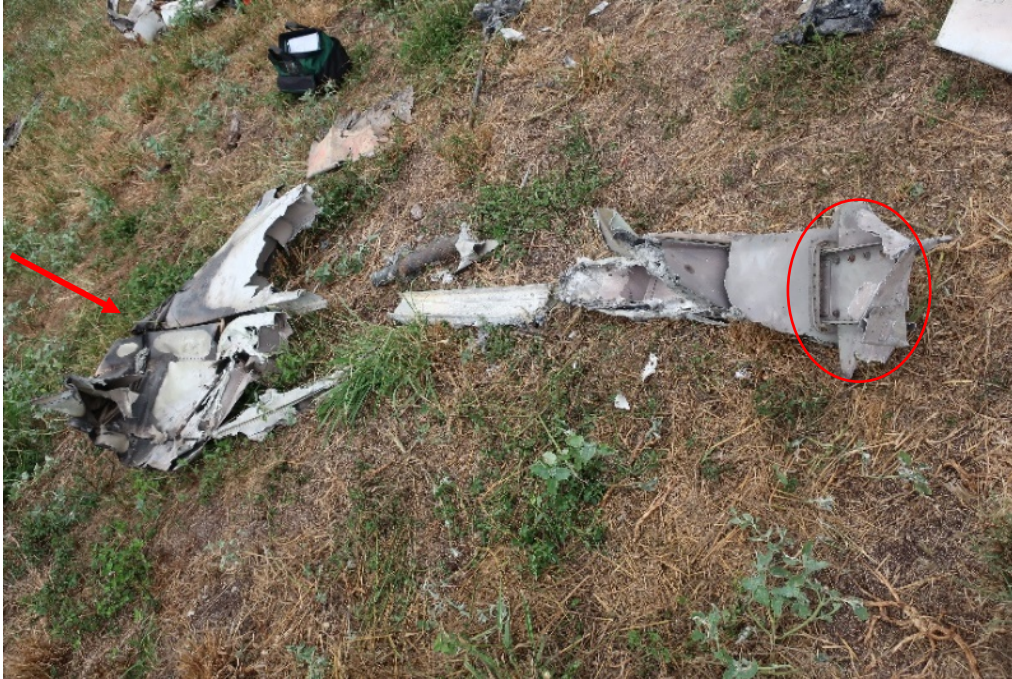
Portions of the vertical stabilizer and rudder from the fuselage bulkhead to the cap of each were found in small fragments. The top of the stabilizer and rudder were crushed together and broken to the side. (See Figures 53 and 54)

Figure 53. Fragments of the rear spar from the fuselage bulkhead (oval) to the caps of the vertical stabilizer and rudder (arrow).

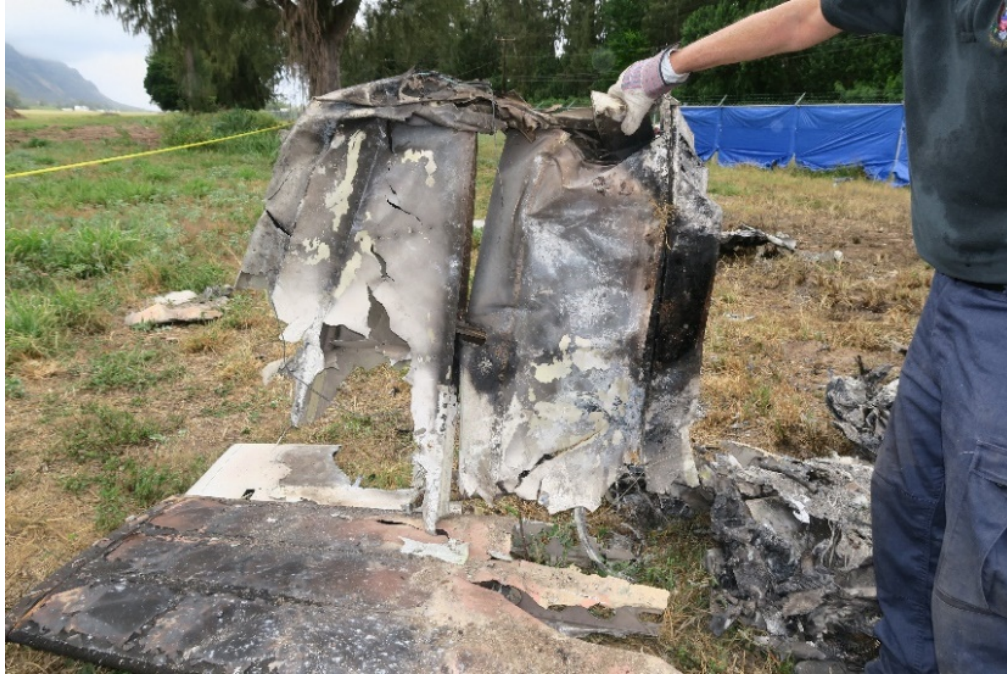
Figure 54. Tops of rudder and vertical stabilizer. (Photo from: Textron)

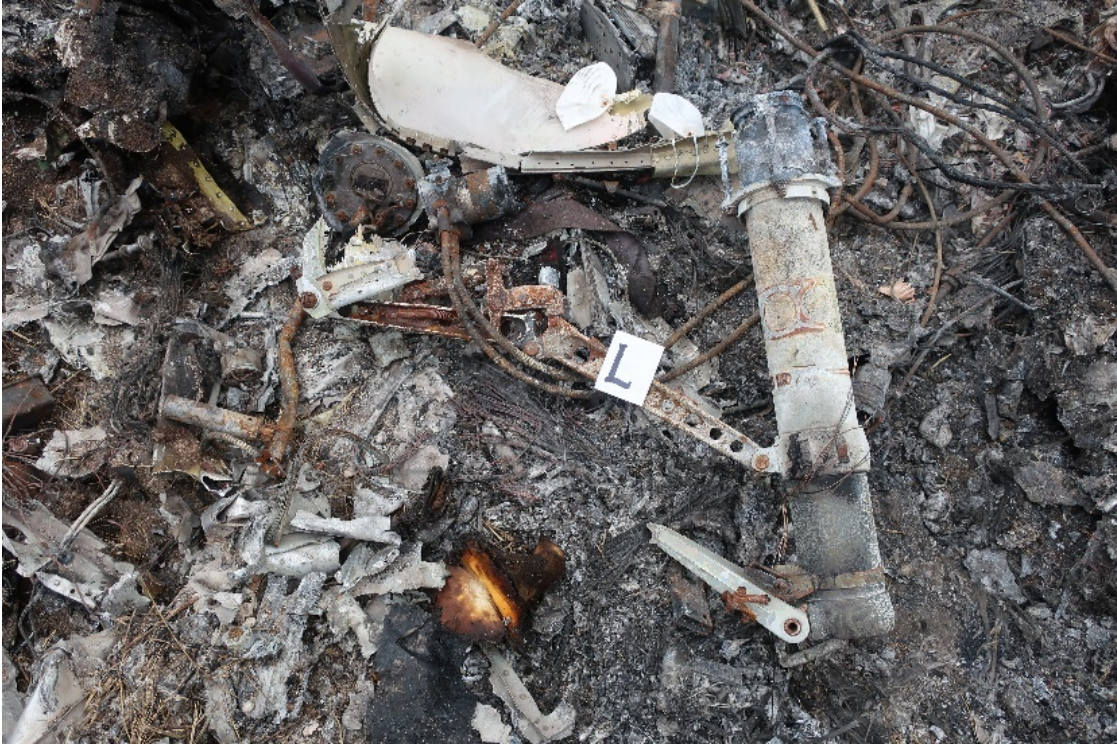
The main landing gear were designed to retract forward and up into the nacelles, behind each engine, with the wheels oriented forward. The left and right main landing gear housing cylinders were found in the area of the associated engine nacelles and each was found in the retracted orientations. Each of the main landing gear inner strut and wheel assemblies had been ejected from the cylinders. The left wheel and inner strut assembly was found to the east of the majority of debris and from the surrounding fire patterns on the ground, they appeared to have been there during the fire. The right wheel and strut assembly was found partially past the bottom of the perimeter fence. The down-locks of each had separated and there were no scars or other damage consistent with the landing gear not having been in the retracted orientation. (See Figures 55 - 57)

Figure 55. Left main landing gear strut and lock assembly. (Photo from: Swaim)

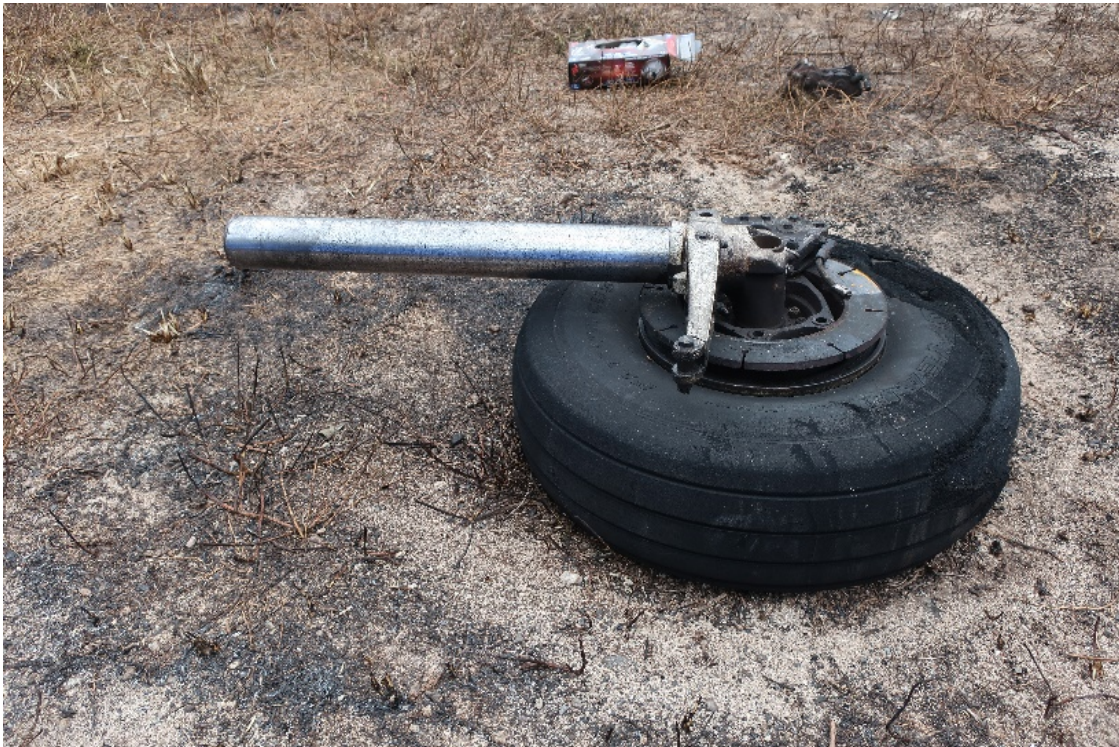
Figure 56. Left main landing gear with inner strut, separated from outer strut and found to east of the majority of the debris. (Photo from: Swaim)

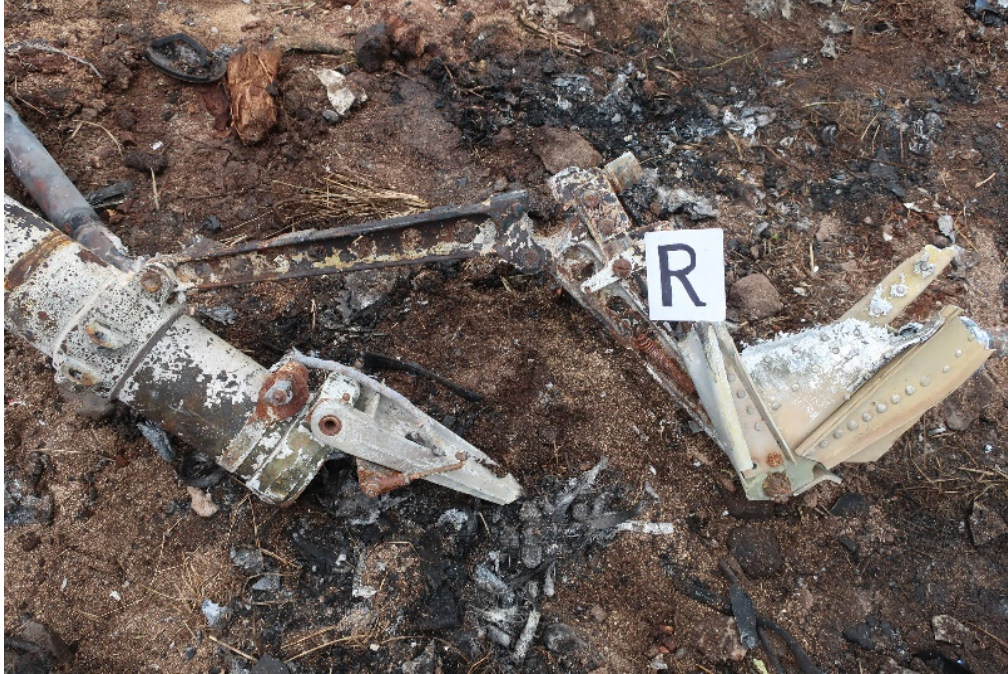
Figure 57. Right main landing gear strut and lock assembly. (Photo from: Swaim)

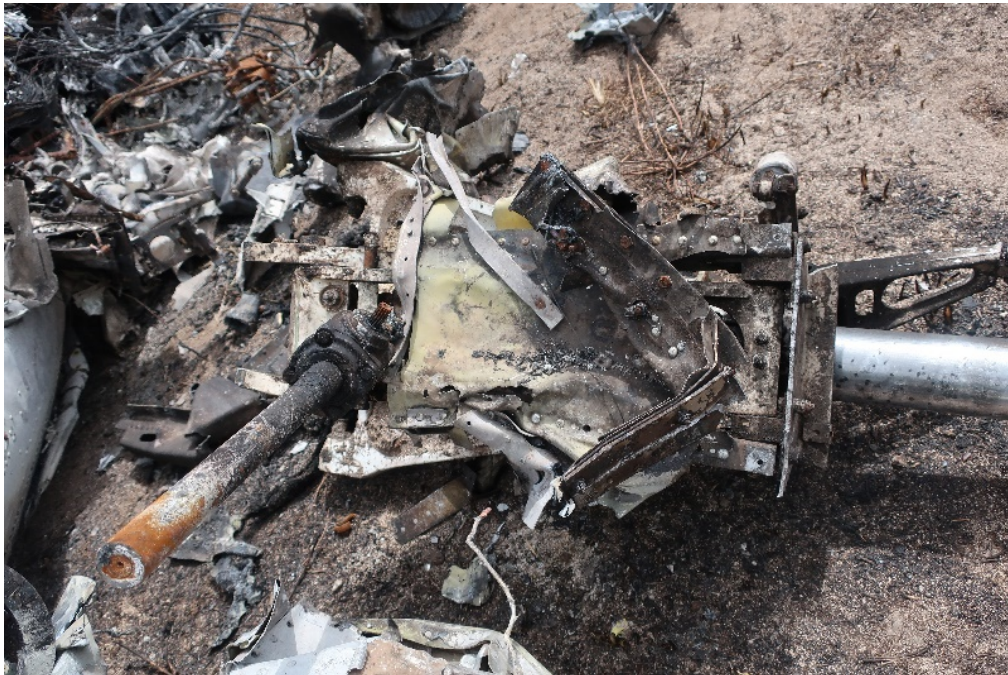
The nose landing gear was designed to retract aft, with the top forward and tire aft. In one large wreckage fragment were the complete nose landing gear assembly with portions of the forward and top of the landing gear well. Sheet metal from the front and top of the gear well were bent around the nose gear toward the tire, in the retracted orientation. (See Figure 58)

Figure 58. Top of the nose landing gear assembly with the box fragments bent aft toward the tire.

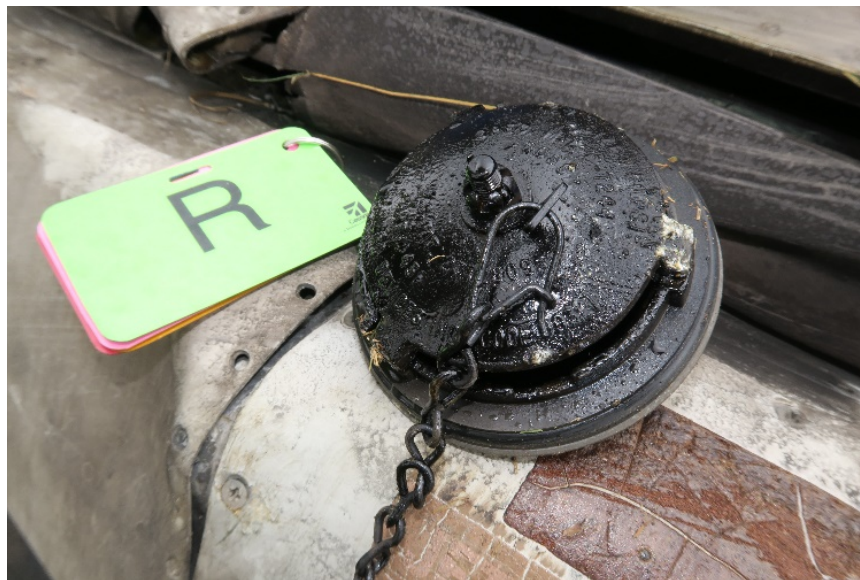
The right wing leading edge fuel cap was found in the closed position at the filler neck. Upon removing the cap, fire residue was evenly distributed on the interior surfaces of the cap and tank area. (See Figures 60 and 61)

Figure 60. Right wing fuel cap with fire residue. (Photo from: Textron)

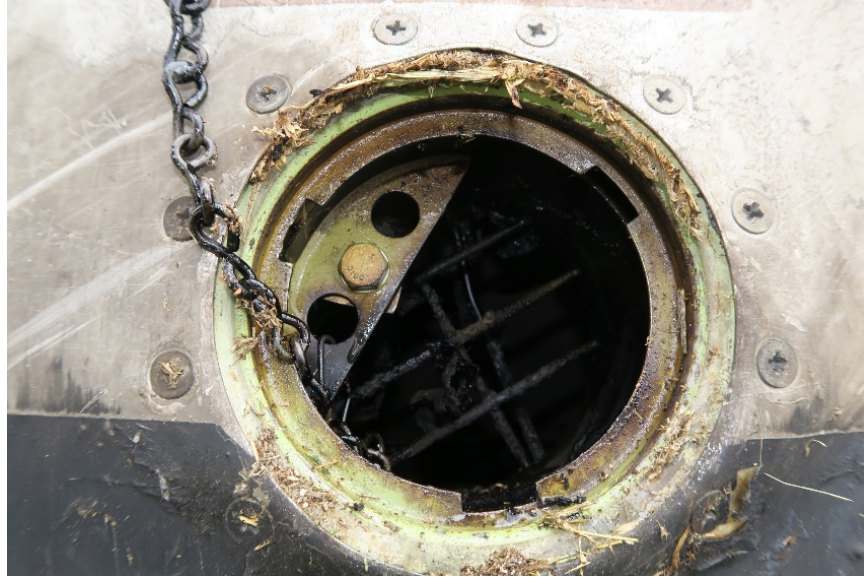
Figure 61. Interior of right fuel tank after removal of cap. (Photo from: Textron)

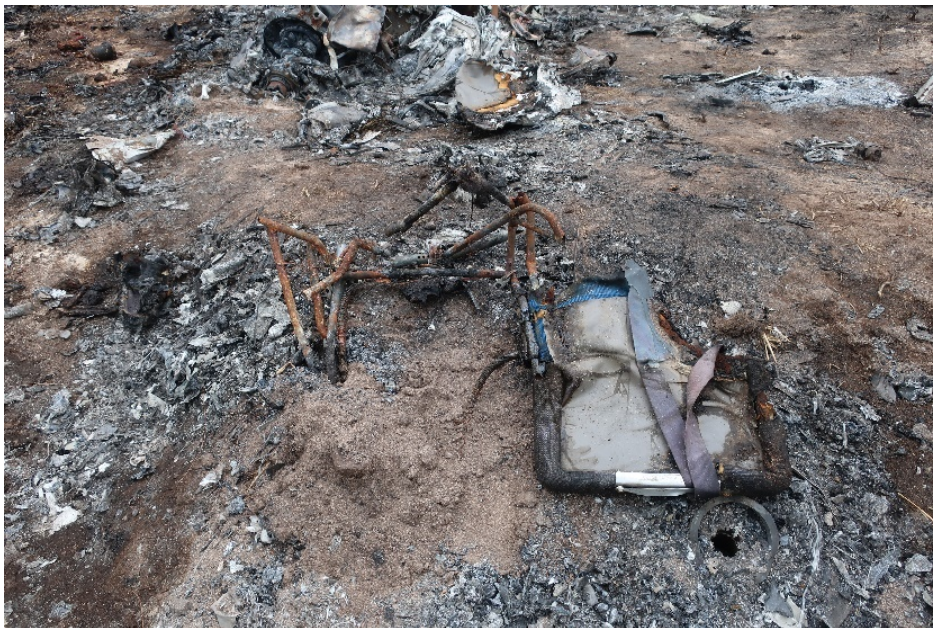
Only a small fragment of one of the foam covered benches was found and most of the pilot and front passenger seats had been consumed by fire. (See Figure 64)

Figure 64. Remnants of pilot seat. The circular item below the seat is the left propeller hub. (Photo from: Swaim)

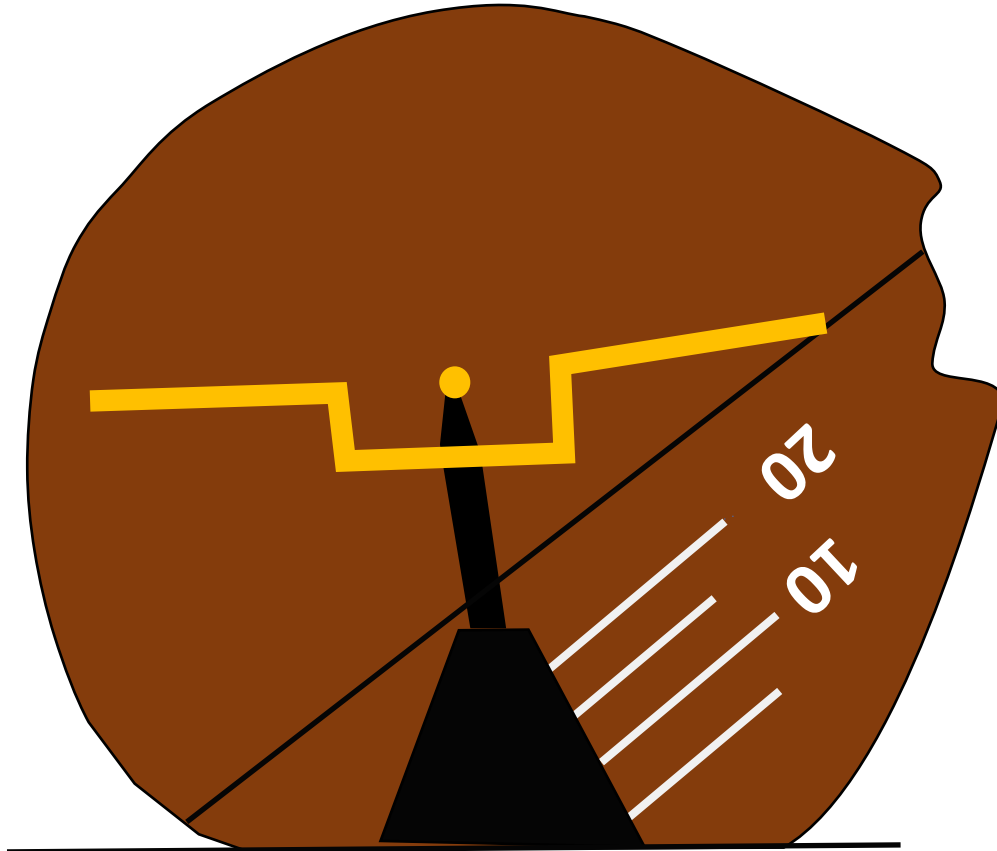
Attitude Indicator: Pitch -45 degrees, Roll 142 degrees left (See Figure 68)

Figure 68. Tracing of displayed orientation of attitude indicator. The right and upper right irregular shapes are due to obscuration by debris.⁹

- The indicator was found in a portion of the instrument panel with the facial features softly hydroformed to the gyroscope case. Crushed glass and biologic material were in the facial features. The reference image of an airplane silhouette was complete and nearly in the original position, displaced 4 degrees to left of center.
- From the level instrument frame, the displayed roll was 38.5 degrees from inverted and level, with the left wing (on the right) closer to the ground.
- The pitch display was 45 degrees nose down, as scaled from the facial display.

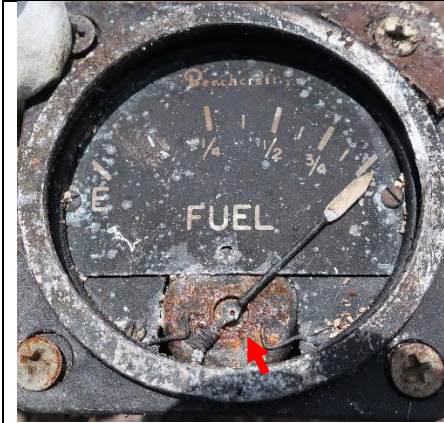
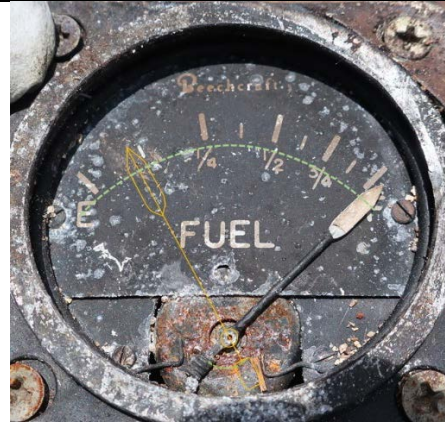
Fuel Quantity (from the panel located on the left cockpit wall): About 10% or Full (See Figures 69A and 69B)

Figure 69A. Fuel gauge with red arrow denoting mark which aligns with the distance and orientation of the counterbalance on the needle. (Photo from: Swaim)

Figure 69B. Graphic added to show shape of needle over collection of damage points in face.

The Nacelle tank is considered the main tank. Per the manual, “Fuel level in the nacelle tank is automatically maintained at nearly full capacity during normal operation...” The recovered gauge was a nacelle tank gauge based on the needle style seen in photographs from the accident in 2016. It could not be determined if it was for the left or right tank.

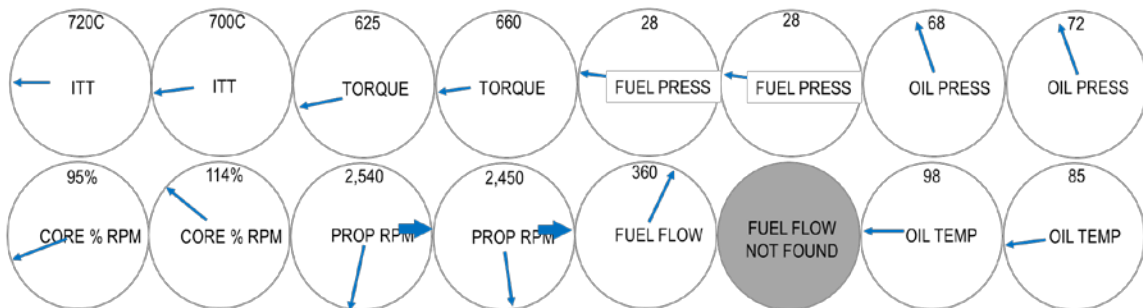
The engine instruments were found with the panel fragment which carried them. Most of the engine instruments were found packed with biological material that hydroformed the faces into the internal mechanisms. Numerous witness marks were found in each, as listed in the Attachment A description for each instrument. The majority had been immobilized at displays consistent with impact values. Neither the annunciator panel nor any of its associated lamps could be located in the wreckage.

Figure 73. Collected values and approximate needle displays from examination of engine instruments.

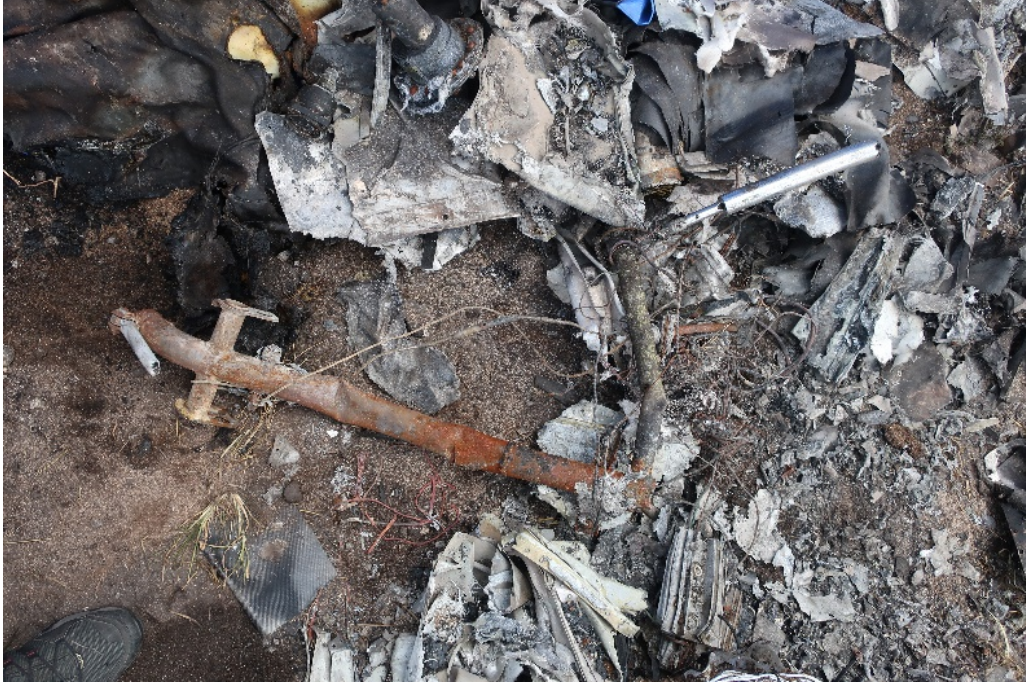
The steel cockpit control column was the largest part of the pitch control system recovered from the cockpit. The forward cable bellcrank section from beneath the floor was in an area which had been consumed by fire. A section of the control column-to-bellcrank pushrod remained attached at the base of the column; the remaining section had been consumed by fire. The right side of the horizontal upper section of the control column was missing, the left side remained attached to the wheel shaft assembly; the control wheel had detached from the shaft (See Figure 74). The area of the aft fuselage bulkheads which had mounted the aft bellcrank were also consumed by fire and impact forces.

Figure 74. Cockpit control column. (Photo from: Swaim)

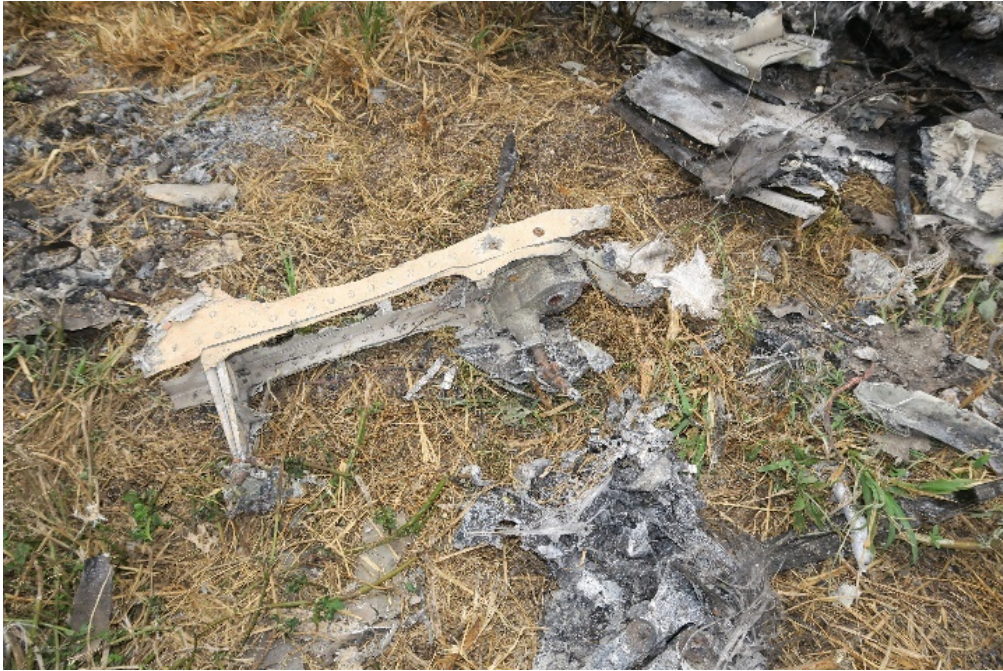
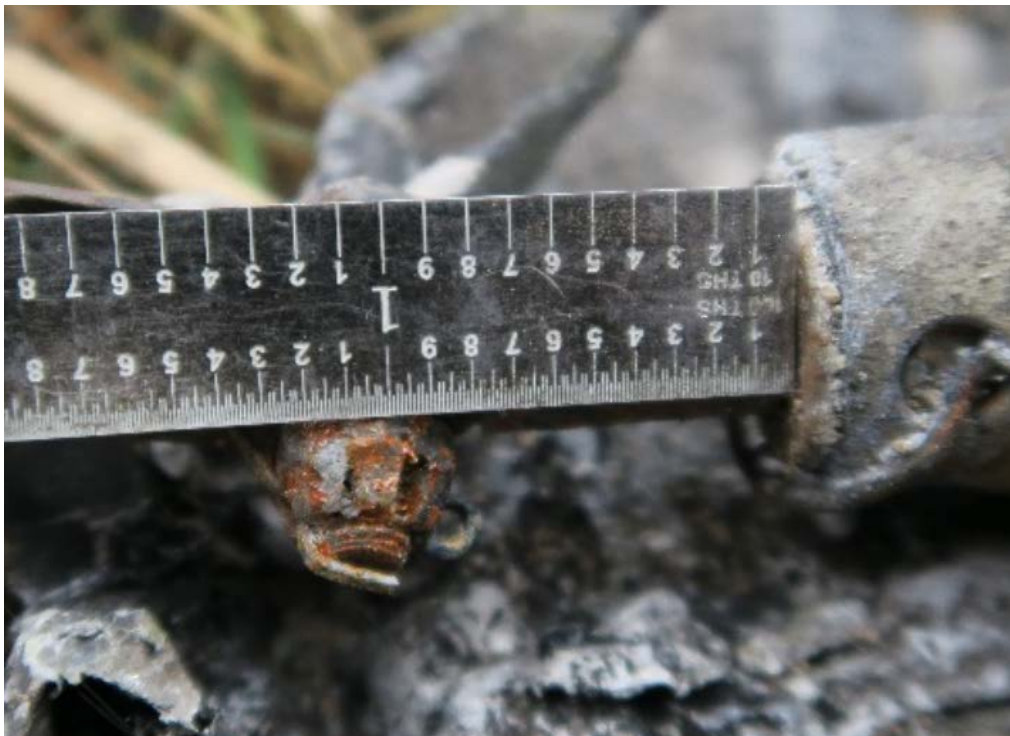
As shown in previous figures, the right elevator remained from outboard of the trim tab and little was found of the left elevator. The right pitch trim drum and actuator rod were found and the extension from the actuator face to the center of the rod bolt was 1.06 inches. According to Textron, this actuator extension was consistent with a pitch trim position of 5 degrees tab trailing edge down. The full range of the elevator trim tab was 10 degrees tab trailing edge up to 21 degrees tab trailing edge down. (See Figures 75 and 76)

Figure 75. Right pitch control trim drum on fragment of horizontal stabilizer spar.
(Photo from: Textron)

Figure 76. Right pitch control trim extension. (Photo from: Textron)

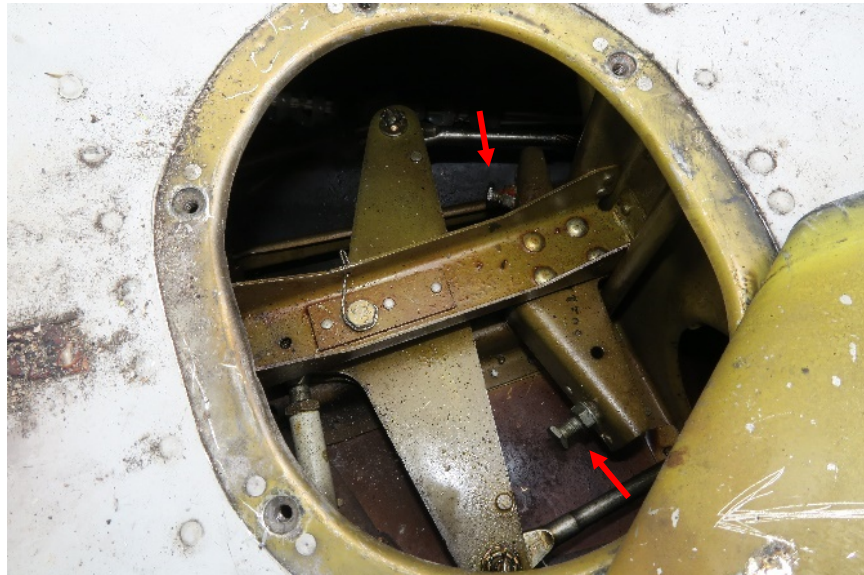
The aileron control stops in the right wing were also found intact and unbent in the mid-ranges of adjustment, unlike the ends of the adjustment limits found in the left wing. (See Figure 80)

Figure 80. Right aileron control stops. (Photo from: Textron)

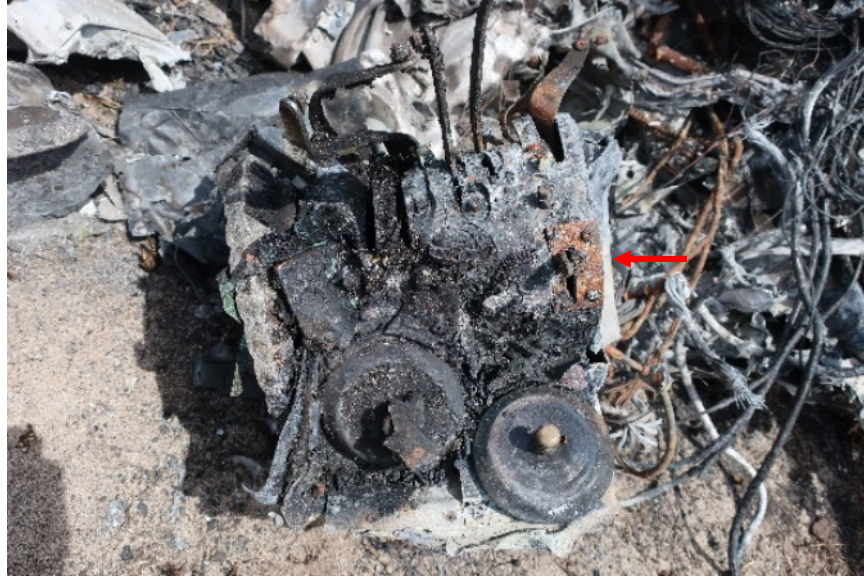
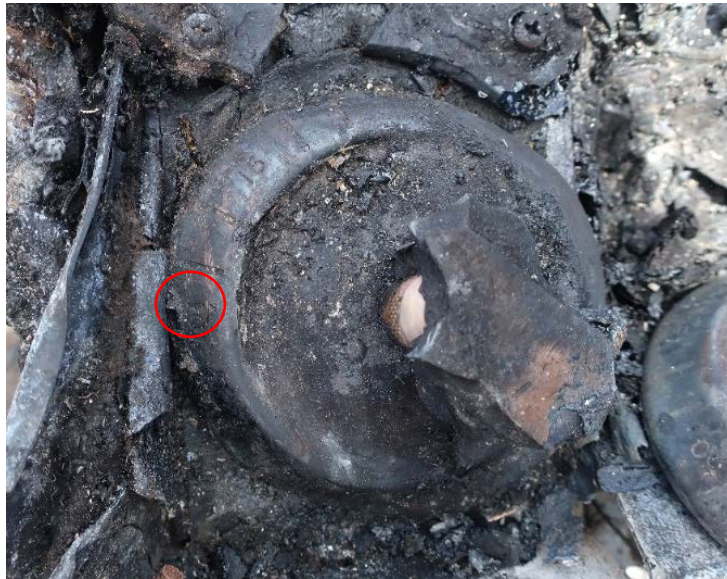
The aileron trim knob in the cockpit was found adjusted to the full left wing down position. This was the same position photographed after landing when the right horizontal stabilizer separated in 2016 and in a pilot photo of 2018. (See Figures 83 and 84)

Figure 83. Cockpit control pedestal with aileron trim knob to left and rudder trim knob to right. Arrow points to flap handle in up/retracted position. (Photo from: Swaim)

Figure 84. Closer view of aileron trim knob with center "0" marking circled. (Photo from: Textron)

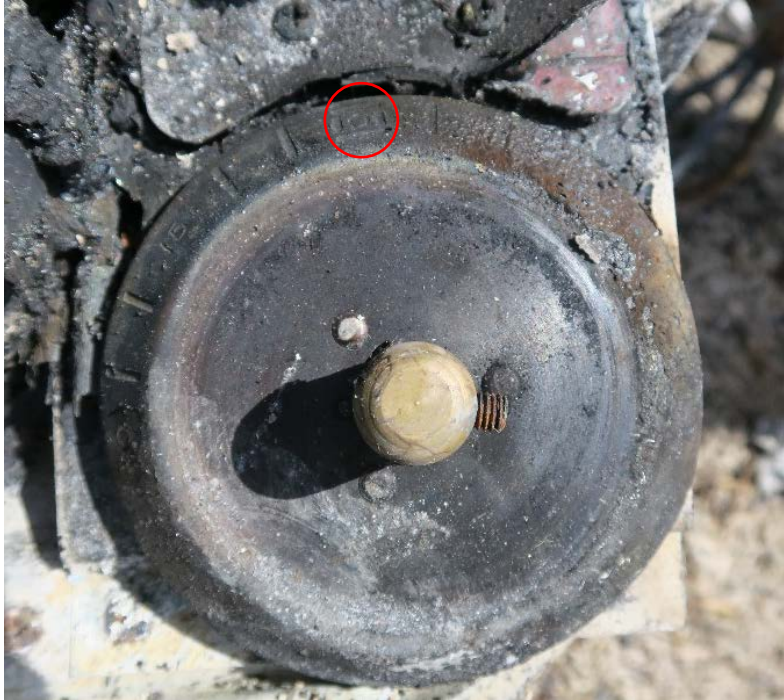
The rudder trim control knob in the pedestal was found fixed in place and near center. (See Figure 86)

Figure 86. Rudder trim control knob with center “0” marking circled. (Photo from: Textron)

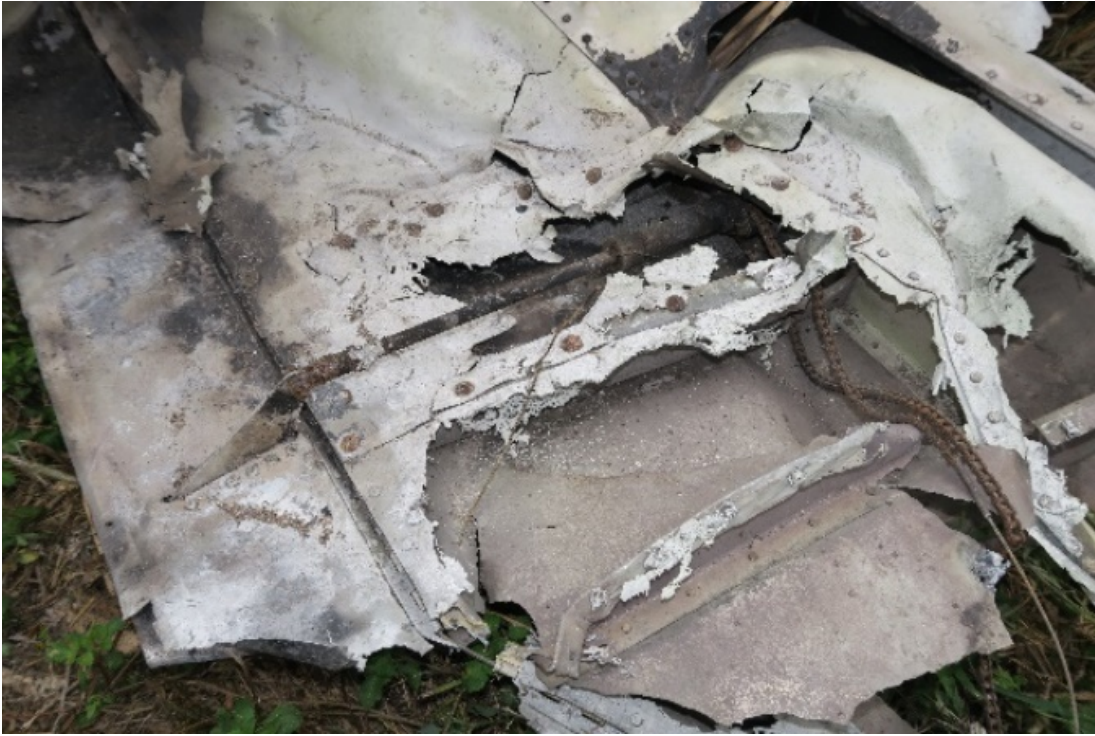
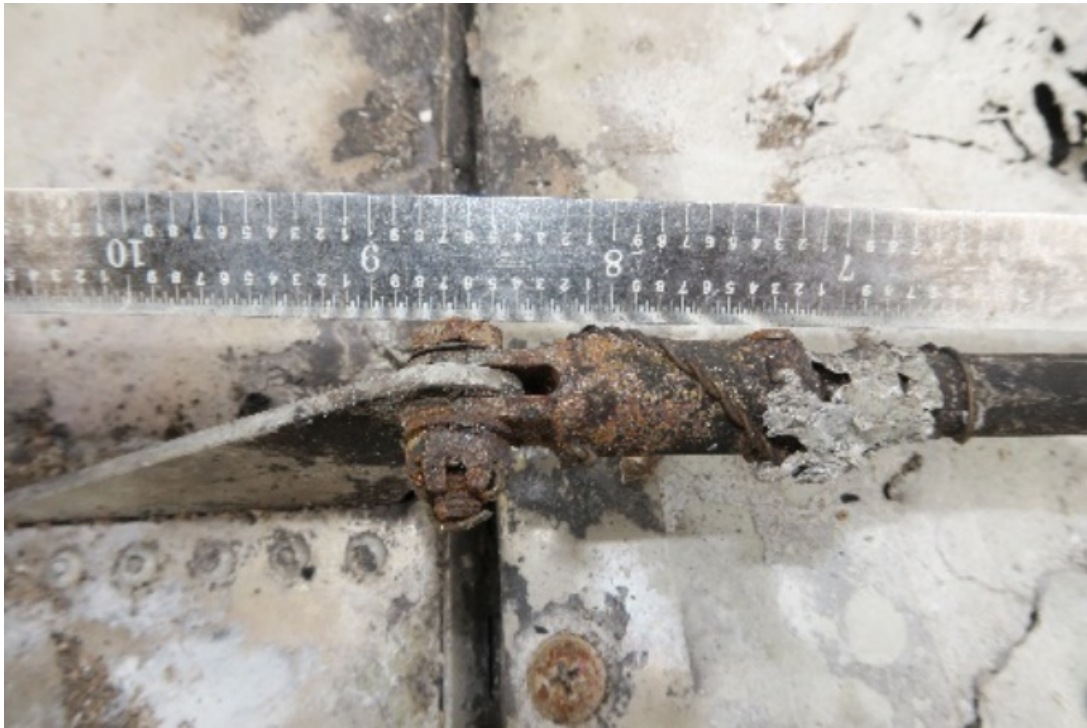
The rudder trim actuator extension was found to be 8.65 inches from the face of the actuator to the center of the actuator rod bolt. According to Textron, this actuator rod extension equates to a trim tab position of 5 deg trim tab trailing edge right (See Figures 87 and 88)

Figure 87. Rudder and trim remnants with exposed trim actuator. (Photo from: Textron)

Figure 88. Rudder trim measurement. (Photo from: Textron)

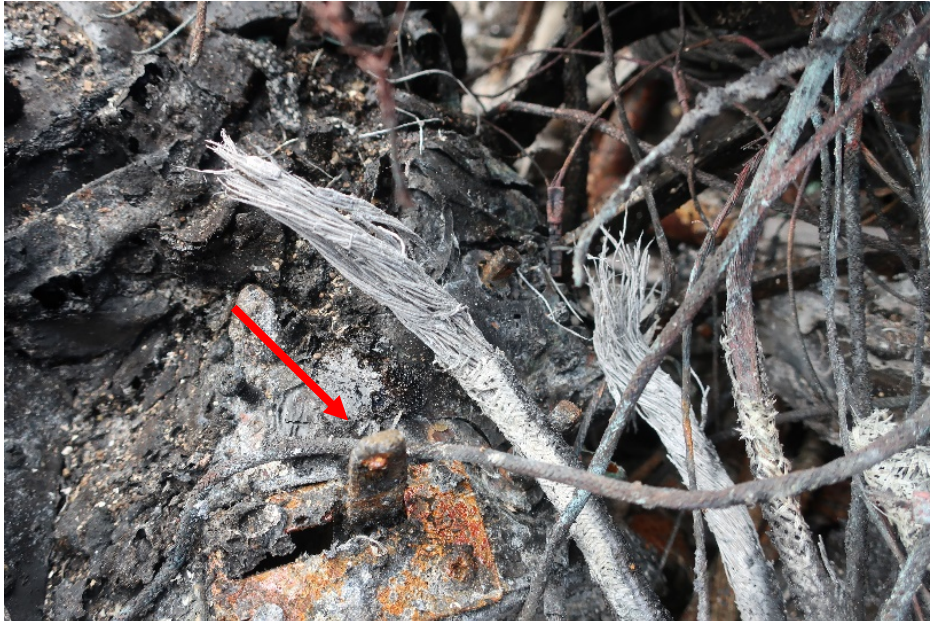
The flap handle was found in the UP position and the position indicator was not found (See Figure 89)

Figure 89. Arrow points to remnant of flap handle.

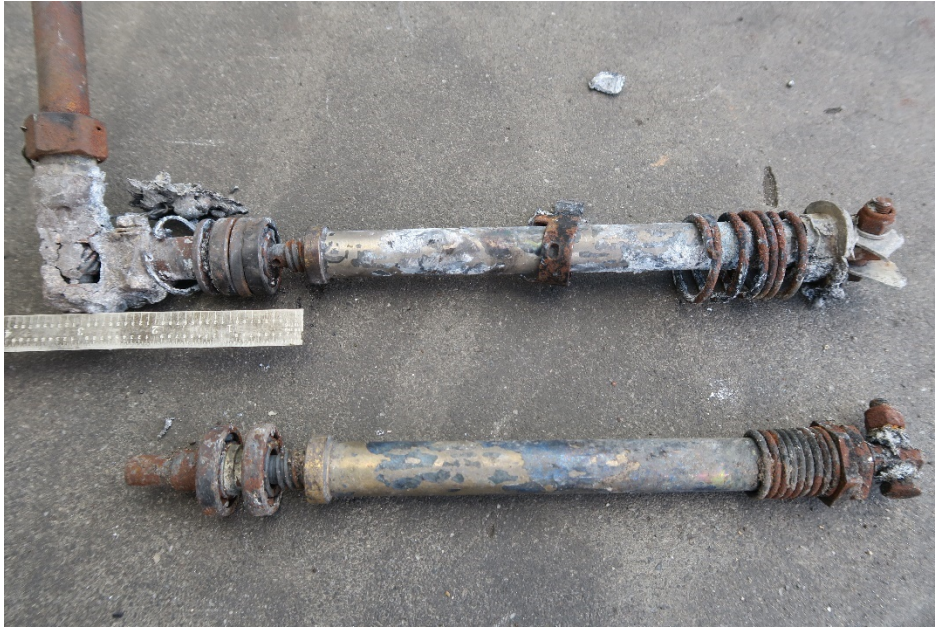
Figure 90. Left side flap actuators

Remnants of the flap flex shafts were found twisted in the wreckage and heavily rusted from the post-crash fire. The left flap actuators were found loose in the wreckage. Both of the left flap actuators were in a position consistent with the flaps being in the up position (See figure 90).

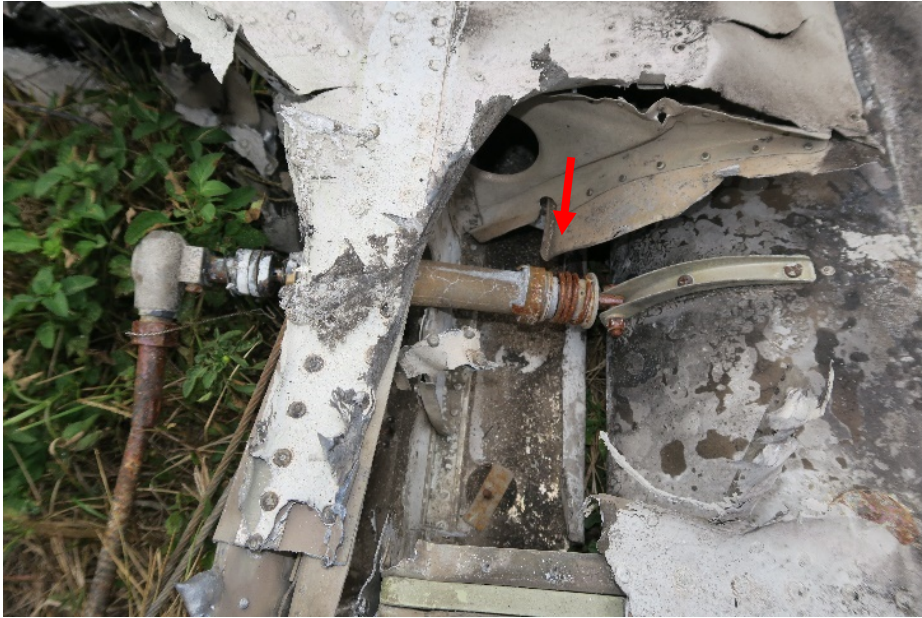
The outboard right flap actuator was found broken. (See Figure 91) The right flap actuator was found in the orientation of full flaps up. (See Figure 92)

Figure 92. Right flap actuating assembly extension indicated by arrow. (Photo from: Textron)
