Collapse of the Fern Hollow Bridge

Pittsburgh, Pennsylvania
January 28, 2022

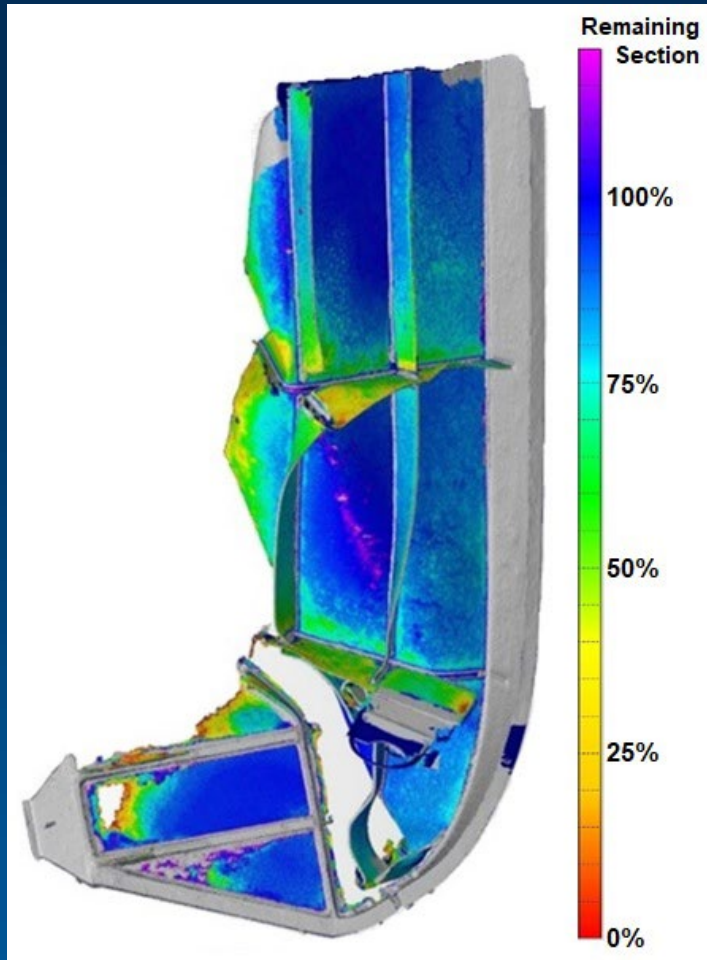
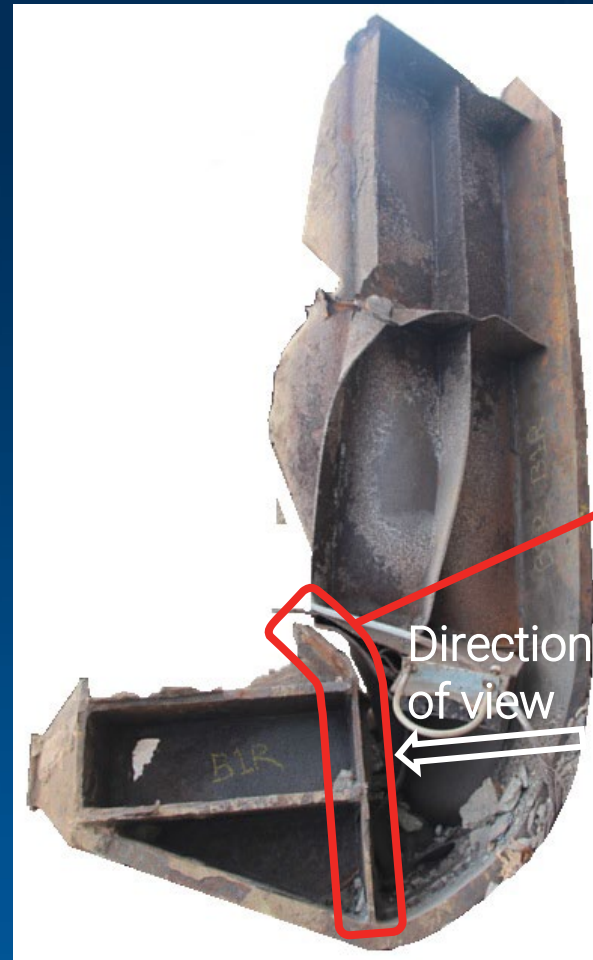
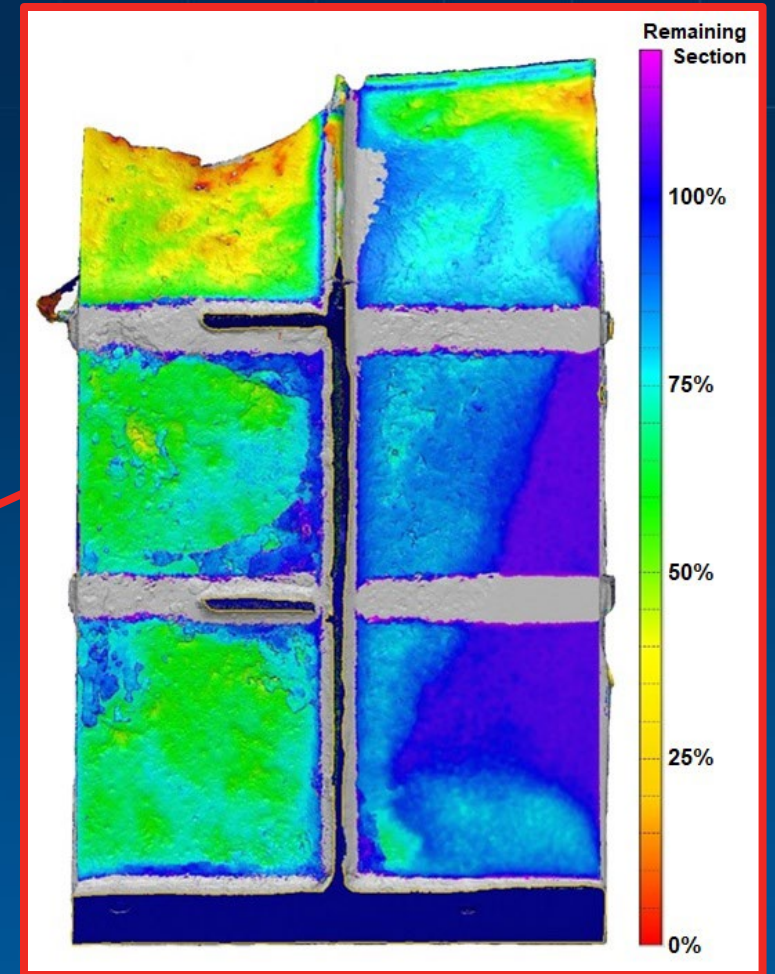
3D Laser Scanning – Southwest Leg

- The southwest leg failed because it had reduced capacity due to extensive corrosion and section loss
 - The collapse initiated at the corroded transverse tie plate
- The following were excluded as factors in the collapse:
 - Use of uncoated weathering steel
 - Materials fabrication
 - Weld quality
 - Bridge design

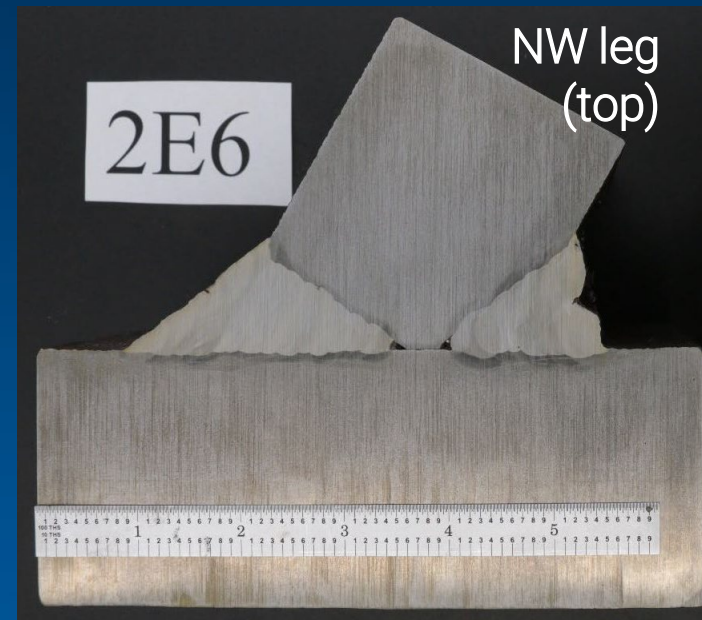
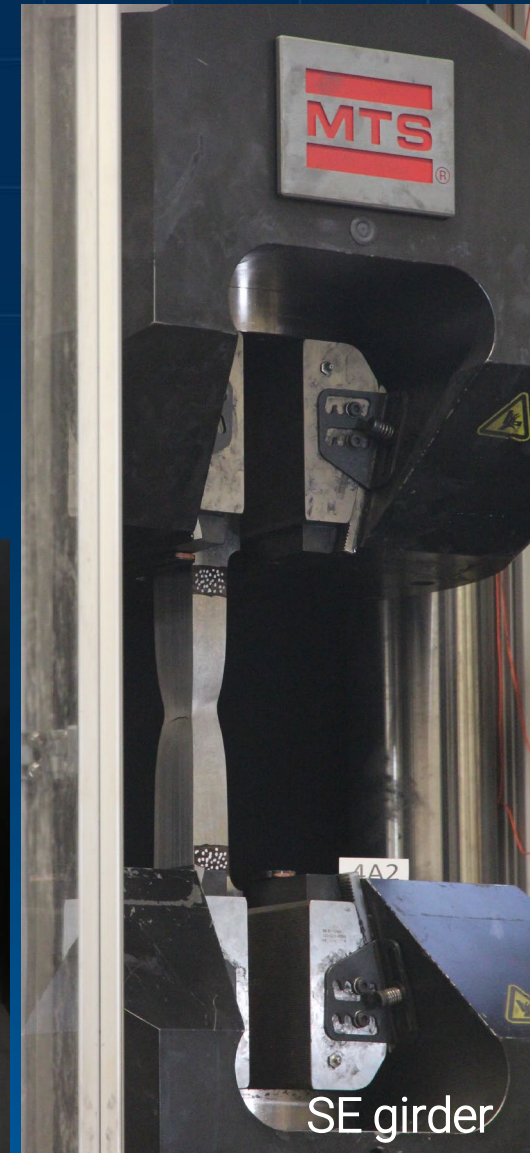
- Tensile strength
 - Most plates met requirements
 - A few plates located in girders were at most 4% below minimum standards
- Impact strength
 - All plates met requirements
- Chemistry
 - Several plates non-conformant
 - All plates could form patina
- Metallographic examination
 - Welds showed corrosion, lack of fusion

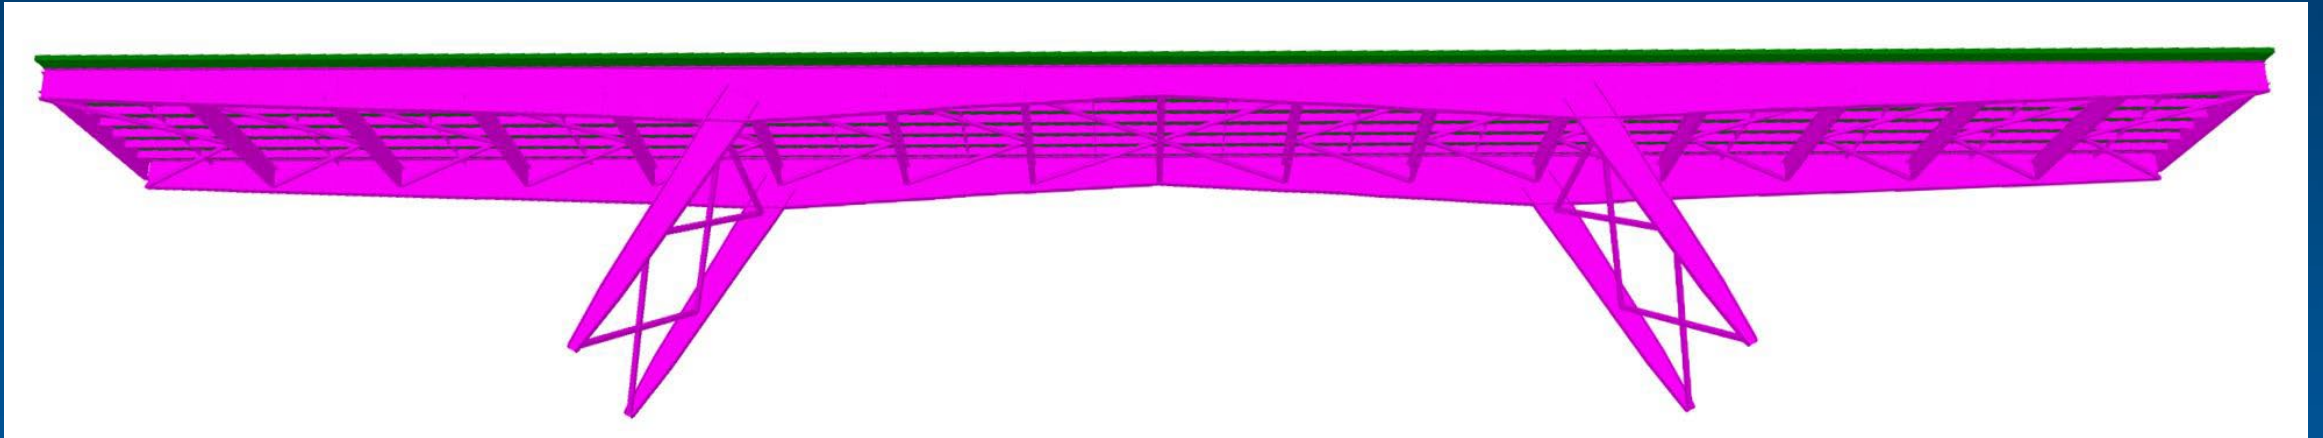
- Global behavior of structure during collapse
 - As-designed bridge had sufficient capacity to support all loads
- Local behavior of bottom of legs
 - Model of southwest leg shows corrosion present results in decreased capacity
 - When loaded, separation of transverse tie plate at the flange occurs first

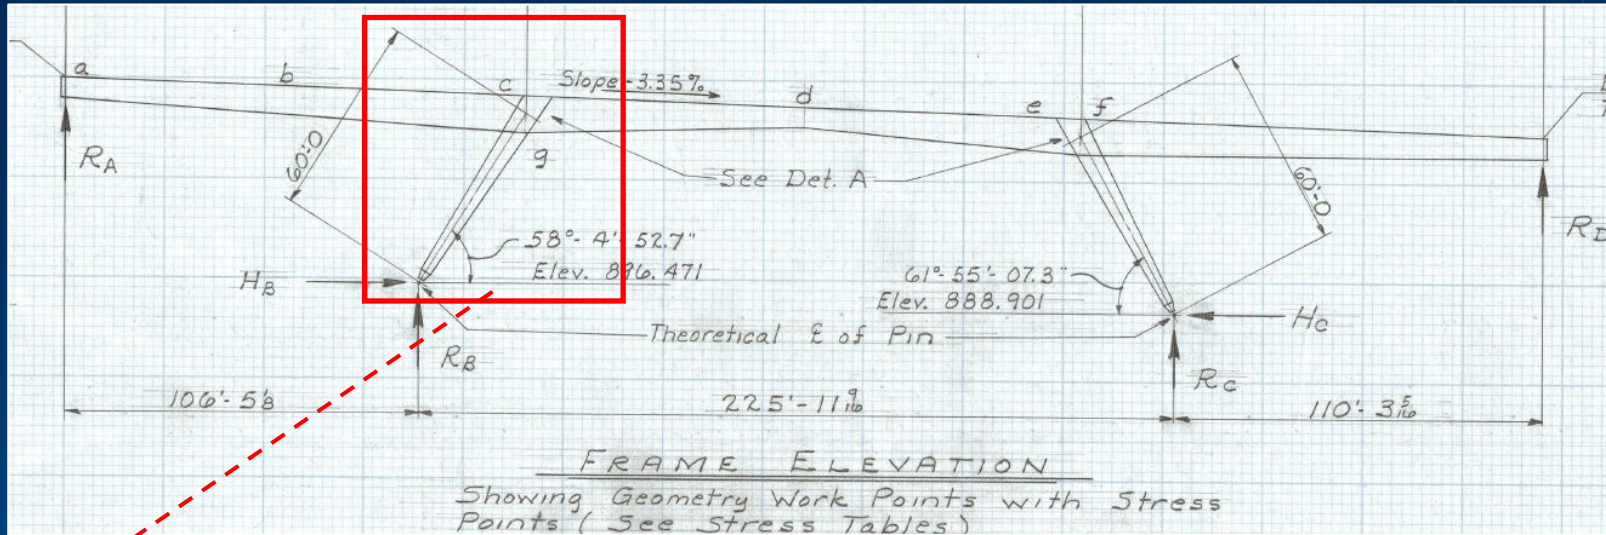
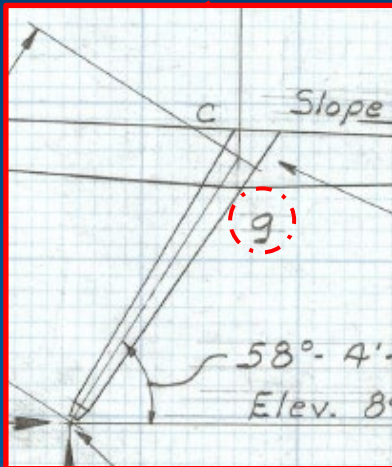
Design Plan Bending Stresses

- Rigid connection between girders and bridge legs would have transferred bending moments
- Transferred bending moments (forces) would have added to those originating in the legs due the angled connection

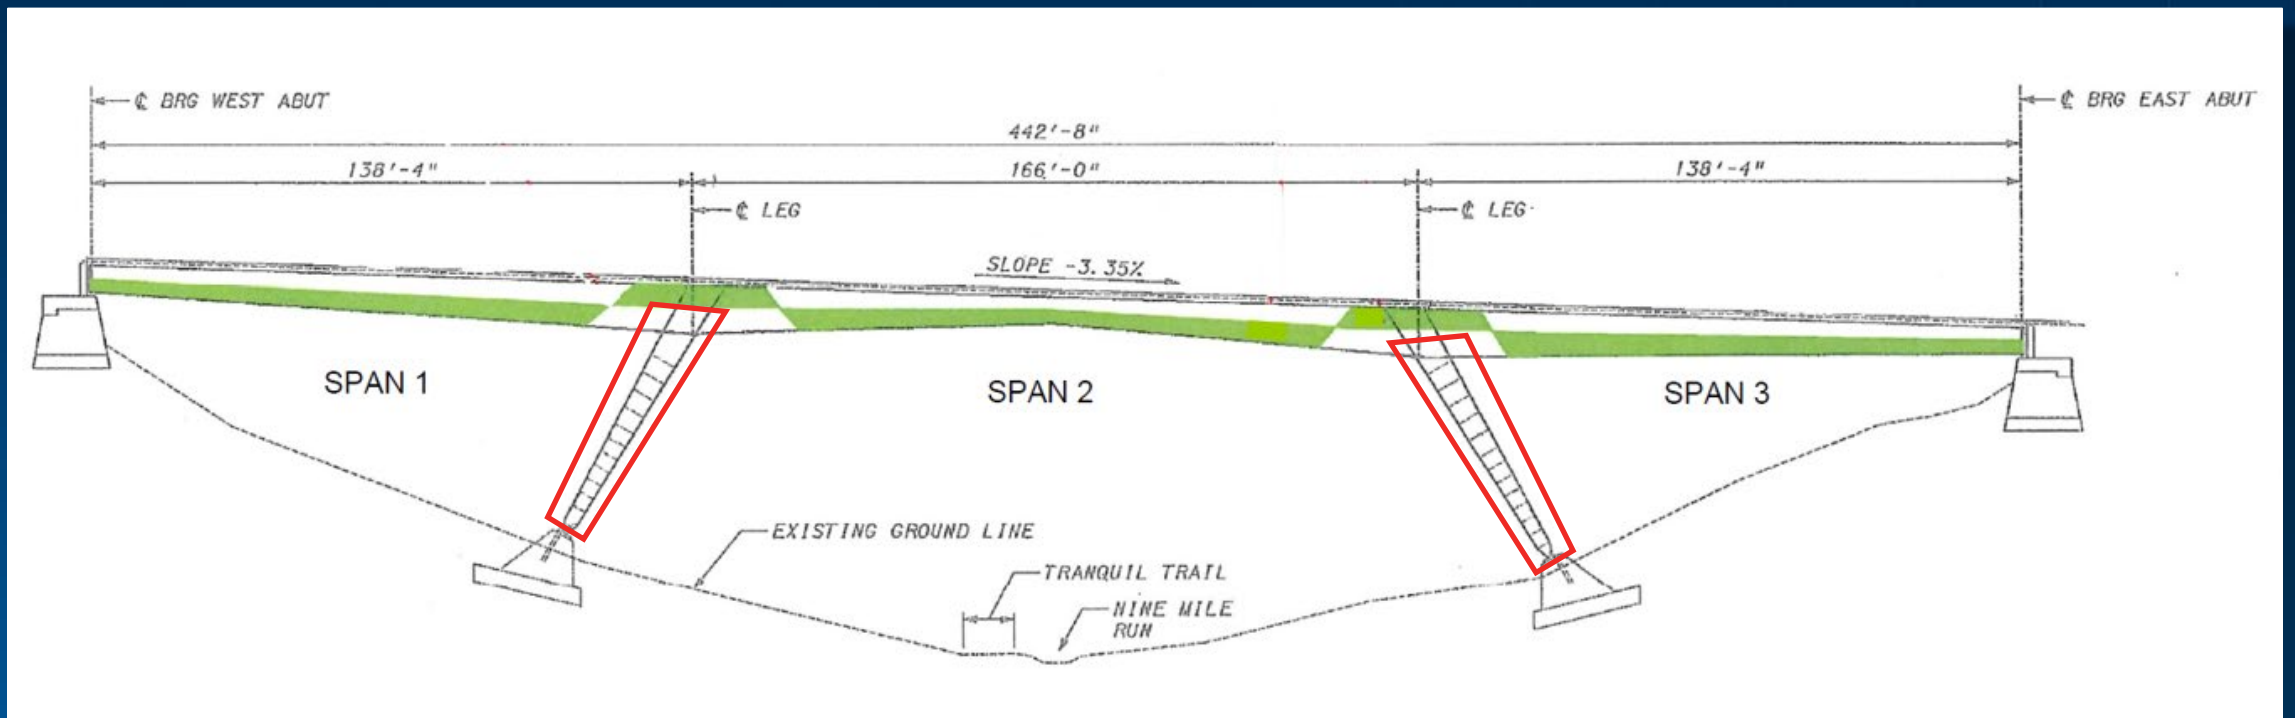
Fern Hollow Bridge Fracture-Critical Member Inspection Plans

- Bridge legs were not properly identified as fracture-critical
- Bridge legs did not consistently undergo an in-depth FCM inspection
- Maintenance and repair recommendations for the bridge legs were not assigned appropriate priority codes
- Repairing the bridge legs could have prevented the collapse
- The correct identification of FCMs is crucial
- What we propose:
 - **One recommendation to the Federal Highway Administration**

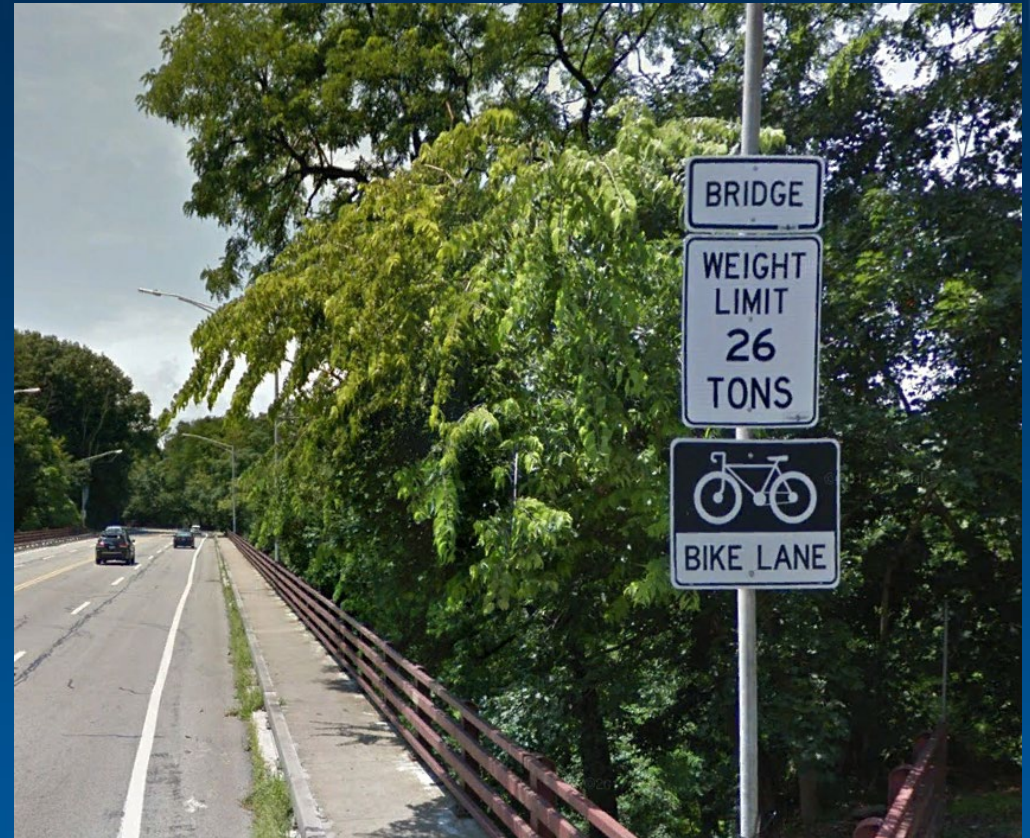
Fern Hollow Bridge Posted Weight Limit

- Posted weight limit of 26 tons
- Load rating analysis conducted in 2014
- In response to 2013 routine inspection report to perform an analysis of the structure's stability
- NTSB investigators found 3 issues with the 2014 load rating analysis

- Thickness of asphalt wearing surface was 3 inches in 2014 load rating
- Postcollapse, the wearing surface thickness was measured to be about 6 inches
- Doubled wearing surface would have resulted in a load posting of less than 26 tons
