NATIONAL TRANSPORTATION SAFETY BOARD

ENGINE EXAMINATION

WPR18LA278

Howard DGA-15P – N9471H

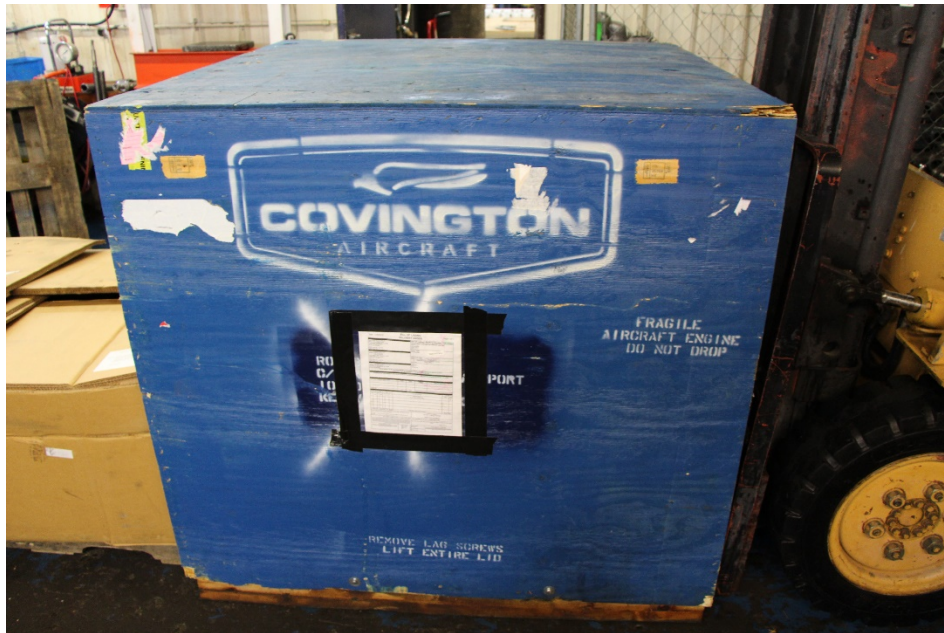
Photograph 1: Crated Engine Prior to Examination

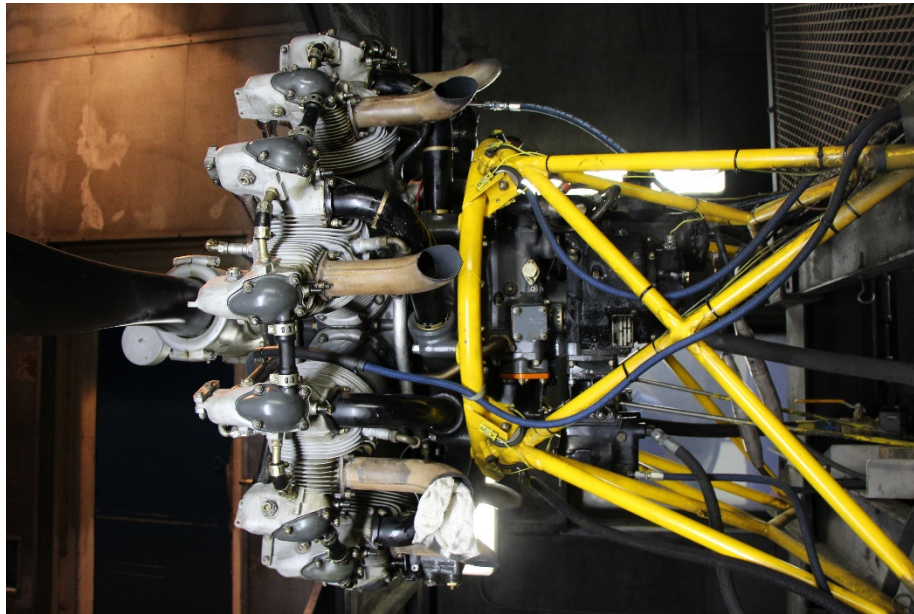
The results of the engine run are included in Appendix A of this examination report. The engine was initially run for 10 minutes at 1,000 rpm and subsequently advanced 200 rpm every 10 minutes. During the 15 minute engine run at 1,800 rpm, the left and right magnetos were shut down individually, which revealed a drop of 60 rpm for the left magneto and 80 rpm for the right magneto. At the time, the ambient temperature was 73° F and barometric pressure was 29.51 inches Hg. Engine power was then advanced to 1,900 rpm for 15 minutes, 2,000 rpm for 15 minutes and finally 2,100 rpm for 5 minutes. The engine’s maximum power achieved during the test was 2,300 rpm for about 1 minute at 37 inches of manifold pressure.

Photograph 8: Engine in Test Cell
