NATIONAL TRANSPORTATION SAFETY BOARD

AIRPLANE AND ENGINE EXAMINATION

WPR19FA244

Aircraft: Cessna 172

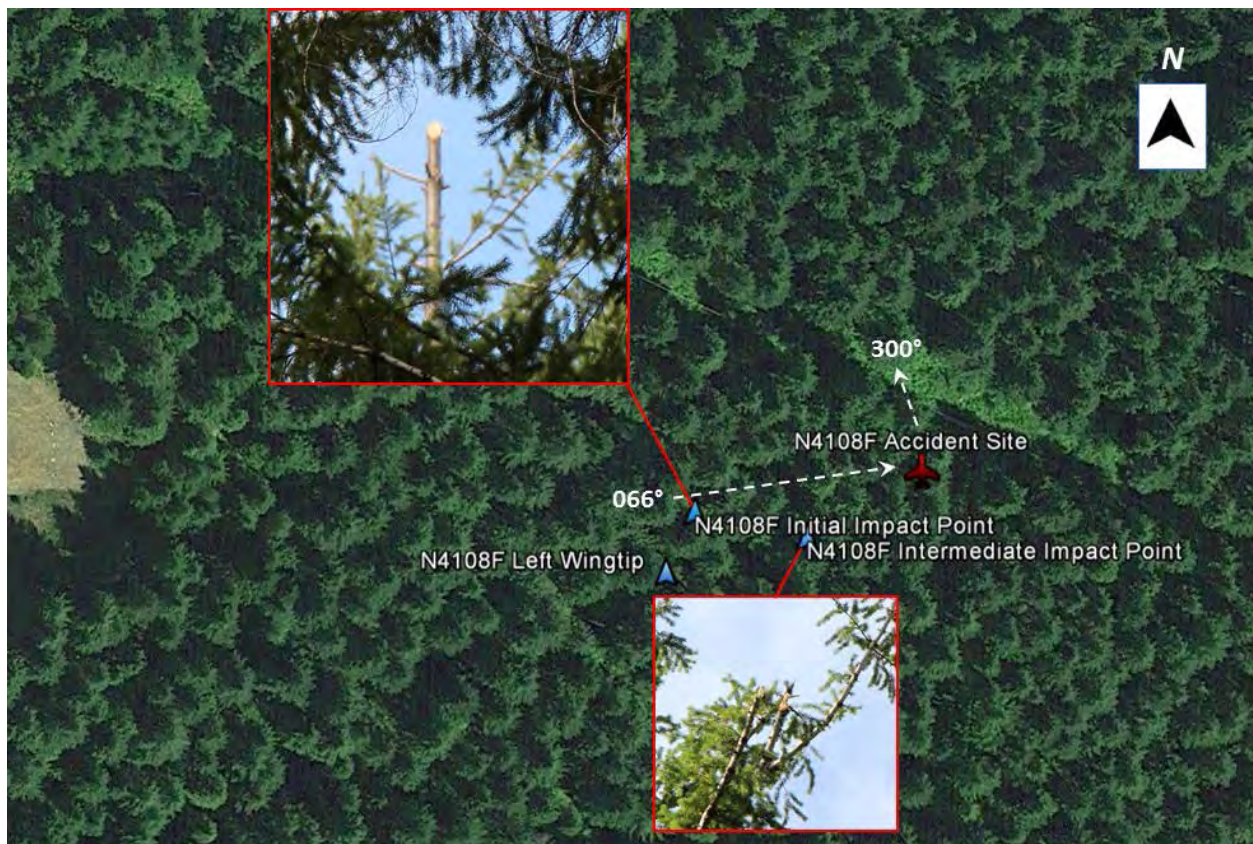
The airplane came to rest inverted in a wooded area about 615 ft east of the departure end of runway 06. The initial impact point (IIP) was marked by an approximate 120 foot tall tree with a severed tree top. A section of the left wingtip was found about 40 feet southwest of the IIP and was comprised of an 8 inch long concaved shaped depression in the leading edge of the wingtip. An intermediate impact point was observed along the debris path and marked by several broken tree branches at the top of an approximate 120 foot tall tree about 75 feet southeast of the IIP. The main wreckage was located about 150 ft from the IIP and was mostly consumed by postcrash fire, but was comprised of all four corners of the airplane.
