National Transportation Safety Board
Washington, D.C. 20594

Date: November 2, 2020
To: Robert Hall, Director
Through: Sean Lynam, Chief, Pipeline and Hazardous Materials Division
From: Sara Lyons, Pipeline Accident Investigator
Pipeline and Hazardous Materials Division
Subject: Atmos Energy's Party Submission Containing Pre-Decisional Information
Investigation of Natural Gas-Fueled Explosion of Residence, February 23, 2018
Dallas, Texas (PLD18FR002)

Supplement
to
Atmos Energy Corporation's
Proposed Findings, Probable Cause, and
Recommendations to
the National Transportation Safety Board

Docket No. PLD18FR002
Relating to Natural Gas-Fueled Explosion
3534 Espanola Drive in Dallas Texas
February 23, 2018

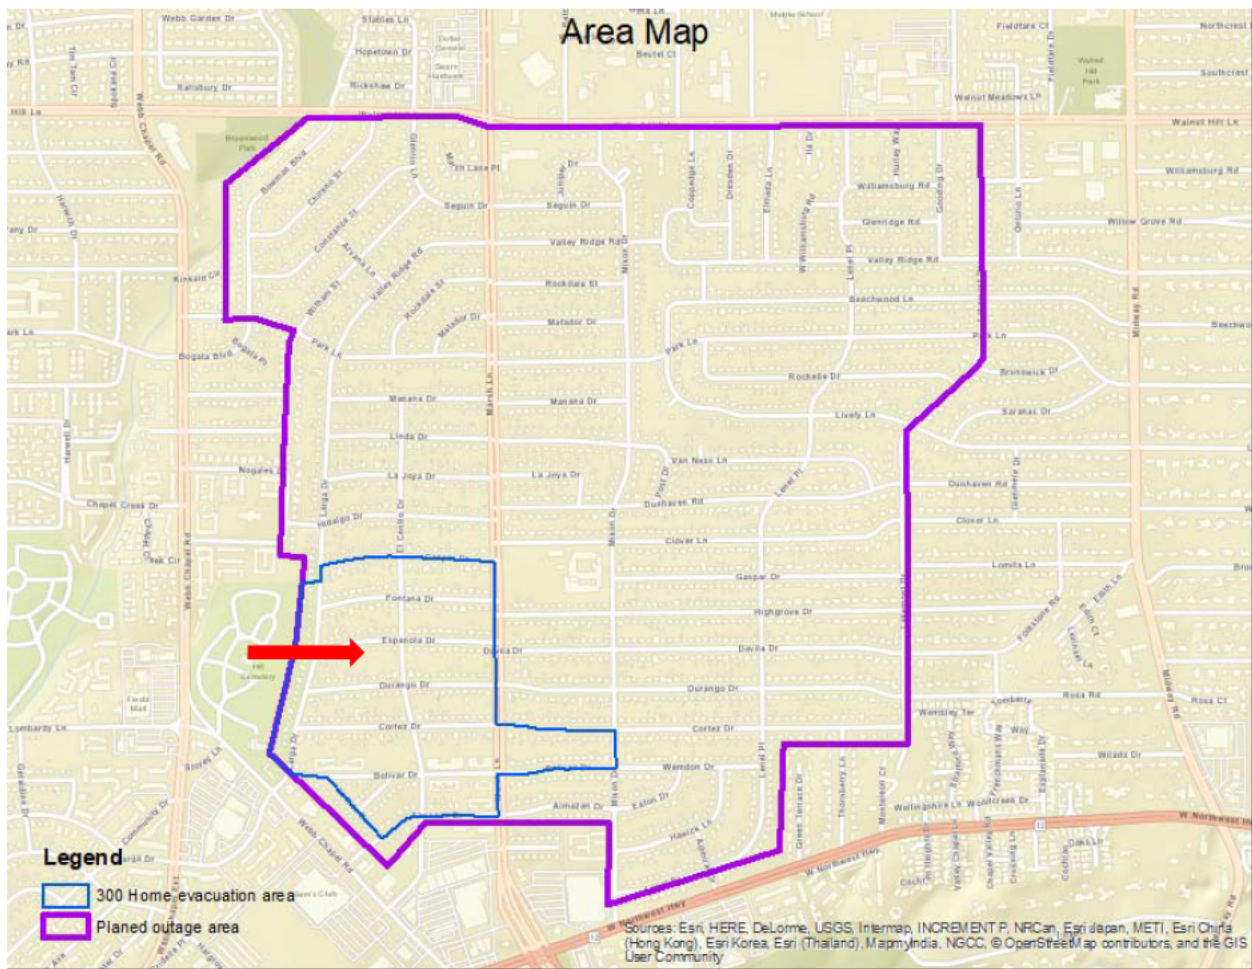
Figure 7 – Accident site at 3534 Espanola (indicated with red arrow toward bottom, left) shown relative to the much larger area Planned Outage Area where Atmos experienced an unprecedented number of leaks

- d. The USACE Report also states its purpose was to evaluate the technical accuracy of BCI's Preliminary Assessment "regarding the possible cause of the gas pipeline explosion in Dallas, TX." It is unclear why the USACE characterized the Preliminary Assessment as attempting reach a conclusion about the cause of the incident on February 23 when the Preliminary Assessment has no language suggesting the same. As Atmos Energy confirmed multiple times, BCI was not engaged to investigate, or draw conclusions, regarding the events of February 21-23, 2018, and did not perform any testing within the 3500 block of Durango and Espanola Drives. With its testing limited to the only area BCI did not review, the USACE report cannot evaluate the technical accuracy of the BCI report.

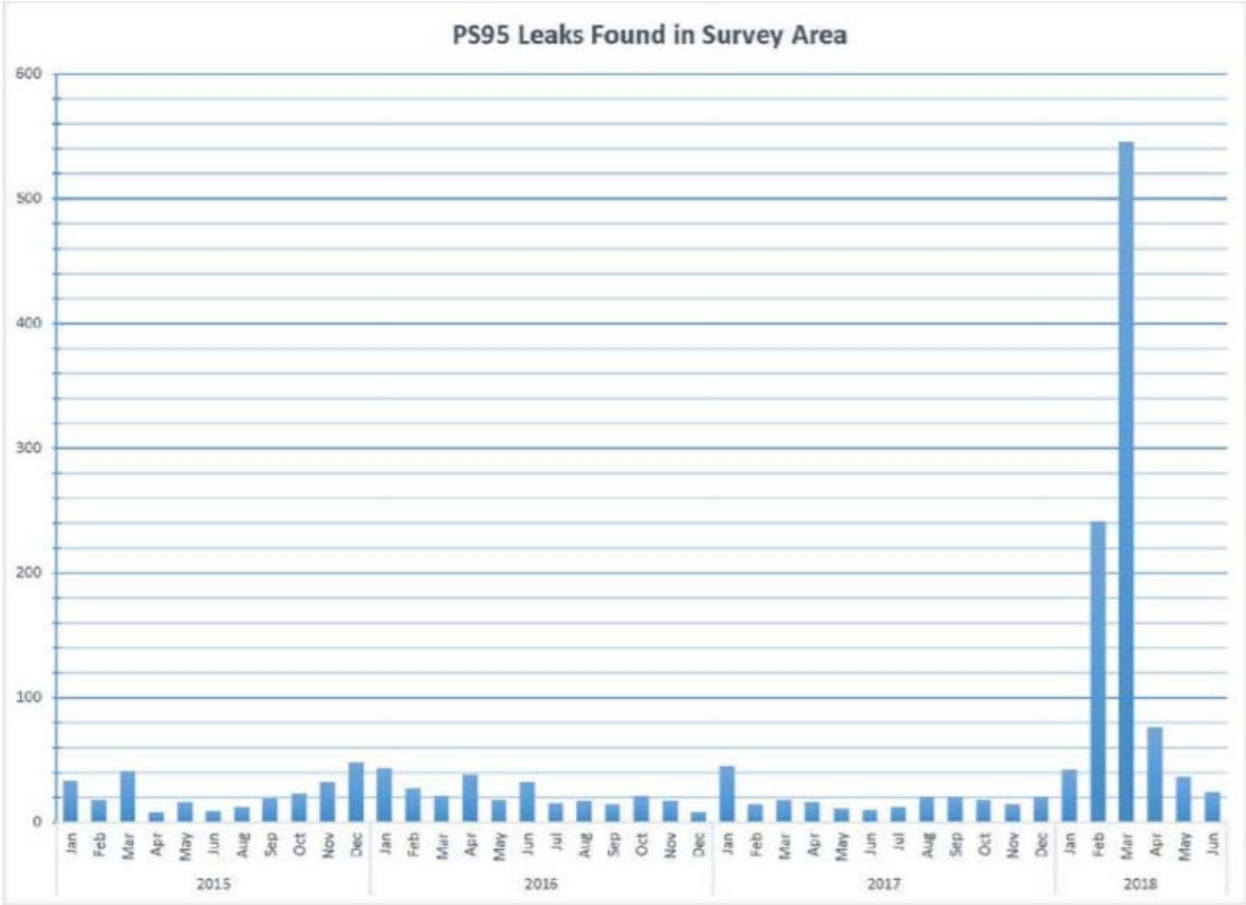
Figure 8 – Rate of leaks found in NW Dallas Area from January 2015 through April 2018 showing unprecedented leak rates in February and March 2018 (data taken from Atmos Energy’s PS-95 public filing with the Texas Railroad Commission).

below, the rate at which leaks were discovered was unlike anything Atmos had ever experienced. In the first weeks of 2018, Atmos found an average of 9 leaks per week in a leak survey area in NW Dallas (including the Planned Outage Area).⁹ In the days leading up to March 1 and through the end of March, Atmos found an average of 130 leaks per week. From April through June 2018, that average returned to normal even as Atmos continued to perform more frequent leak surveys. The information provided by BCI allowed Atmos to understand why so many leaks were developing in this particular area in NW Dallas, and develop a response which ultimately led to the difficult decision to isolate part of its system thereby interrupting service to approximately 2,800 customers. The USCAE Report not only mischaracterizes the purpose of BCI’s Preliminary Assessment, but it completely discounts the importance of its findings and the positive safety impact it has had on Atmos’ customers in this area.

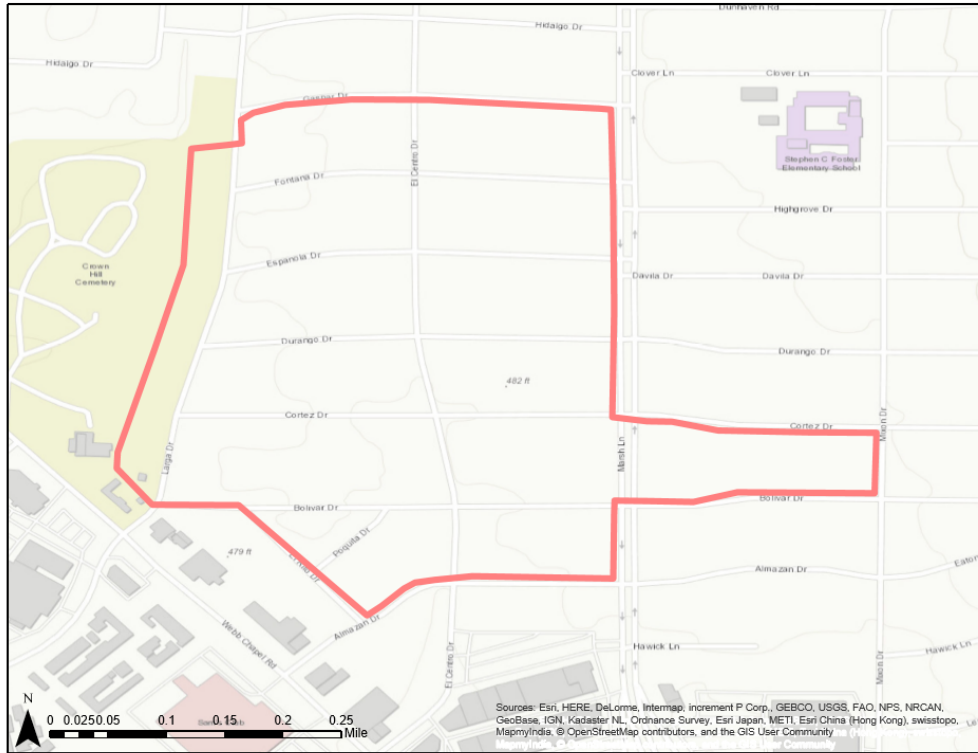
Figure 1—Map of Area Evacuated on Friday, February 23, 2018

Atmos monitored the system and performed leak surveys surrounding the 3500 block of Espanola. As a precaution, Atmos decided to isolate a nine-block area through a series of staged system isolations (Figure 1). System isolation work was completed Friday evening. Atmos also evacuated 300 residences in this area, working with its public affairs team and coordinating with local officials to provide lodging and other assistance to residents in the affected area.

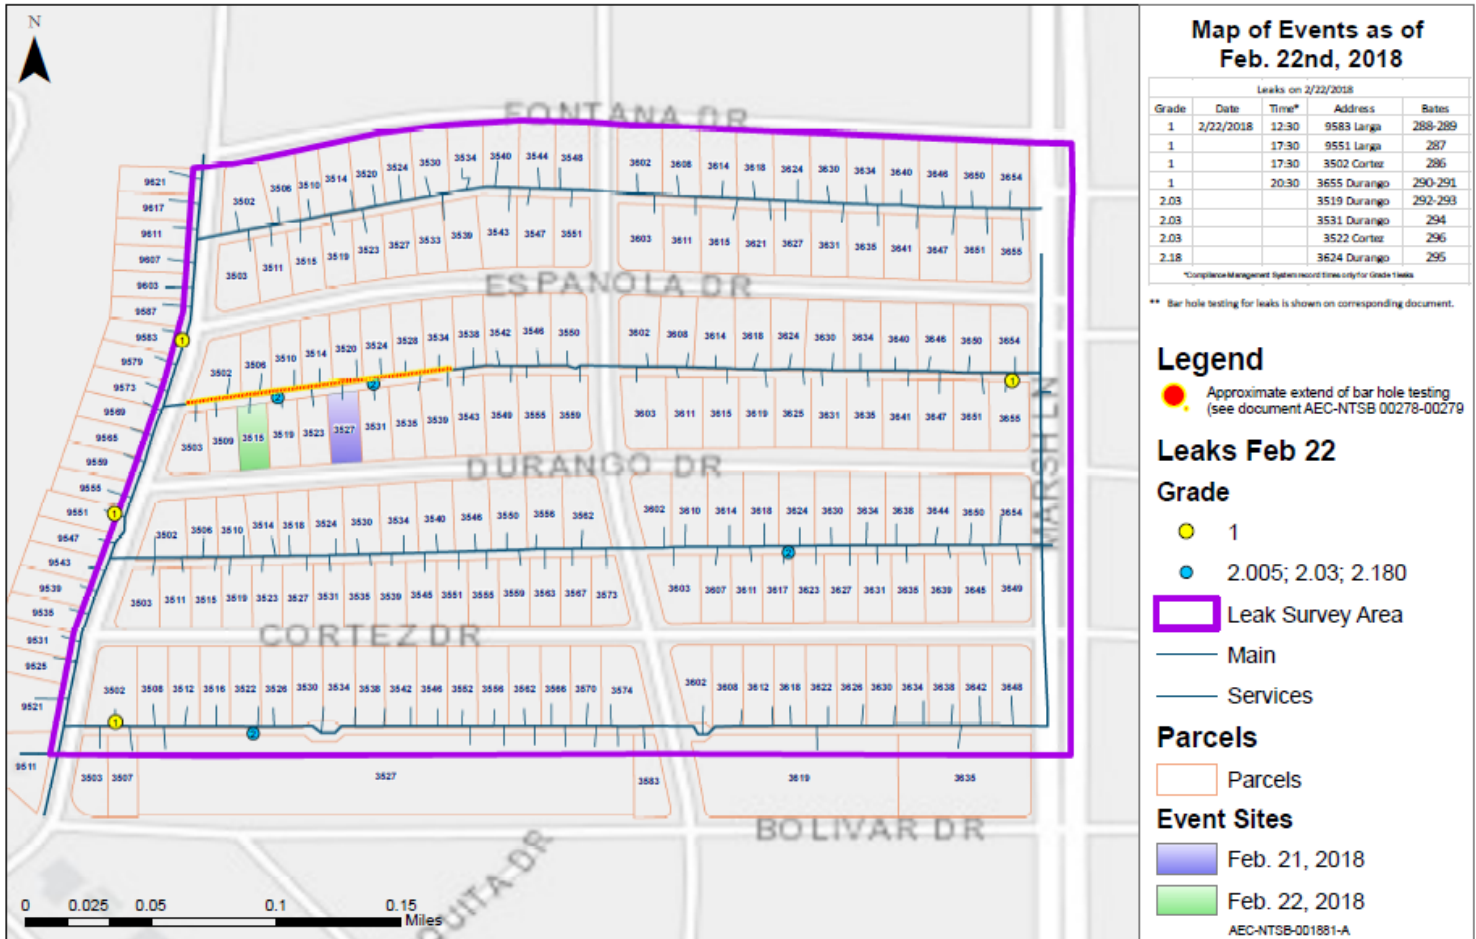
Figure 17 : Map of leak survey area and leaks on February 22, 2018 (Attached as Exhibit D to the Appendix).

The leak survey started that afternoon and continued to approximately 1 a.m. on Friday, February 23. The leak survey detected three additional Grade 1 leaks and nine non-hazardous spread over an eight-block area (Figure 17) –none of which were in the alley of the 3500 block of Espanola.

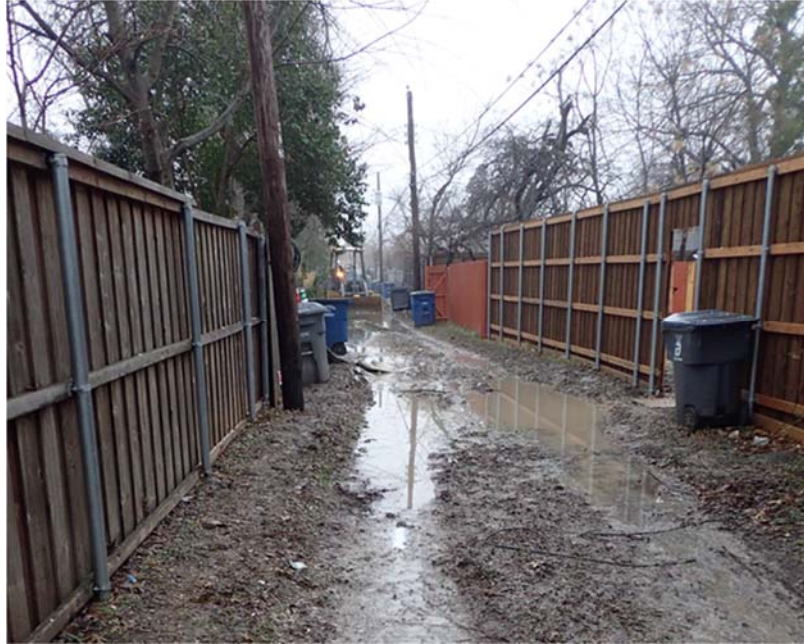
Figure 18 — showing the alley behind 3534 Espanola looking west. The fence on the right-hand side of the photo is behind 3534 Espanola.

It was raining intermittently on Thursday. There was also standing water in the alleys from the historic amounts of rain that Dallas experienced that month as detailed in the Operations Report (Figure 18).⁵⁷ Employees bar hole testing throughout the day and the night made multiple holes to ensure they were able to get readings because water would quickly fill the holes. While scheduled compliance leak surveys are not typically performed in those conditions, the leak survey's results reflected the ability of the equipment to detect leaks.

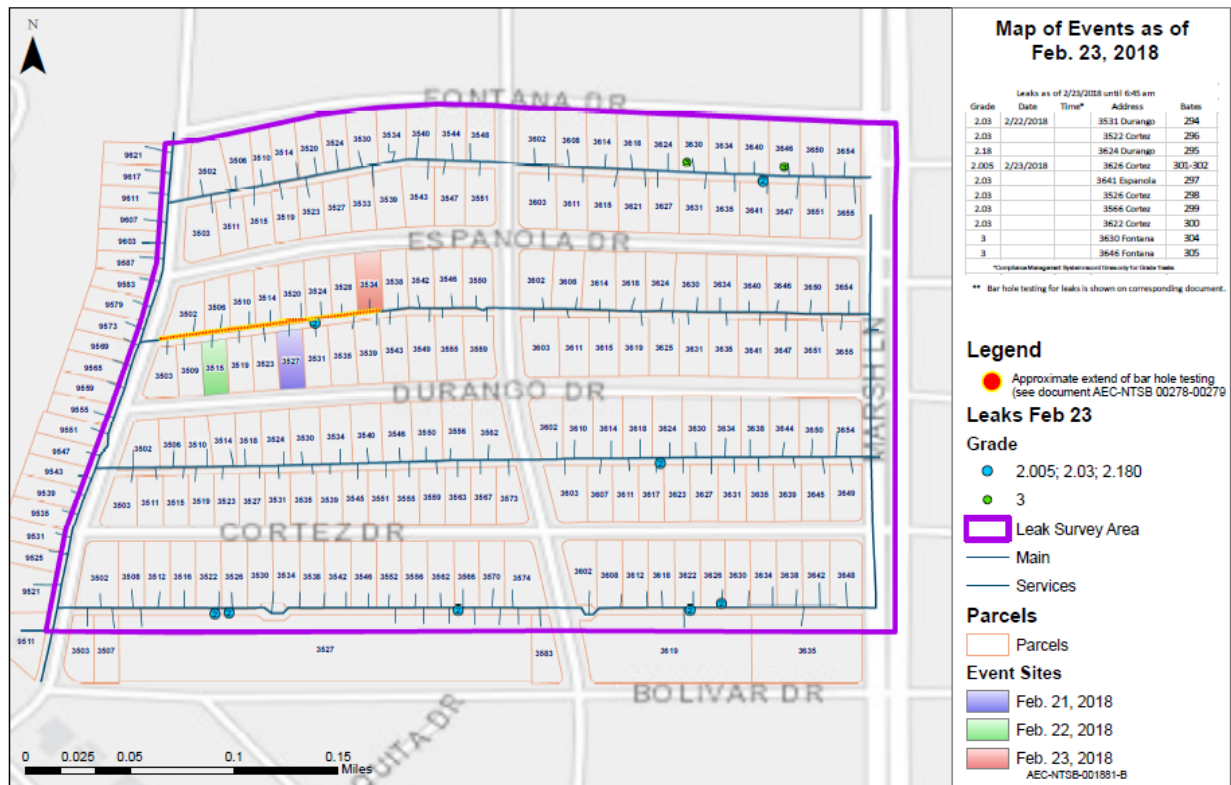
Figure 19 — Map of leak survey area and leaks on February 23, 2018 (Attached as Exhibit E to the Appendix).

Durango and 9583 Larga were continuously monitored and repaired before 3 a.m. on Friday, February 23, 2018 (Figure 19.)

By early morning Friday, Atmos had repaired the hazardous leaks detected in the leak surveyed area. (Figure 19). When asked by NTSB investigators, the Director of Operations confirmed there was no indication that any part of the system— including the main in the 3500 block of Durango Drive/Espanola Drive— should be shut down:⁶² system performance was being monitored and evaluated, and the four hazardous leaks were spread out over 8 blocks. He concluded “we had a survey, we had the leaks identified, we had crews on the leaks....In fact, we had a couple of crews on the Grade 2 30s that actually we had 30 days to fix. . .”⁶³ Operations
