National Transportation Safety Board

ERA24NA237

WRECKAGE IDENTIFICATION

Location: Lake Champlain, Vermont
Date: January 27, 1971
Time: 1955 Local
0055 UTC
Airplane: Aero Commander 1121, N400CP

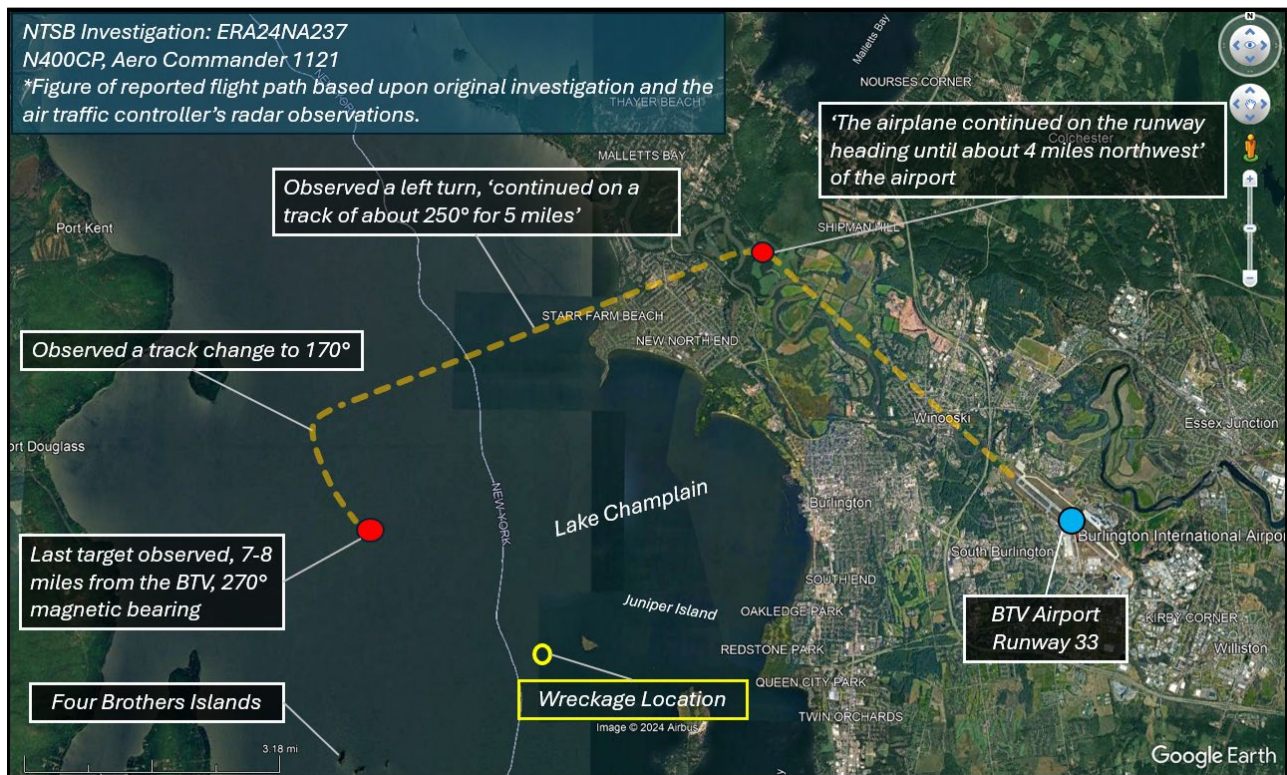
Figure 1 below provides an overview of the reported flight path based upon the original NTSB investigation and the controller's recollection of its radar flight path. The red circles denote the radar reported position per the controller's recollection and the yellow circle denotes the approximate location of the discovered wreckage.

Figure 1: Overview of the reported flight path based upon the original investigation and the newly discovered wreckage approximate location.

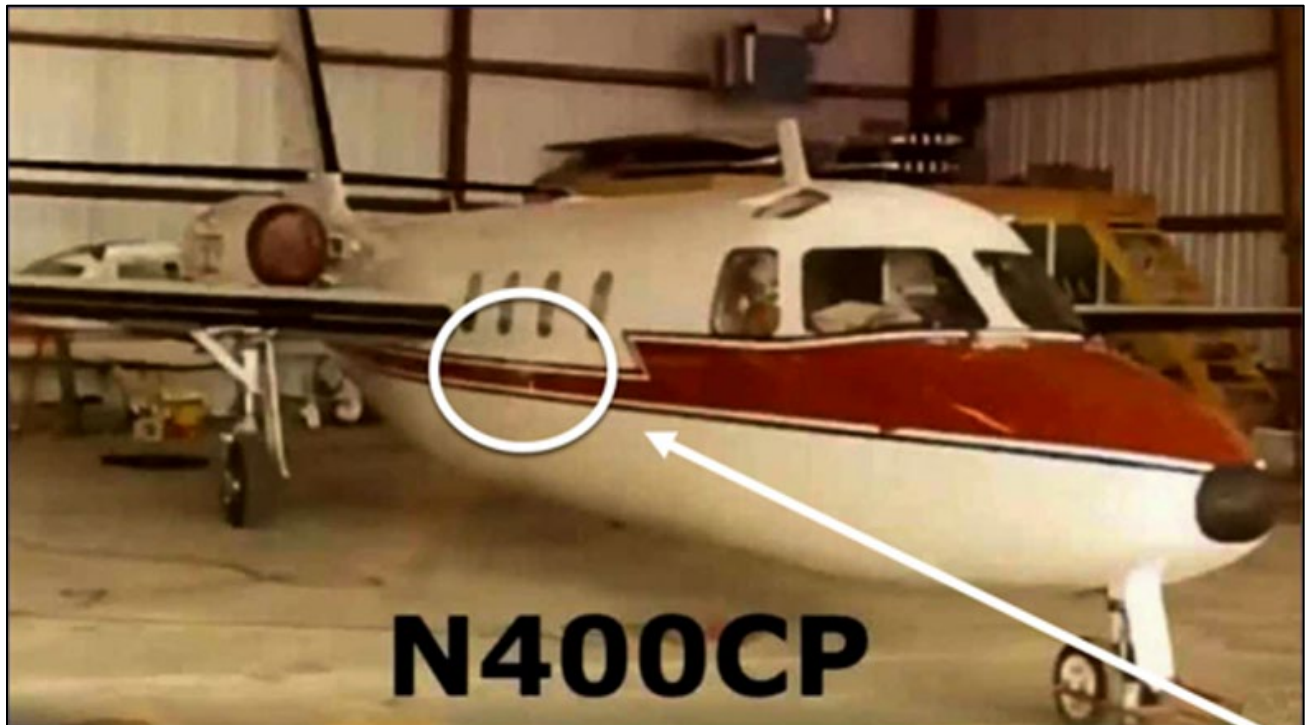
Figure 2: Photograph provided by GK Consulting reportedly showing the accident airplane preaccident at an unknown date.

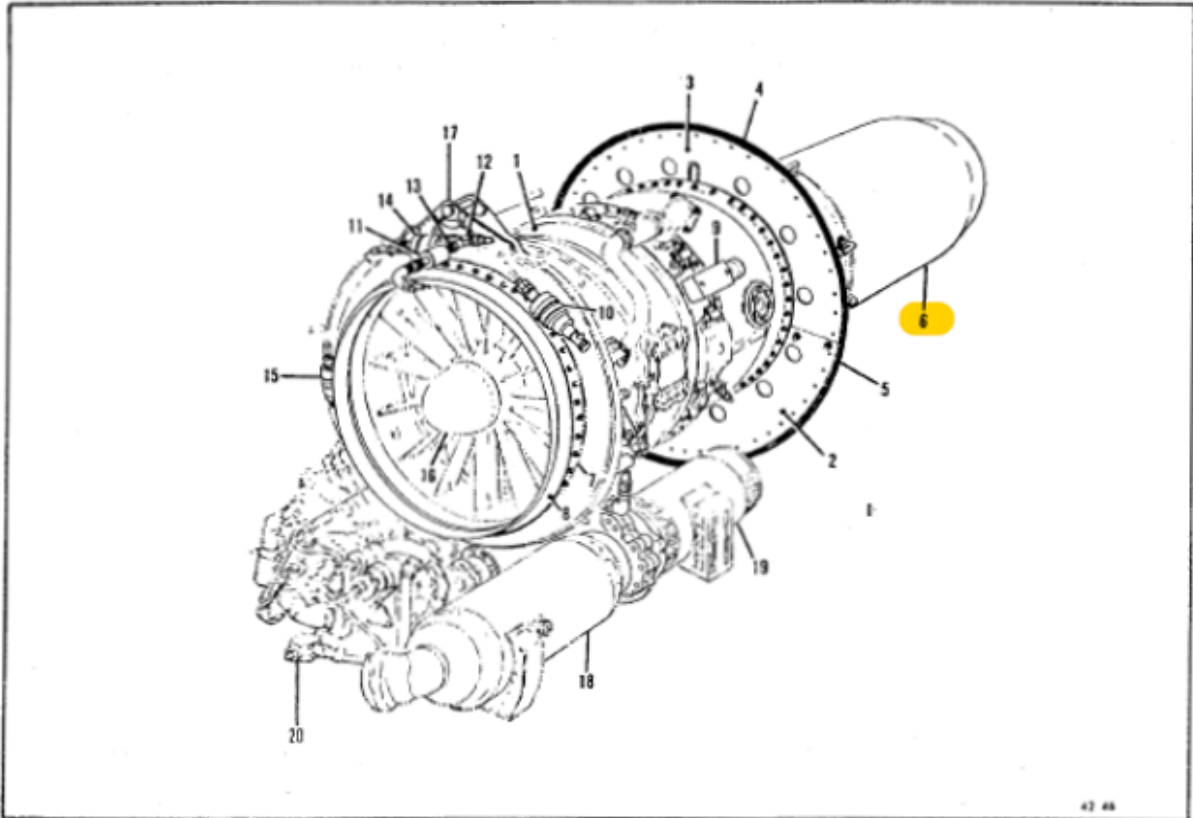
Areas of the engine tail pipe assembly were identified.

Figure 6: Illustrated Parts Catalog Excerpt, Tail Pipe Assembly.

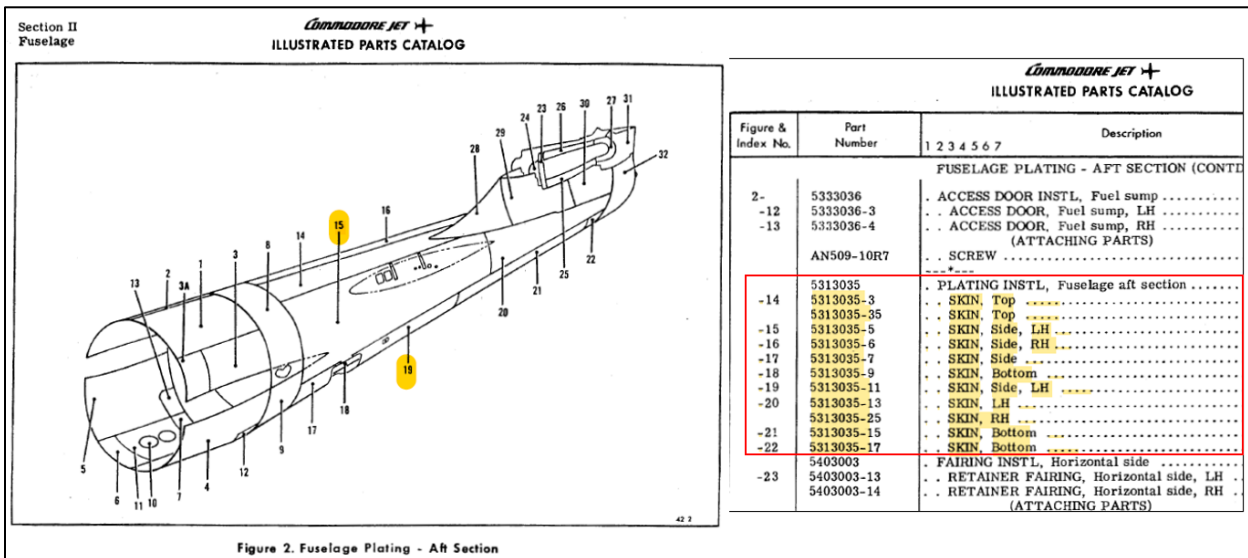
Additional areas of aft fuselage plating were identified near station '403.'

Figure 9: Illustrated Parts Catalog Excerpt, Fuselage Plating

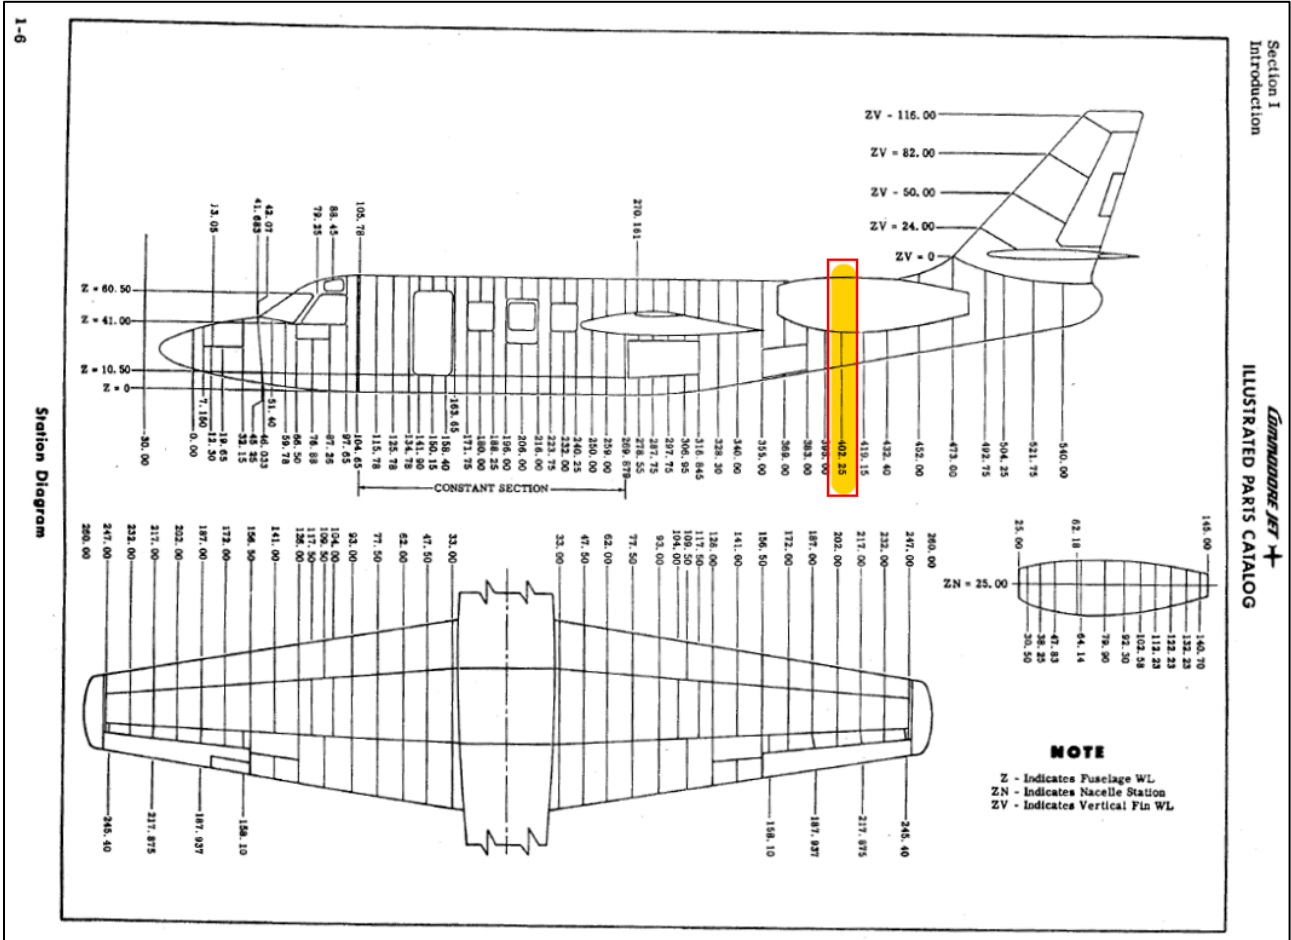
Figure 10: Illustrated Parts Catalog Excerpt, Station Diagram Denoting Position near '403.'
