Product Evaluation Report

Vessel Name: *Capt. Kirby Dupuis*

Engine Model: *3512*

Serial #: *TTF00289*

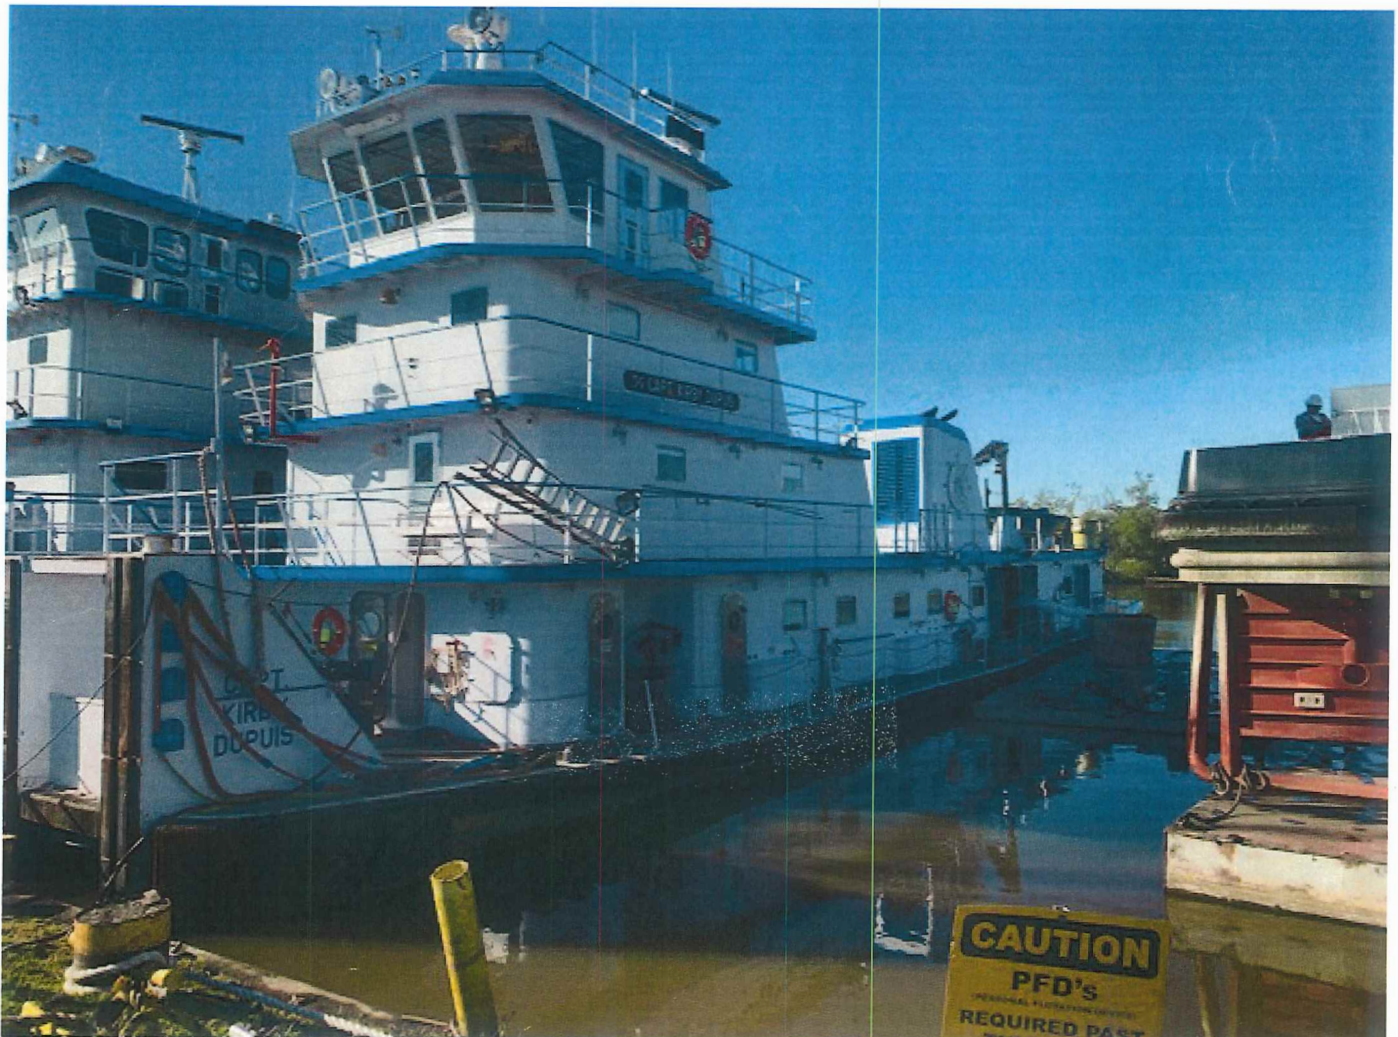
This vessel experienced an engine room fire on 11-09-2021. The fire caused extensive damage to both main engines and the vessels upper and lower levels of the engine room. The fire seems to have started near the front of the port main engine. A video from the vessels camera system shows oil spraying on the floor in the center of the engine room moments before fire erupts on the top, front inboard area of the port main engine.
