# National Transportation Safety Board

Edwardsville, Illinois  
March 11, 2022

## **PIPELINE OPERATIONS/INTEGRITY MANAGEMENT**

Group Chair's Factual Report  
Report Date: October 19, 2023

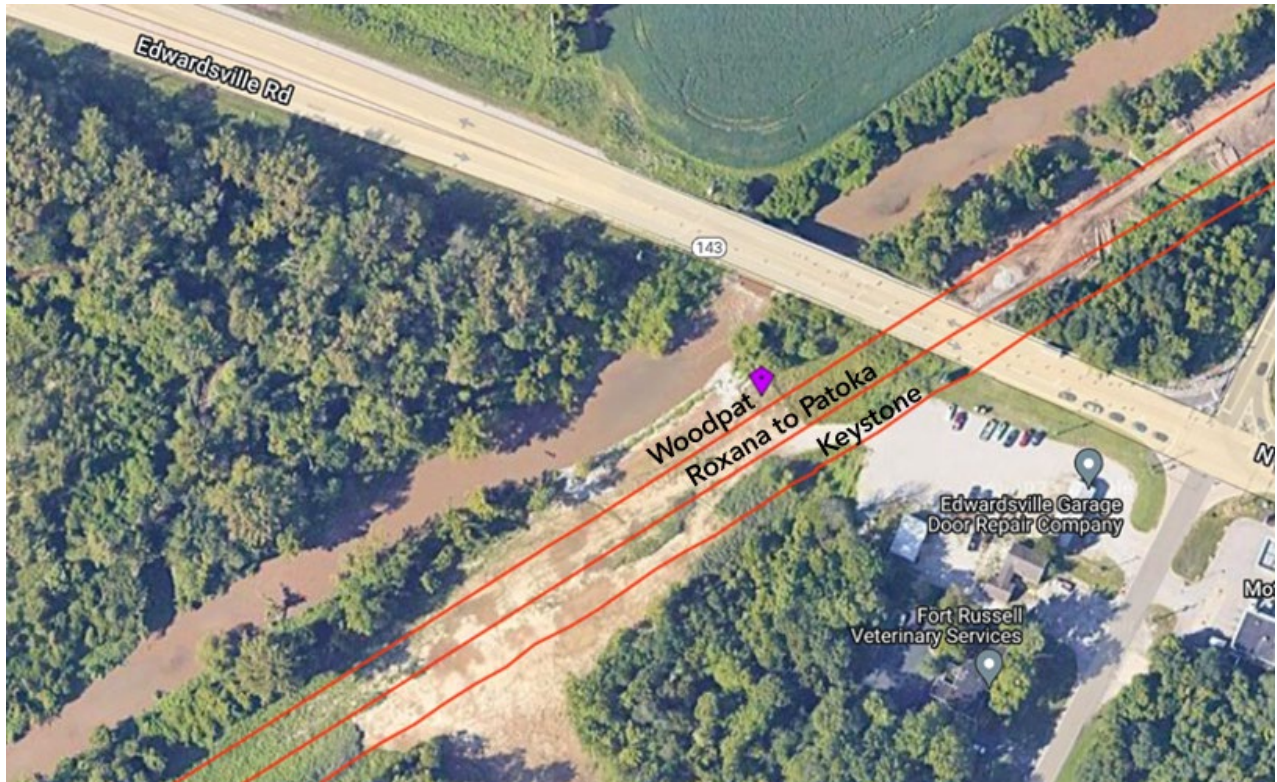
**Figure 3.** The Woodpat 22-inch pipeline, Roxana to Patoka 12-inch pipeline, and Keystone 30-inch pipeline, are shown north to south, in a shared ROW adjacent to the Cahokia Creek, the purple diamond shows the failure location. (Source: National Pipeline Mapping System.)

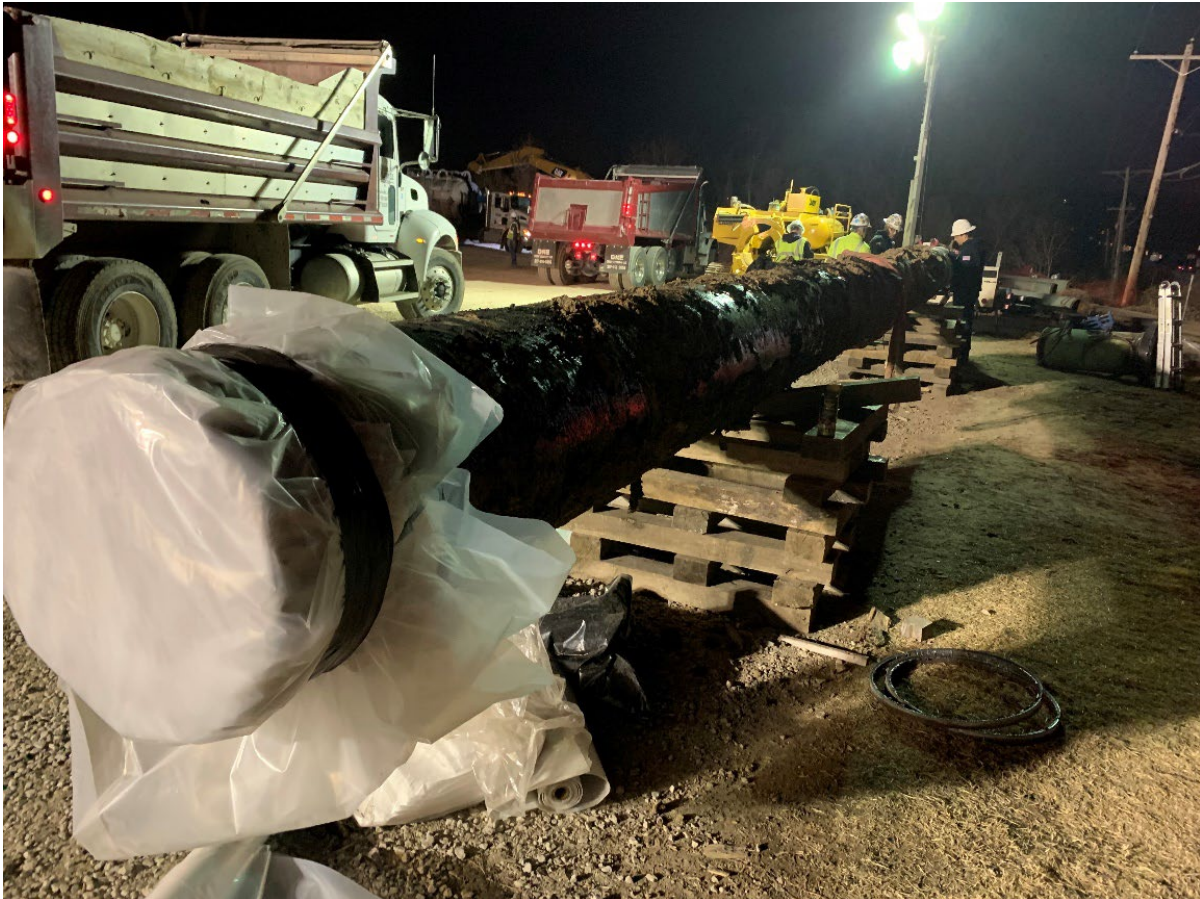
**Figure 7.** Woodpat pipeline section preparing for shipment to the NTSB Materials Laboratory. (March 14, 2022, 9:19 p.m.)

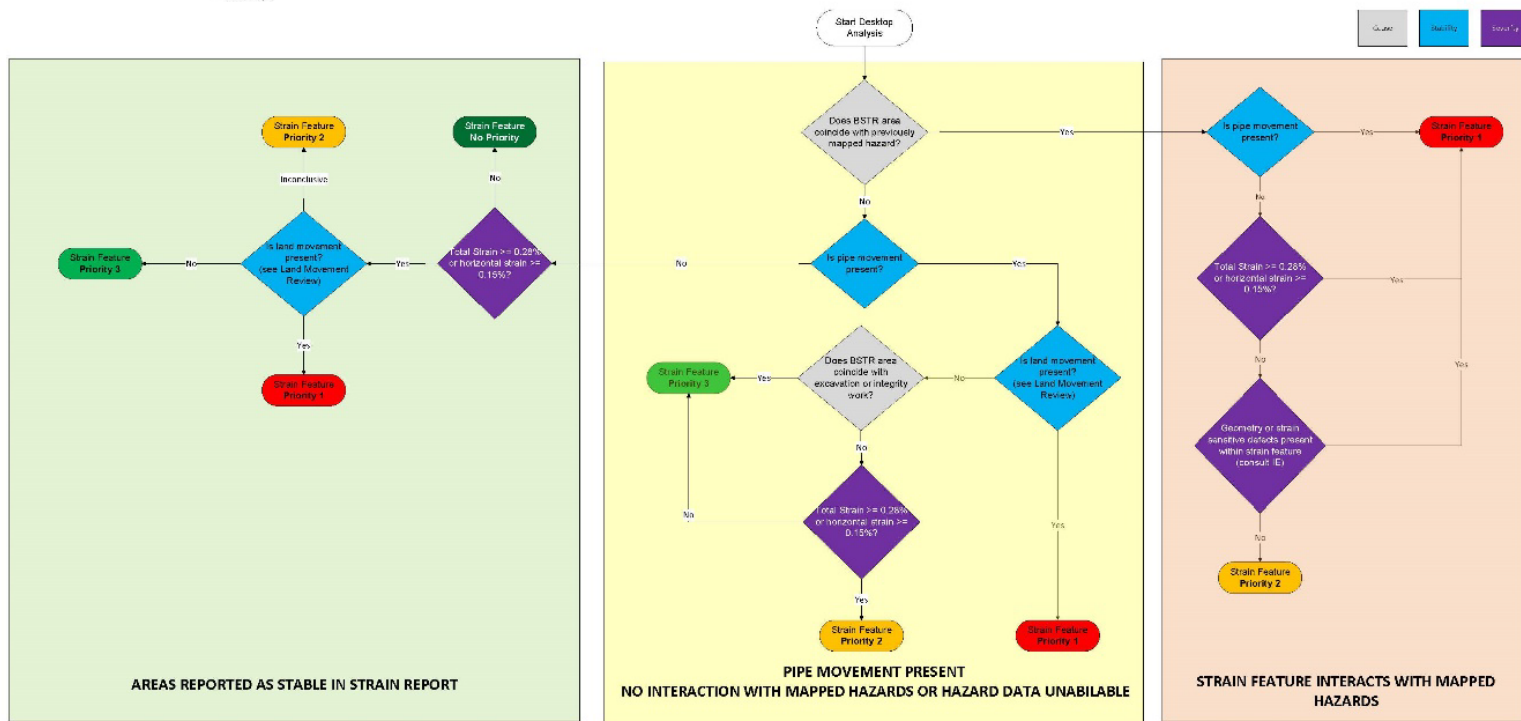
**Figure 10.** Marathon updated strain feature prioritization flow chart. (Source: Marathon.)

To provide an outside review of its geohazard program, Marathon hired third-party geotechnical and engineering consultants to review the program's identification of geohazard threat protocols, strain analysis protocols, and to identify gaps. The consultants found that the matting and riprap placed in 2014 and 2017, to control the erosion occurring along the Cahokia Creek streambank, had little to no impact on preventing or slowing the ground movement. The hydrotechnical analysis determined the cause of the ground movement was due to scouring in the river and large woody debris, which creates localized areas of scouring. Slope stability was also analyzed and Geosyntec reported that in combination with the scouring occurring, there was a reduction of shear strength in the soil. Based on the final report, Marathon's prioritization for immediate action was lowered to 0.28% total bending strain from 0.35%. The lower prioritization level will result in additional site investigations and remediation projects for locations that could be at risk of geohazard-related damage. Marathon also started collecting deviation from straight values during bending strain analysis to be included in the analysis of bending strain features which assists with analysis of baseline IMU runs. Based on the report, Marathon has also expanded the use of LiDAR to proactively identify geohazards threats and formalized the protocol to calculate total strain demand on pipelines from strain features.

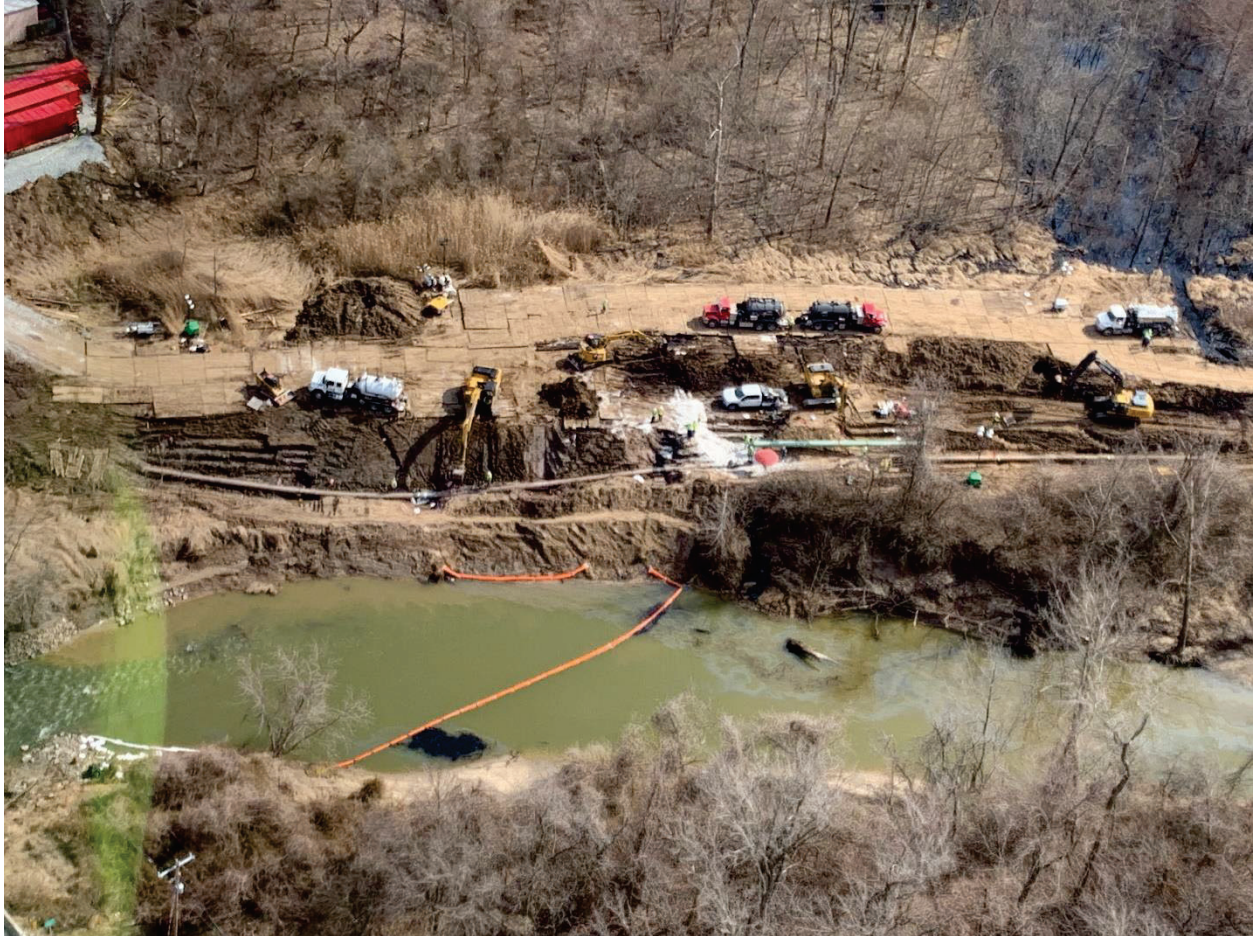
**Figure 1.2: Aerial Image of Failure Location**

The failed pipeline transports refined products from Wood River, IL to Patoka, IL and is referred to as the “WoodPat” system. The incident and subsequent product release occurred because a girth weld failed during operations. Images taken during the remediation of the girth weld failure are shown in Figure 1.1. The image on the left is taken looking upstream across the incident site toward the failed girth weld with Cahokia creek on the right-hand side of the image. The image shows that the WoodPat pipeline experienced both horizontal and vertical displacements. The image on the right-hand side of Figure 1.1 shows an image of the failed girth weld. The pipeline separated both laterally and axially at the failure location. An aerial image of the remediation site is shown in Figure 1.2.

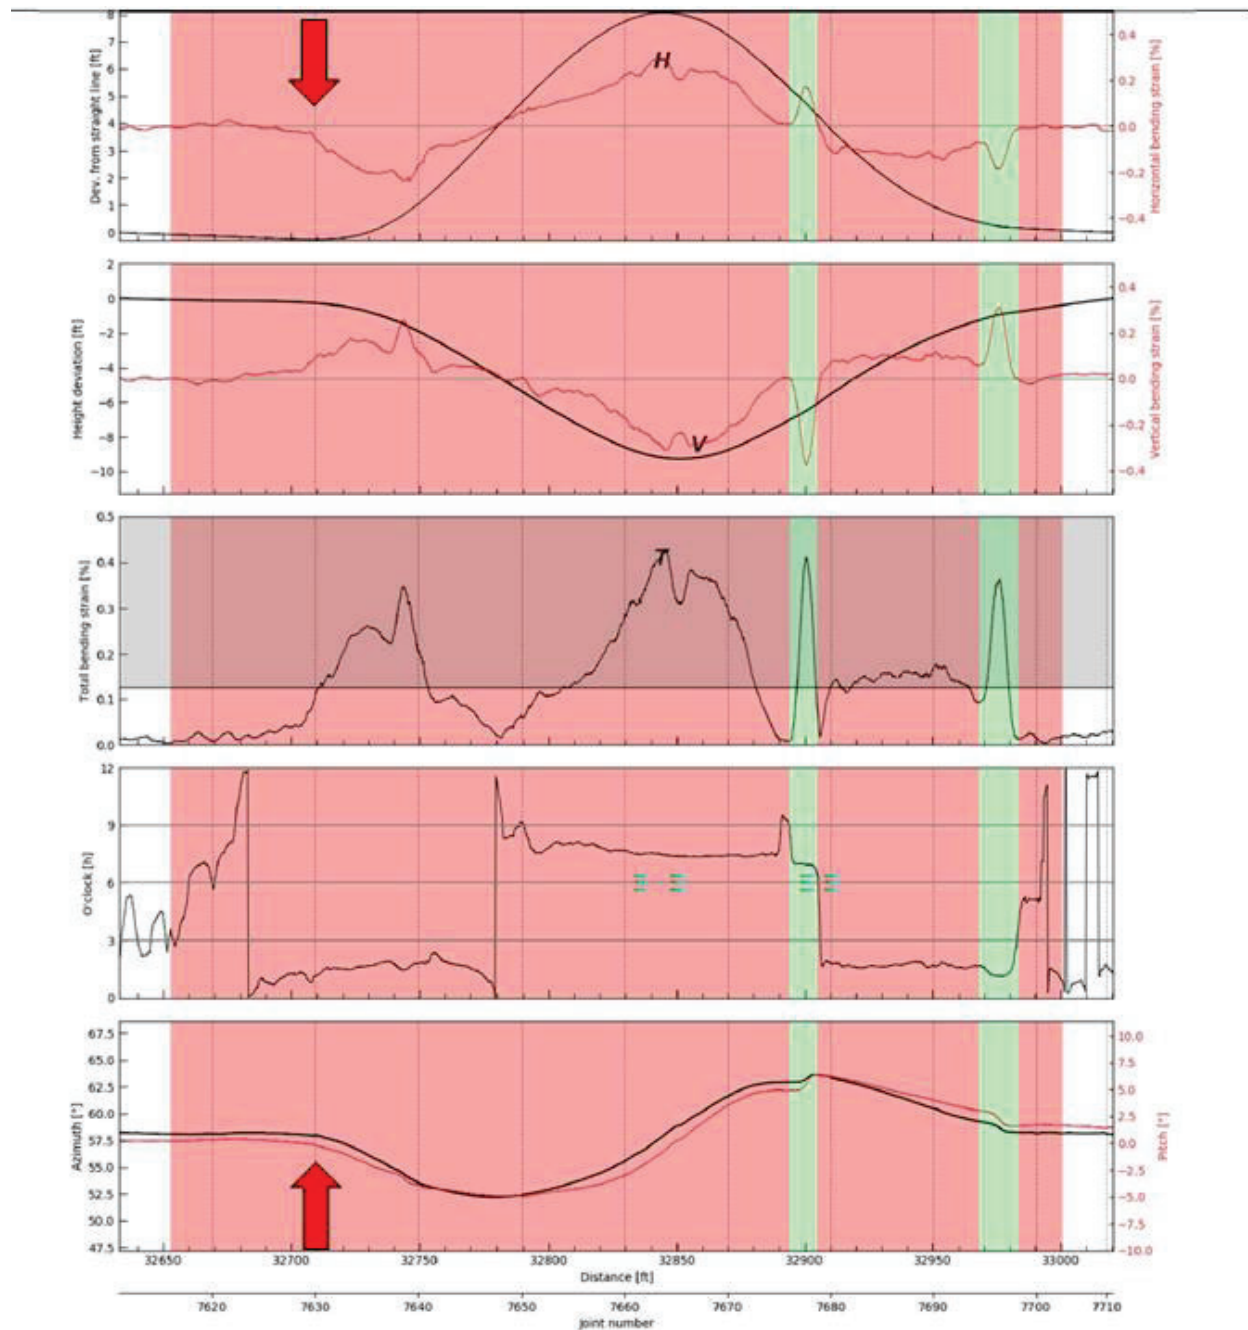
Figure 3.1: Bending Strain Site #7610 (ref: Strain Comparison Report)

The bending strains based on the inspection from October 28, 2021 are reproduced in Figure 3.1. The maximum combined bending strain at this location is 0.41%. The girth weld that failed is #7630, located at odometer 32709.3 ft, and is annotated in the image with the red arrow. The IMU data indicates approximately 8-ft of horizontal deviation from a straight line across the impacted area and 9.3 feet of vertical deviation from a straight line across the impacted area.

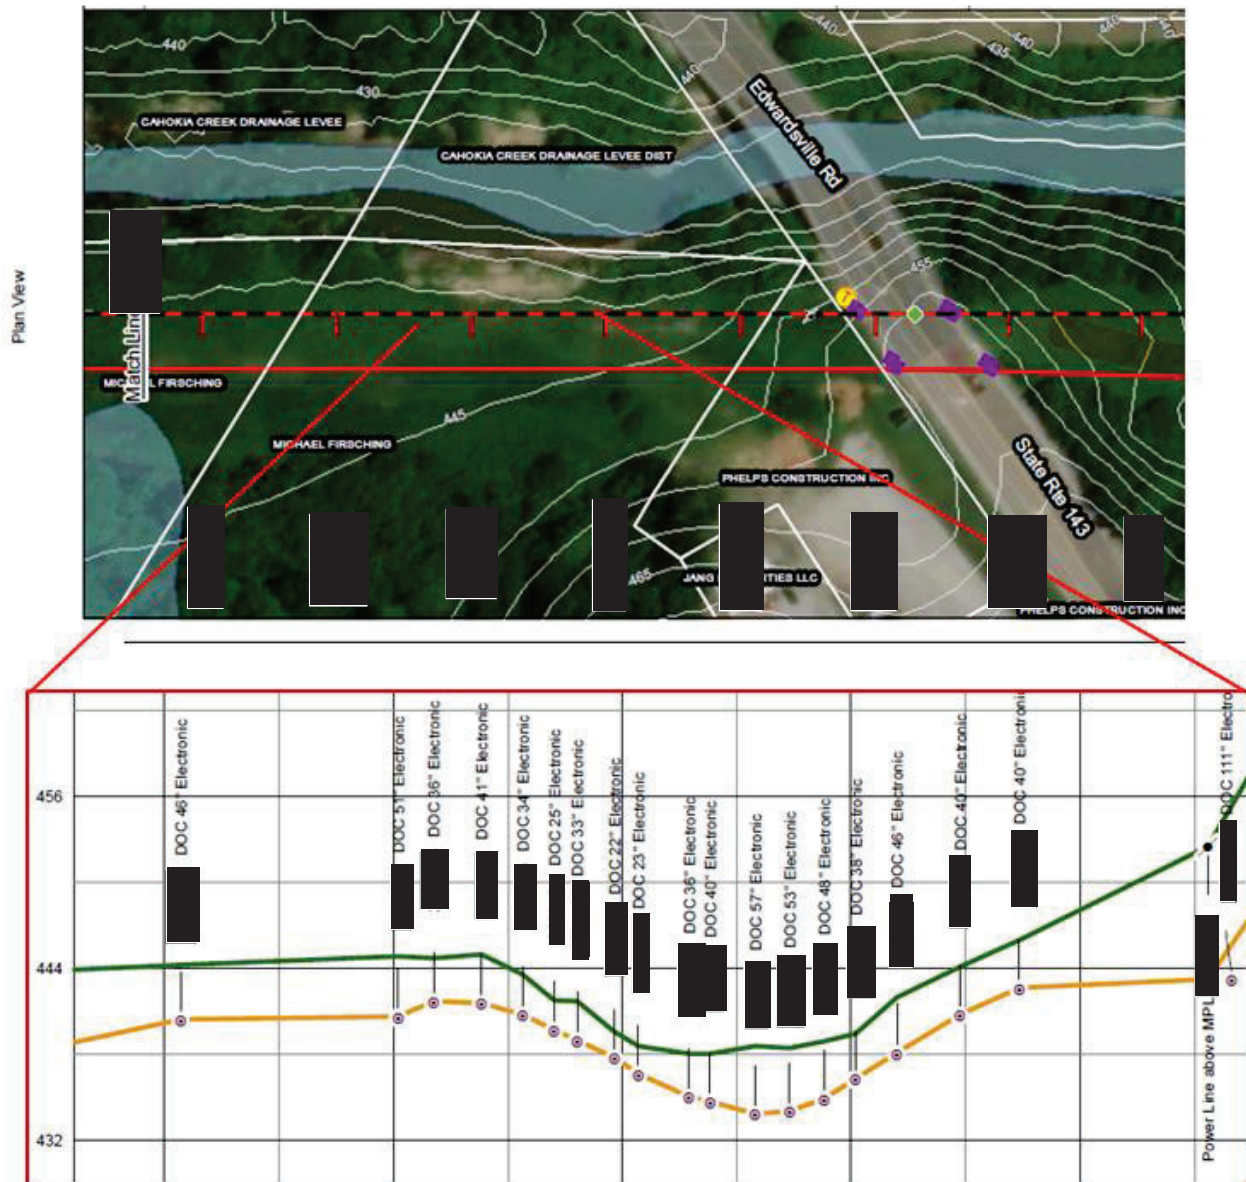
Figure 3.3: Alignment Sheet Information

Information showing the original pipeline construction location from 1949 was not available. Marathon provided alignment sheets with information on the surface elevation, top of pipe elevation, and depth of cover. The information from the alignment sheet near the failure is enlarged in Figure 3.3. This information does not reflect as-built conditions but was collected prior to the incident (the alignment sheet was dated February 18, 2022). The information shows that the ground elevation near the failure was characteristic of a depression with the low-point approximately 4-6 feet lower than the surrounding area. This

information was confirmed by satellite imagery showing a drainage channel crossed over the pipeline near the failure location. The alignment sheet also confirmed the depth of cover near the failure varies from 22 to 57 inches.

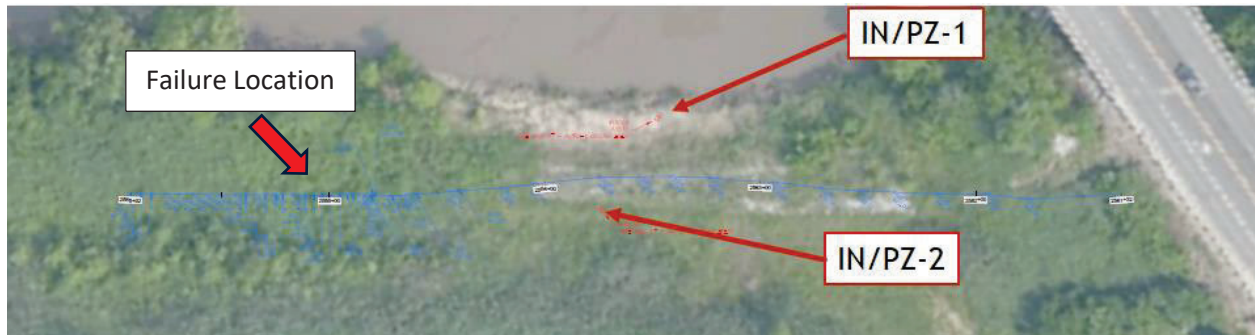
Figure 3.4: Borehole Locations

Soil characteristics were collected from two boreholes located near the failure as shown in Figure 3.4. Based on the depth of cover survey, the soils of interest would occur between 3 and 8 feet deep. An image of the data from the IN/PZ1 borehole is provided in Figure 3.5. The IN/PZ1 borehole shows soft to medium stiff clays at the pipeline depth. The information from the IN/PZ2 borehole is provided in Figure 3.6,

showing soft clay at the pipeline depth. The pocket penetration values for unconfined compressive strength varied from 0.5 to 1 ton per square foot between the two boreholes. The lab results indicated a dry unit weight of 100.3 pcf and a moist unit weight of 125.8 pcf.

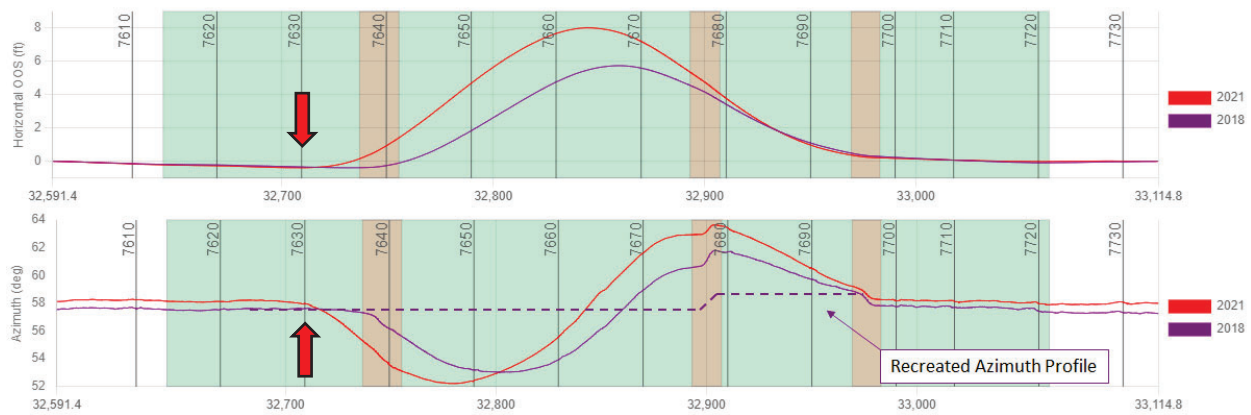
**Figure 4.2: Azimuth Recreation**

Figure 4.2 provides a comparison of the horizontal out-of-straightness profiles and azimuth angles from the 2018 and the 2021 inspections. The 2012 data was not included in the comparison as the heading

angles and out-of-straightness profile were not considered accurate as discussed in the previous section. Both inspections show similar behavior in the azimuth angle consistent with external loads acting on the pipeline. The azimuth angle is approximately 58-degrees near the beginning and end of the bending strain and movement area in both inspections. Two minor 2-degree horizontal manufactured bends appear in the data near odometer 32,900 feet and 39,990 feet. This information suggests that the pipeline was initially laid nearly straight throughout this area with minor deviations. This pattern is typical of most pipelines. Within the displaced area, the azimuth shows a distinct “S”-shaped pattern. This pattern is produced when a pipeline is displaced from its initial location. It is reasonable to conclude that the pipeline was initially laid straight through the area and account for the two minor manufactured bends in the recreated heading profile as shown with a dashed line in Figure 4.2.

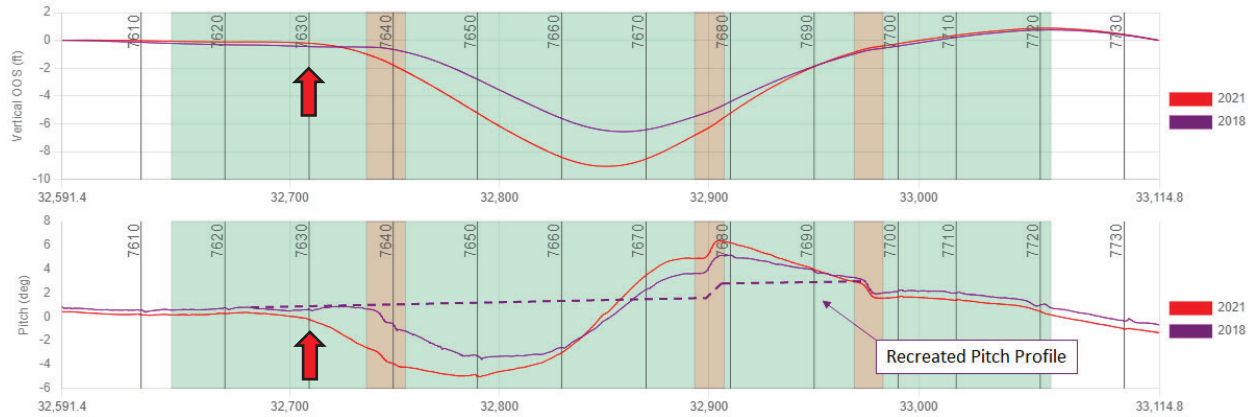
**Figure 4.3: Pitch Recreation**

Figure 4.3 provides a comparison of the vertical out-of-straightness profiles and the pitch angles from the 2018 and the 2021 inspections. Both inspections show similar behavior in the pitch angle consistent with external loads acting on the pipeline. Near the beginning of the movement area, both tools enter with a near-flat pitch of approximately 0.5-degrees and exit the movement area with a pitch of approximately 2-degrees. Within the movement area, three small vertical bends can be seen near odometer 32750 feet, 32,900 feet, and 33,990 feet. These vertical bends form an overbend-sagbend-overbend combination that is typical of pipeline construction at shallow crossings. The presence of these vertical manufactured bends confirms the information from the depth of cover assessment that showed a shallow drainage area at this location. It is reasonable to conclude that the pipeline was constructed with shallow bends to cross the drainage. Similar to the azimuth heading angles, the pitch angles in both inspections show the characteristic “S” shape within the movement area as a result of external loads. The recreated pitch profile is shown in Figure 4.3 with the dashed line. The recreated profile preserves the manufactured bends near 32,900 feet and 33,990 feet.

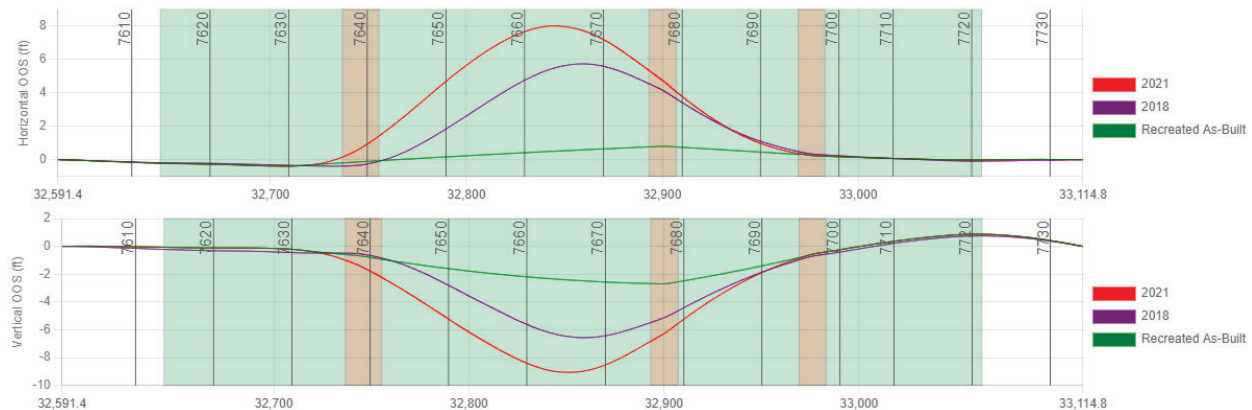
**Figure 4.4: Recreated Out-of-Straightness Profiles**

The resulting as-laid condition used for the baseline is shown in Figure 4.4 for both the horizontal and vertical profiles. The recreated as-built profile is shown as a green line. The horizontal out-of-straightness shows a near straight trajectory with less than 1-ft of deviation, and the vertical out-of-straightness shows an initial vertical change of approximately 3-ft. This agrees well with the depth of cover information which showed similar deviations in the ground elevation near the drain crossing.

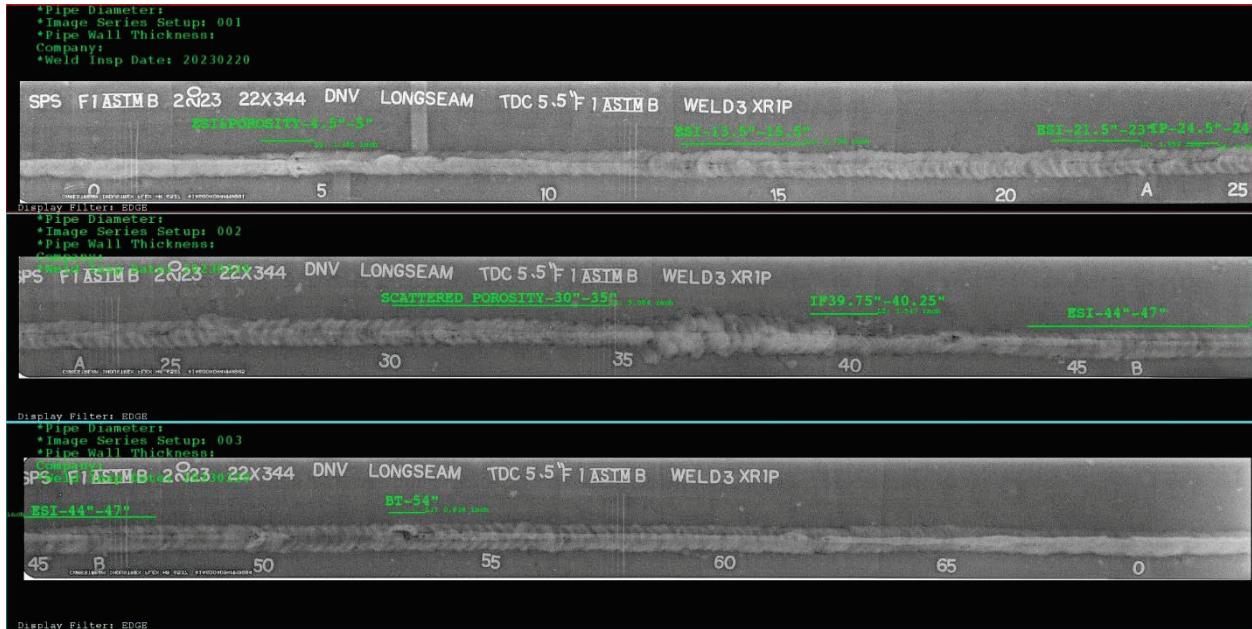
Figure 3: RT image of intact girth weld.

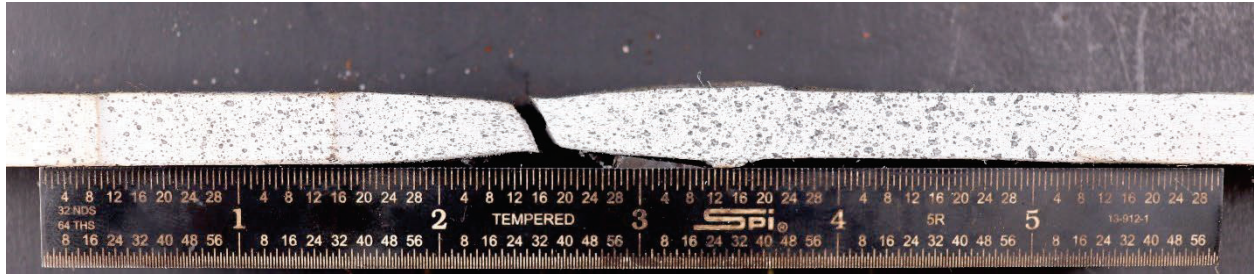
Sample	Yield Strength (psi)	Tensile Strength (psi)	Elongation (%)
Pipe Body, Longitudinal, Upstream Pipe	51,200	82,600	30.0
Pipe Body, Longitudinal, Downstream Pipe	55,700	82,000	30.0
API 5LX, Grade X46 5 <sup>th</sup> Edition (1954)	46,000 (min)	63,000 (min)	23.5 (min)
Cross Girth Weld 1 (12:00)	---	69,400 <sup>1</sup>	---
Cross Girth Weld 2 (3:00)	---	69,400 <sup>1</sup>	---
Cross Girth Weld 3 (6:00)	---	81,200 <sup>2</sup>	---
Longitudinal, 3/4" wide reduced sections <sup>1</sup> Failed in base material, <sup>2</sup> Failed in girth weld or HAZ

Figure 4: 12:00 o'clock orientation cross girth weld tensile.

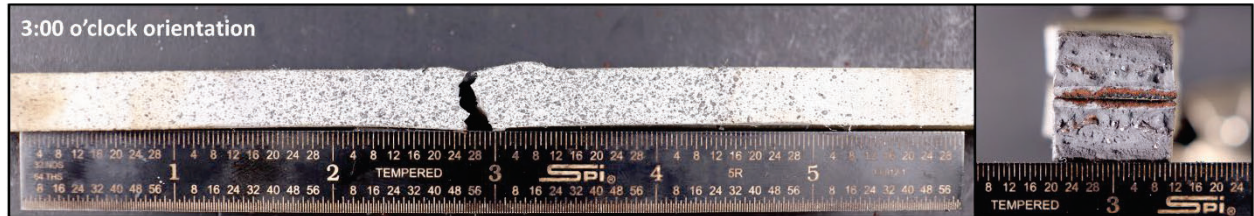
Figure 5: 3:00 o'clock orientation cross girth weld tensile.

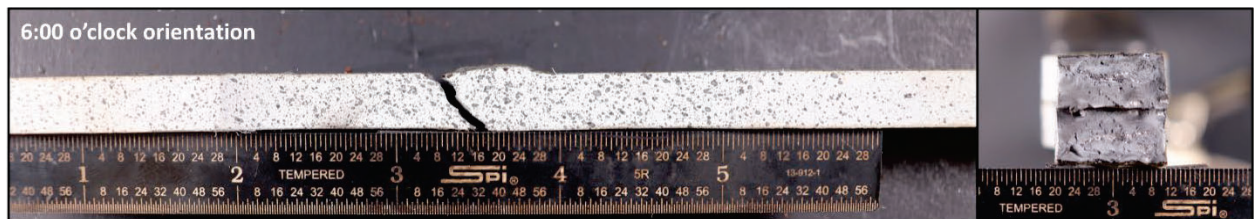
Figure 6: 6:00 o'clock orientation cross girth weld tensile.

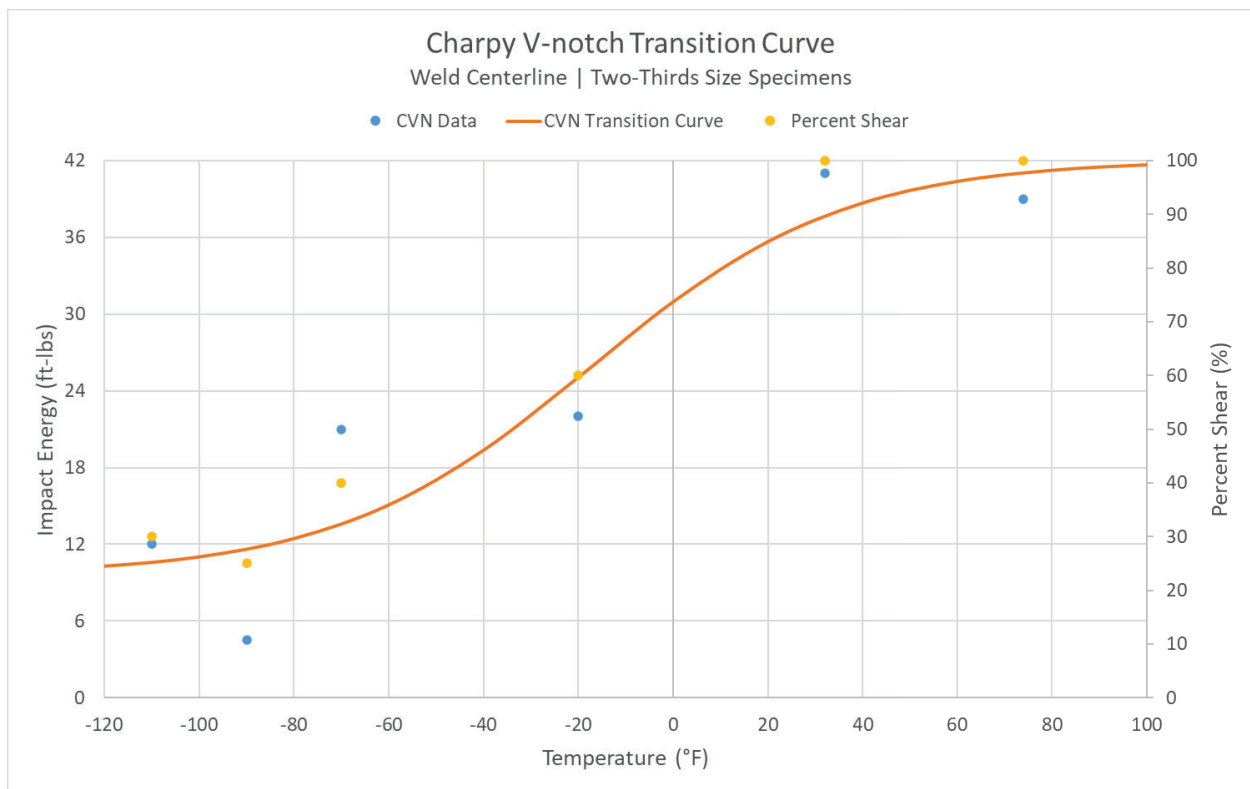
Location	Specimen	Temperature	Absorbed Energy (ft-lb)	Approx. Full-Size Equivalent Absorbed Energy (ft-lb)	Percent Shear (%)
Weld Centerline	1	-110	12	17.9	30
	2	-90	4.5	6.7	25
	3	-70	21	31.3	40
	4	-20	22	32.8	60
	5	32	41	61.2	100
	6	74	39	58.2	100
Weld HAZ	1	-70	4	6.0	10
	2	-20	8	11.9	40
	3	32	34	50.7	60
	4	74	37	55.2	70
	5	120	41	61.2	80
	6	170	49	73.1	100

**Figure 7: Girth weld centerline CVN transition curve.**

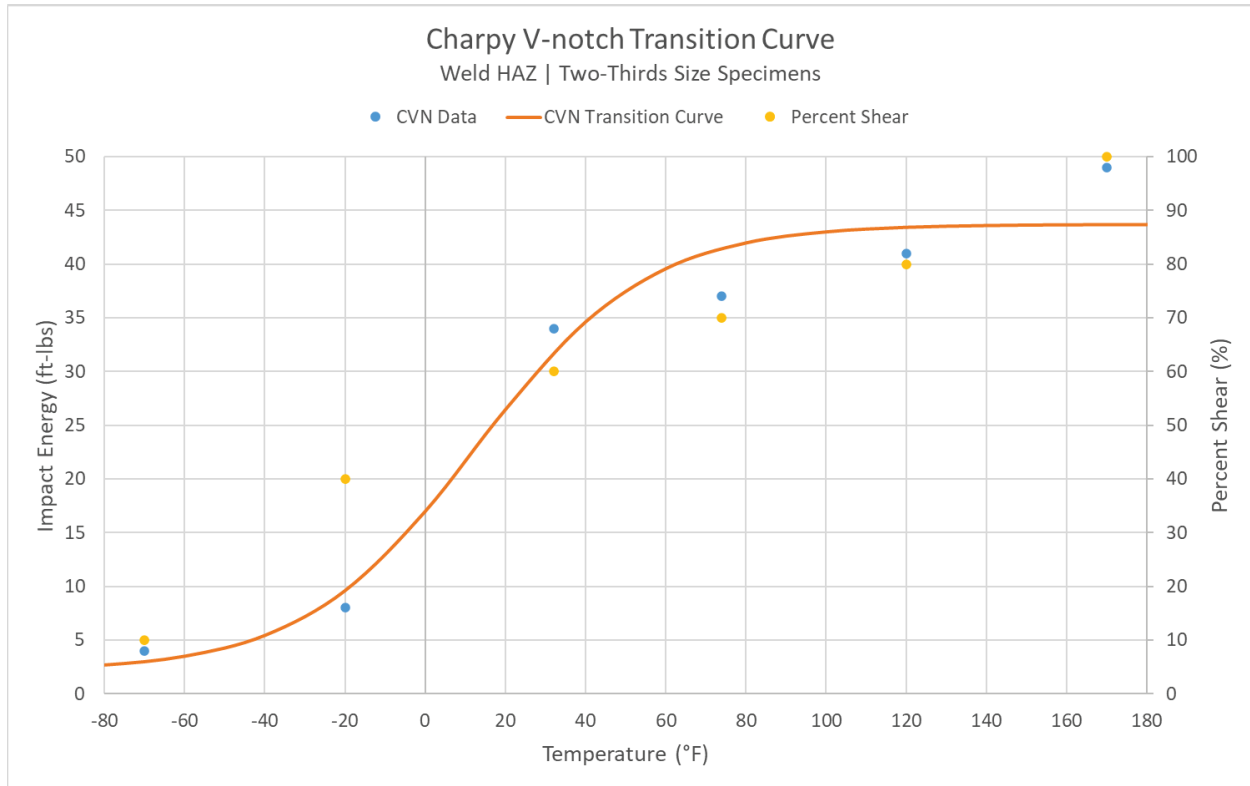
**Figure 8: Girth weld HAZ CVN transition curve.**

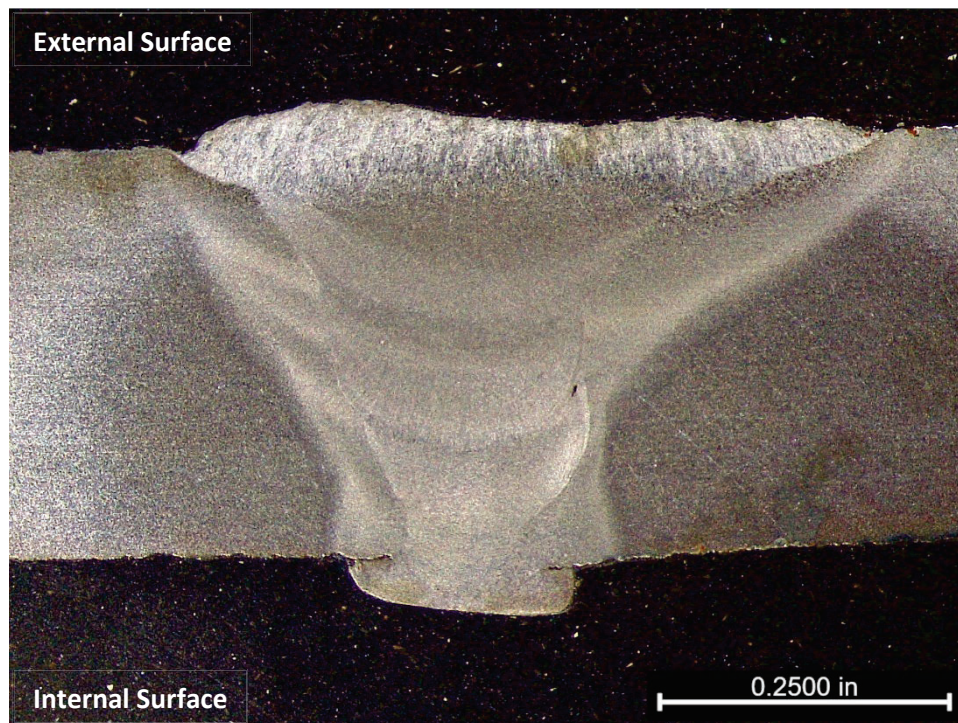
Full hardness maps were performed on the cross sections at a 500-gram load (HV0.5). Images of the hardness traverse are shown in Figure 14 and Figure 15, respectively. No evidence of widespread heat affected zone softening was identified. ADV further calculated a weld strength factor (weld strength / pipe strength) for each macro: both were approximately 0.95. The full hardness reports are attached in Appendix B.

Figure 9: Photomicrograph of across the intact girth weld at the 12:00 o'clock orientation. Etchant is 2% Nital; original magnification is 0.6x.

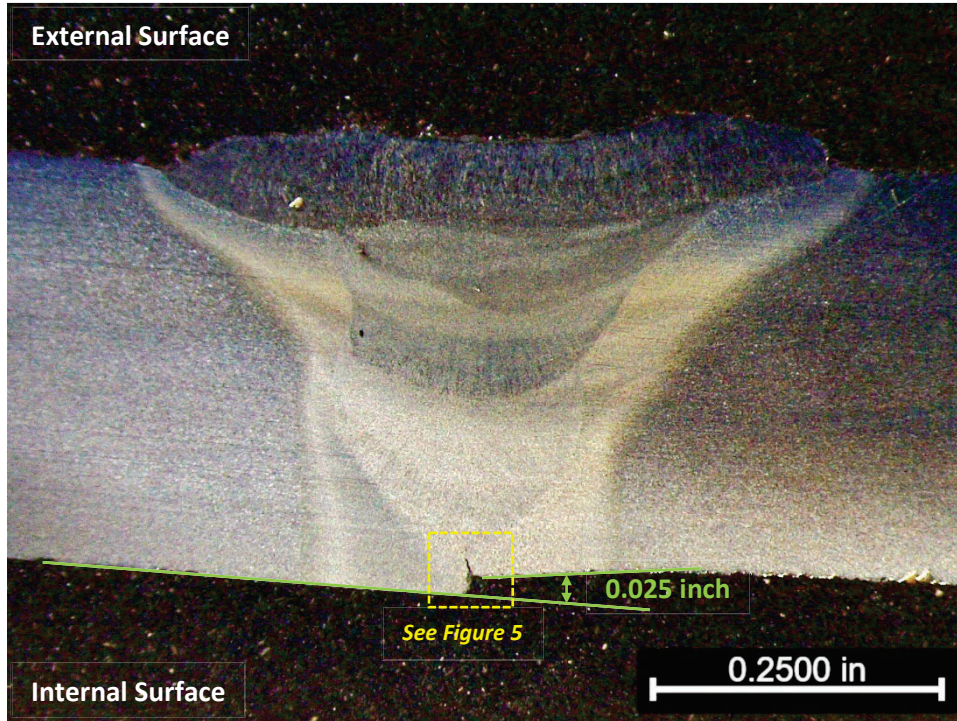
Figure 10: Photomicrograph of across the intact girth weld at the 3:00 o'clock orientation. Etchant is 2% Nital; original mangification is 0.6x.

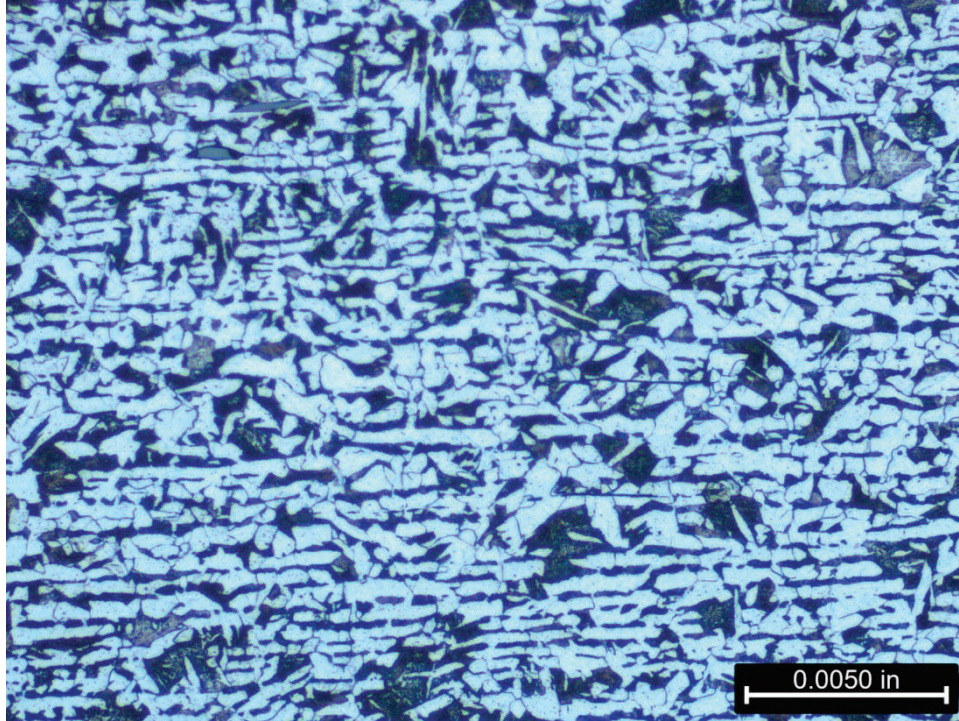
o'clock orientation is shown in Figure 11. An area of incomplete penetration was identified connected to the high-lo present. The base pipe microstructure on both sides of the girth weld is consistent with a ferrite-pearlite mixture expected for carbon steel, shown in Figure 12 and Figure 13.

**Figure 12: Photomicrograph of the base pipe material upstream of the girth weld. Etchant is 2% Nital; original magnification is 200x.**

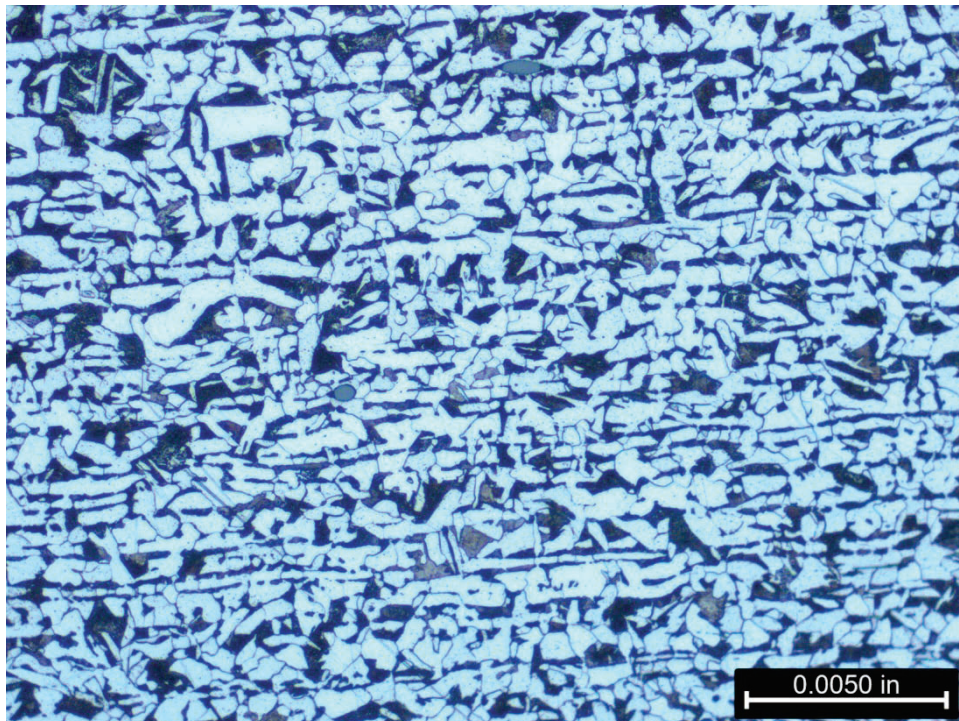
**Figure 13: Photomicrograph of the base pipe material downstream of the girth weld. Etchant is 2% Nital; original magnification is 200x.**

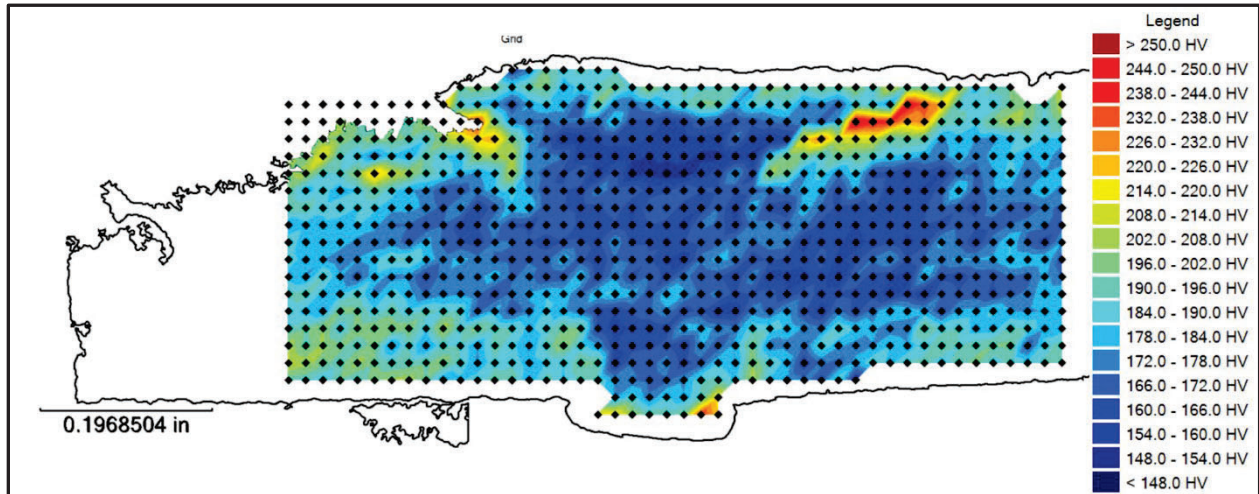
Figure 14: HV0.5 hardness map of weld, 12:00 o'clock orientation.

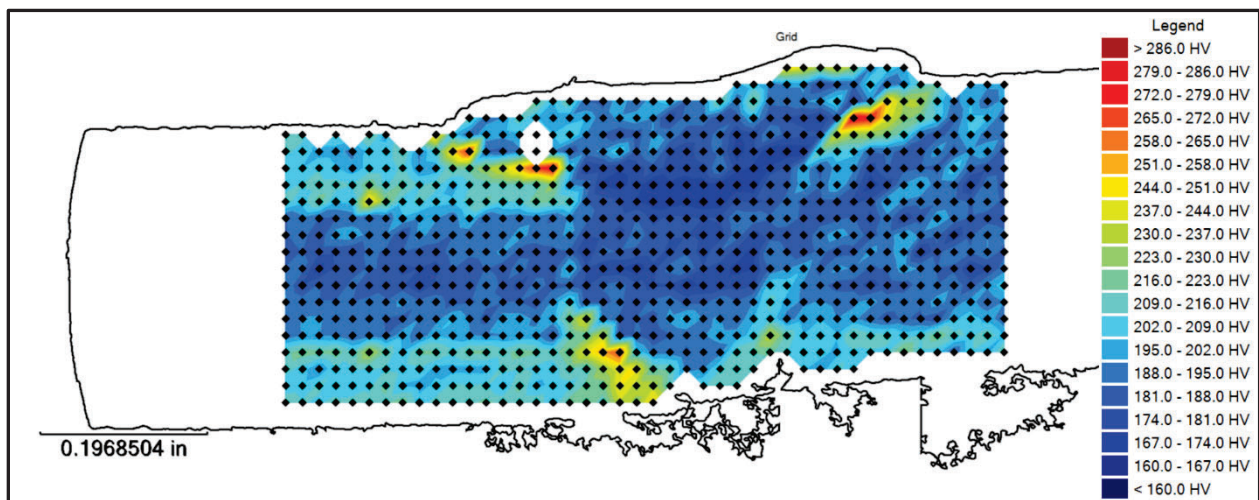
Figure 15: HV0.5 hardness map of weld, 3:00 o'clock orientation.

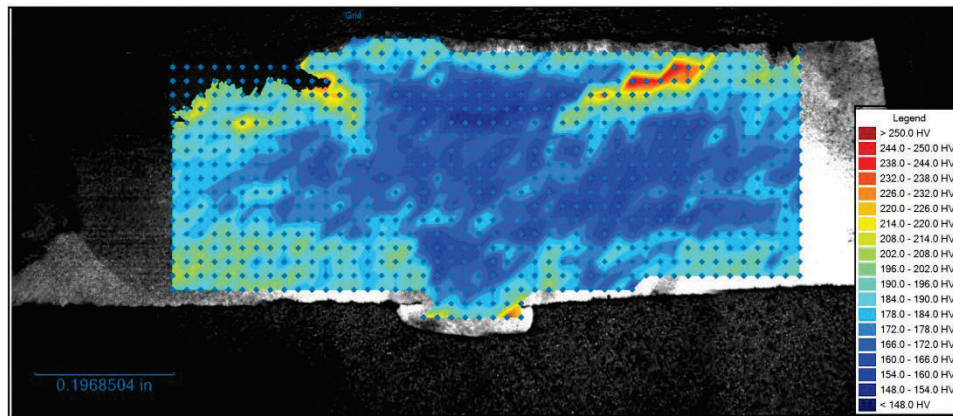
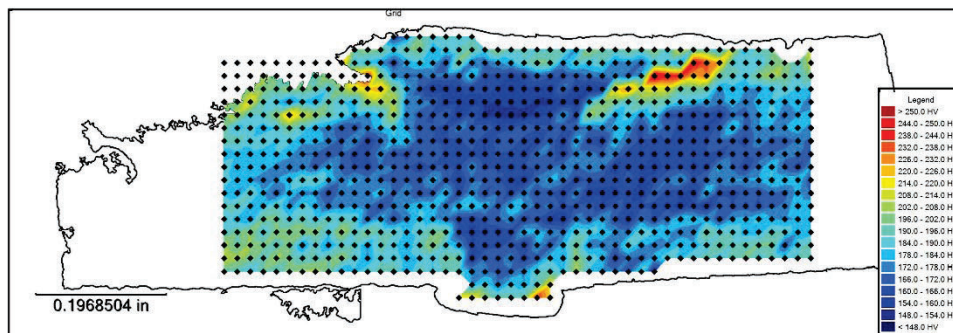
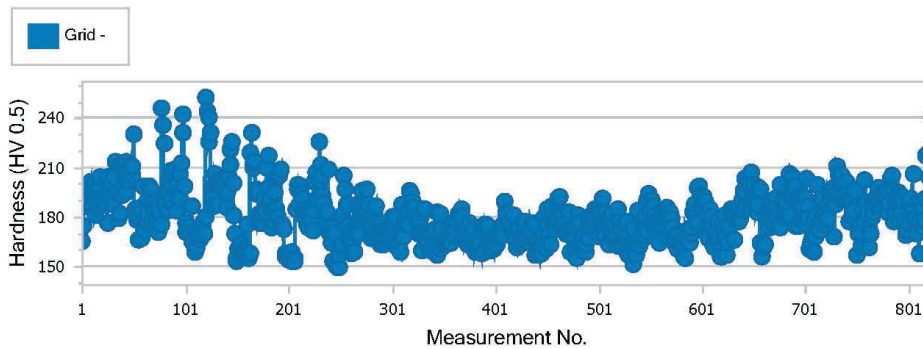
ADV PN 100794 12:00 o'clock

Mean	Minimum	Maximum	Range	Std. deviation
180.3	149.4	252.2	102.9	15.9

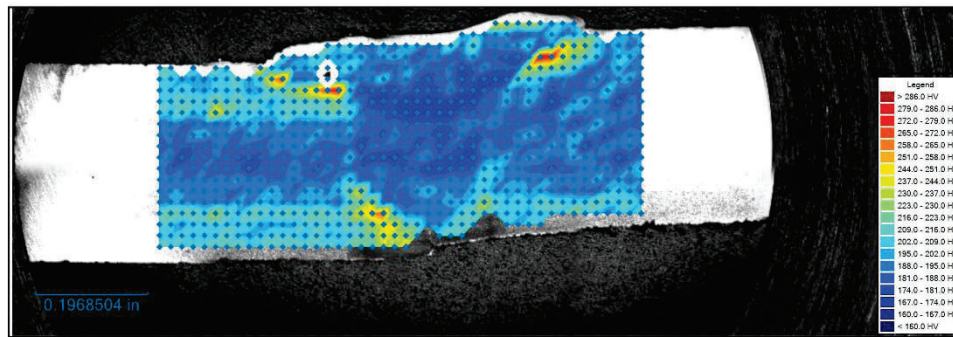
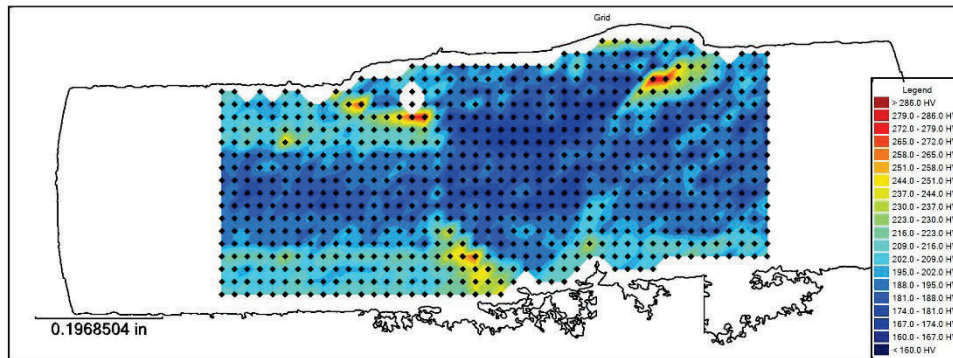
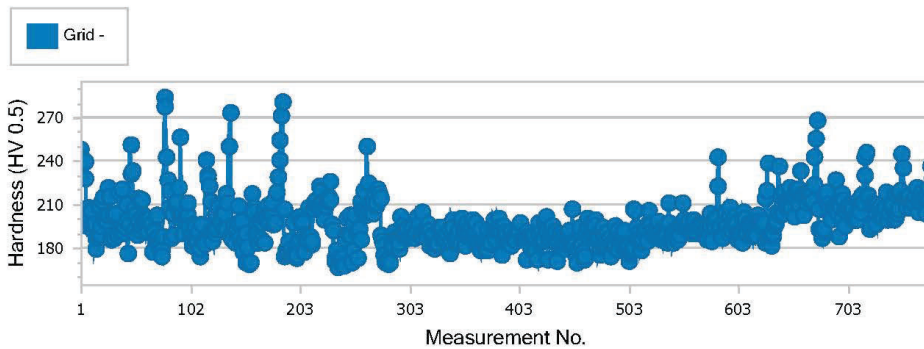
ADV PN 100794 3:00 o'clock

Mean	Minimum	Maximum	Range	Std. deviation
197.2	166.4	283.7	117.3	16.9
