## **EL PASO LINE 2000 CONVERSION**

## Response to NTSB Request from Kinder Morgan

SUBJECT: Line 2000 Hydrotest Ruptures

Hydrotesting Line 2000 during the months of August and September produced four ruptures at MPs 487.5, 493.1, 496.9, and 498.6. All of the ruptured pipe sections were submitted to the Metallurgy Lab for analysis. Although operational background information on this line is unavailable, the pipe is nominally a 30 inch OD, 0.303 inch wall thickness, X70, manufactured by Bergrohr.

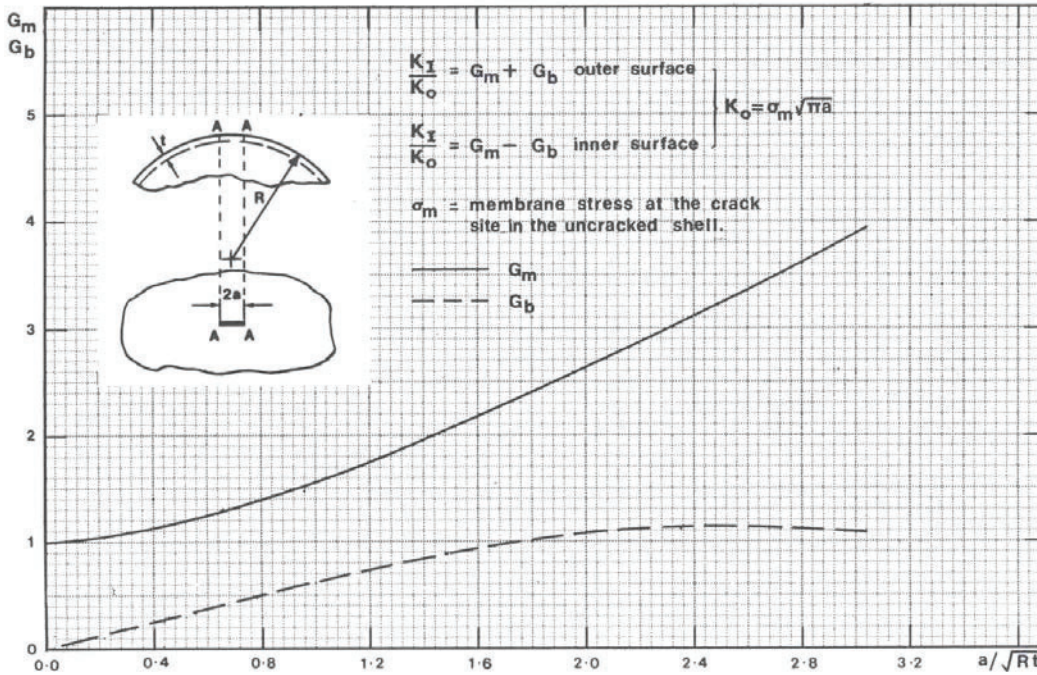
Using the fracture mechanics approach used in the hydrotest failure investigation on this same line at MP 945.1 (report dated June 13, 2002), a circumferential lamination of width (2a) is used to model the pipe defect and its influence on rupture behavior during hydrotesting (see Figure 2). The membrane stress represents the hoop stress and the parameters,  $G_m$  and  $G_b$ , can be computed based on the flaw size width (2a), pipe radius (R), and pipe wall thickness (t). Utilizing the actual hydrotest rupture pressure of 1294 psi for MP 498.6,  $K_I$ , and the stress intensity factor for the outer and inner membrane surfaces can be calculated. Although the boundary conditions for plane strain conditions are not satisfied for these pipe dimensions, conservative predictions of the critical stress intensity factor can be determined. For this case,  $K_I$  for the inner pipe surface was 58.8 ksi (in.)<sup>1/2</sup>, while the outer pipe surface was 75.6 ksi (in.)<sup>1/2</sup>. The difference in stress intensity magnitude suggests that the rupture initiated in the outer membrane first along the lamination interface and progressed to the inner membrane as the longitudinal interface grew radially and axially.

Figure 2. The stress intensity relationship for a crack in a spherical shell subjected to a uniform membrane stress. Ref: D. P. Rooke and D. J. Cartwright, Compendium of Stress Intensity Factors, Hillingdon Press, Uxbridge, 1974, p. 328.
