National Transportation Safety Board

WPR22FA196

VIDEO STUDY

February 2, 2023

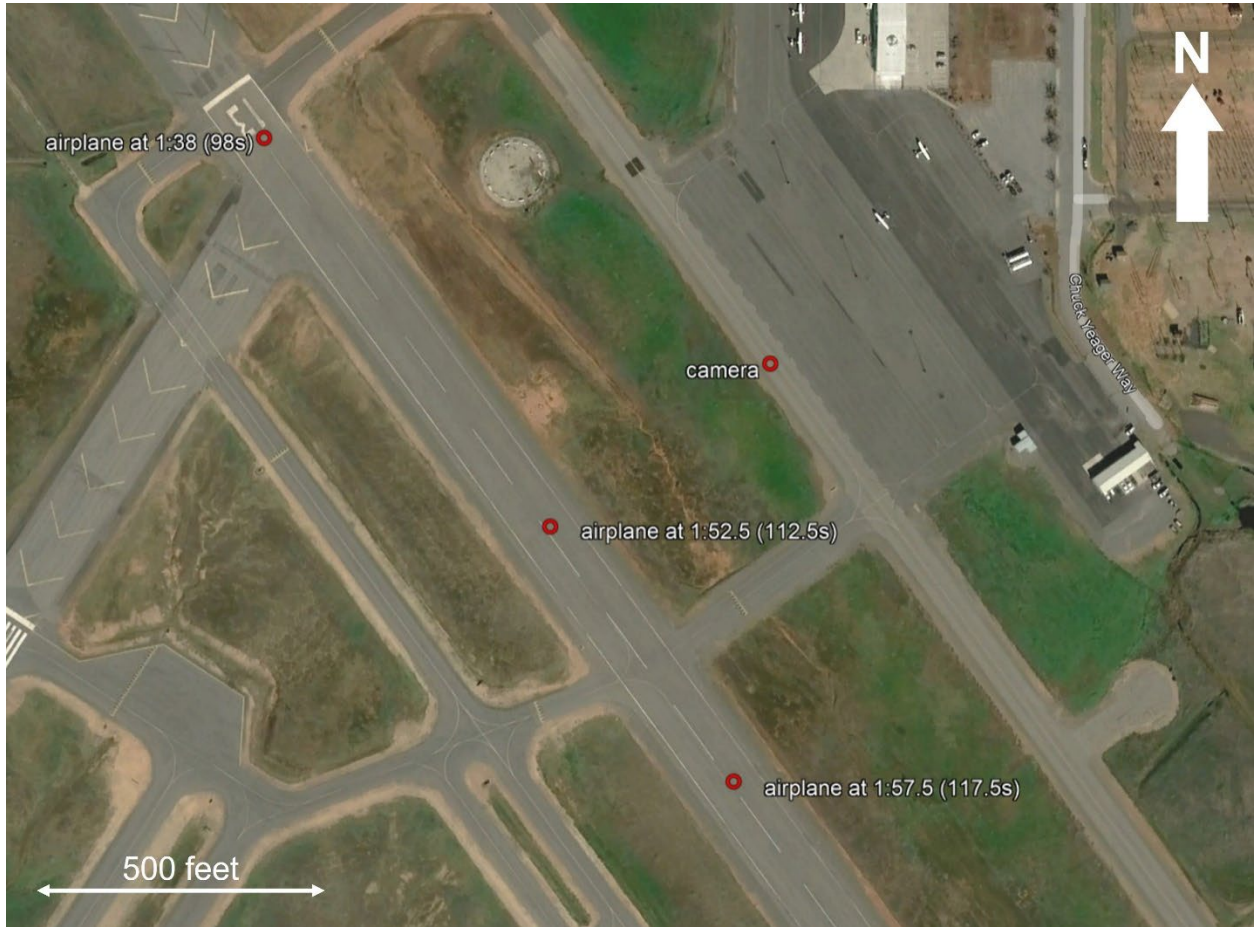
The analysis was based on a video that was recorded with a hand-held phone. The video had 1920x1080 resolution and frame rate of 60 frames per second (fps). The video lasted 150 seconds. The airplane started its takeoff roll at video time 75 seconds and it lifted off at about time 115 seconds. The airplane was last in the field of view of the camera at time 141 seconds. Past that time, the camera holder's voice recorded in the video indicated that he knew that the airplane was experiencing problems and he stopped filming it. The audio in the video was sampled at the rate of 48,000 samples/second. Figure 1 shows an aerial view of the accident area. It shows three locations of the airplane that was taking off on runway 13. The locations are labeled with the video times when the airplane was there.

Figure 2 shows the sound signal intensity and its root mean square (rms) value during the 150-seconds-long video. The rms has its maximum value at about video time 114 seconds, just past the time when the airplane was closest to the camera as seen in Figure 1. Past 114 seconds, the airplane was moving away from the camera and, therefore, decreasing sound intensity was expected. However, Figure 2 shows

Figure 1. Aerial view of the accident area
