Metallurgical Investigation Final Report

Subject: Metallurgical Investigation of Fan Blades from PW4077 Engine SN 777047

Date: February 24, 2023

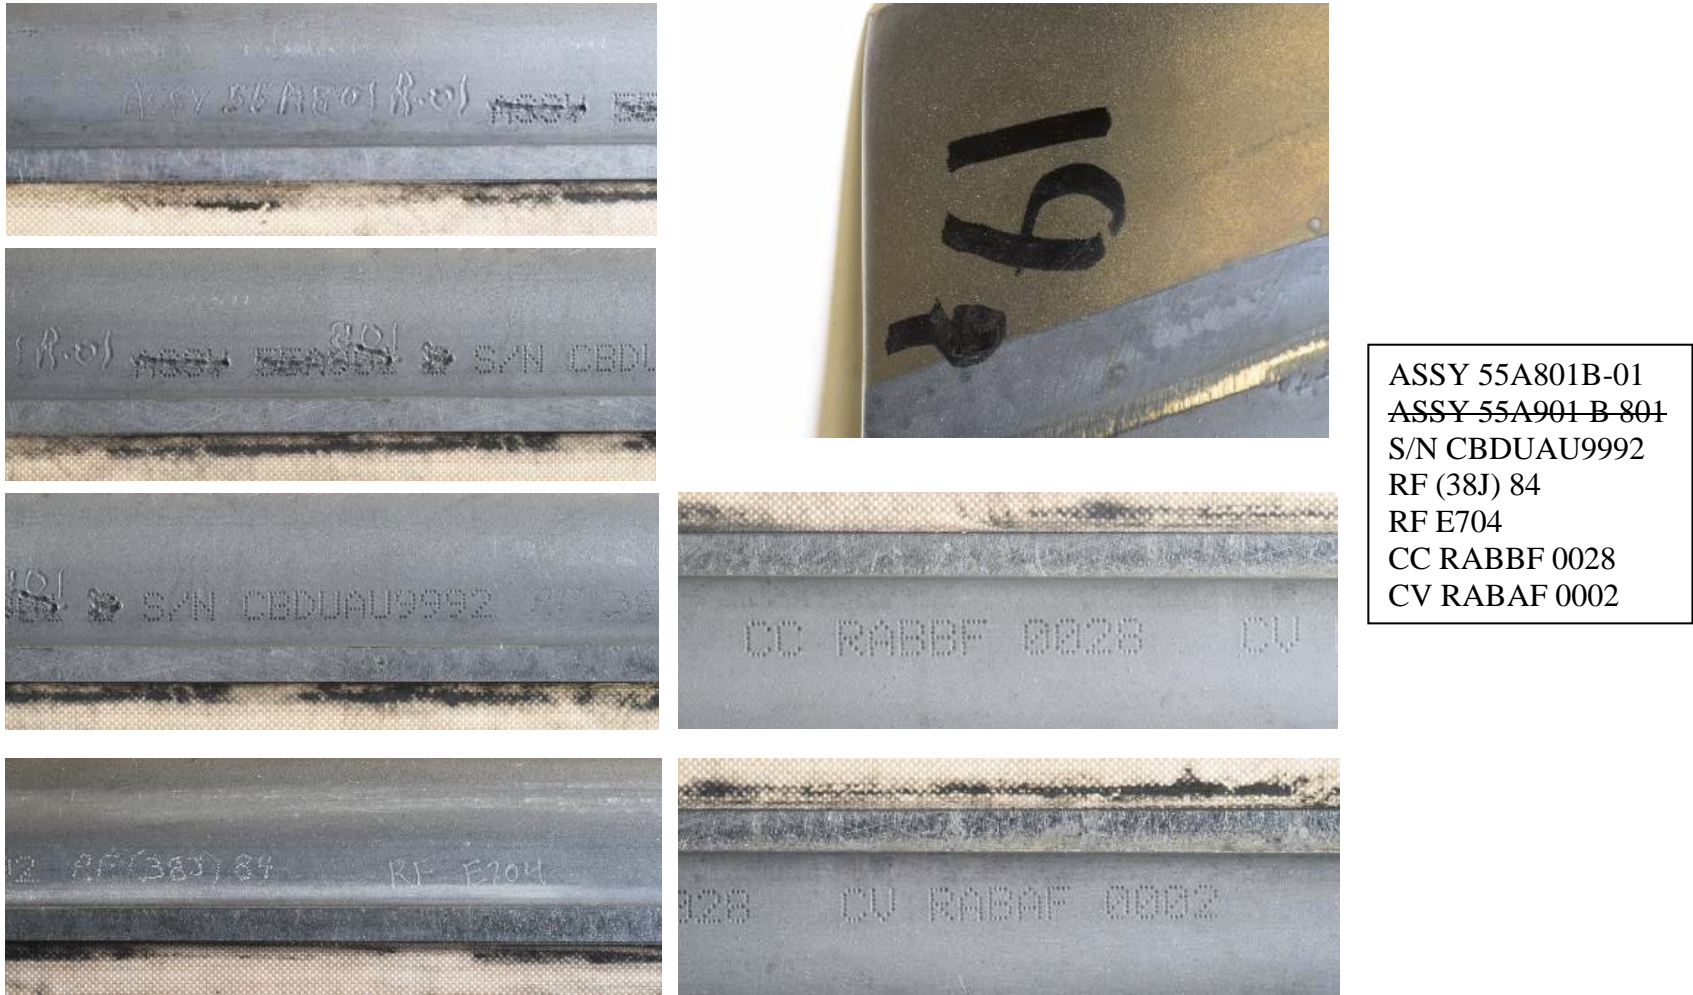
Figure 2: Images of the part markings observed on the root bottom of the fractured blade.

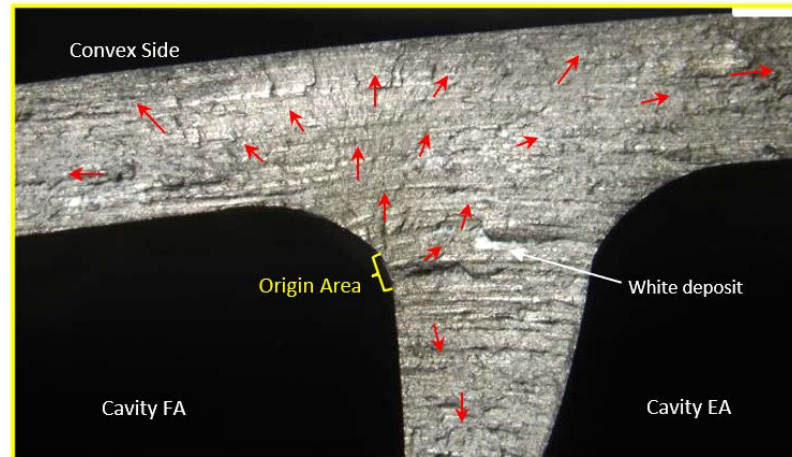
Fan blade S/N CBDUAU9992 fractured due to fatigue, which initiated internally ~6.6" above the root bottom from multiple origins in cavity FA along the transition radius between the convex side wall and the internal spanwise rib. The origins were located near the radius runout to the rib which exhibited an irregular contour (lack of tangency).

Figure 4: Overall and close-up views of fracture surface showing fatigue features propagating from an area located at the radius runout to the internal rib at the forward end of cavity FA. A white deposit was observed on areas of the fracture surface and on the internal cavity walls; this deposit was likely fire retardant used following the event.

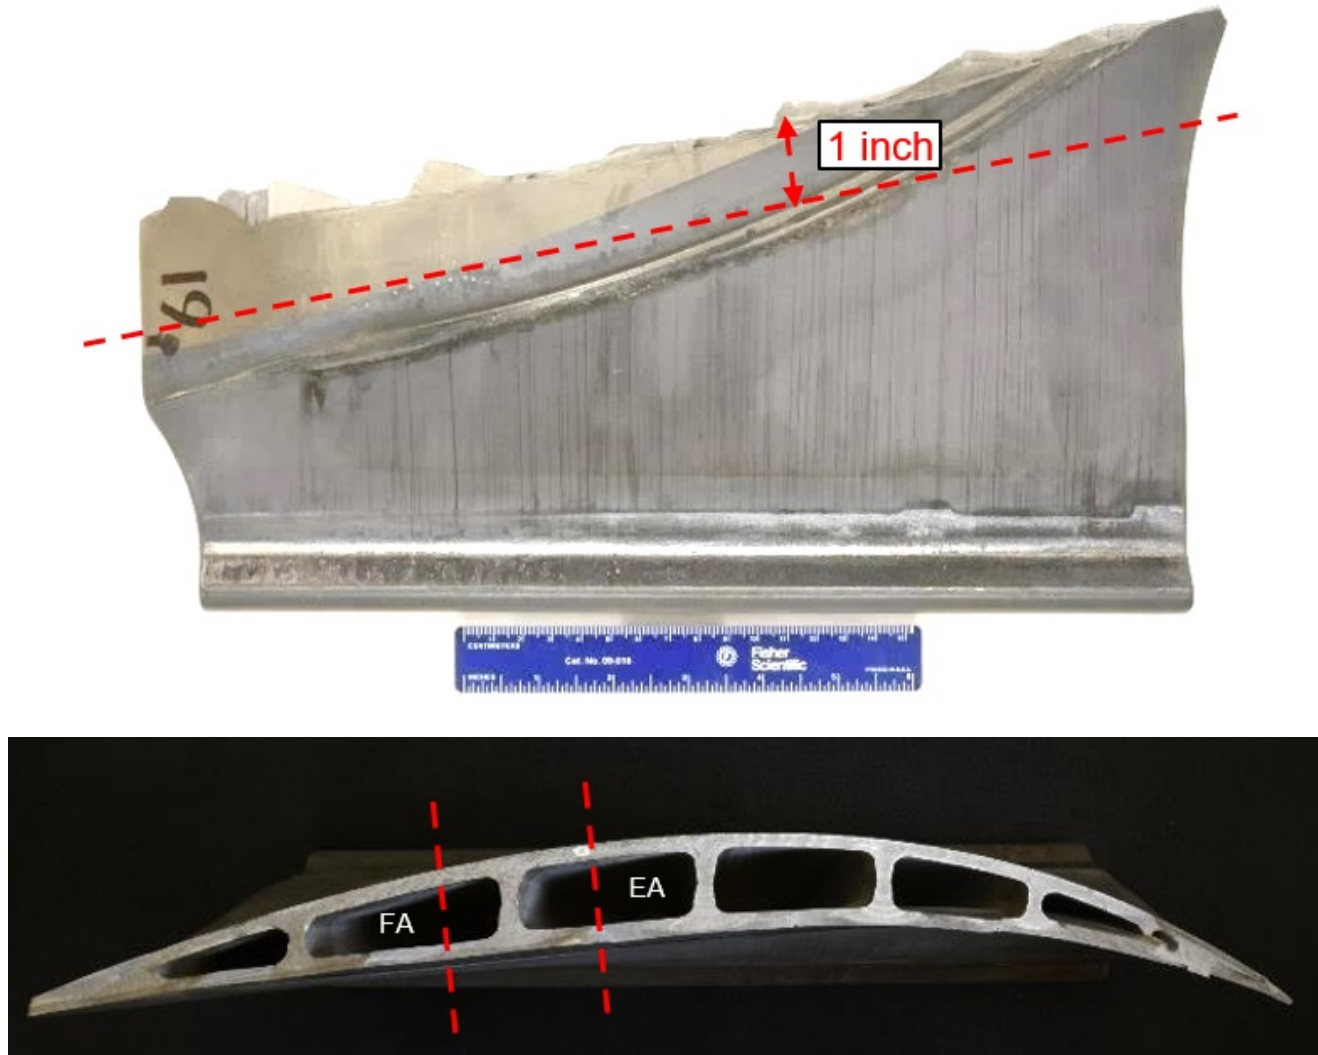
Figure 6: Images showing where the fractured blade was sectioned for further analysis (red dashed lines).

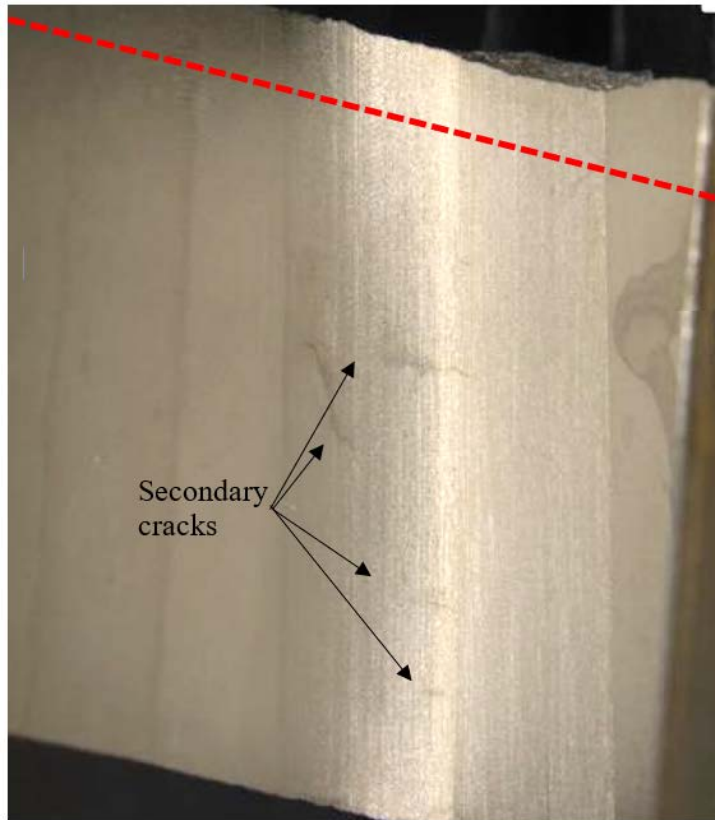
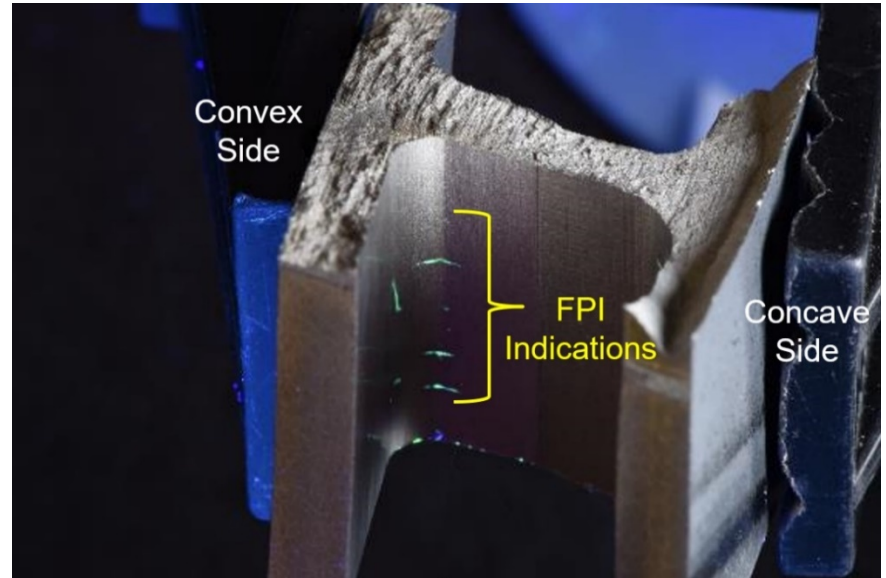
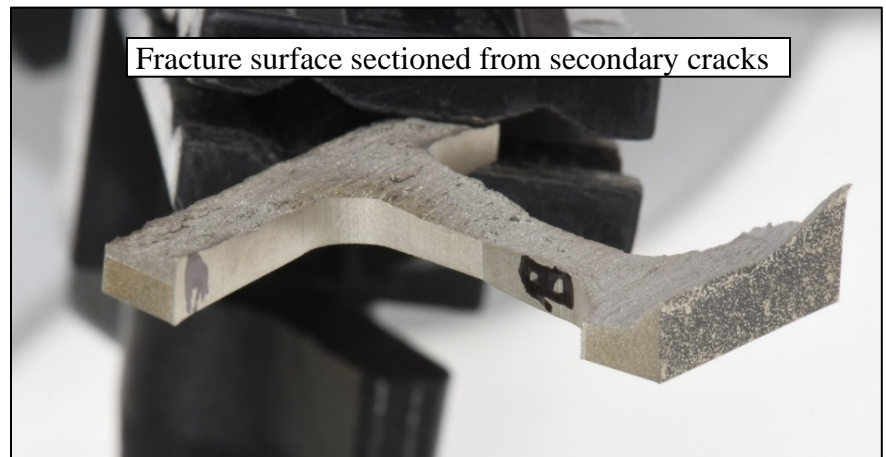
Figure 7: FPI and binocular examination identified multiple cracks inboard of the fracture surface. A section was made via wire EDM to remove the fracture surface from the secondary cracks for further evaluation (red dashed line).

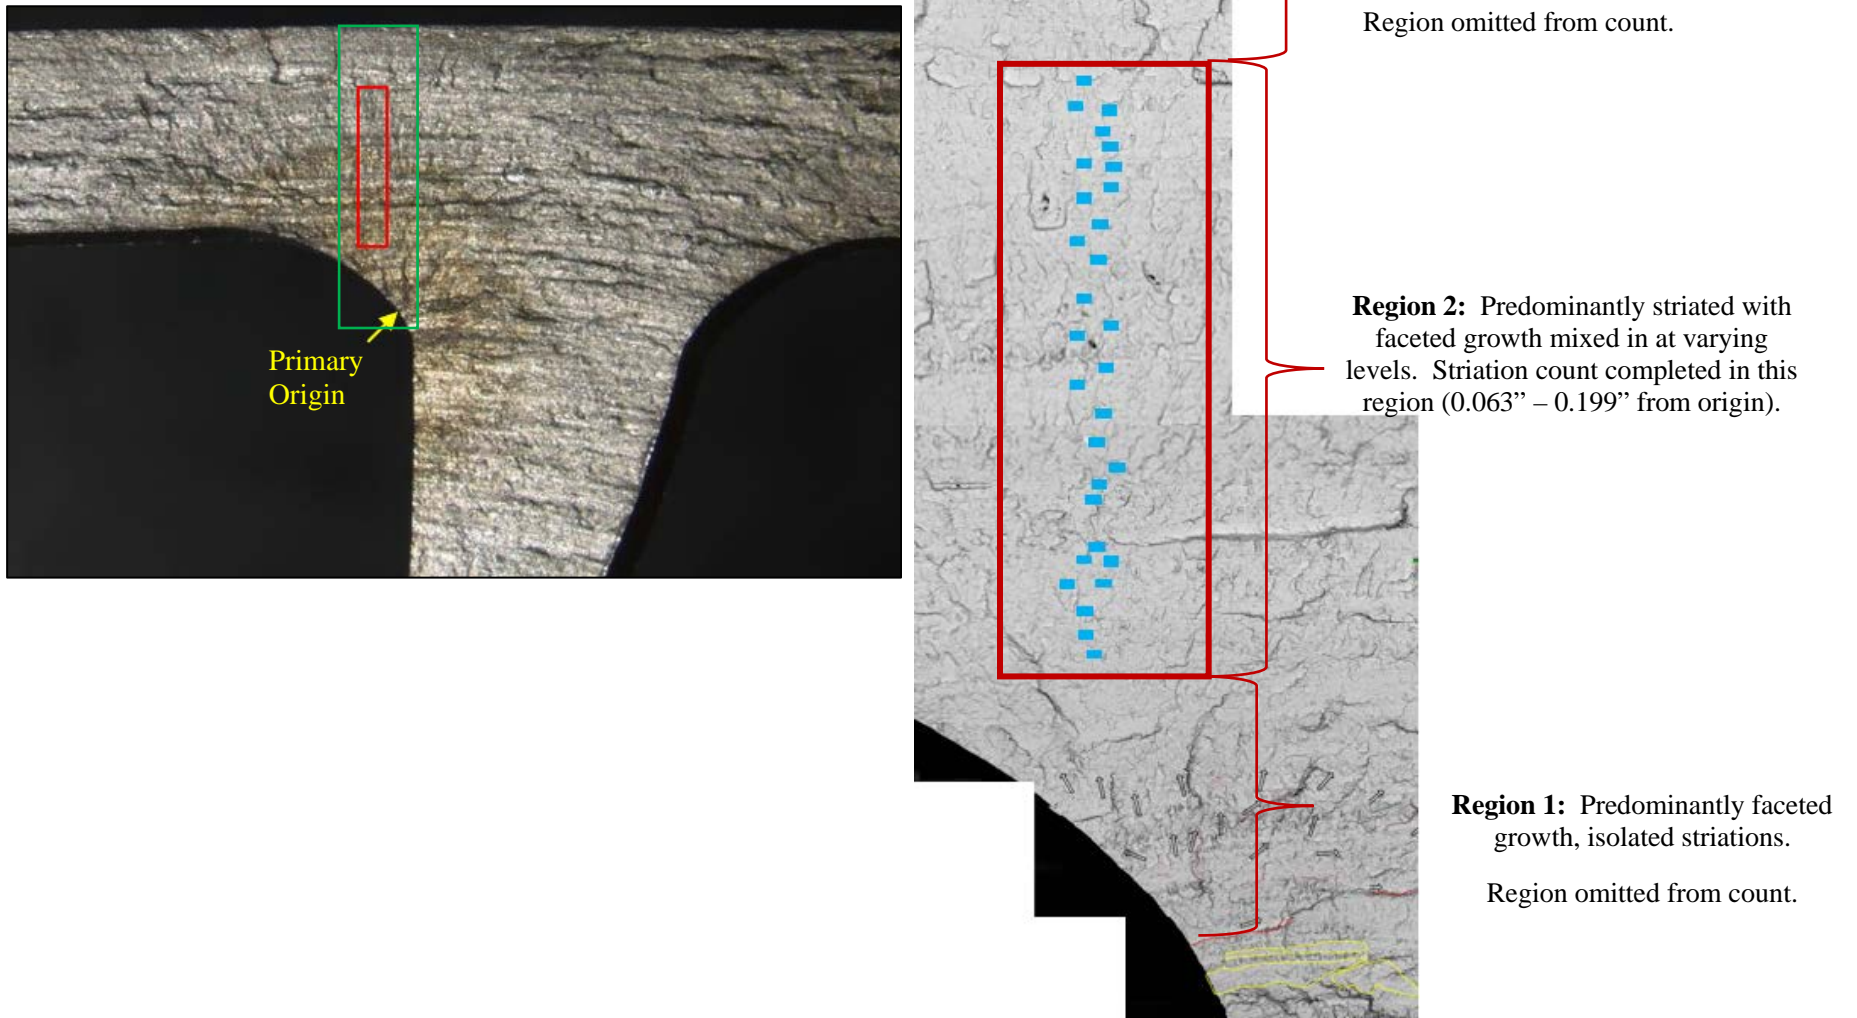
Figure 13: Images showing the region where the striation count was completed (0.063" to 0.199" from the origin).

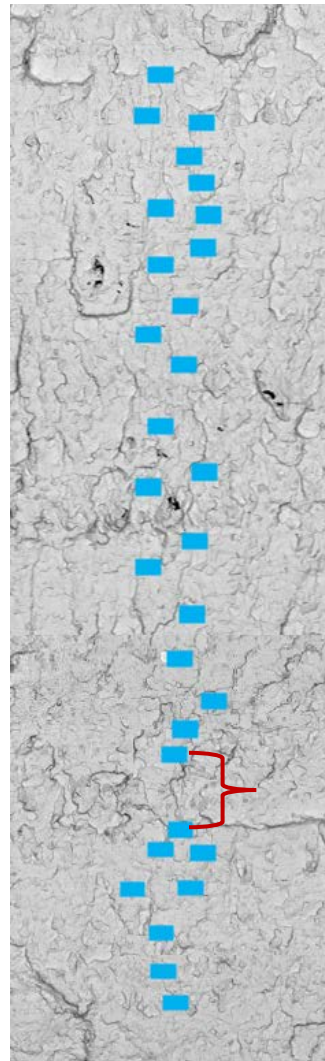
↑ Beyond separately nucleated MTR region.
Region omitted from count.

Region consisted of <50% striated
features. No credit was taken for crack
growth in this area.

Relatively weak separately nucleated
initiations observed that did not impede
the major crack progression through this
area.

Figure 14: Image showing the striation count region. Points measured were represented by the blue boxes.

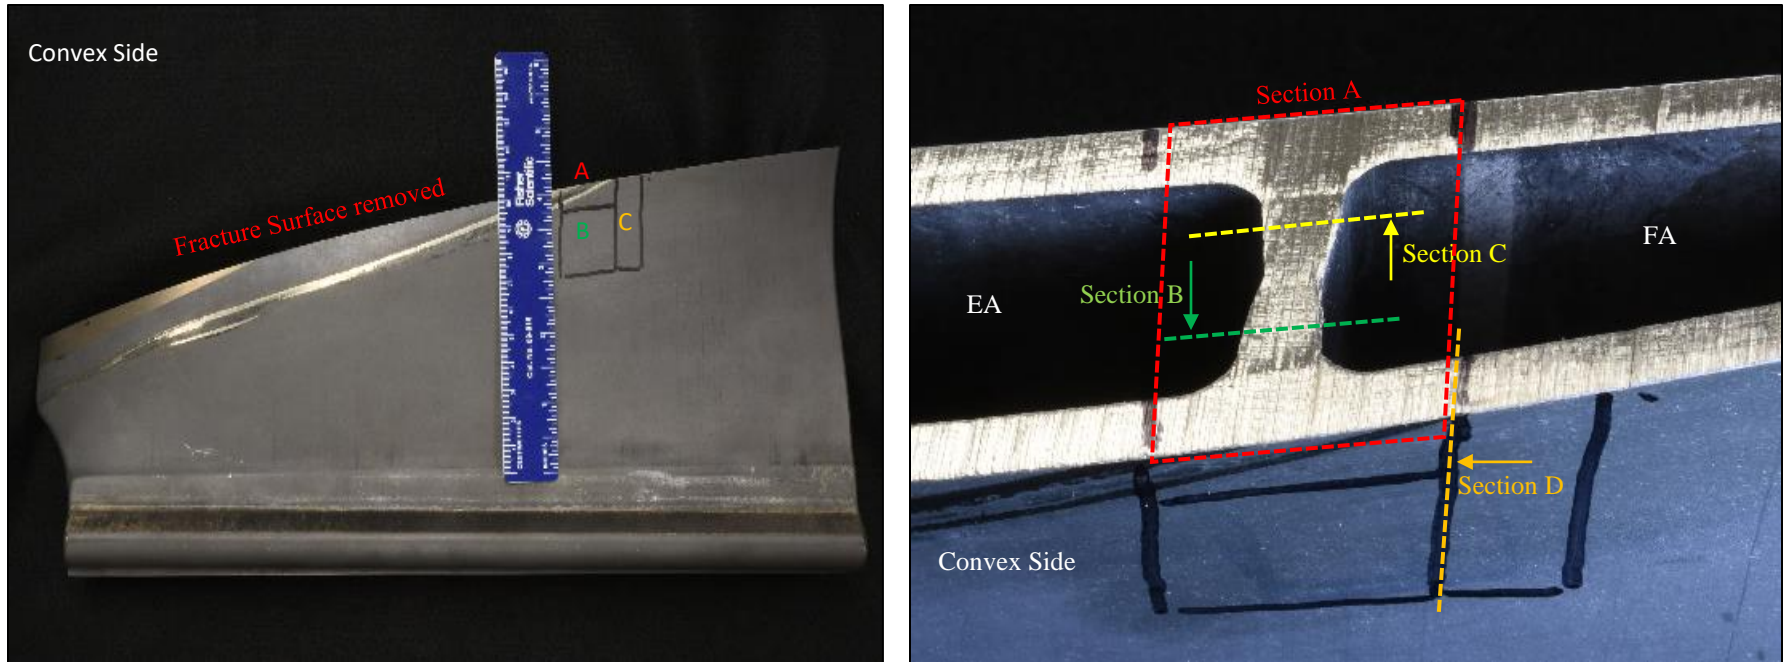
Figure 15: Images showing the locations of metallographic sections taken from the root, inboard of the fracture surface. The sections were prepared for initial evaluation of the bulk and surface microstructure.

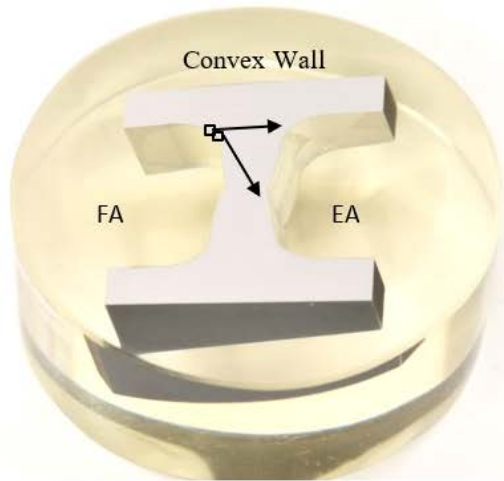
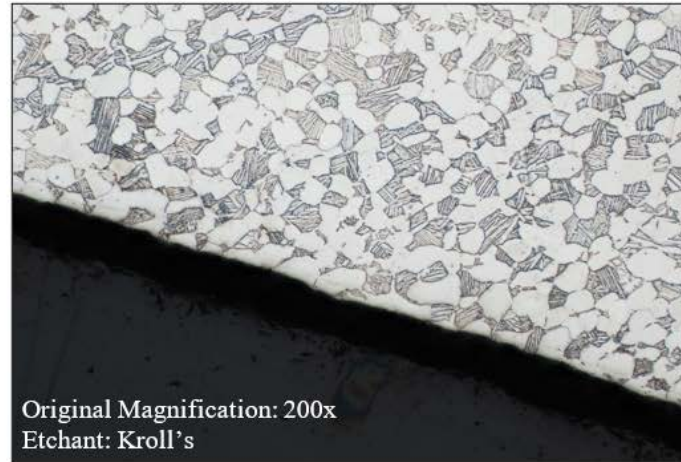
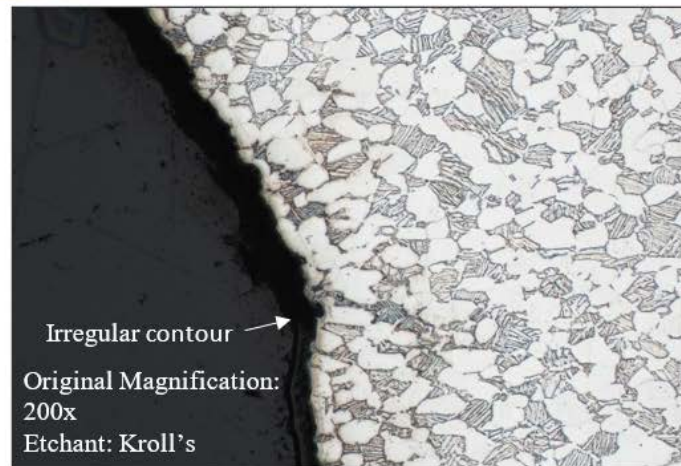
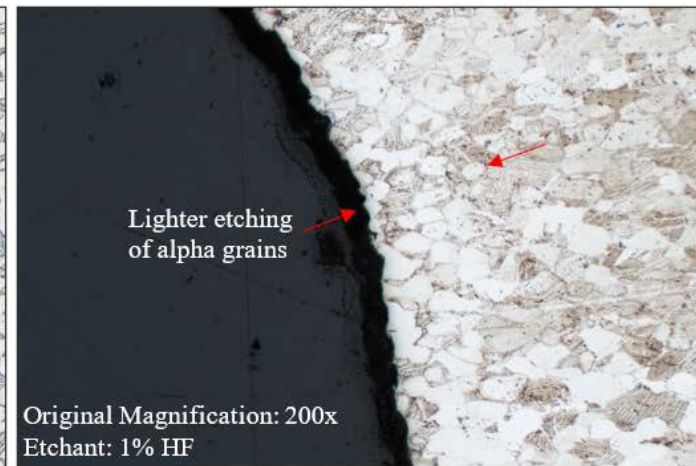
Figure 16: Images showing transverse section A into the ribs/walls approximately 1” below the fracture surface. The microstructure appeared typical, and no surface layer/deformation of the grains was observed. There was an irregular contour at the radius runout to the rib (left image). The alpha grains at the internal surface etched lighter when etched with 1% HF (right image).

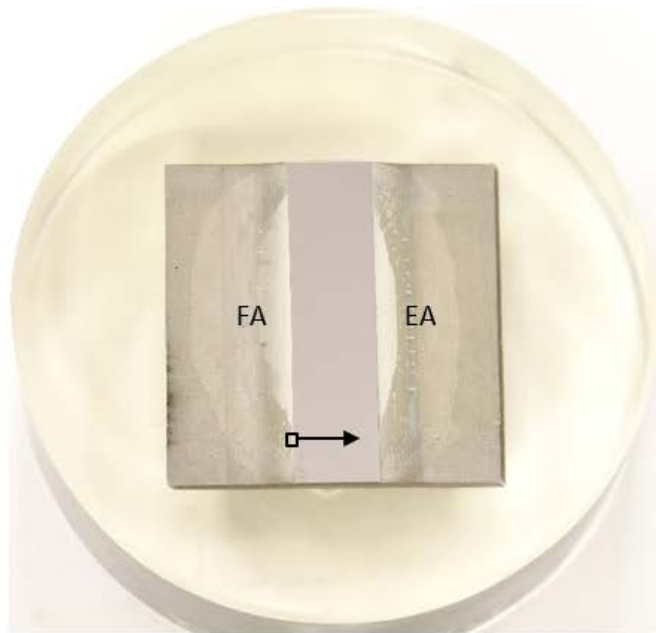
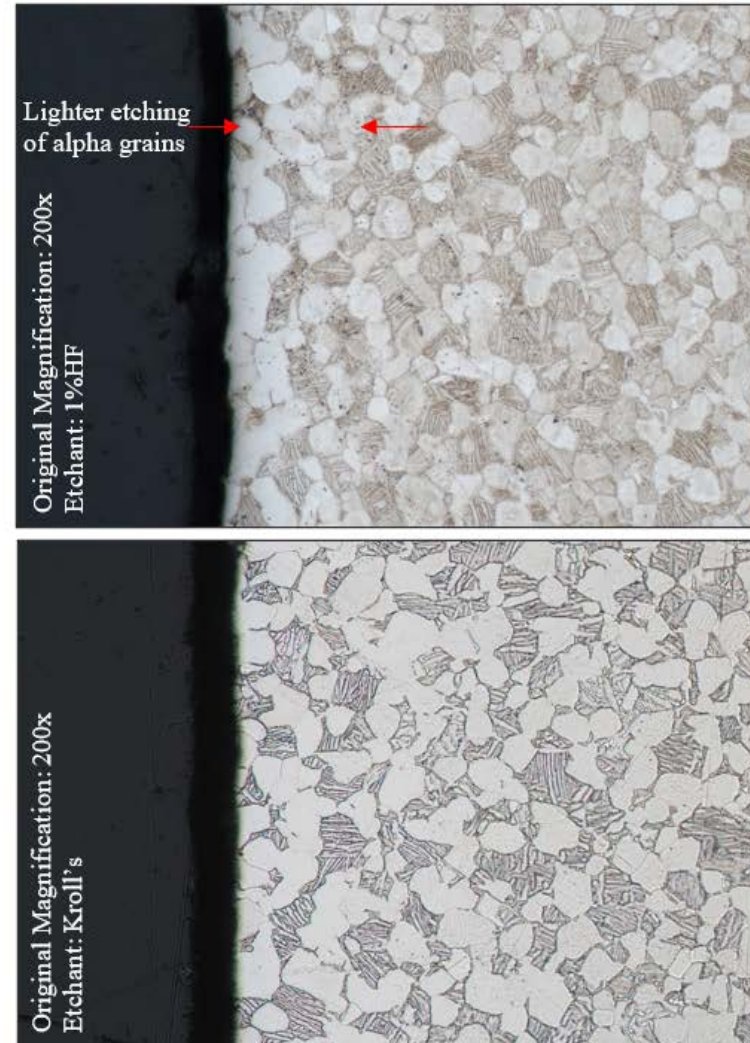
Figure 17: Images showing section B - a longitudinal section through the spanwise rib between cavities FA and EA on the convex side of the bondline, approximately 1.25” below the fracture surface. No surface layer/deformation or secondary cracks were observed. Alpha grains near the surface etched lighter when etched with 1% HF (top image).

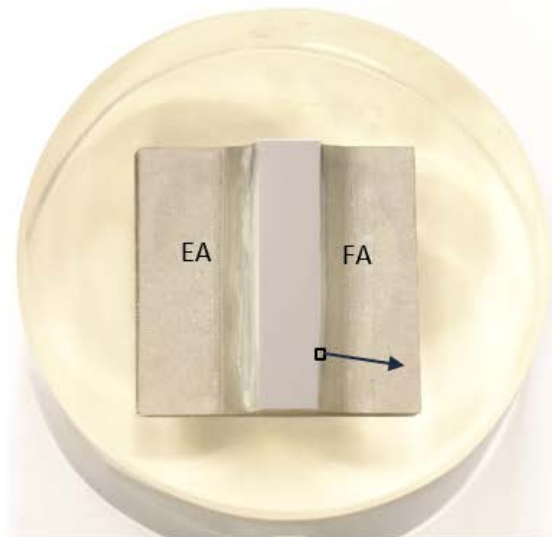
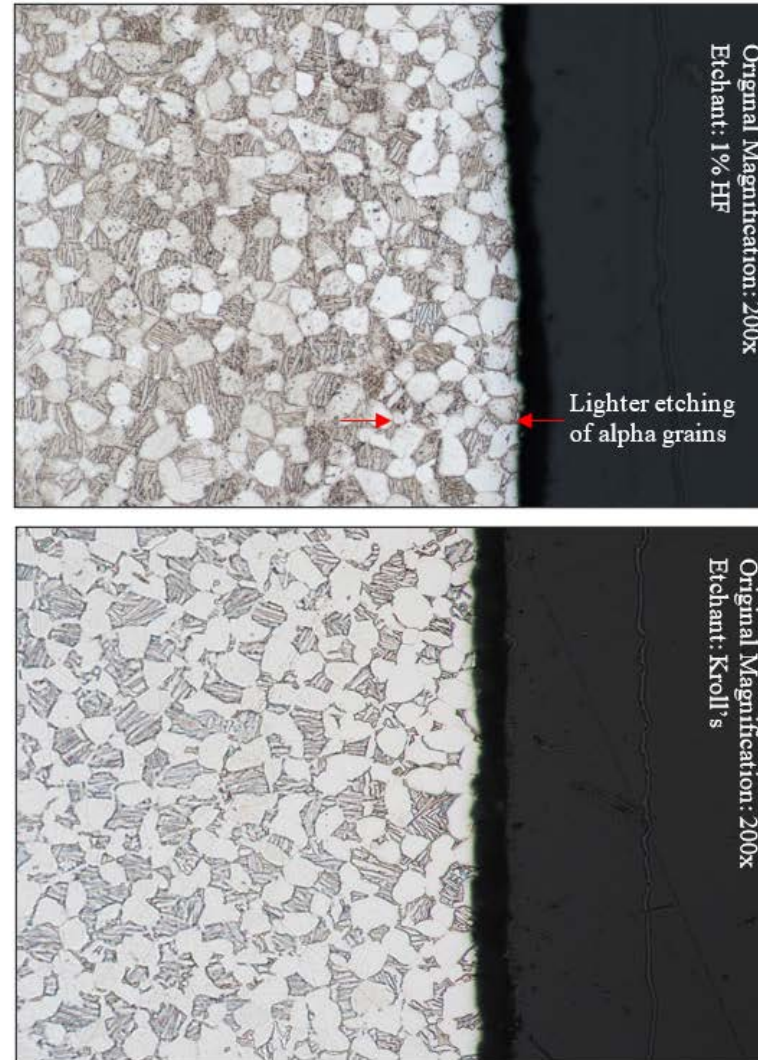
Figure 18: Images showing section C – a longitudinal section through the spanwise rib between cavities FA and EA on the concave side of the bondline, approximately 1.25” below the fracture surface. No surface layer/deformation or secondary cracks were observed. Alpha grains near the surface etched lighter when etched with 1% HF (top image).

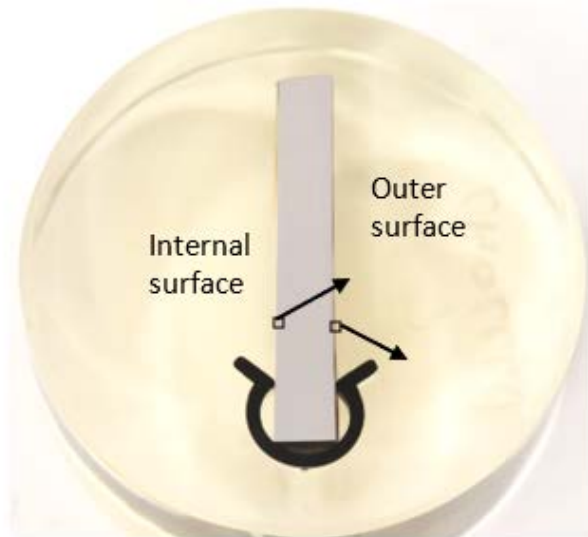
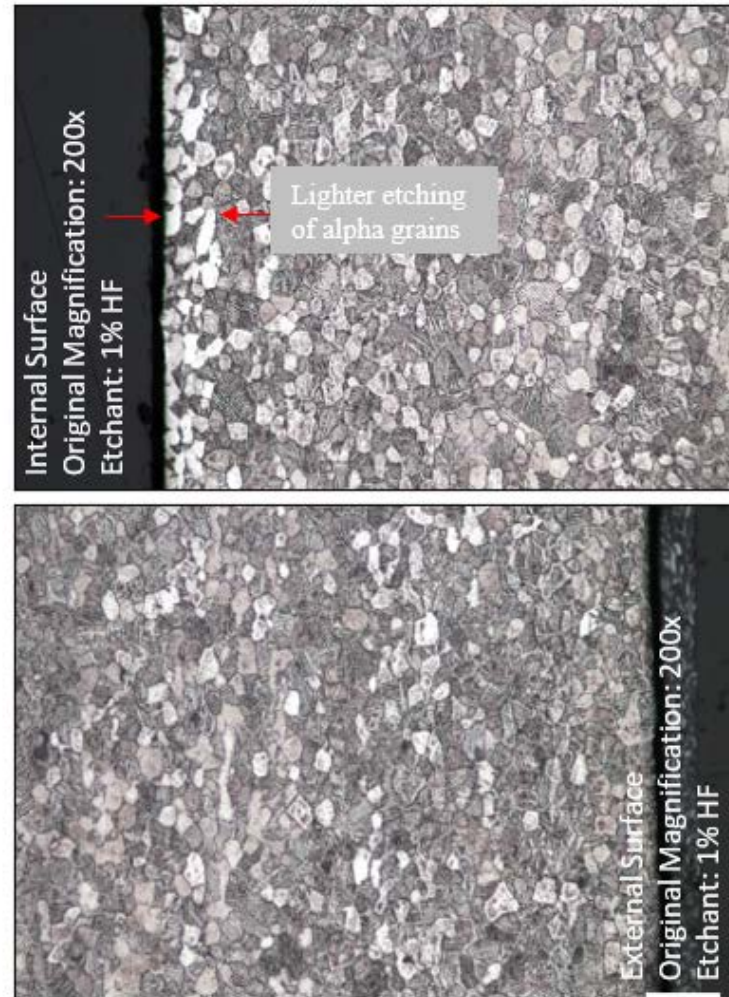
Figure 19: Images showing section D – a longitudinal section through the convex wall in cavity FA, approximately 1” below the fracture surface. No uniform surface layer/deformation or secondary cracks were observed. Alpha grains near the internal surface etched lighter when etched with 1% HF (top image). The alpha grains at the external surface of the blade did not exhibit this condition.

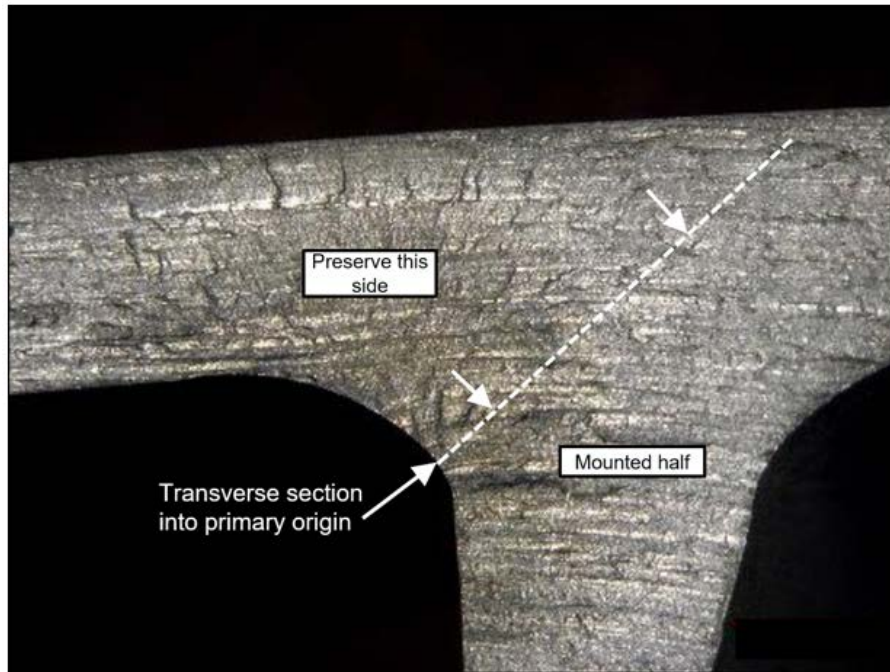
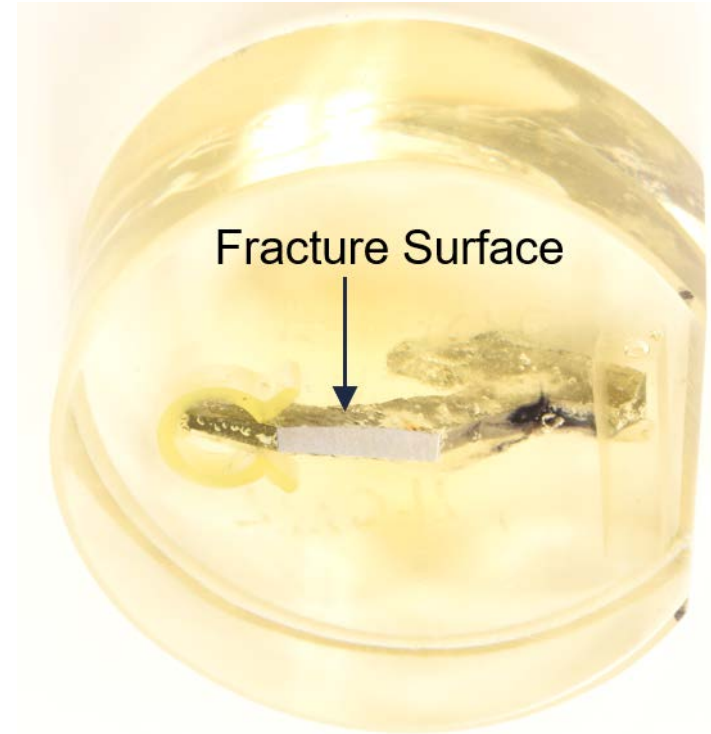
Figure 20: Images showing the location of the spanwise metallographic section through the origin. The white line in the left image shows the plane of polish and which side of the fracture was mounted.

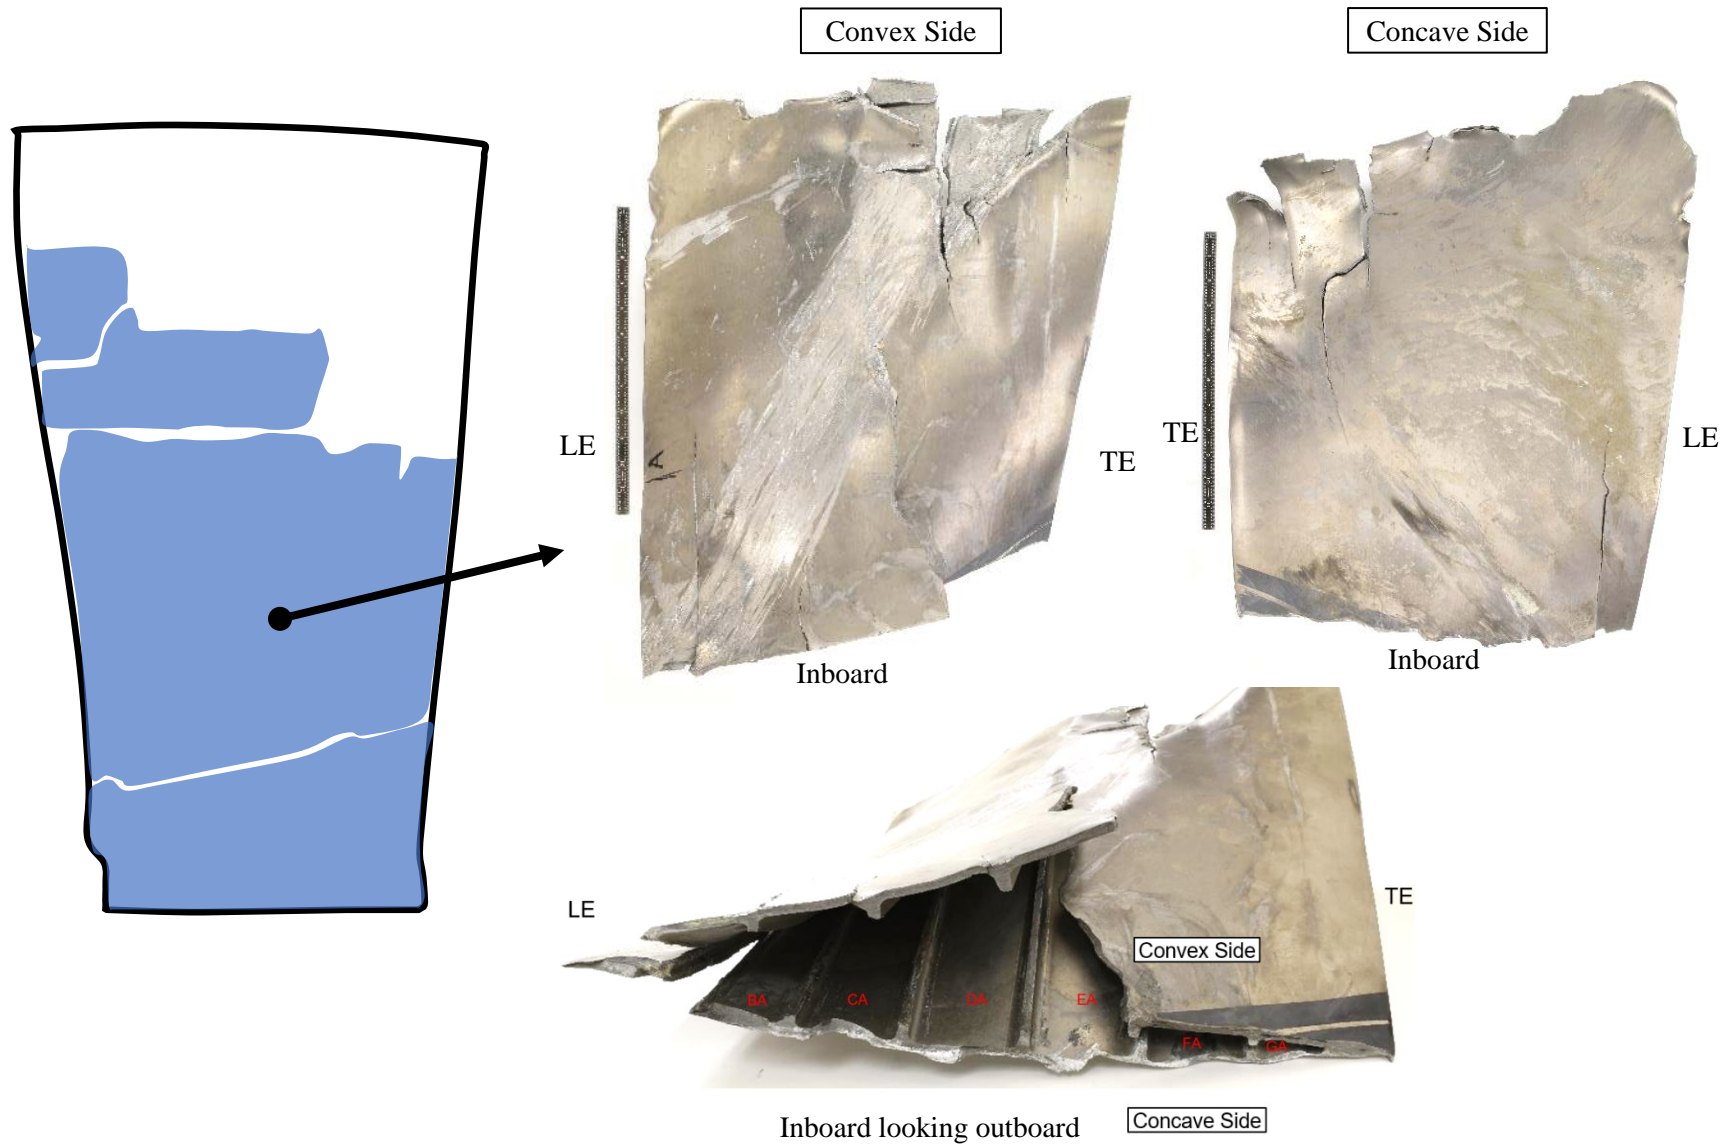
Figure 39: Images of the midspan blade fragment recovered from the fan containment case.

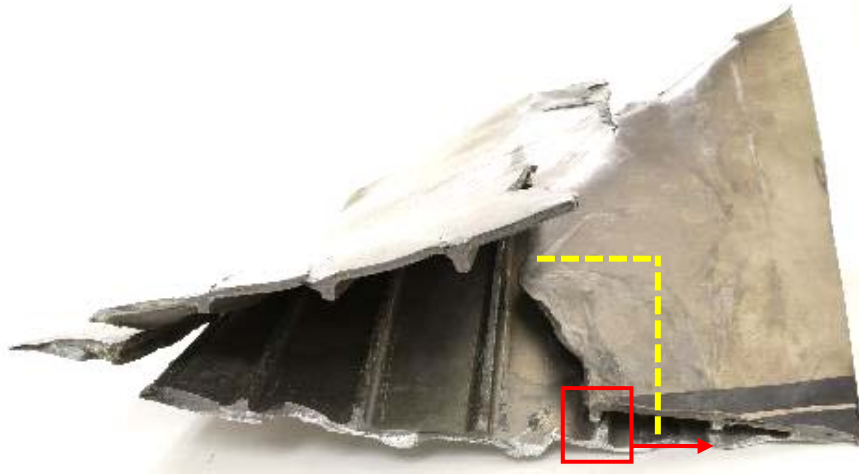
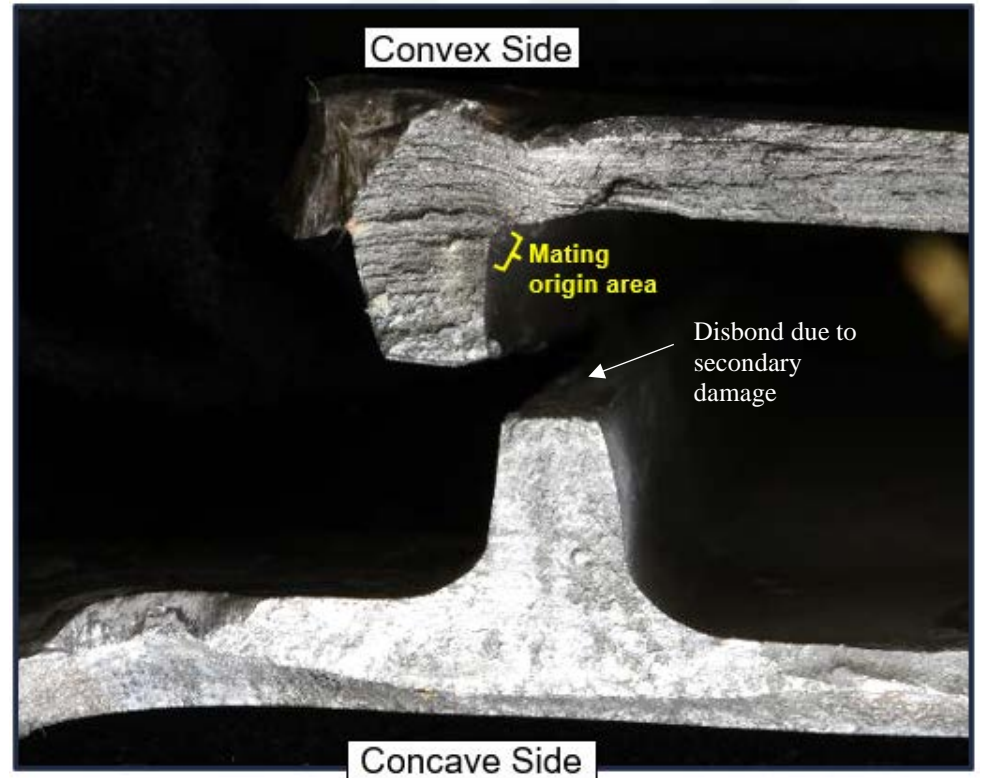
The mating flowpath origin area was mostly intact but exhibited secondary damage from the post-fracture event. The convex and concave sides of the blade were disbonded at several spanwise ribs in the flowpath due to secondary damage. The origin area was sectioned from the fragment for further evaluation ([Figure 40](#)). Binocular review identified two additional secondary cracks outboard of the fracture surface. The furthest outboard crack was located ~0.32" from the fracture origin. The fracture surface was sectioned from the secondary cracks via wire EDM for further evaluation ([Figure 41](#)).

Figure 40: Images showing the outboard half of the flowpath fracture surface. The origin area was mostly intact with some post-fracture damage. The concave and convex sides of the blade were disbonded due to secondary damage. Sectioning was completed along the yellow dotted lines to remove the origin area for further evaluation.

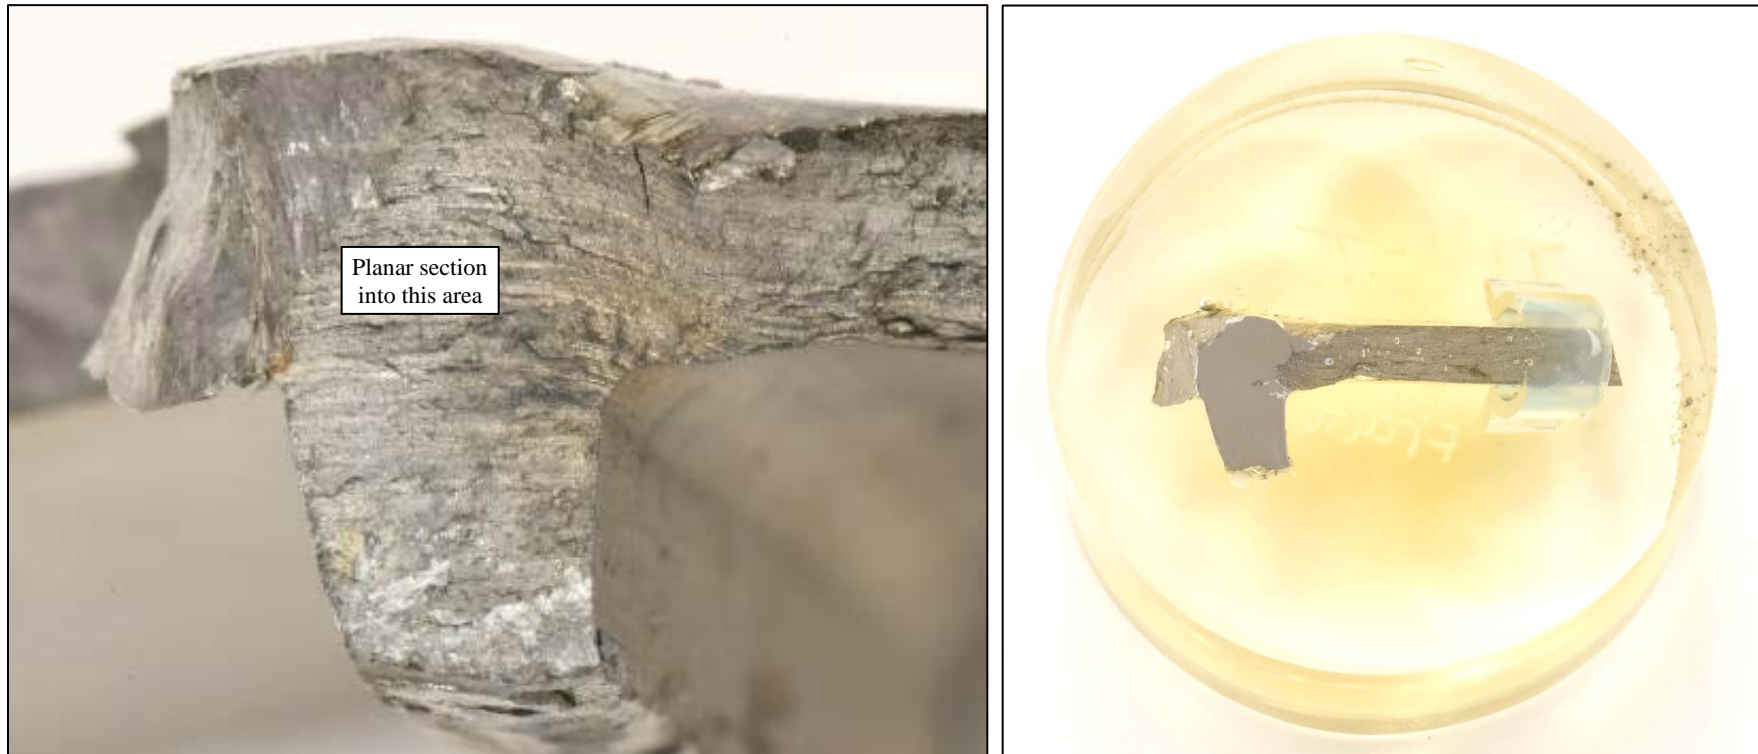
A metallographic section was prepared planar into the outboard half of the fracture surface as shown in [Figure 43](#). EBSD/OIM evaluation of the section confirmed that there were no MTRs at the primary origin ([Figure 44](#)). The planar section was etched with 1% HF. The alpha grains near the cavity surface etched lighter. No distorted surface layer/deformation was observed. A spanwise microcrack, approximately 0.001” in depth, was observed at the radius runout to the rib ([Figure 45](#)).

Figure 43: Image of the metallographic section prepared planar into the outboard half of the fracture surface. This section was used for EBSD/OIM to evaluate for MTRs near the origin area.

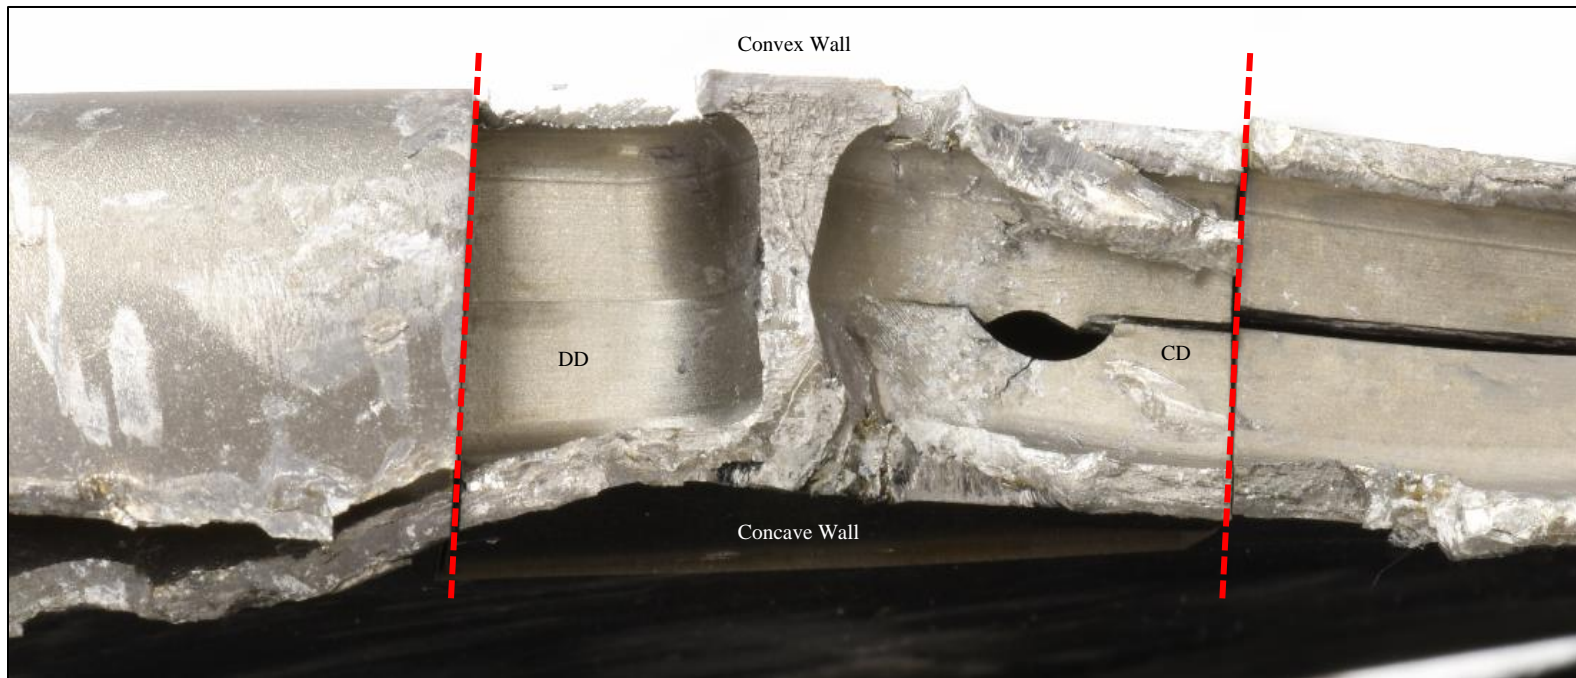
Binocular examination of the midspan blade fragment that was removed from the case identified possible fatigue on the outboard surface, located on the spanwise rib between cavities CD and DD approximately 0.2” outboard of the inboard chordwise rib ([Figure 49](#)). The fatigue appeared to extend under a flap of material on the convex side of the blade. The area was sectioned from the blade fragment and the flap of material was removed for further evaluation ([Figure 50](#)).

Figure 50: The area was sectioned out of the airfoil and the flap of material was removed. The area was located in the spanwise rib between cavities DD and CD, approximately 0.2” outboard of the inboard chordwise rib.

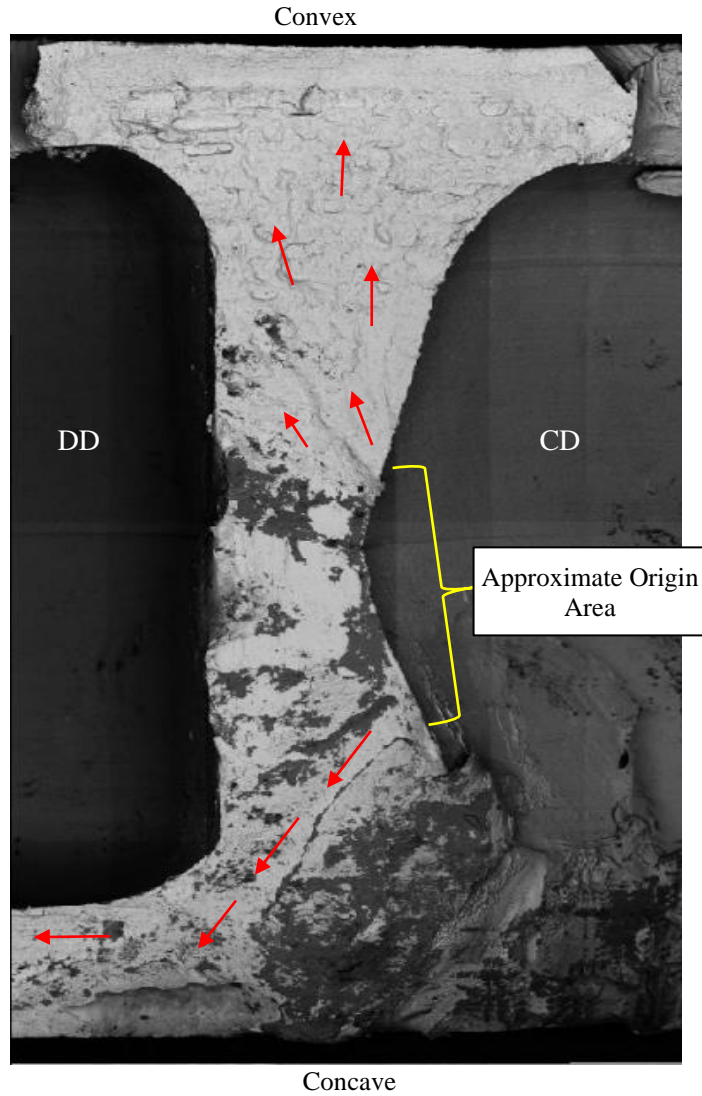
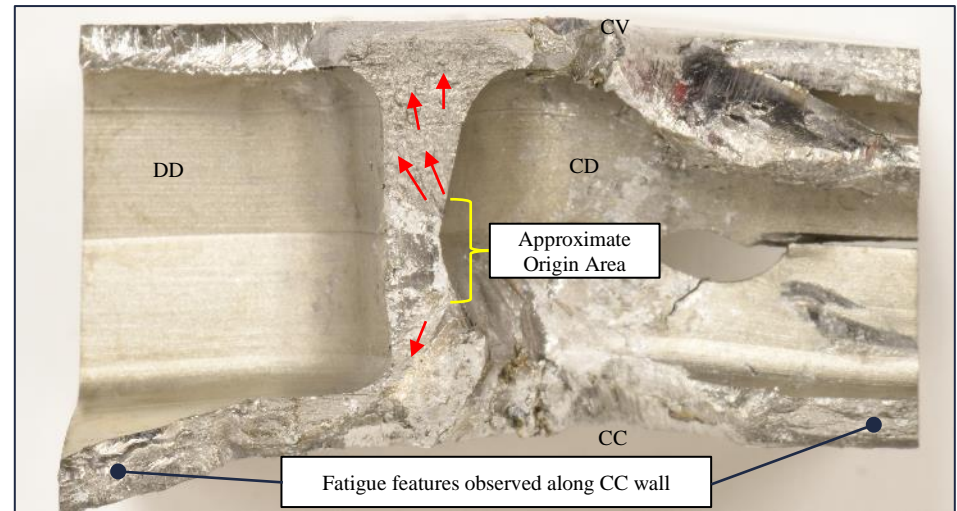
SEM examination confirmed fatigue features on the crack. Areas of striations and faceted features were identified among large areas of secondary damage/smearing. Fatigue features progressed from an origin area located on the CD side of the rib, however, due to the secondary damage, the exact origin could not be identified. Fatigue features were observed progressing along the concave wall ([Figure 51](#)). Crack growth rate measurements were taken at points progressing both towards the concave and convex walls. The path towards the convex wall was less damaged. Crack growth rates

Figure 51: SEM examination identified areas of striations and faceted features interspersed among large areas of secondary damage/smearing. Fatigue features progressed from an origin located on the CD side of the rib (red arrows). Due to the damage, the exact origin area could not be identified. Fatigue features were also observed progressing along the concave wall.
