Metallurgical Investigation Final Report

Subject: Metallurgical Investigation of Fan Blades from PW4077 Engine SN 777047

Date: February 24, 2023

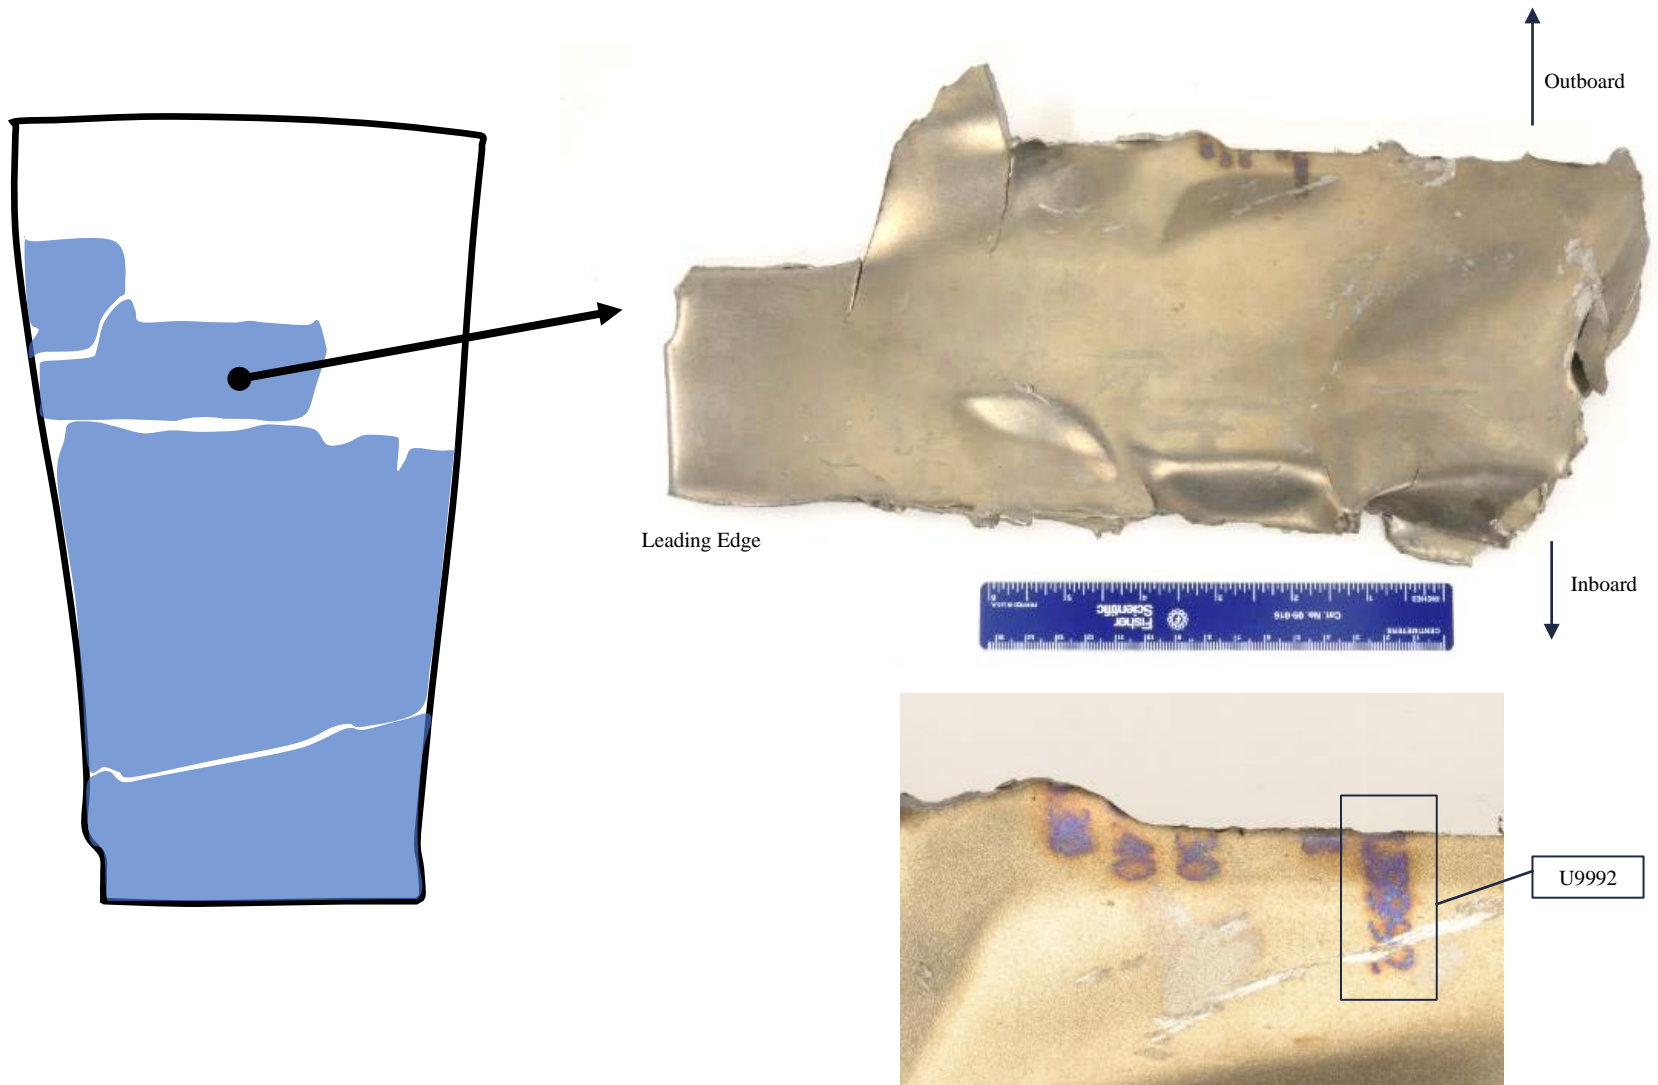
Two additional blade fragments that were confirmed to be from the outboard portion of the event blade were recovered from the debris on the ground following the event. The larger of the two fragments measured approximately 13”x5.5” and weighed 1.9 lbs./0.8 kg ([Figure 52](#)). Remnant part markings included the last 5 digits of the event blade S/N – “U9992”, confirming that the fragment was from the event blade. The smaller of the fragments measured approximately 4.75”x5.5” and weighed 0.6 lbs./0.3 kg.

Figure 52: Images showing the largest of the outboard blade fragments. Remnant part markings included the last 5 digits of the incident blade S/N – “U9992”, confirming that the fragment was from the incident blade.

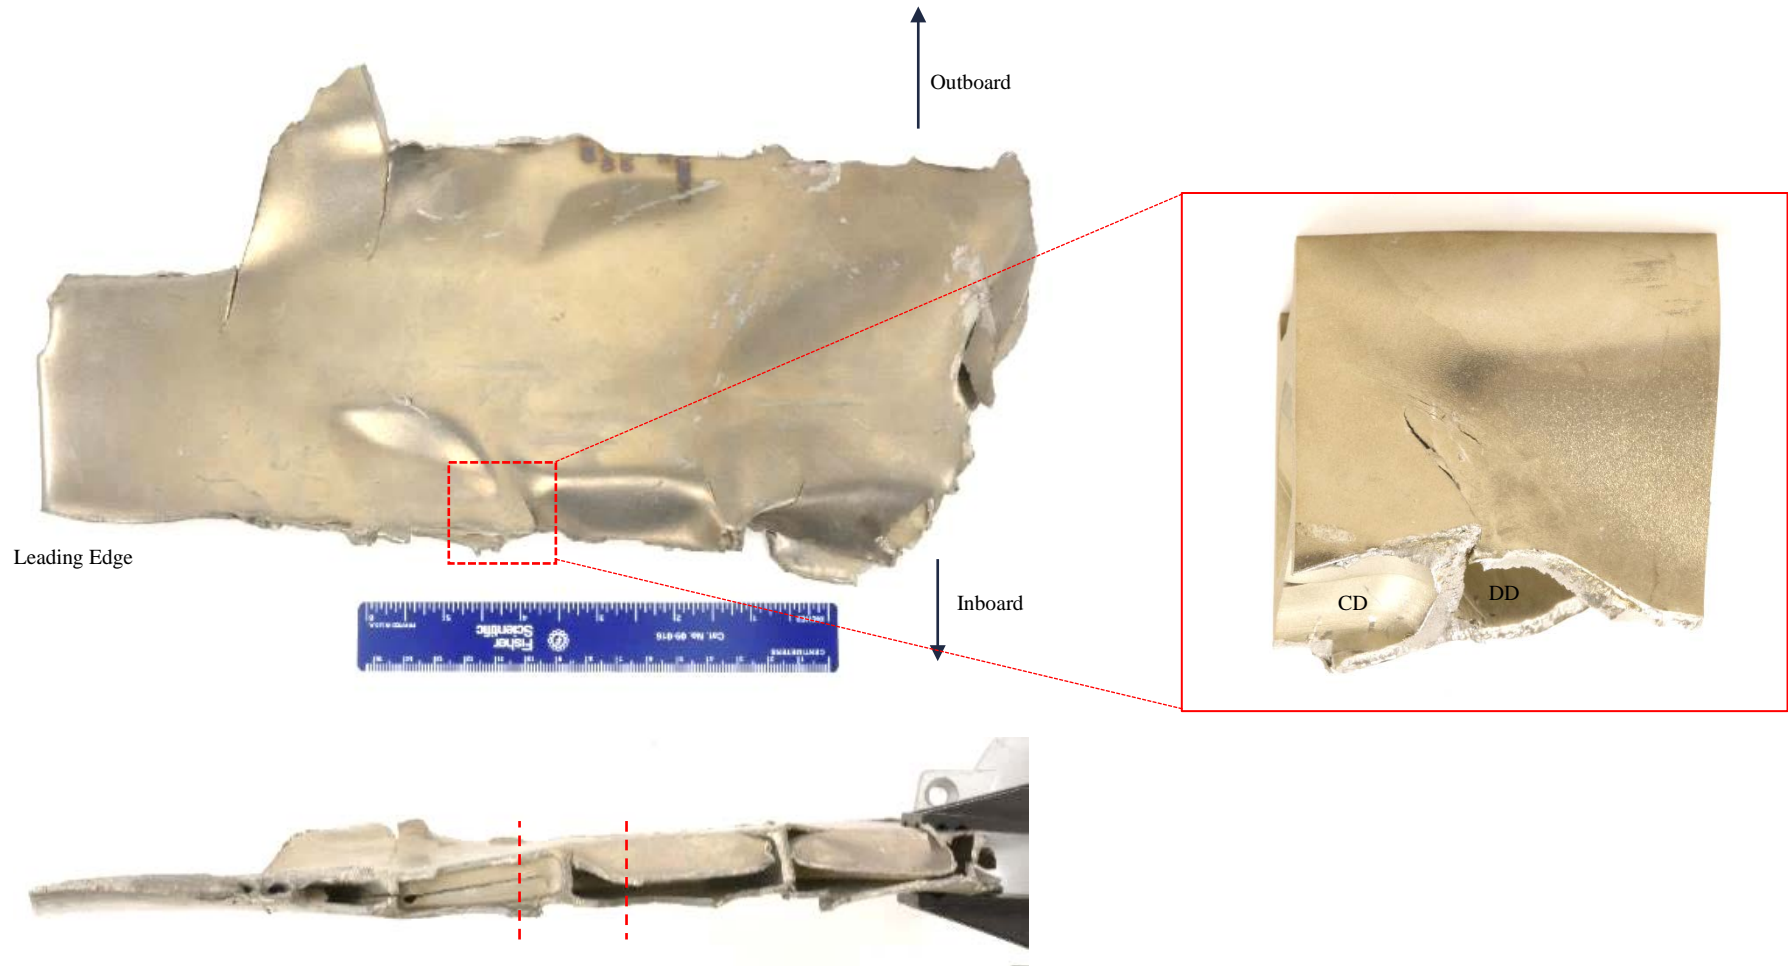
Binocular microscope inspection of the fracture surfaces identified possible fatigue on the inboard side of the fragment between cavities CD and DD, approximately 0.1” inboard of the outboard chordwise rib in cavity CD ([Figure 53](#)). The region of possible fatigue was sectioned from the outboard blade fragment ([Figure 54](#)).

Figure 54: The region identified as possible fatigue was sectioned from the outboard midspan fragment as shown.

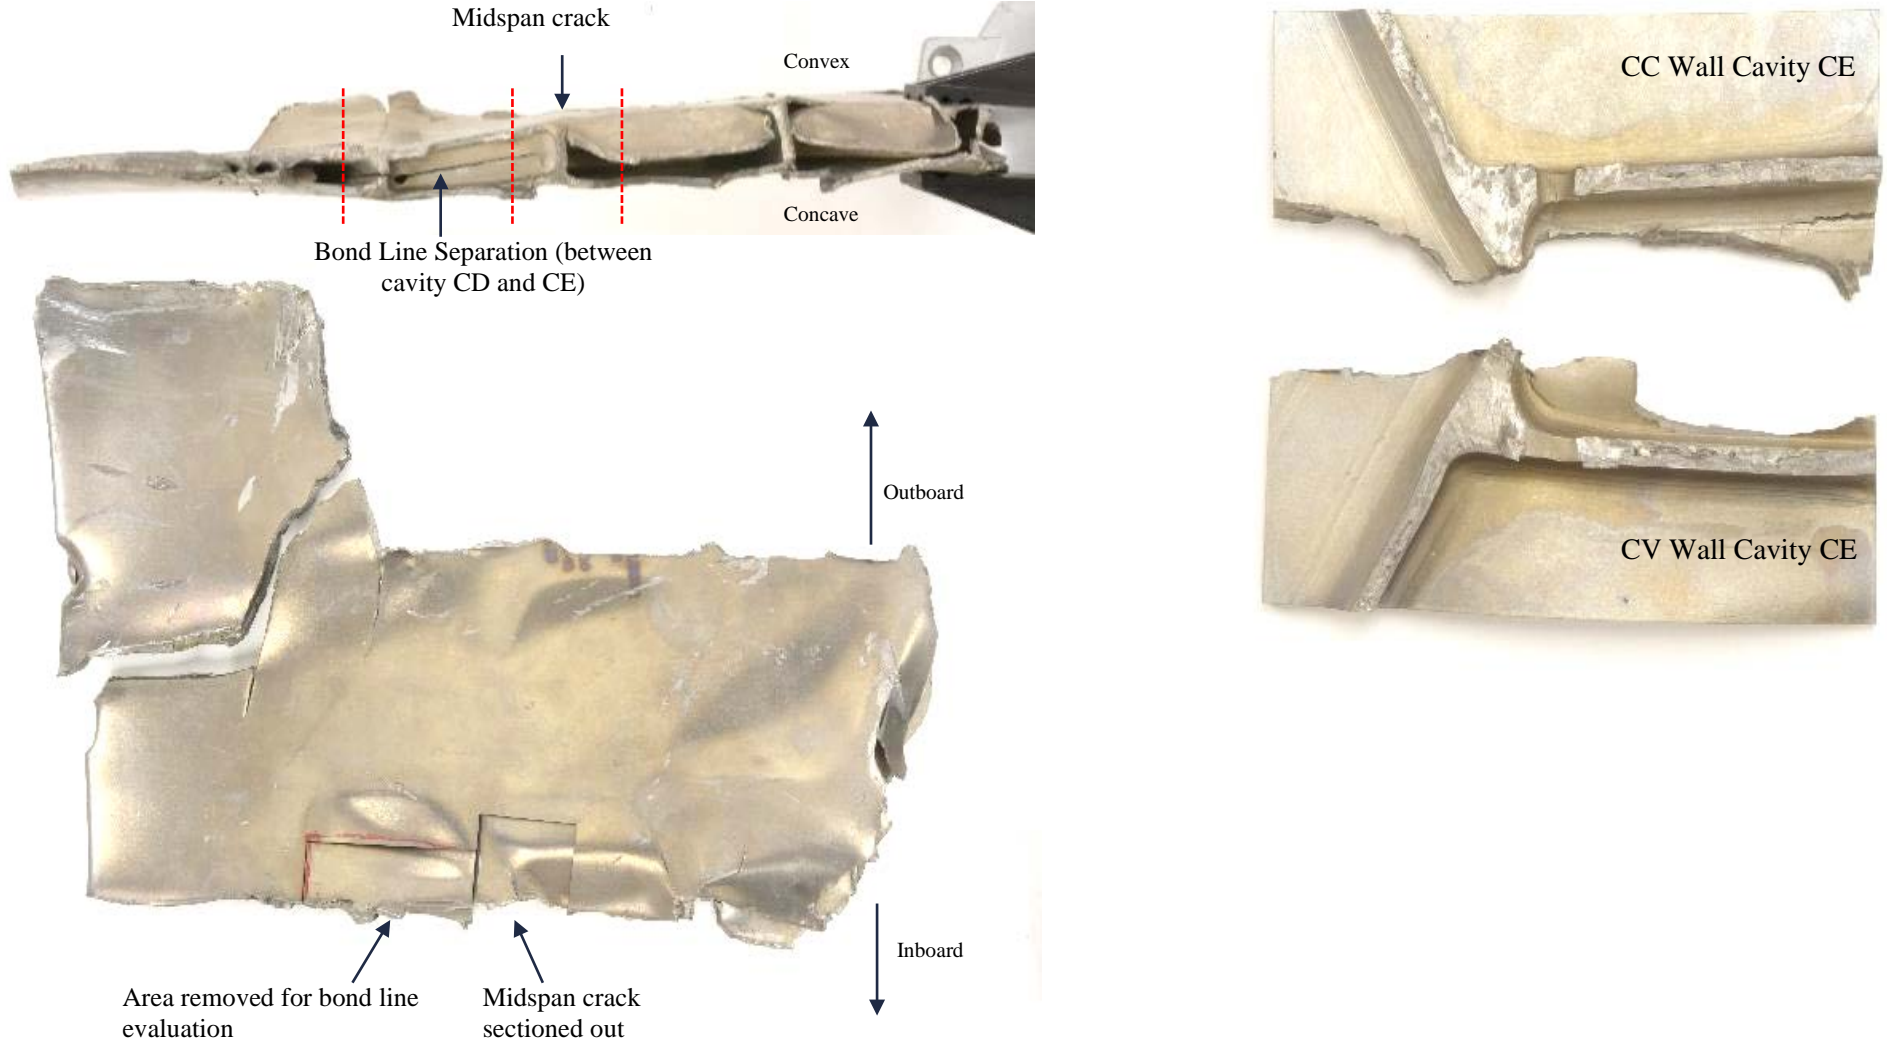
The bond line between cavities CD and CE, adjacent to the midspan crack in the outboard blade fragment, appeared separated. It was removed from the part for further evaluation ([Figure 58](#)).

Figure 58: The bond line in the cavity adjacent to the crack was separated. It was removed from the part as shown above for further evaluation.

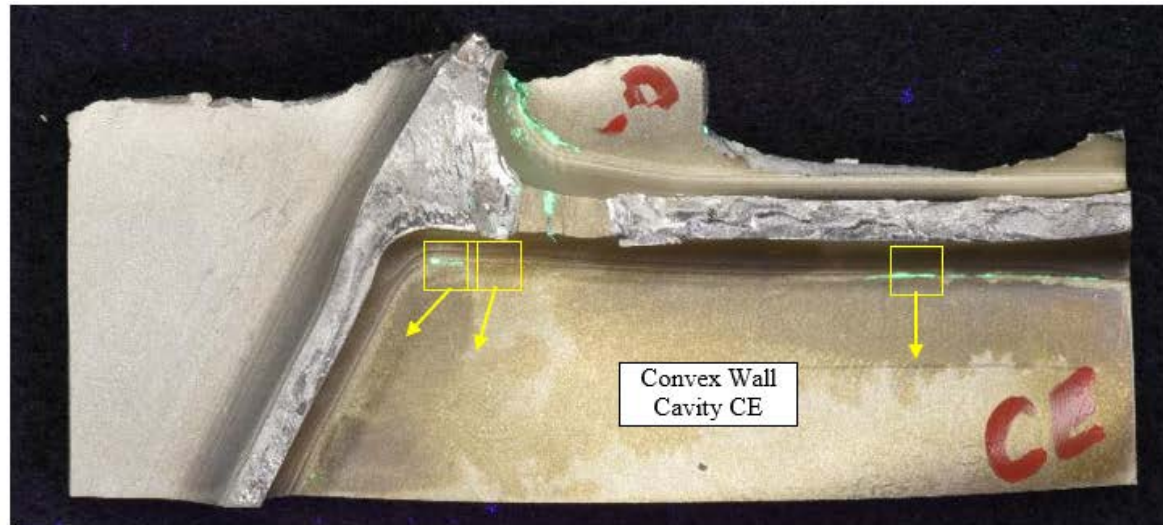
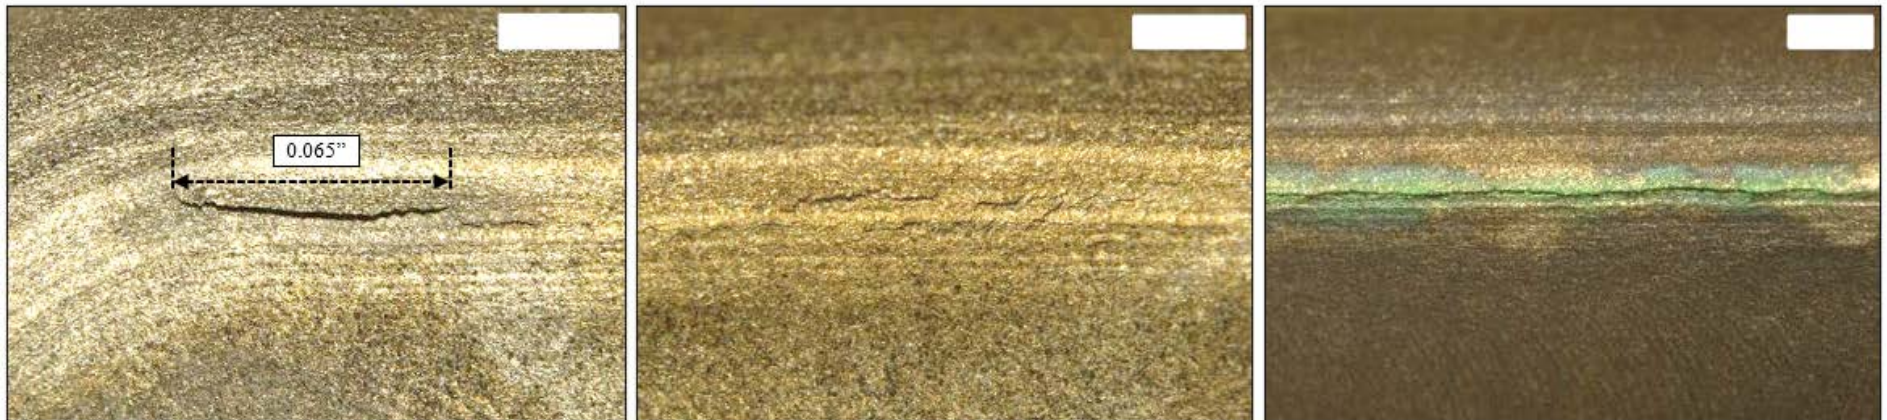
Binocular review and FPI identified crack-like indications on the convex wall side of Cavity CE, adjacent to where the bond line was disbanded and previously evaluated. The indications were located in the radius between the convex wall skin and the chordwise rib between cavities CE and CD. The cavity side wall in this area was deformed, most likely due to secondary damage ([Figure 61](#)).

Figure 61: Images showing crack-like indications in the radius between the convex wall skin and the chordwise rib between cavities CE and CD.

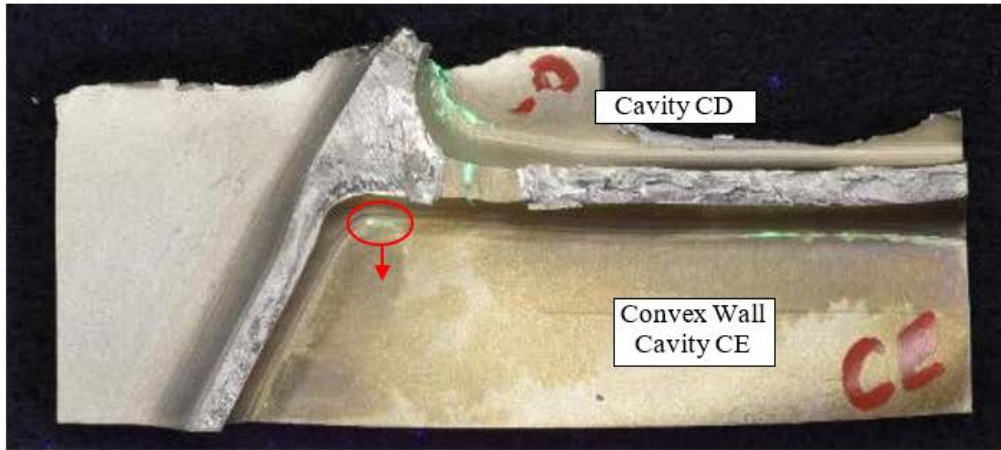
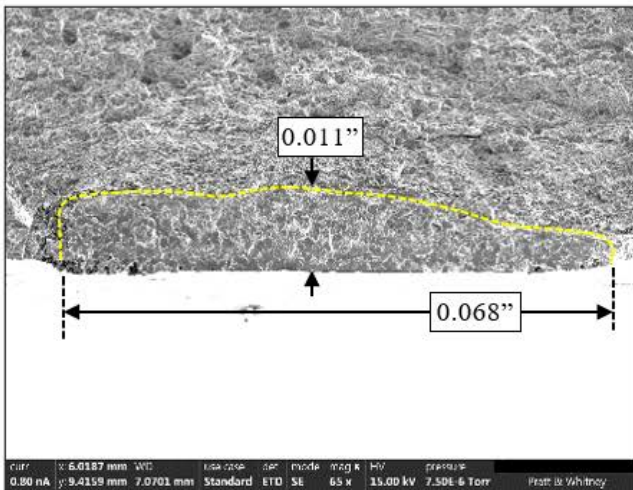
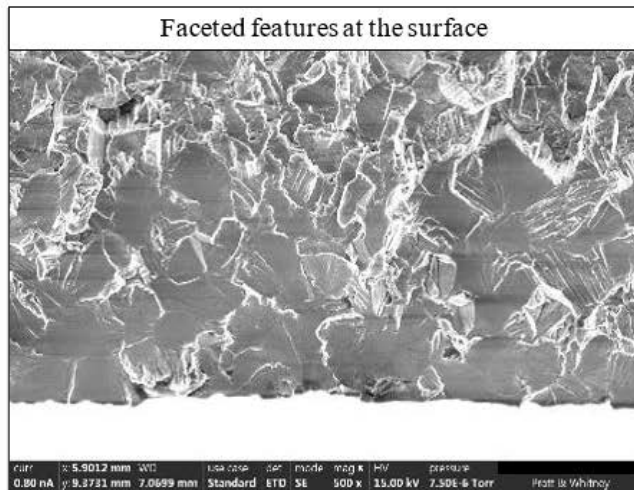
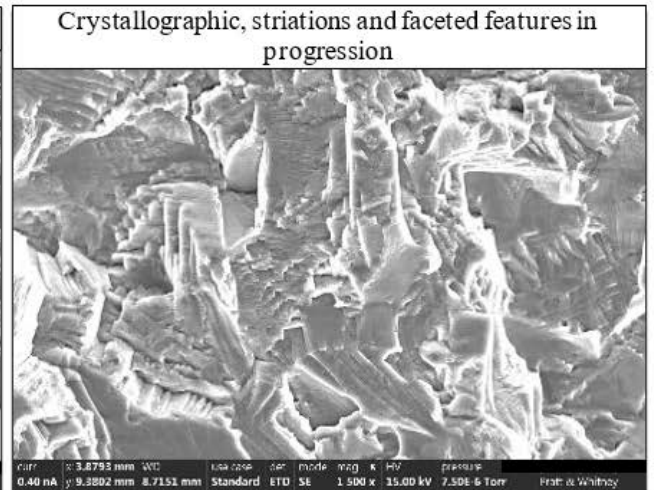
The broken open crack at the LE corner of the cavity measured 0.068” x 0.011”. SEM examination confirmed fatigue features. Features near the cavity surface were faceted. The progression exhibited a mix of faceted and crystallographic features, with isolated striated grains ([Figure 62](#)). SEM examination also identified faceted areas one or two grains deep along the surface in the force fractured region outside of the broken open crack. The remainder of the force fractured surfaces exhibited smear or ductile dimples, typical of overstress ([Figure 63](#)). FPI indications at the TE side of the cavity were also force fractured open. Smear ductile dimples, indicative of overstress, up to 0.008” in depth, were observed ([Figure 64](#)).

Figure 62: SEM images showing the fatigue features at the crack that was broken open in cavity CE.

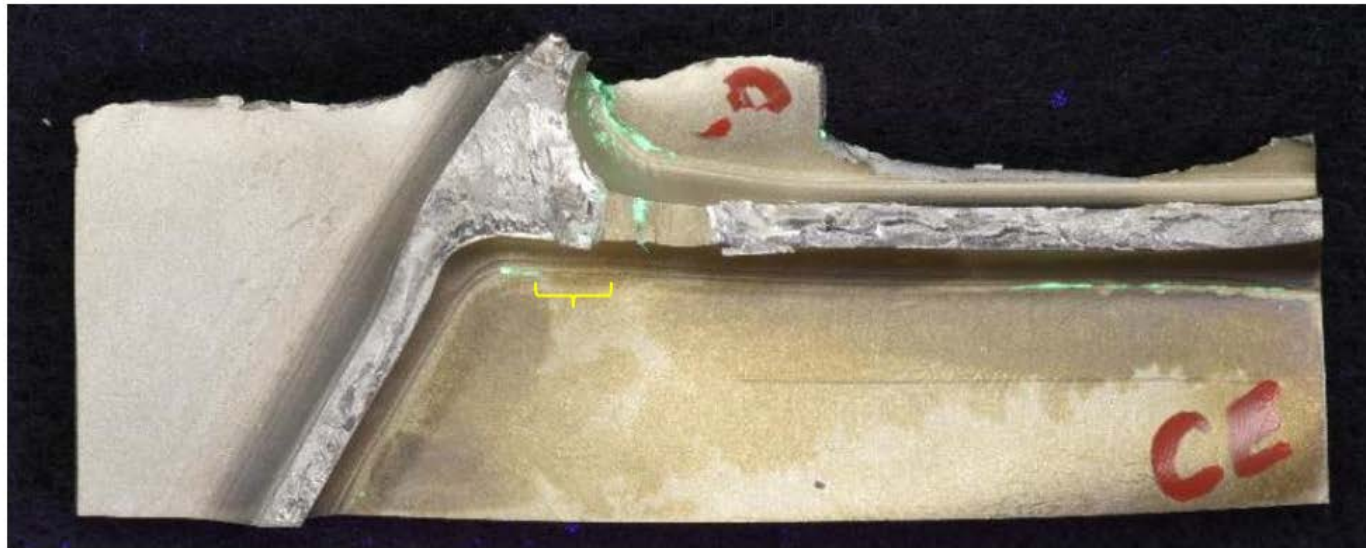
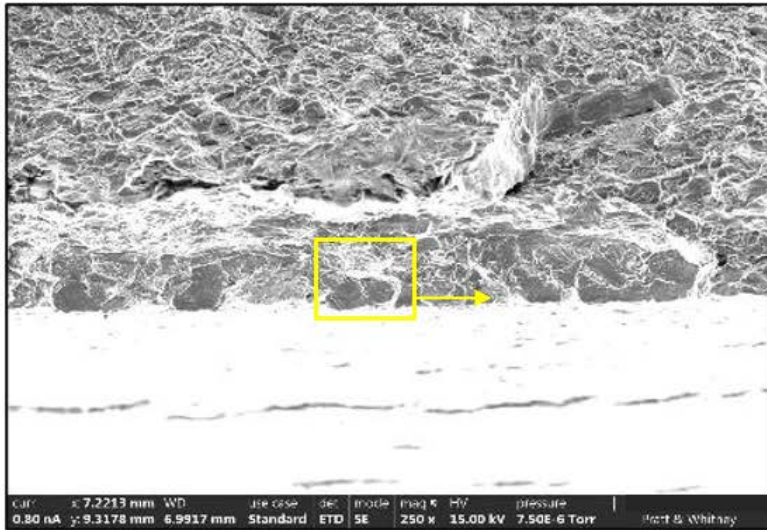
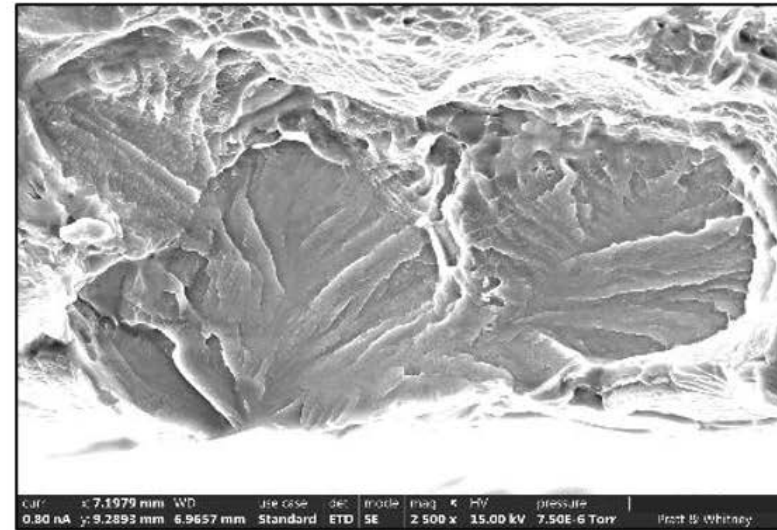
Figure 63: SEM images showing faceted areas one or two grains deep along the surface in the force fractured region outside of the broken open crack.

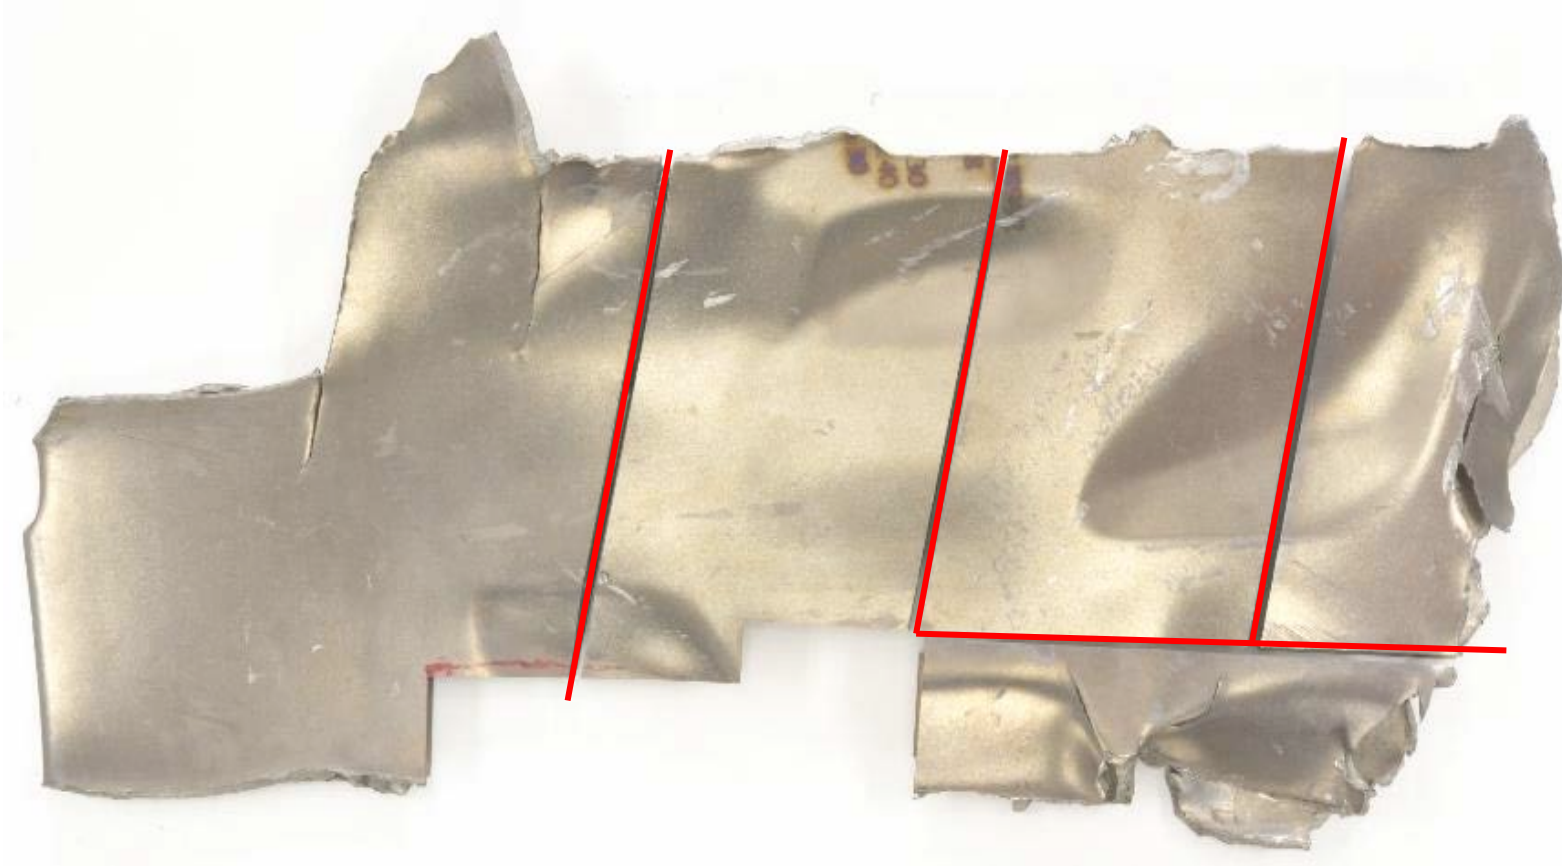
Figure 65: Metallographic images of the longitudinal section through the chordwise rib at the TE side of cavity CE.

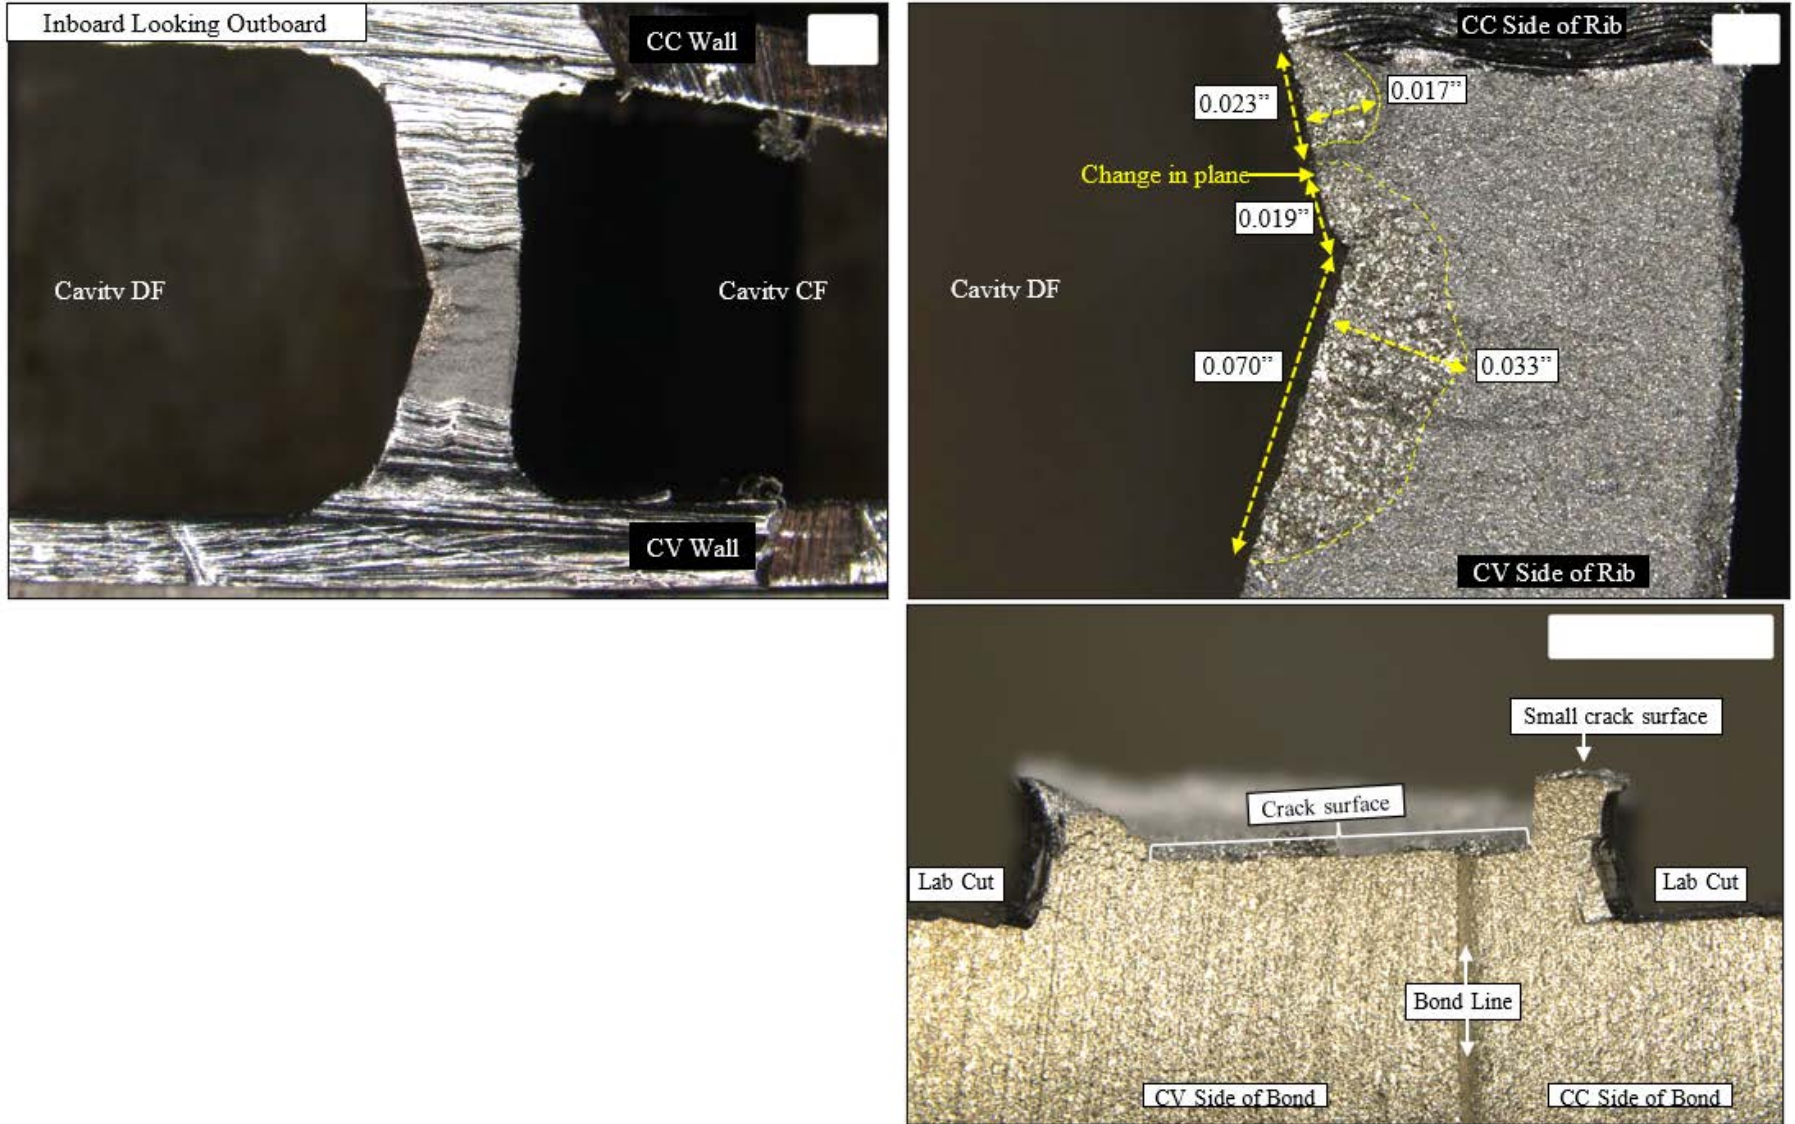
Figure 69: Images showing the broken open cracks in cavity DF.

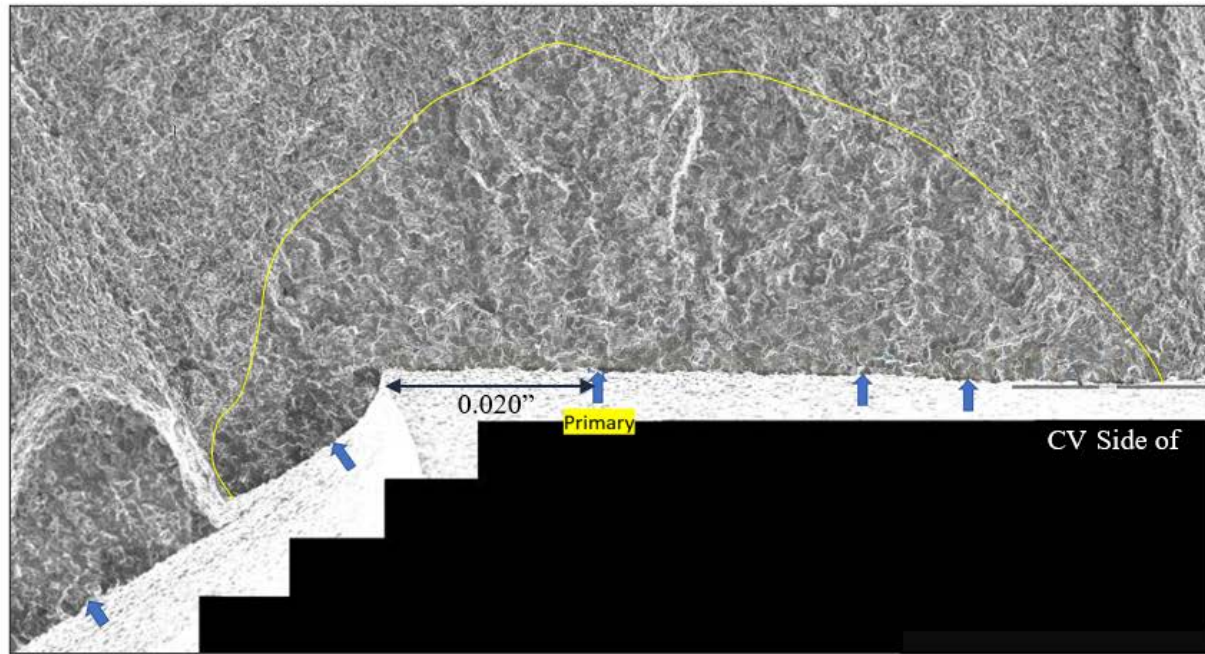
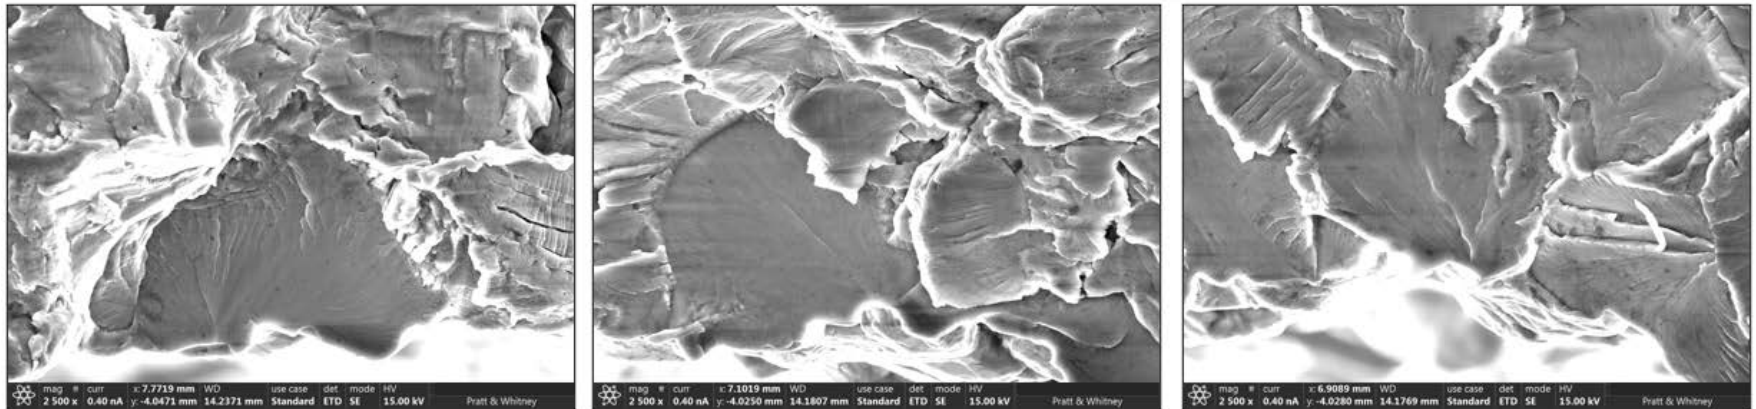
Figure 70: SEM images showing the features in cavity DG after force fracturing the crack open. Faceted alpha grains were observed along some of the fracture at the edge of the cavity surface. The remainder of the features exhibited ductile dimples, indicative of overstress.

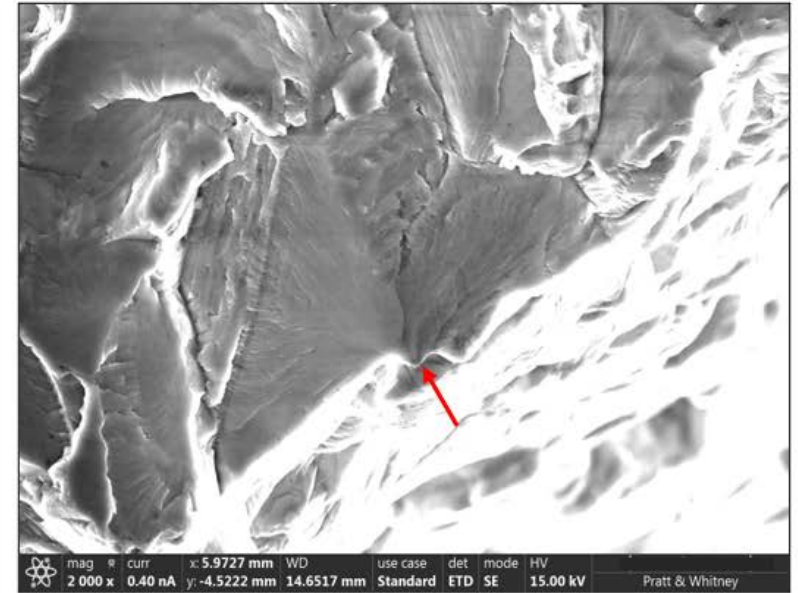
Figure 73: SEM images of the smaller crack on the concave side of the rib in cavity DF. A single surface origin was observed (red arrow).

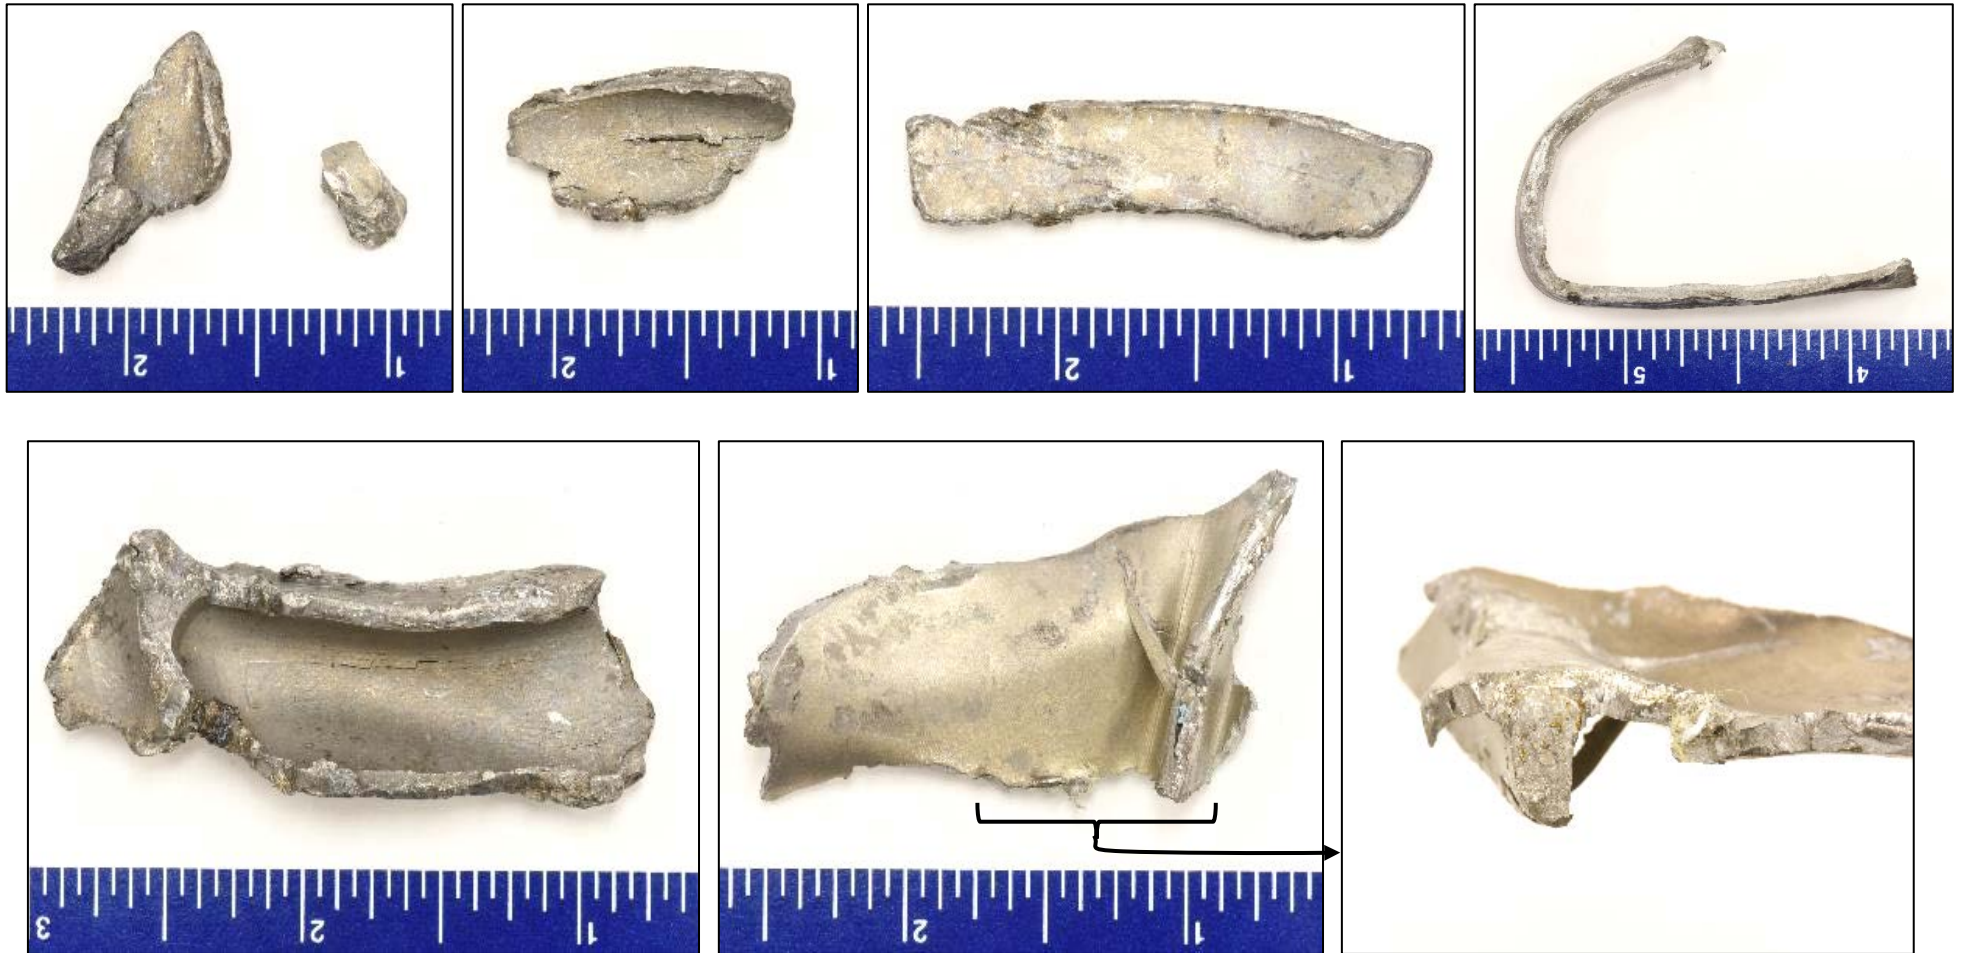
Figure 74: Images of the small blade fragments returned to P&W for evaluation. The fragments exhibited extensive secondary damage.

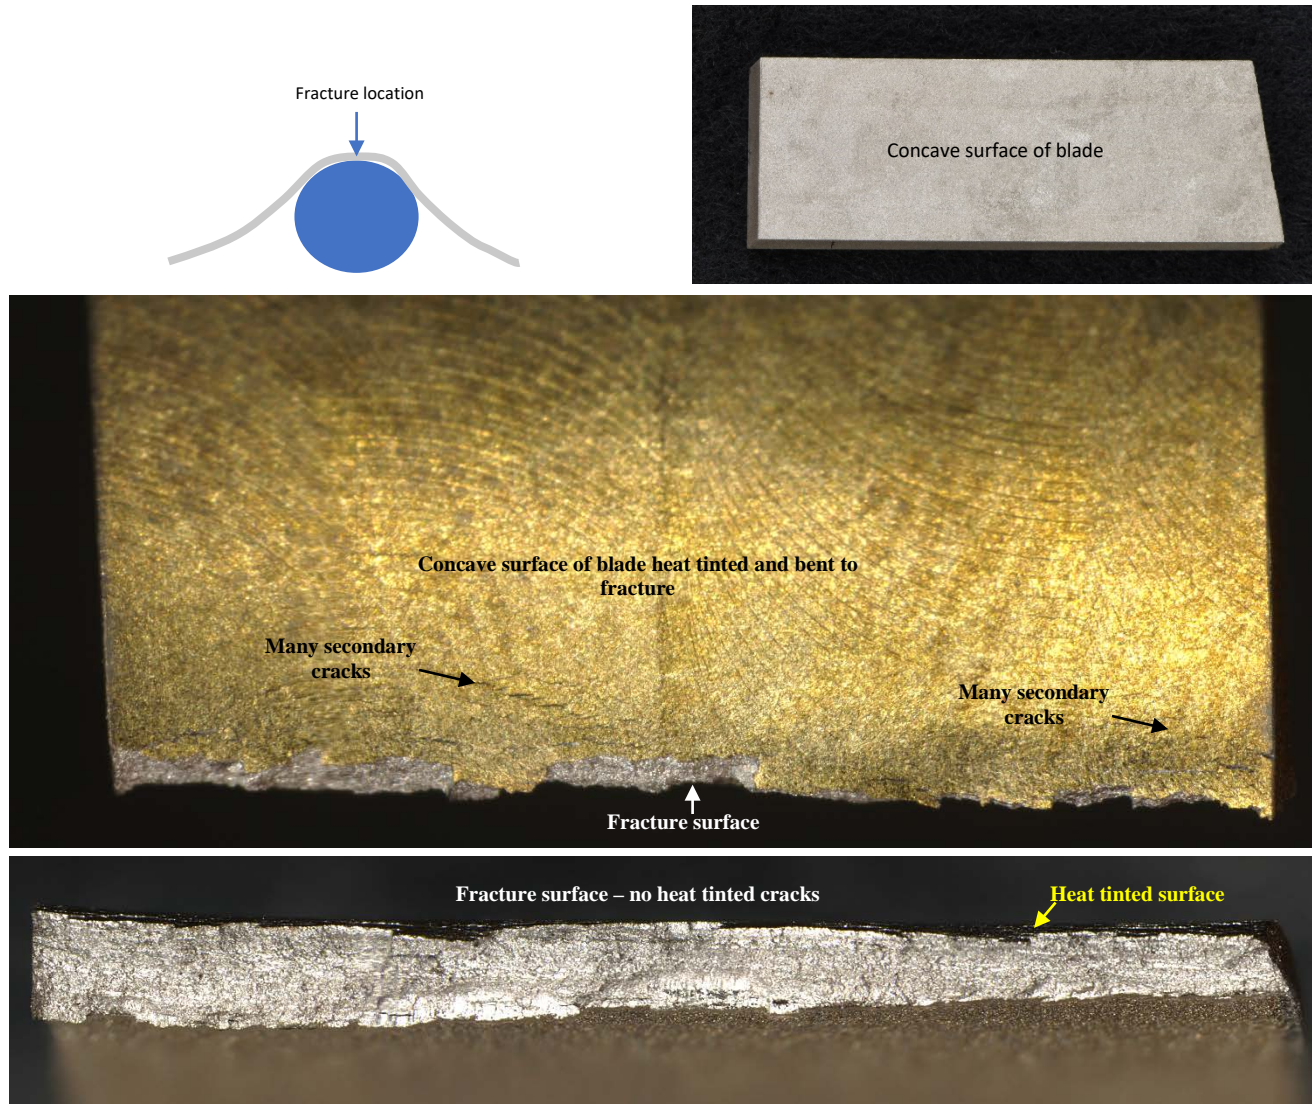
approximately 0.050” via wire EDM and then it was heat tinted in a furnace until the surface appeared gold. The sample was then bent until fracture. There was no heat tint on the fracture surface or on the winked open secondary cracks, indicating that there were no pre-existing cracks ([Figure 77](#)).

Figure 77: Images showing the heat tinted bend test sample after fracturing. Multiple secondary cracks were observed on the bent surface. No heat tint areas were observed on the fracture surface.

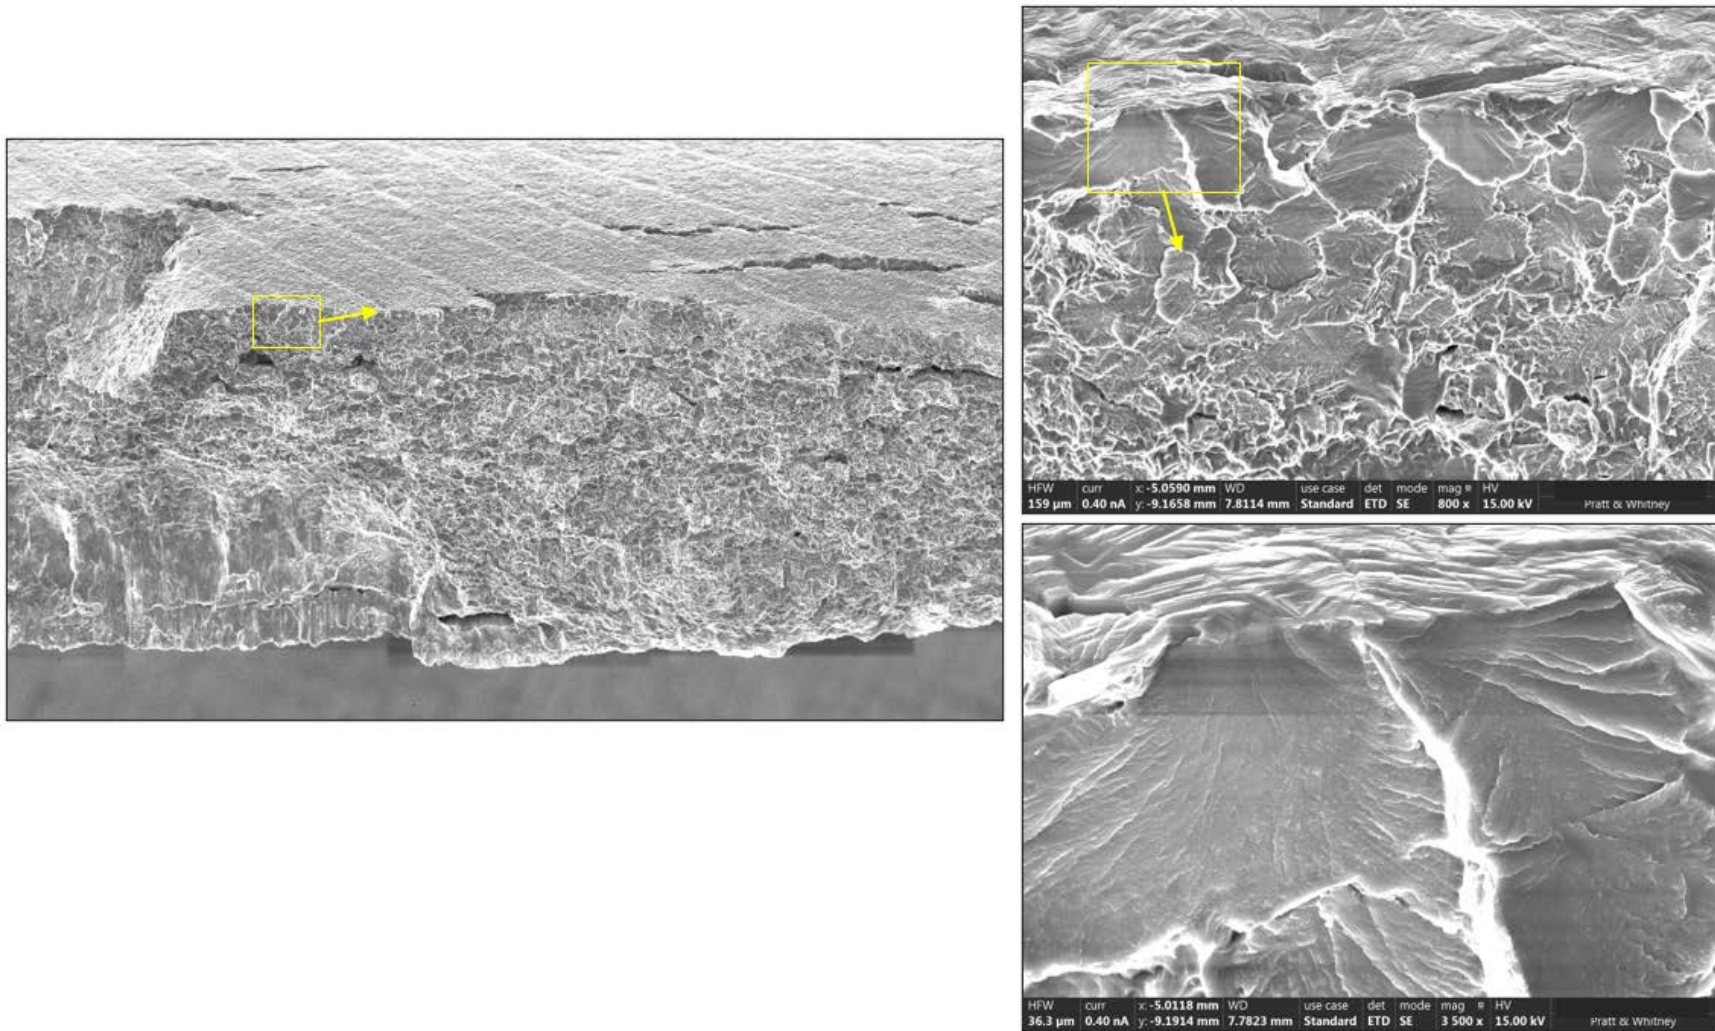
Figure 78: SEM images showing a layer of faceted grains along the surface of the bend test fracture.

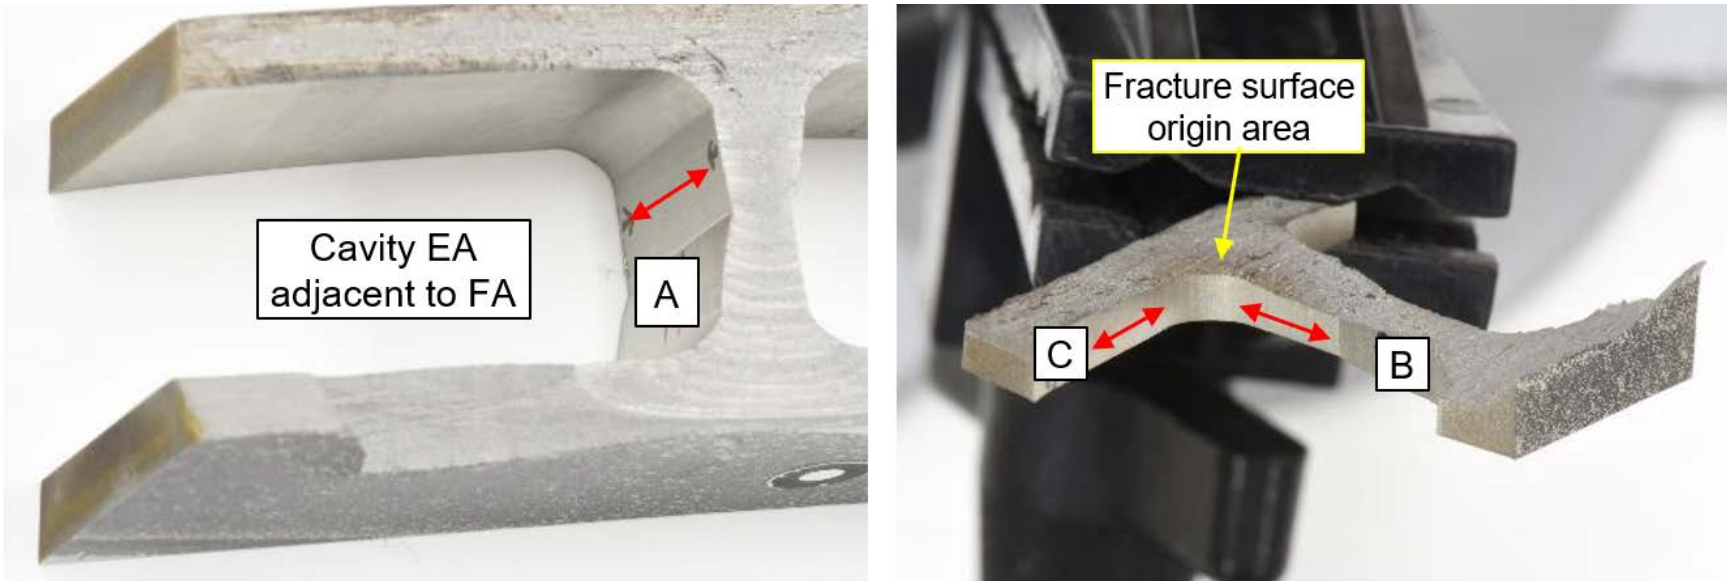
Figure 79: Surface roughness measurements were taken with a Mahr® profilometer using a 4mm stylus along the red lines shown in the images above. Ra values ranged between 18 – 53 μin which met drawing requirements.
