Metallurgical Investigation Final Report

Subject: Metallurgical Investigation of Fan Blades from PW4077 Engine SN 777047

Date: February 24, 2023

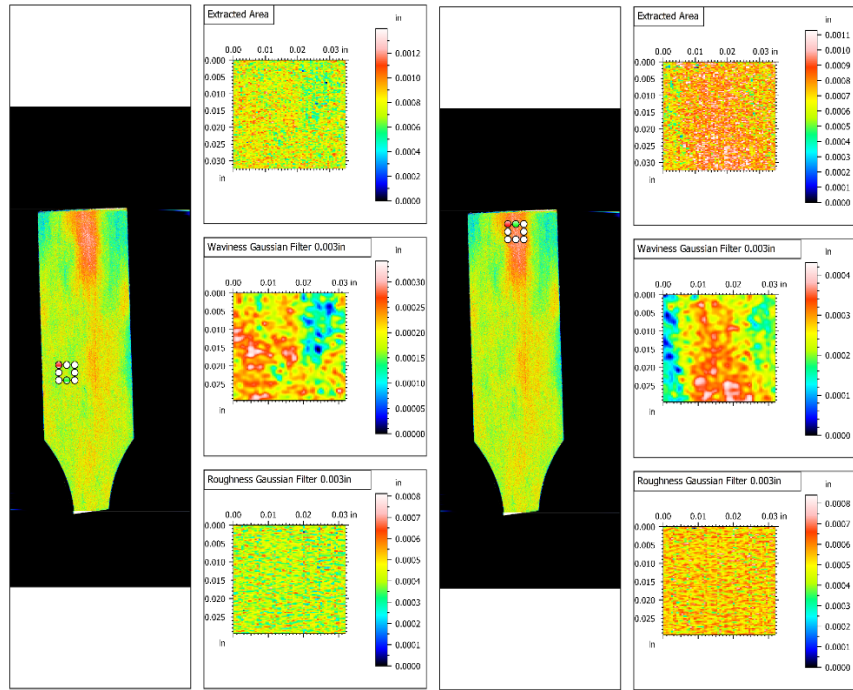
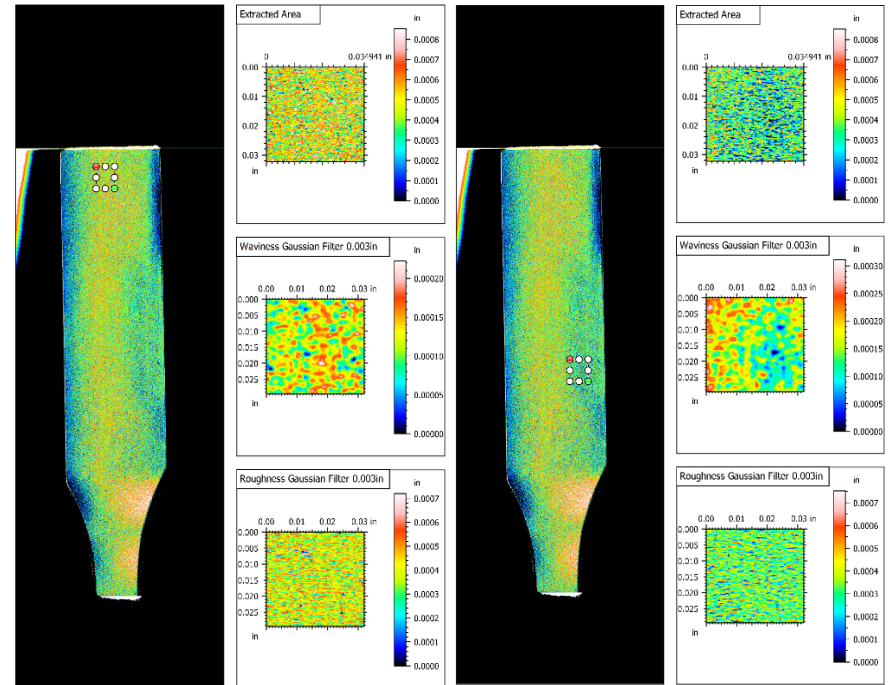
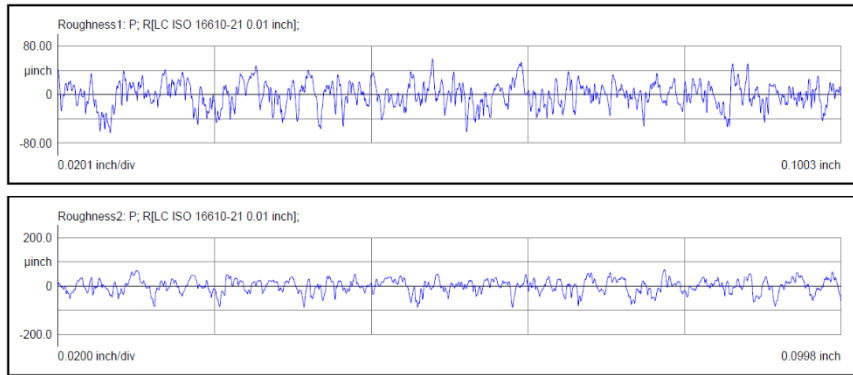
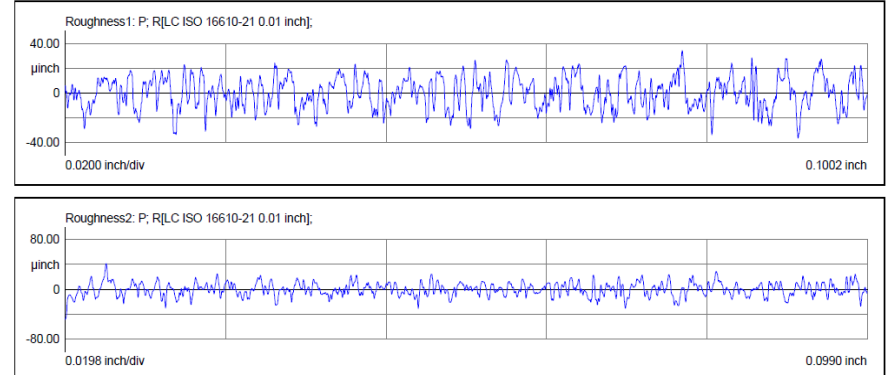
Figure 80: Images showing the laser and stylus profilometry results on fatigue test coupons from the incident blade (DA-CV-1) and a baseline fatigue sample from blade S/N CBDUAY1357.

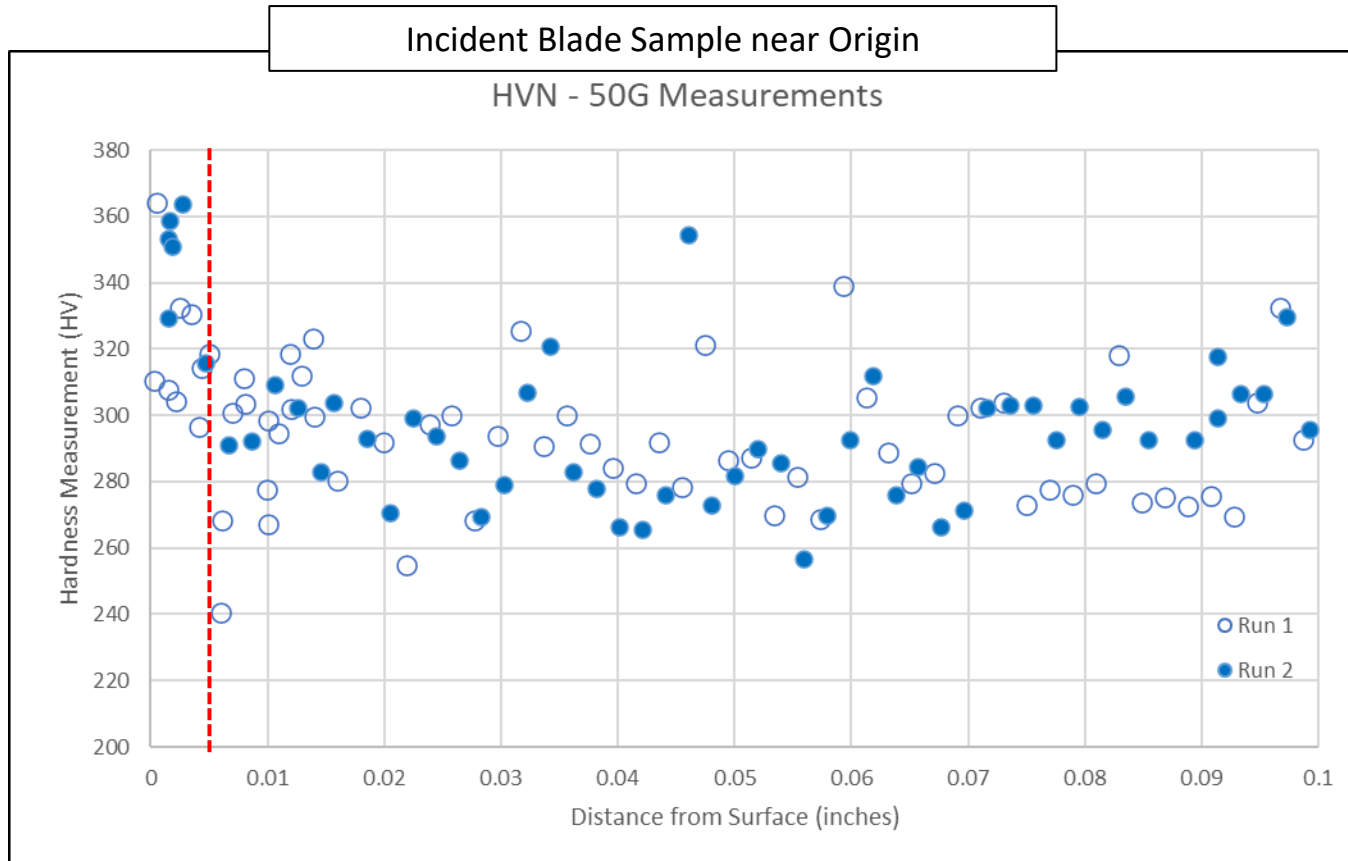
50g micro-hardness traces were taken from the cavity surface near the primary fracture origin into the material at 0.0005” increments. A slight increase in hardness within ~0.005” from the surface was observed ([Figure 81](#)). Vickers hardness measurements were also taken directly onto the surface of the flat fatigue test coupons with original event blade cavity surfaces (FA-CV-1, DA-CV-2, and DA-CC-1). For comparison, a machined bulk material coupon (EA-CC-3) was tested as well as a baseline surface coupon from CBDUA1357. Results showed that the event blade surfaces were harder than the machined and baseline blade surfaces ([Figure 82](#)).

Figure 81: Graph showing the results of microhardness measurement traces taken from the cavity surface near the primary origin. A slight increase in hardness was observed within 0.005” of the surface.

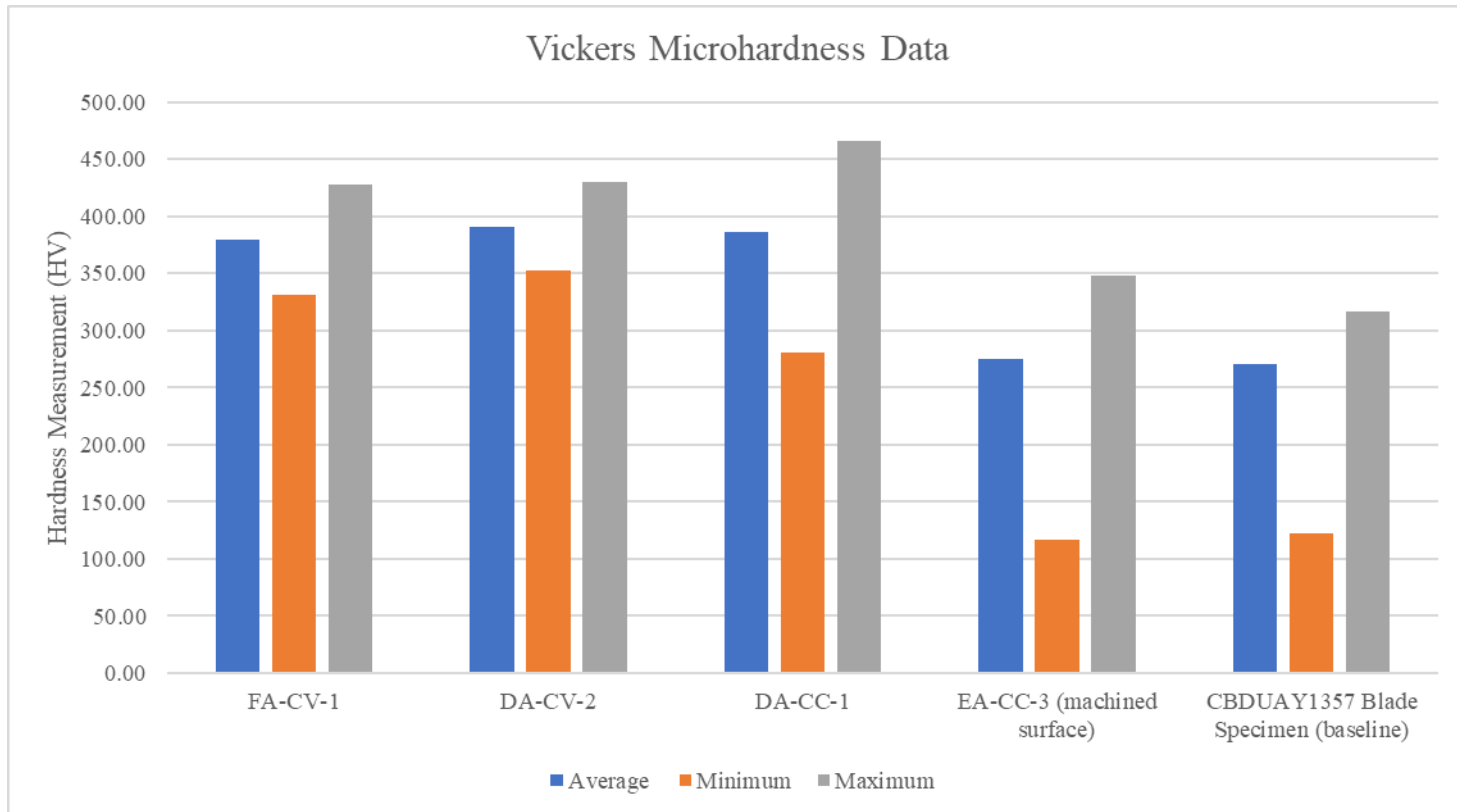
Figure 82: Graph showing the average, minimum, and maximum hardness measurements on the surface of the fatigue test coupons.

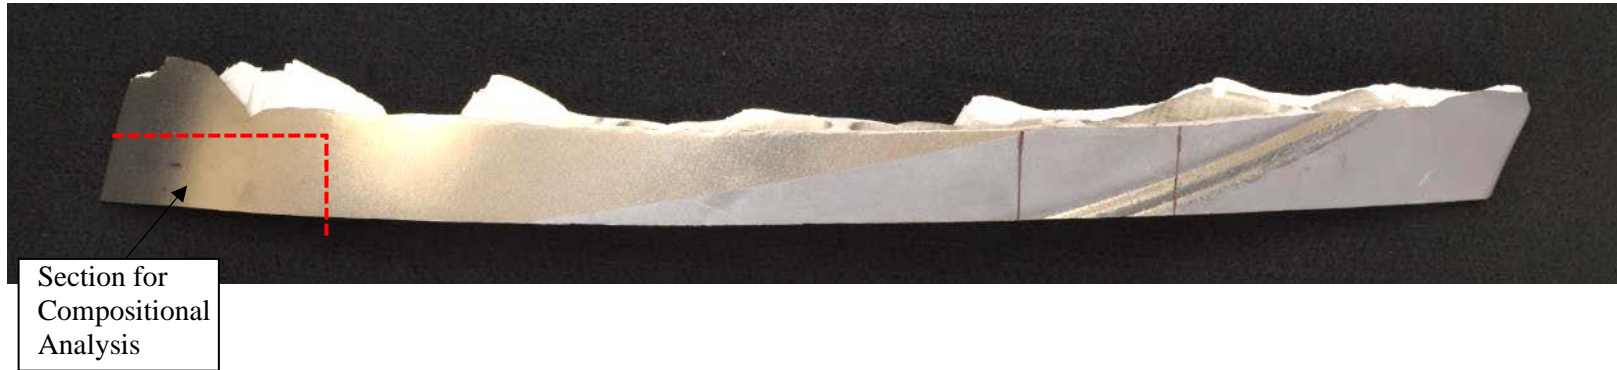
Section for Compositional Analysis

Chemical composition on the bulk material was completed using LECO elemental analysis on a section from the 1” slice that was removed from the fracture surface. The chips used were from near the LE just inboard of the fracture surface ([Figure 83](#)). The chemical composition of the bulk material conformed to the Ti 6Al-4V specification.

Figure 83: Table showing wet chemistry results on the bulk fan blade material. Chips were removed from near the LE just inboard of the fracture surface as shown by the red lines above.

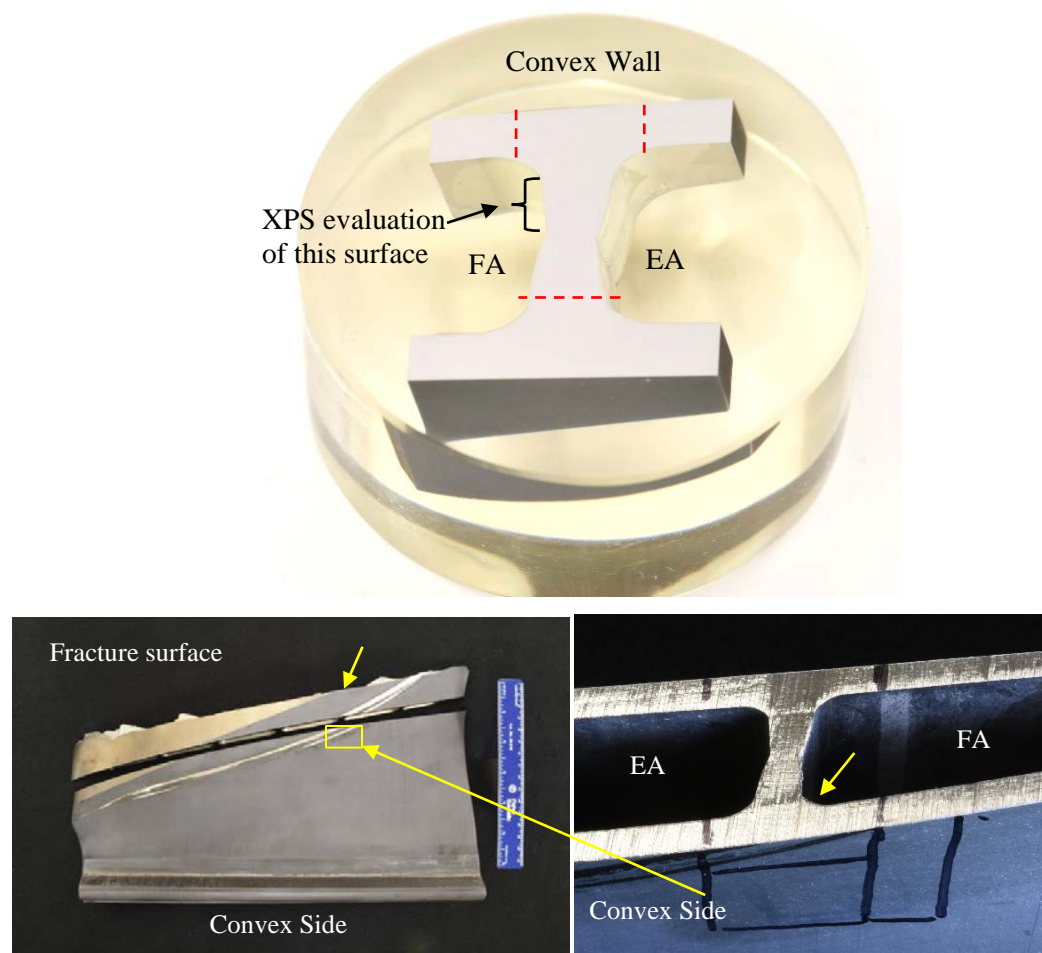
X-ray photoelectron spectroscopy (XPS) was initially completed on a cavity FA rib surface, approximately 1 inch below the fracture surface (metallographic section A in 2.1.1.3). The sample was broken out of the mount for XPS evaluation ([Figure 84](#)). An argon ion beam was used to iteratively remove material (sputter) and analyze the composition through the first ~70nm (0.0000027”) of the blade allowing for measurement of the surface oxide layers. An exemplar reference sample was used from an internal rib surface of a typical blade.

Figure 84: XPS was completed at the location shown above, on a rib in cavity FA, approximately 1 inch below the fracture surface.

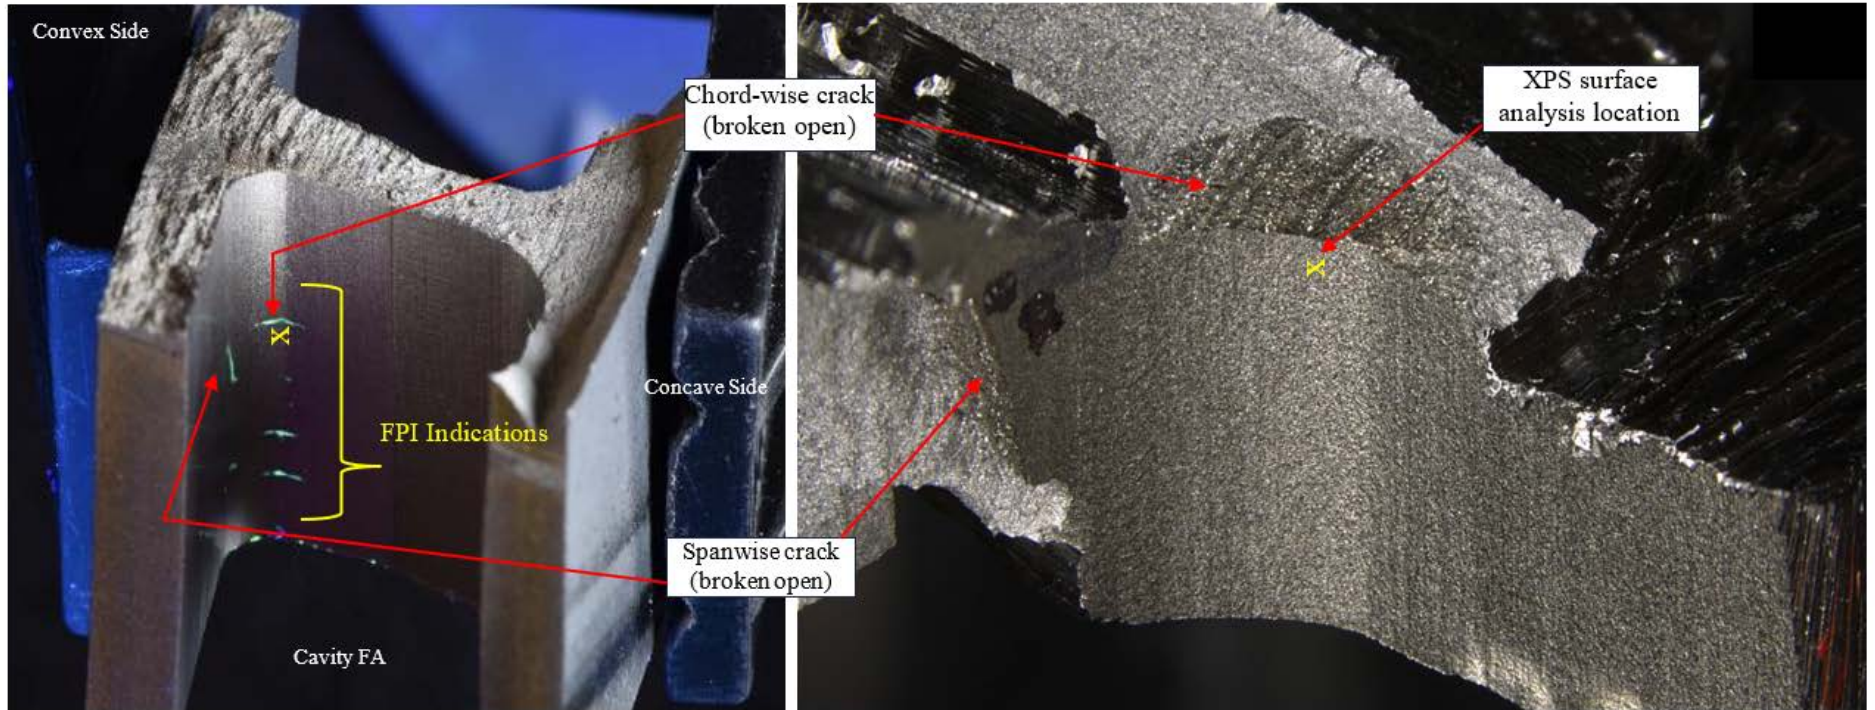
Follow up XPS analysis was completed on the cavity FA surface near the origin area of a secondary chordwise crack ([Figure 85](#)). This sample exhibited a carbonaceous layer that dominated the composition for the first ~40nm of the surface before titanium became the dominant element. Titanium metal is highly reactive when exposed under vacuum, so the ion beam sputtering process used to iteratively remove nanometers of material and analyze the near surface resulted in a lingering amorphous and carbide carbon signature. The distribution of carbon bonding states was not consistent with adventitious carbon (carbon associated with atmospheric contact). Following XPS, SEM examination identified carbon rich deposits of varying size decorating the surface of interest as well as an adjacent lab cut surface, indicating that they were introduced after sectioning. These carbon rich regions were not displaced or dissolved during ~2min of ultrasonic exposure in ethanol which was the cleaning procedure prior to XPS.

Figure 85: XPS was completed at the location shown above, near an origin on the secondary chordwise crack. The section that was used also contained half of the spanwise crack surface.

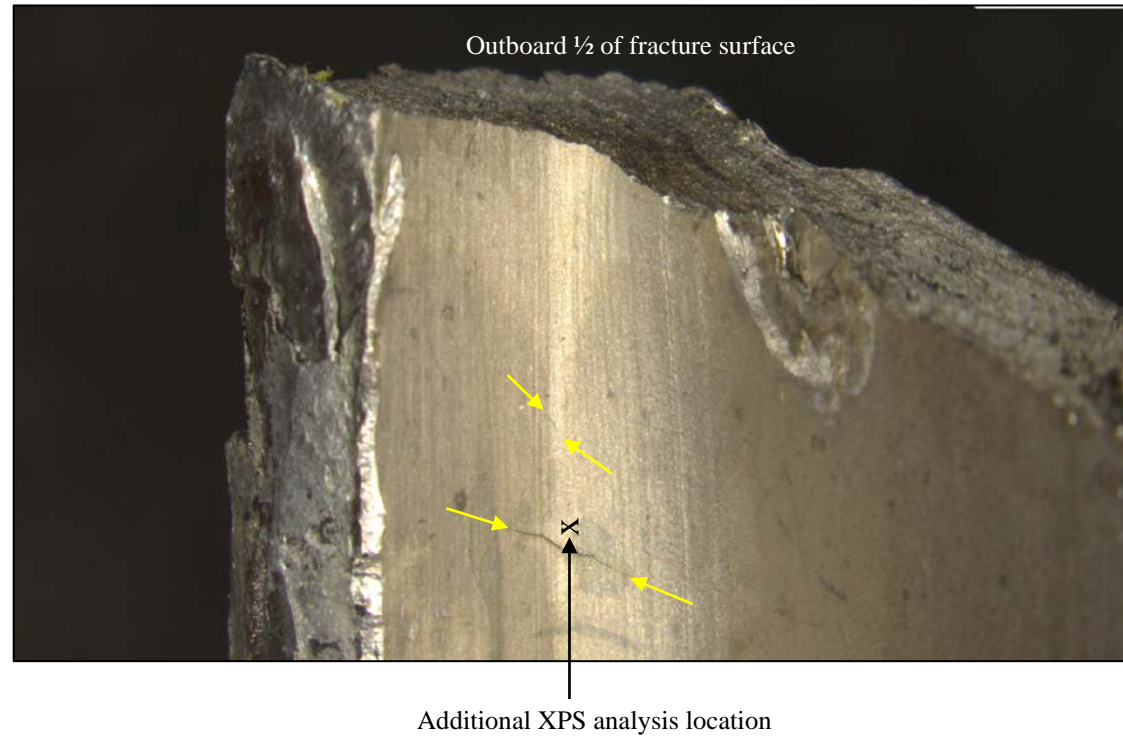
Additional XPS analysis was conducted at a second fatigue origin, adjacent to a secondary flowpath crack just outboard of the primary origin ([Figure 86](#)). SEM examination prior to the XPS was performed to confirm the surface was relatively free from carbon contamination. The oxide layer at the surface was estimated to be ~25nm deep, which was consistent with prior samples and did not suggest an alpha case layer. The carbon levels were consistent with the baseline sample and suggestive of adventitious carbon. These results suggested that the high carbon levels observed previously were likely the result of surface contamination during sample preparation or handling. Overall, the elements detected compared favorably with the exemplar sample. The XPS results did not detect a significantly high surface chemistry gradient at the surface that would have affected fatigue capability.

Figure 86: The third XPS trial was completed at the location shown above, near an origin on the outboard secondary chordwise crack.

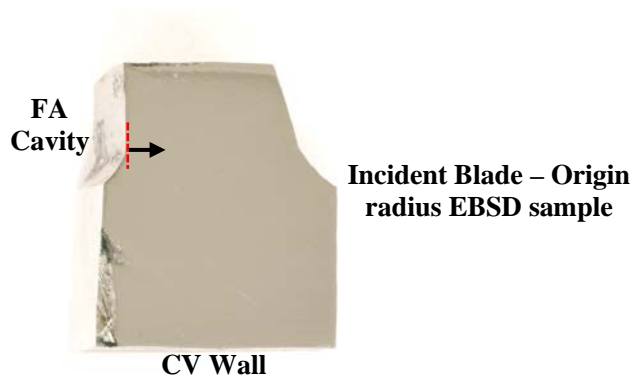
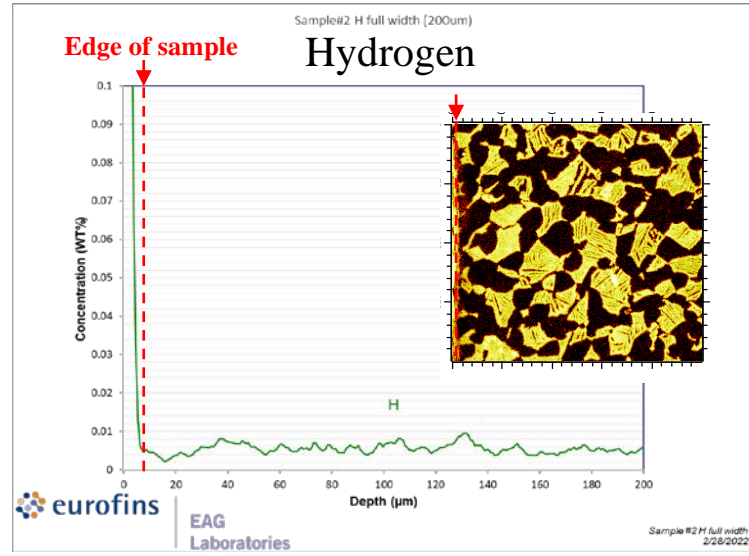
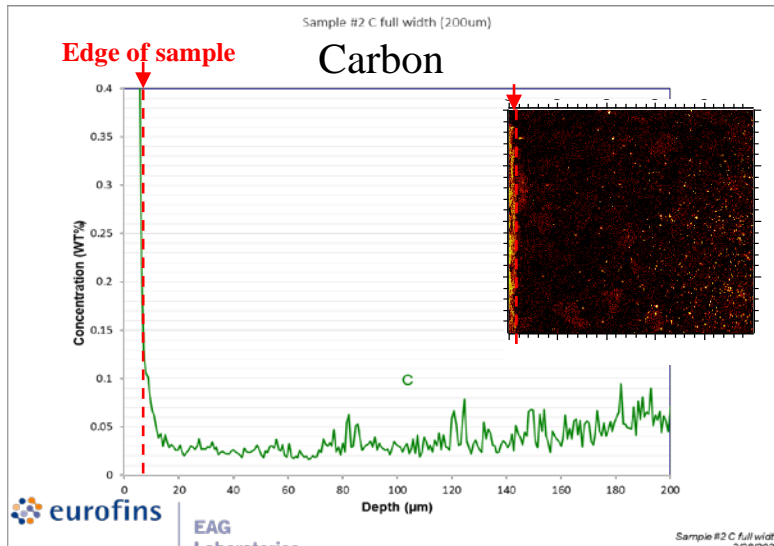
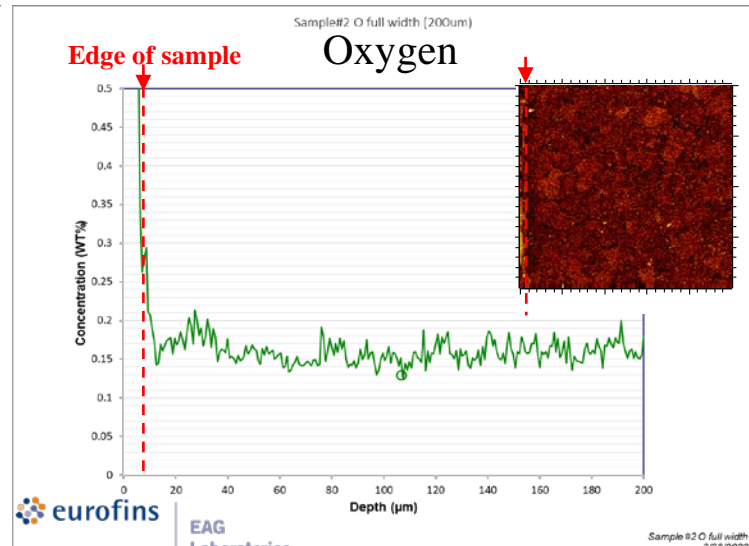
SIMS testing was completed on a cross-section near an origin on the event blade. The sample chosen was a planar polish into a flowpath secondary chordwise crack (Reference [Section 2.1.2.3](#)). Two iterations of polishing and EBSD were previously completed on the sample as well as a 1% HF etch that was subsequently buffed off. It was broken out of the mount for SIMS analysis. Concentration line scans were taken over the width of elemental maps that were 200 μm wide for H, C, and O. SIMS did not detect significant surface concentration gradients for H, C or O. The runout concentration levels were within spec limits for Ti 6Al-4V blade alloy ([Figure 87](#)).

Figure 87: SIMS analysis of a secondary fatigue origin sample from the event blade did not detect significant surface concentration gradients for H, C or O. Concentration line scans were taken over the width of an elemental map that is 200 µm wide. The runout concentration levels were within spec limits for Ti 6-4 blade alloy.

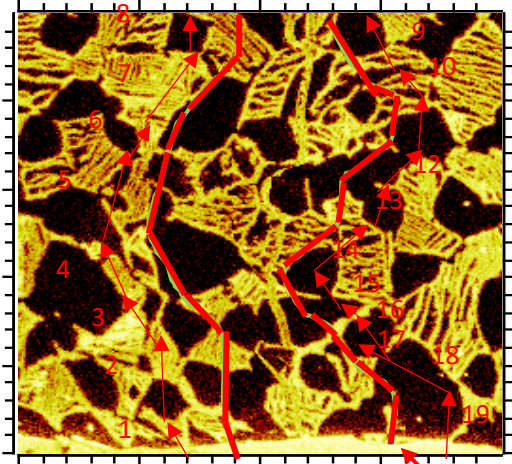
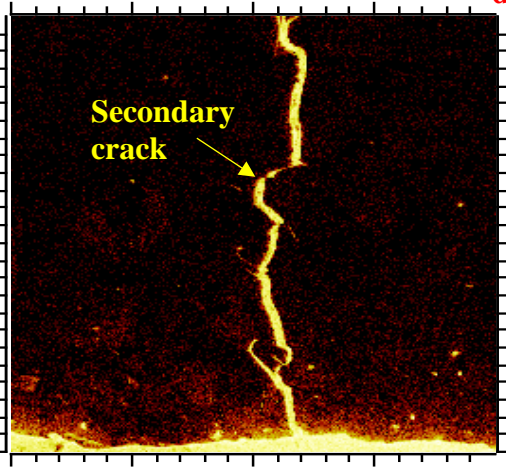
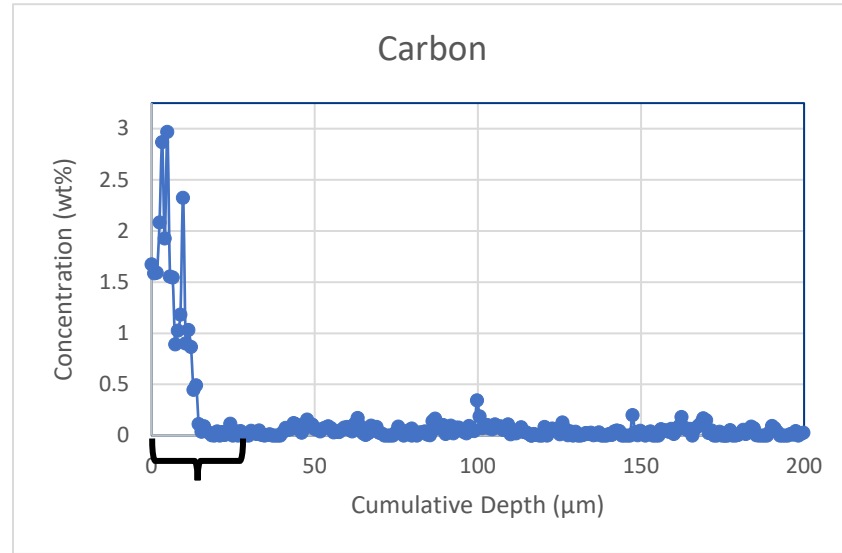
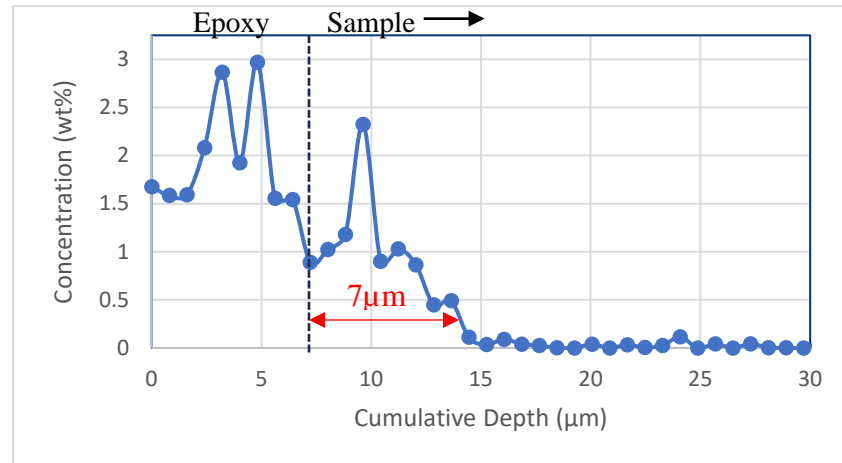
Additional SIMS testing was completed on a spanwise section through a flowpath secondary crack inboard of the fracture surface (Reference [Section 2.1.2.3](#) and [Figure 31](#)). The analysis was completed adjacent to the larger of the two cracks. Data was along multiple line scans primarily staying within alpha grains. A carbon gradient, approximately 7 μm (~0.0003”) deep, was observed. The concentration at the surface was approximately 1 wt.% carbon ([Figure 88](#)).

Figure 88: SIMS analysis adjacent to a flowpath secondary fatigue crack from the event blade (Reference [Section 2.1.2.3](#)) detected a 7 μ m carbon gradient starting at concentrations of approximately 1 wt%.

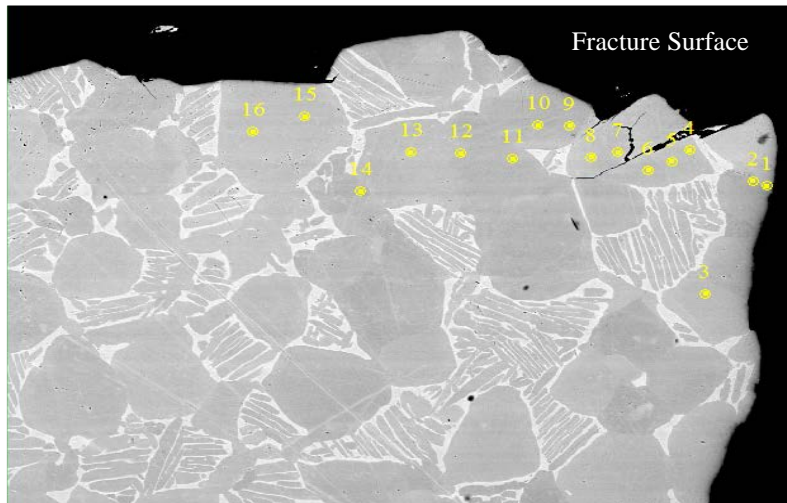
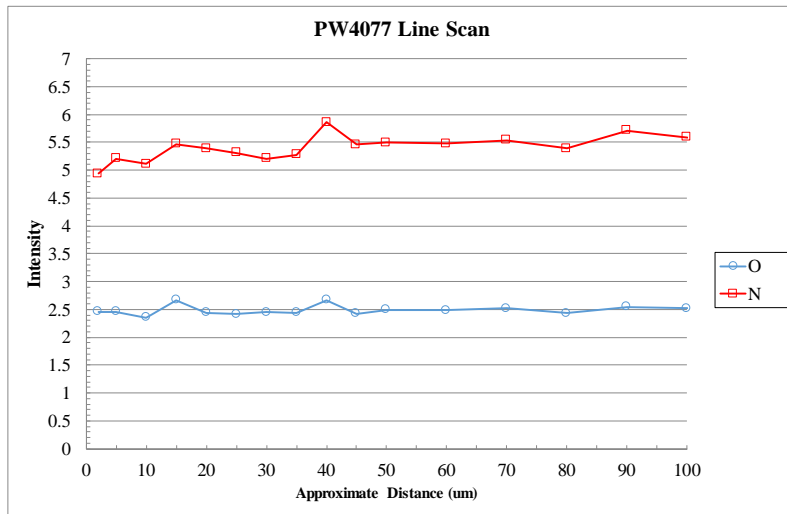
Although electron microprobe (EMP) is less sensitive to low concentration levels than SIMS, EMP can also perform depth profiles of elements such as Ti, Al, V, O and N from the surface. Multiple iterations of EMP traces into the material near the fracture surface and secondary flowpath cracks showed no detectable levels of nitrogen, aluminum or vanadium above the matrix alpha baseline and no significant differences in the oxygen levels between the sub surface and matrix alpha phases. Examples of these traces are shown in [Figures 89 and 90](#).

Figure 89: Image showing EMP traces into the material near the fracture surface on the transverse section through the primary origin (top left image). The data and graph show no detectable levels of nitrogen above the matrix alpha baseline and no significant differences in the oxygen levels between the near surface and matrix alpha phases.

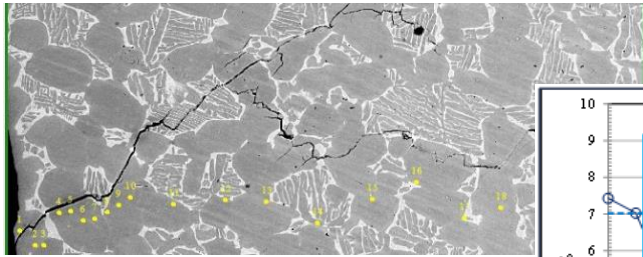
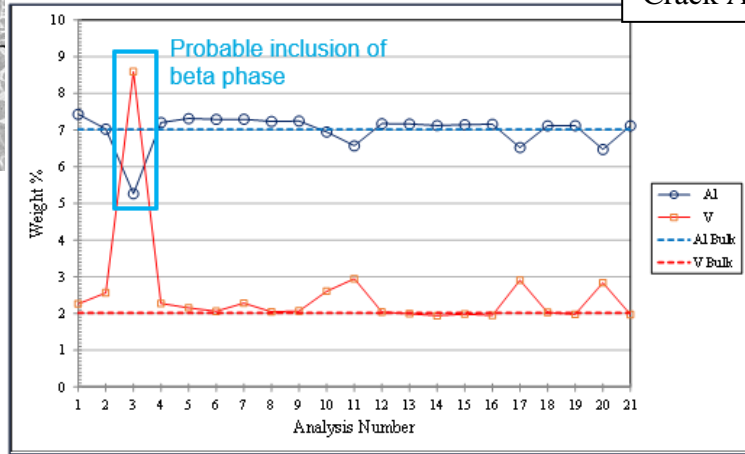
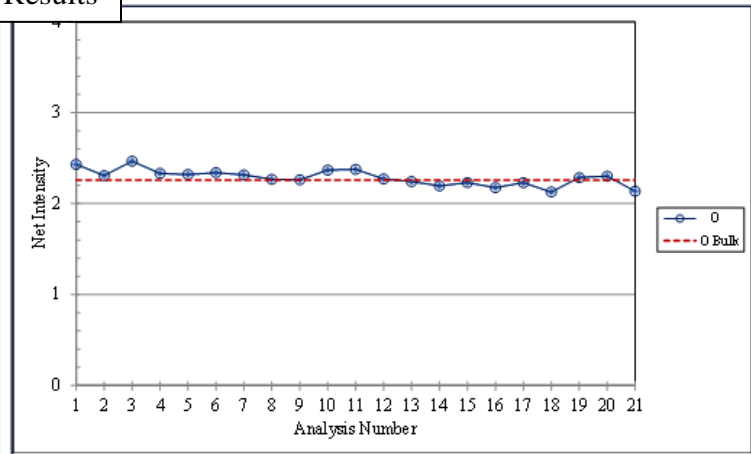
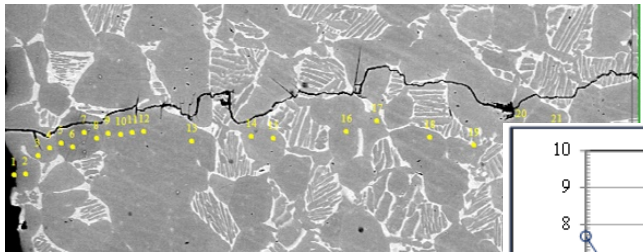
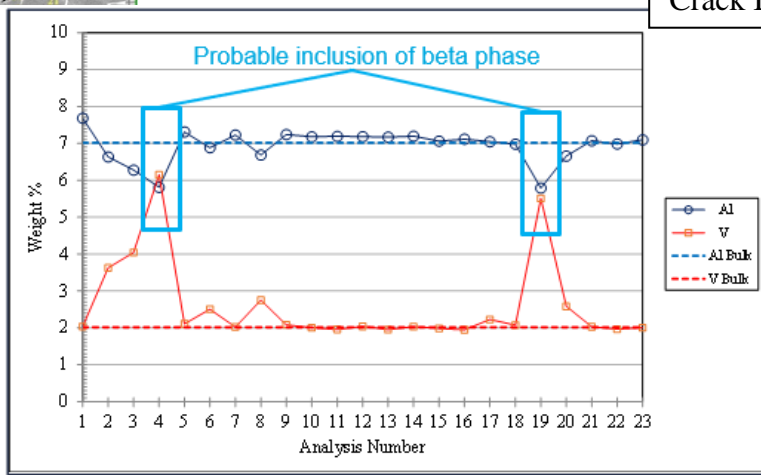
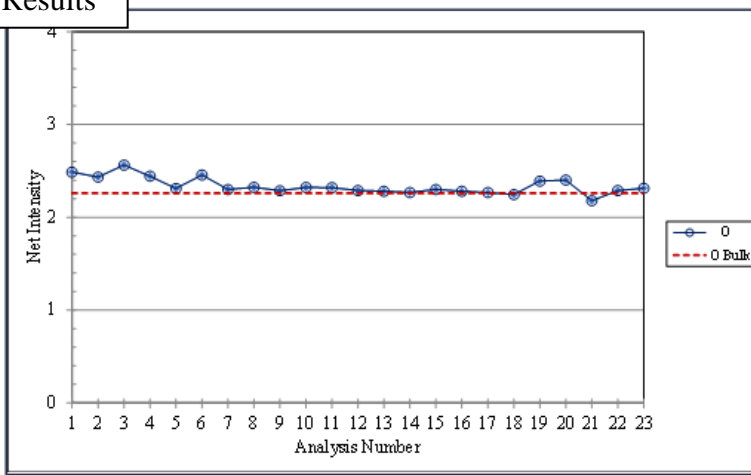
Figure 90: EMP results showing no significant difference in Al, V, and O levels between the surface and bulk alpha grains in the section through additional chordwise cracks.

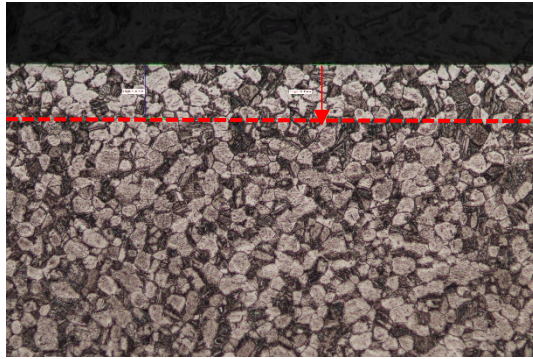
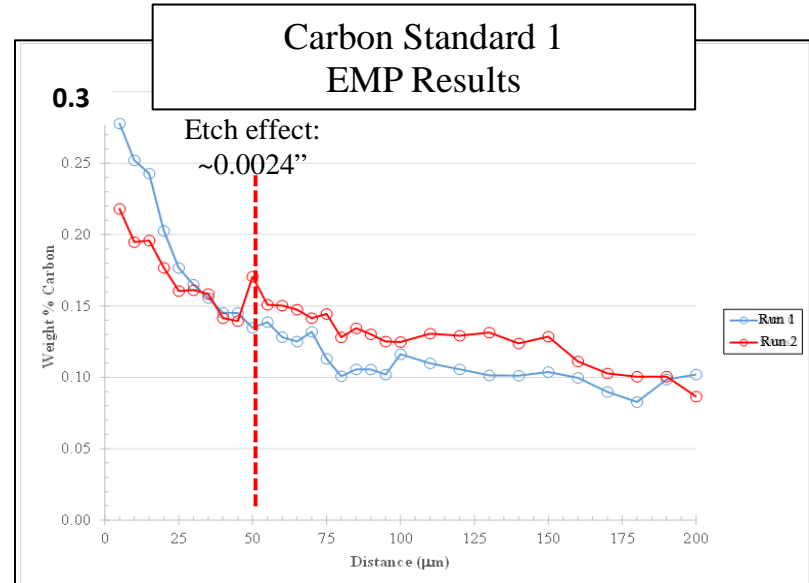
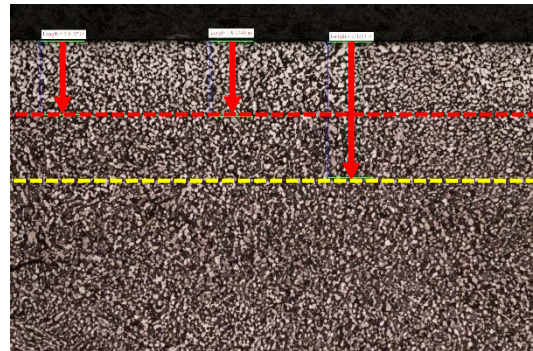
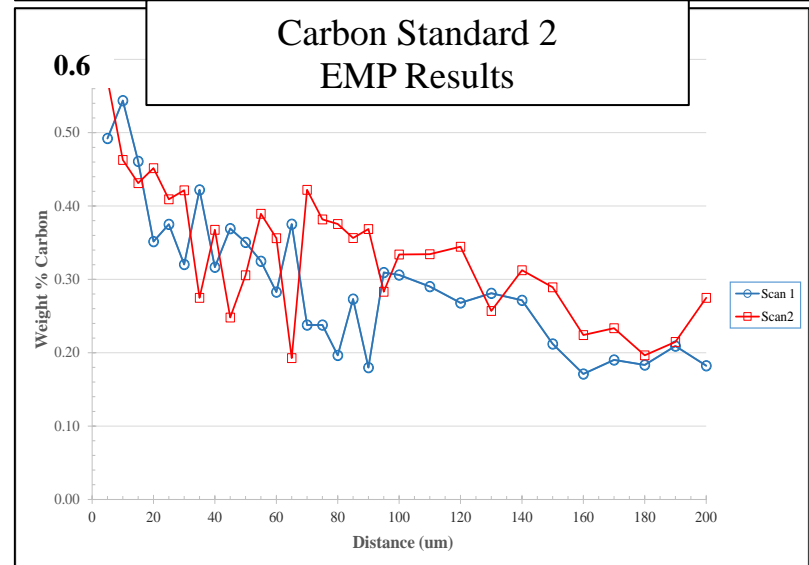
Since no carbon in titanium alloy standards were available at the expected carbon concentrations, a series of carbon in iron reference samples were used to plot an EMP calibration curve in order to analyze carbon concentration in titanium. Using the same beam conditions as the calibration, analyses were performed at 10KV – 50nA with a ~2 μm (~0.00008”) defocused spot for a distance of 200 μm (~0.008”) at intervals of 5 μm (~0.0002”) for the first 100 μm (~0.004”) and 10 μm (~0.0004”) thereafter attempting to stay in alpha grains as much as possible. Carbon contaminated Ti 6Al-4V samples were analyzed to test the feasibility of the new method. Two carbon contamination samples were produced; the heat treat cycle of the first sample replicated the final form step during blade manufacturing and the heat treat cycle of the second sample replicated processes prior to forming. EMP traces identified carbon gradients in the surfaces of both samples. The carbon gradient depth and magnitude of the second sample was larger than the first, which was consistent with the longer soak time and higher temperature of the processes prior to forming ([Figure 91](#)).

Carbon Standard 1
Heat treated per blade final form cycle
Etch effect ~0.0024"

Carbon Standard 2
Heat treat process replicated
processes prior to forming (longer
and higher temp than sample 1)
Etch effect varied from 0.014" to
0.025"

Figure 91: Images showing the etch effect and EMP carbon linescan results of the carbon contaminated samples.

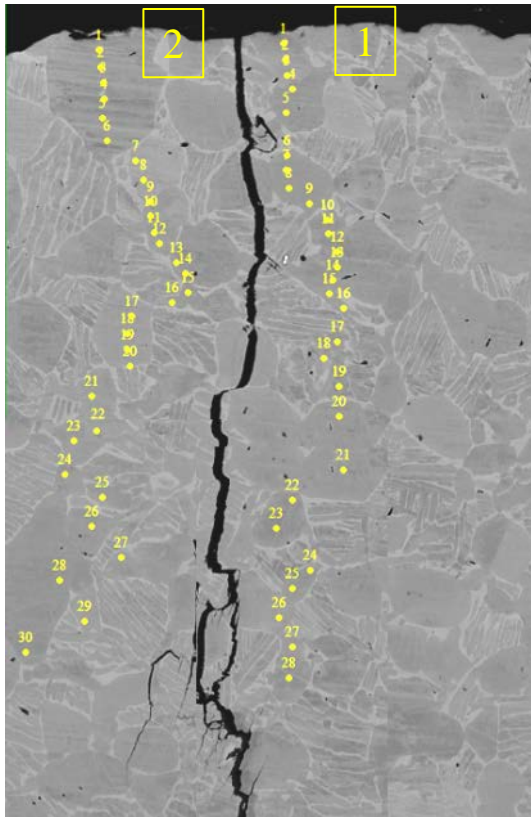
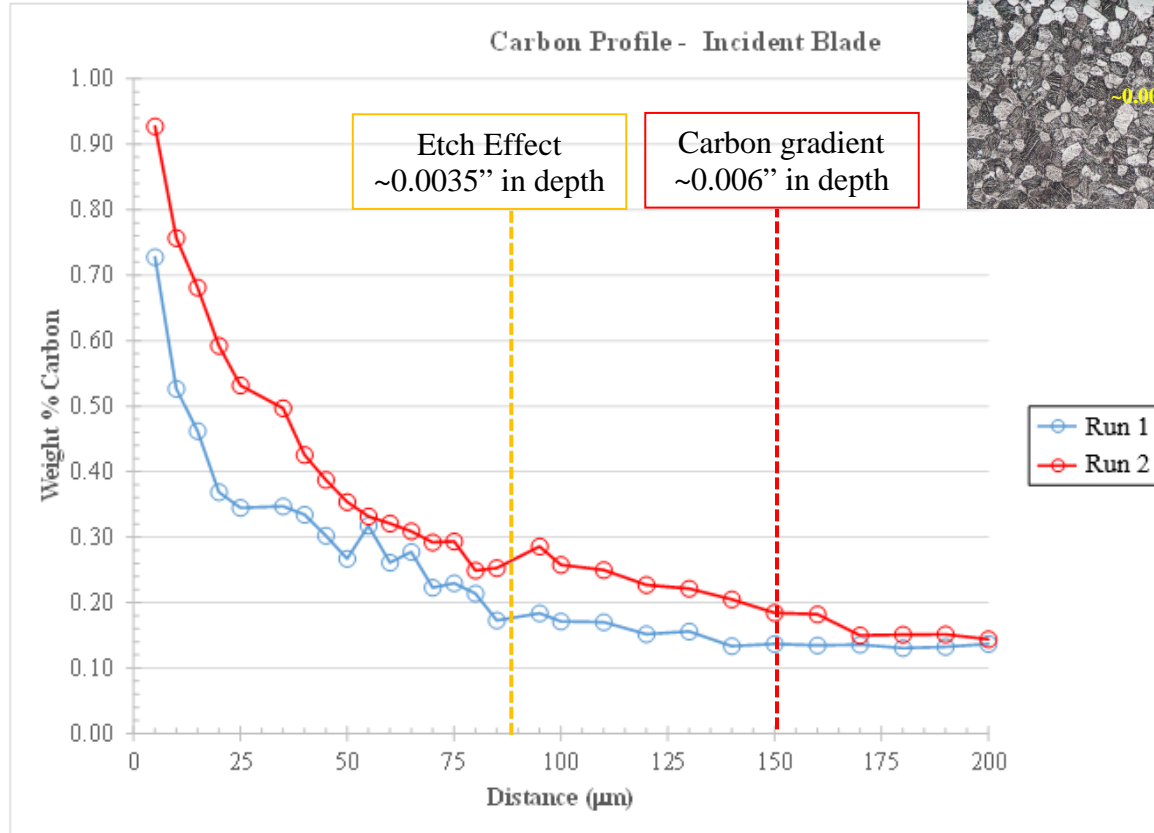
EMP of a spanwise metallographic section through secondary flowpath cracks (Reference [Section 2.1.2.3](#)) identified a carbon concentration gradient from the surface to approximately 0.006” ([Figure 92](#)). The gradient appeared more consistent with the first carbon sample that replicated the final form heat treat cycle. EMP carbon traces were completed on the secondary flowpath crack

Figure 92: Two EMP carbon traces on a spanwise metallographic section through secondary flowpath cracks (Reference [Section 2.1.2.3](#)) identified a carbon concentration gradient from the surface to approximately 0.006” in depth.

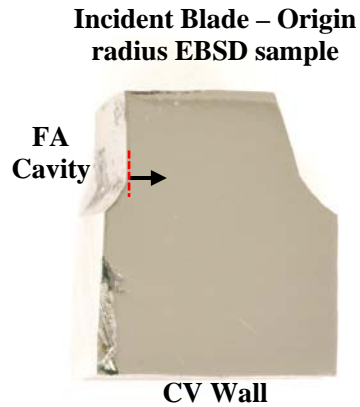
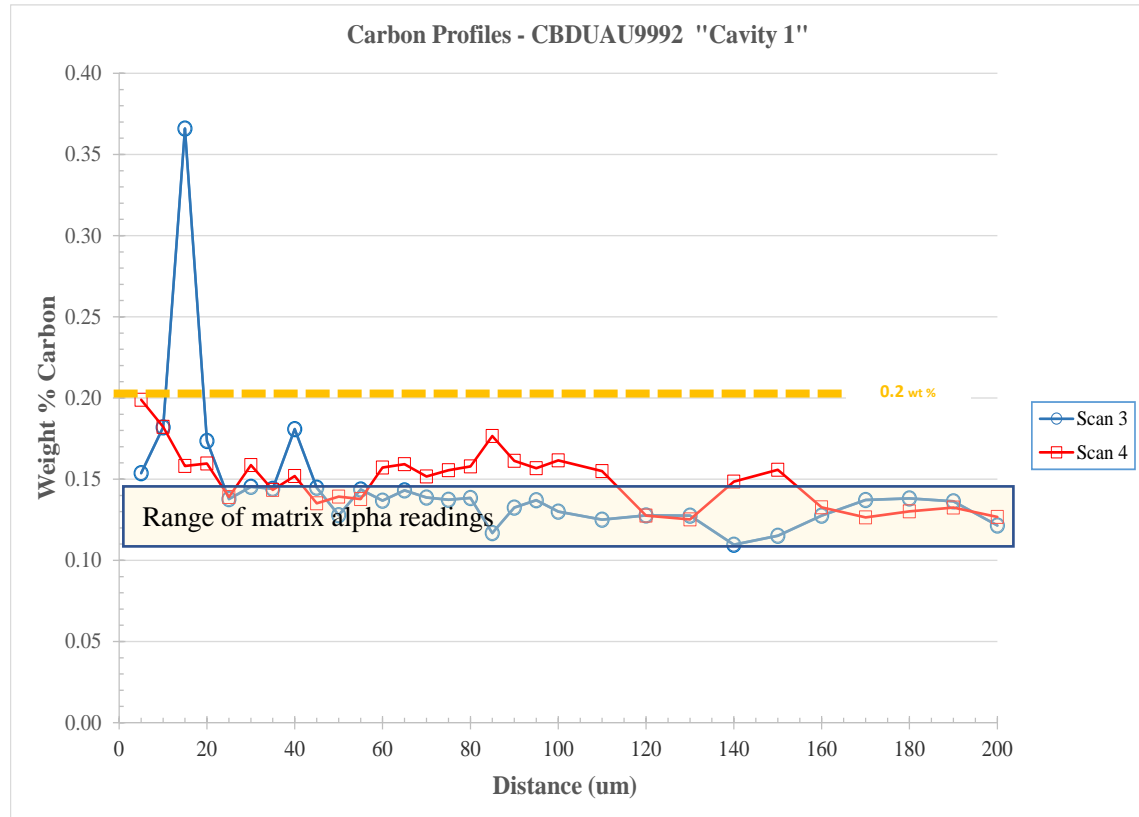
EBSO origin sample that was previously evaluated using SIMS (Reference [Section 2.5.4.3](#) and [Figure 87](#)). EMP did not detect a carbon gradient, consistent with the SIMS results which also did not detect a gradient ([Figure 93](#)). EMP traces at cavities BA and GA exhibited carbon gradients that were shallower than the carbon gradient observed at the origin location, suggesting that the amount of contamination varied within the blade ([Figure 94](#)). EMP carbon traces completed at the surface of a baseline surface fatigue test sample did not identify a carbon gradient, providing a strong correlation between carbon gradients found by EMP and fatigue capability. EMP traces from the sealed cavity on the event blade also did not show a carbon gradient at the surface, indicating that the carbon contamination was introduced after the fan blade bonding process, and likely occurred during the final blade forming process ([Figure 95](#)).

Figure 93: Two EMP carbon traces were completed on the secondary flowpath crack EBSD origin sample that was previously evaluated using SIMS. EMP did not detect a carbon gradient, consistent with the SIMS results which also did not detect a gradient (Reference [Figure 87](#)).

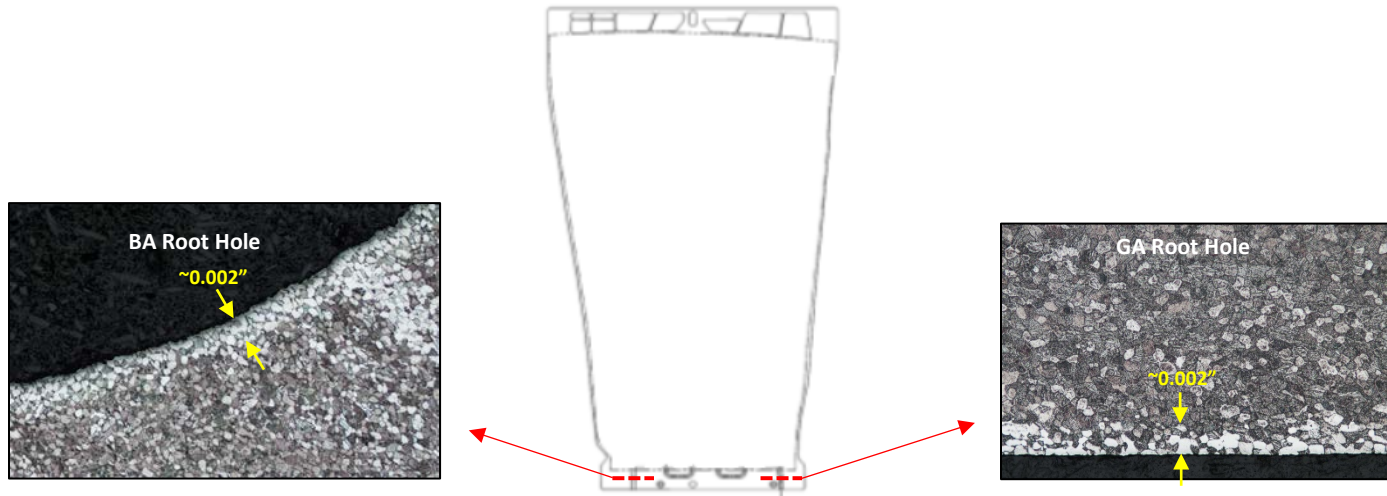
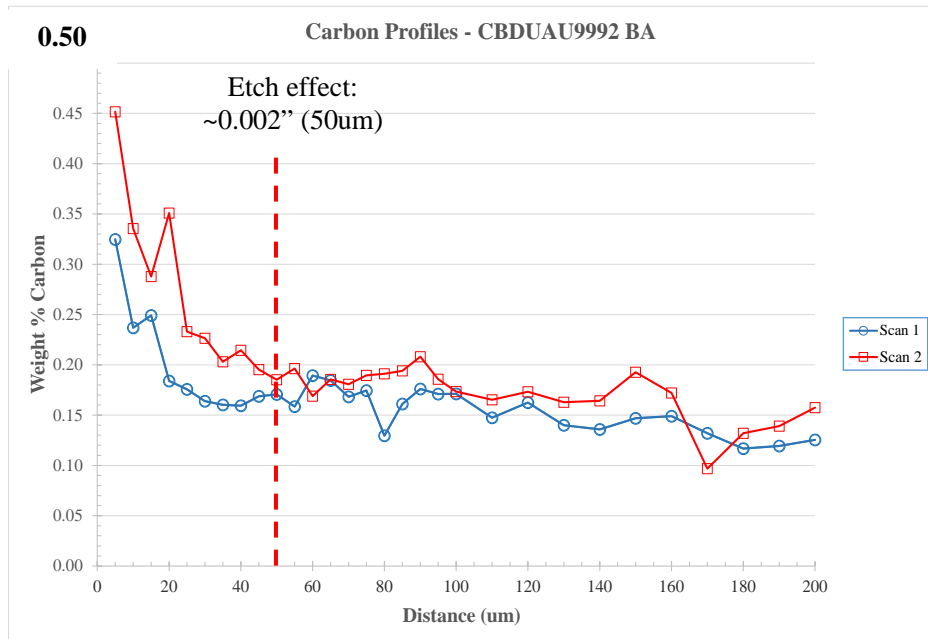
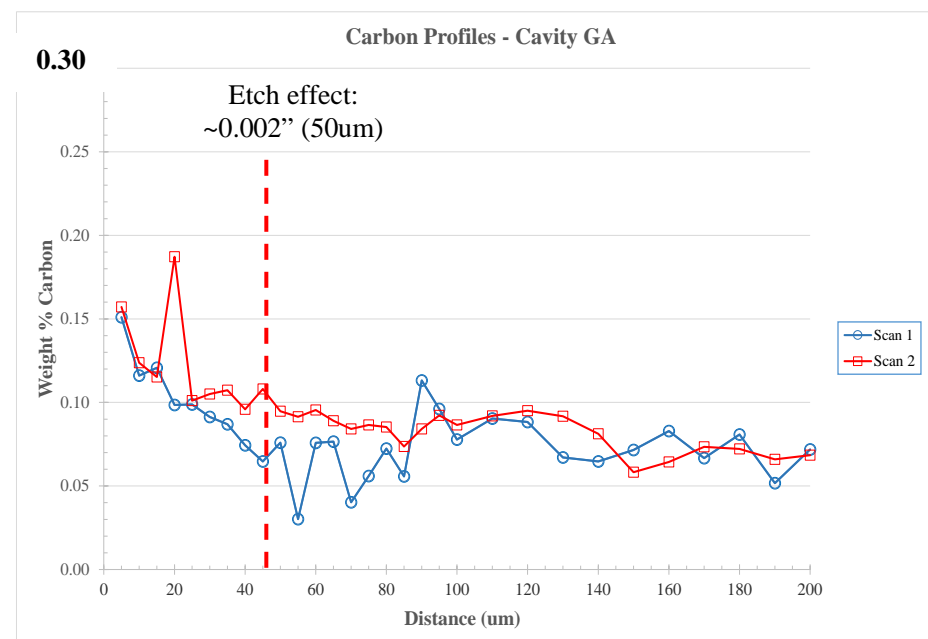
Figure 94: EMP carbon traces at cavities BA and GA identified smaller carbon gradients from the surface.
