Metallurgical Investigation Final Report

Subject: Metallurgical Investigation of Fan Blades from PW4077 Engine SN 777047

Date: February 24, 2023

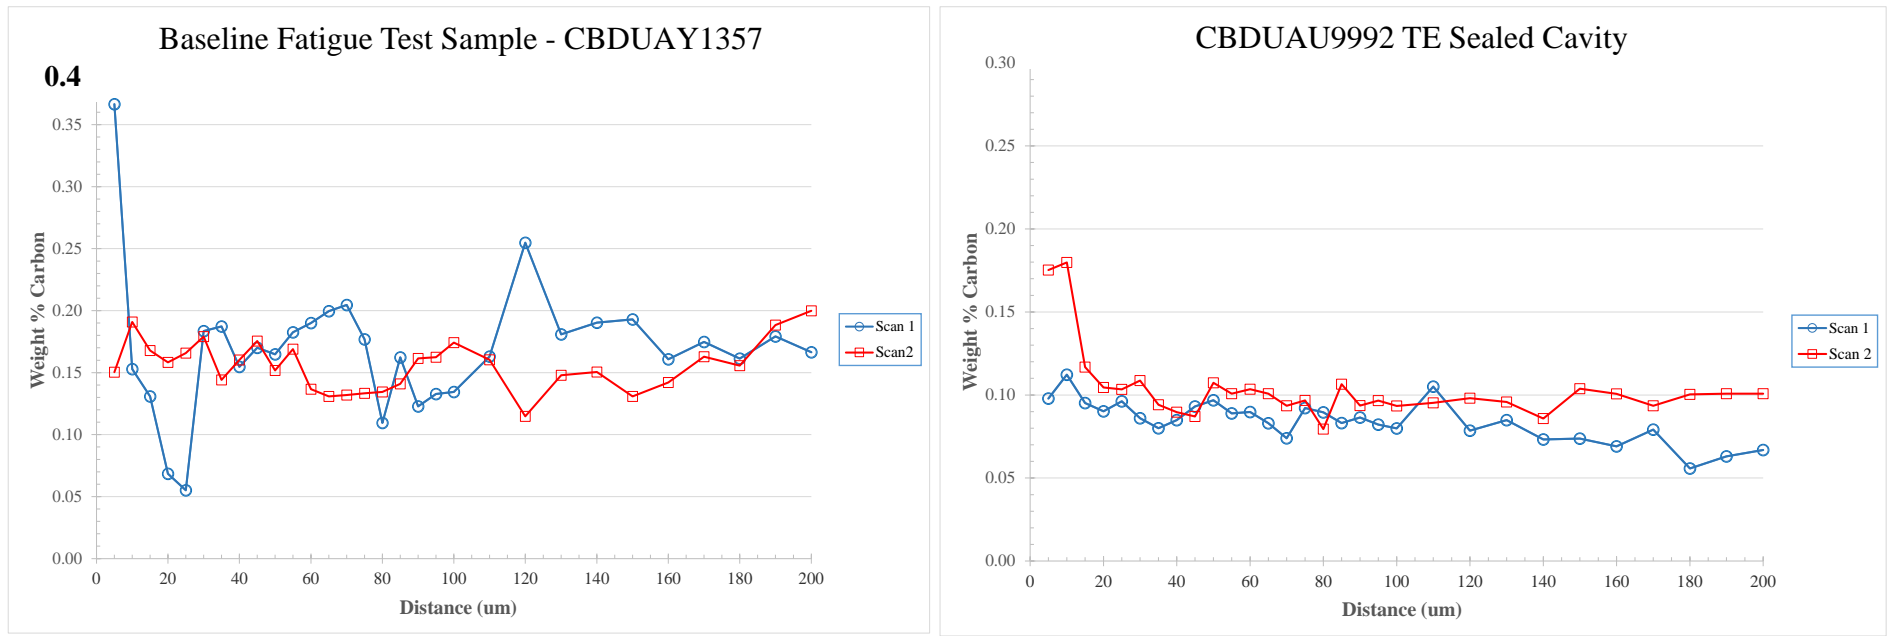
Figure 95: EMP carbon traces of the baseline fatigue test sample from CBDUAY1357 and from the sealed cavity on the incident blade. Neither showed a carbon gradient at the surface.

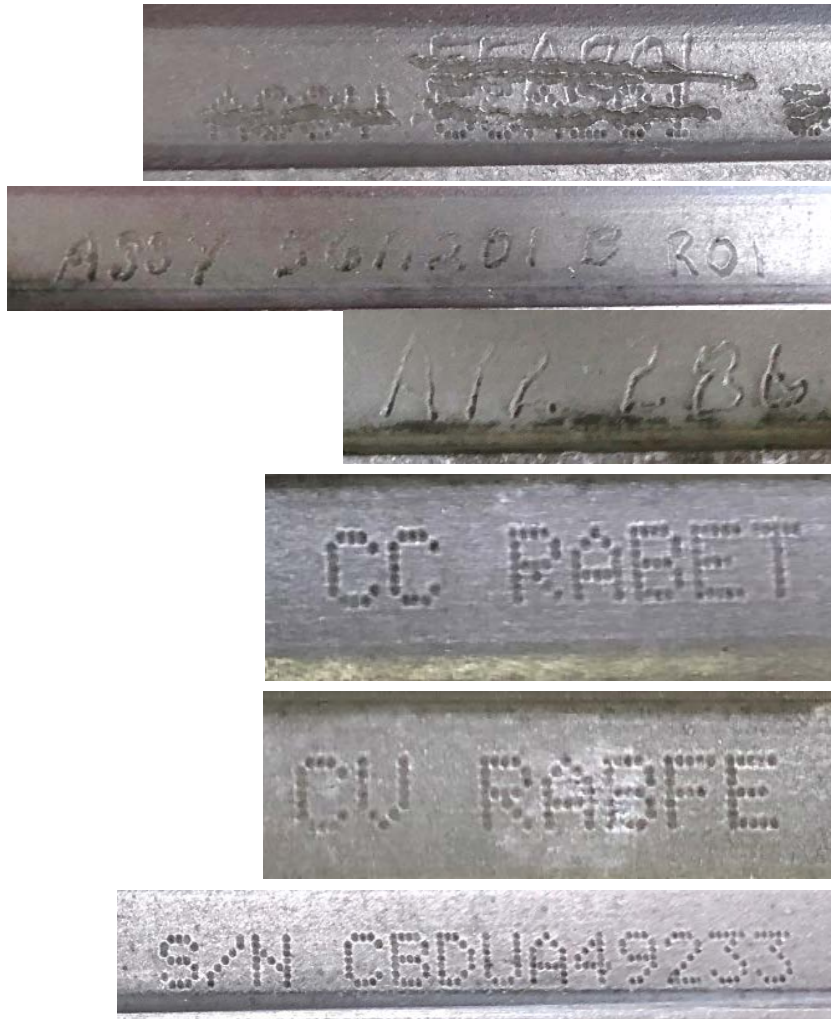
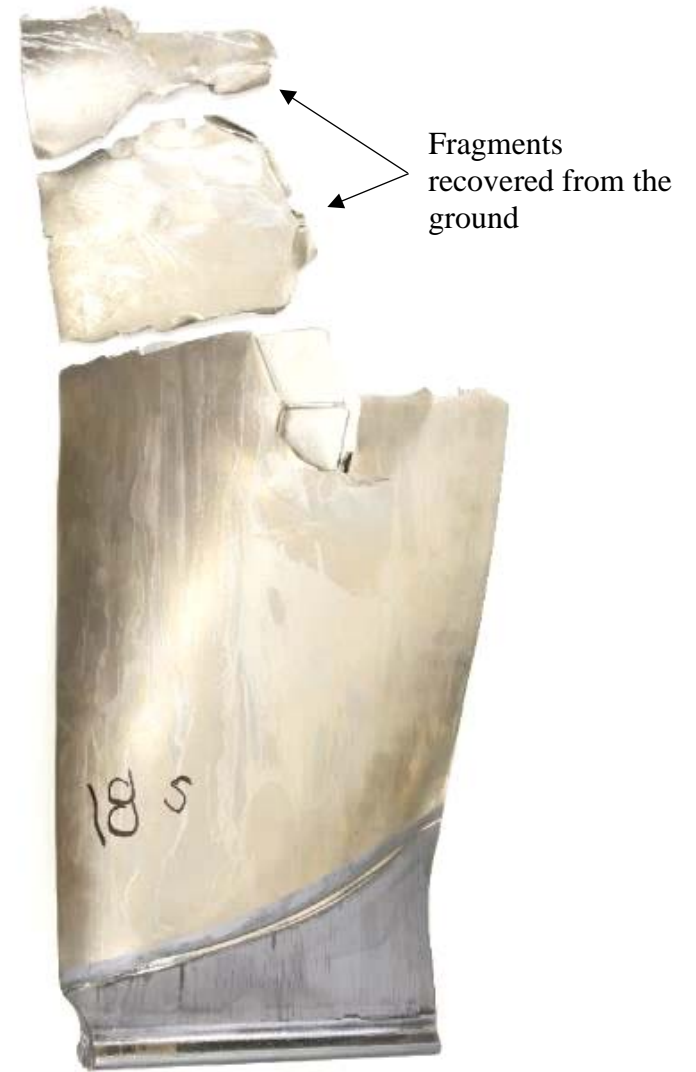
CBDUA49233 was the following sister blade to the event blade. It was labeled as blade #18 upon receipt. The blade measured approximately 26.5”x18” and weighed 25 lbs/11.3 kg. It fractured at midspan, approximately 26.5” above the root bottom. The root portion was still intact in the engine at disassembly. Visual and binocular review of the fracture surfaces identified features consistent with secondary damage and overstress. No fatigue-like features were observed. Two additional fragments were recovered from the ground and found to be remnants of this blade. The first fragment measured approximately 10.5” x 8.5” and weighed 2.3 lbs./1.0 kg. The second, smaller, fragment measured approximately 10”x6” and weighed 1.2 lbs./0.5 kg. The features on these fragments were also consistent with secondary damage and overstress ([Figure 96](#)).

ASSY 55A801
ASSY 56A201 B R01
A12 286
CC RABET
CV RABFE
S/N CBDUA49233

Figure 96: Image showing the following sister blade, CBDUA49233, the part markings, and the pieces recovered from the ground that were found to be remnants of this blade.

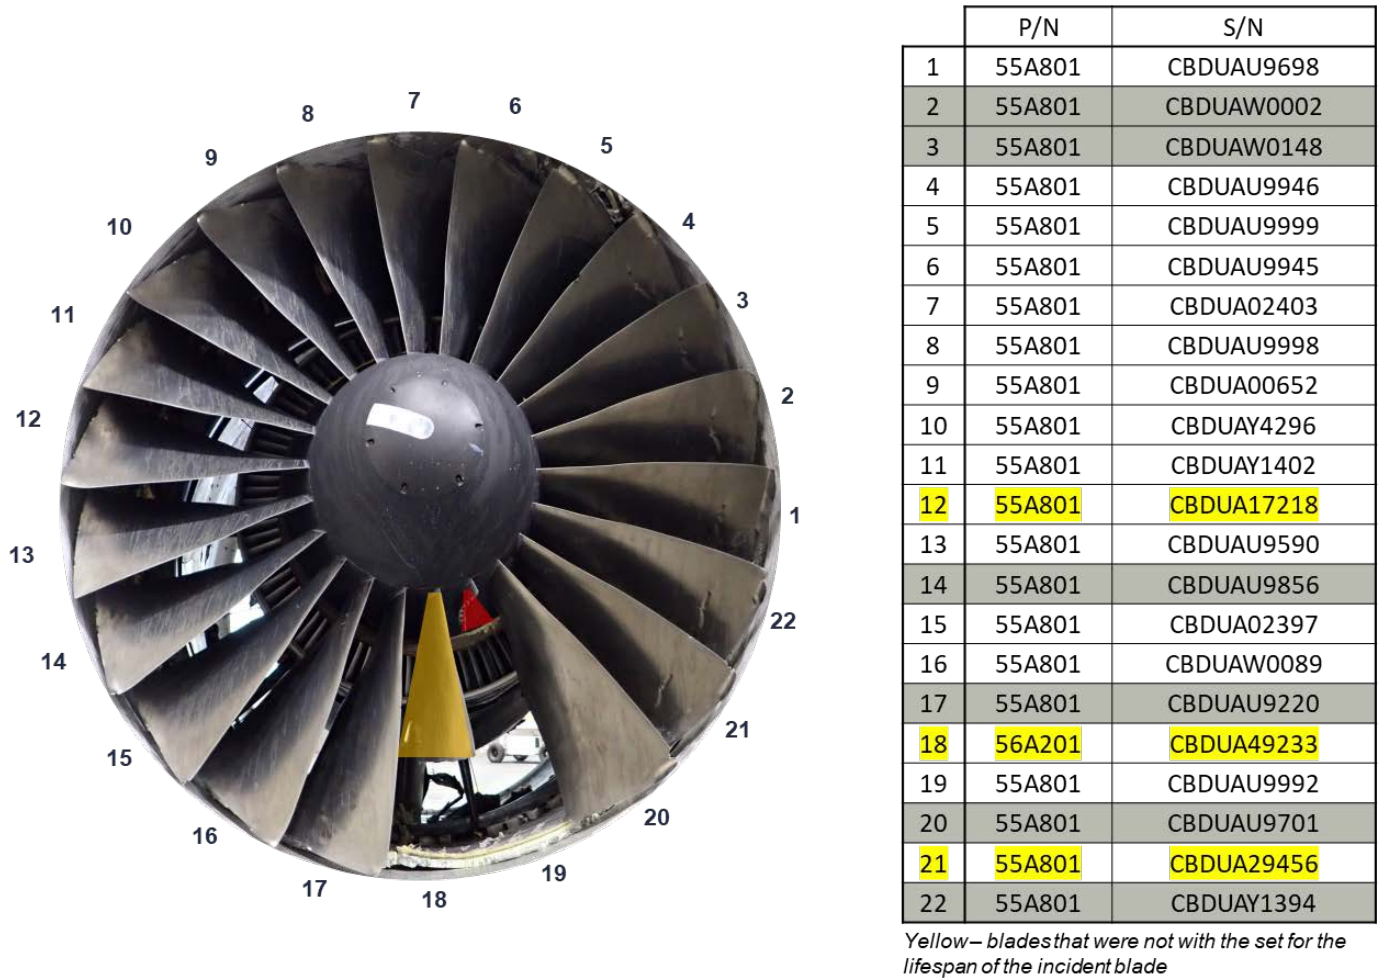
The other blades in engine 777047, the “sister blades”, generally exhibited substantial airfoil impact damage, including heavy tip rub, hard body impact damage and buckled airfoil cavities which occurred following the primary fracture of fan blade S/N CBDUAU9992. Upon arrival at P&W, the sister blades were non-destructively inspected via TAI and UT where possible. UT inspection was not possible on areas that exhibited extensive secondary damage. The inspection results were compared to previous TAI results on the blade set, collected in 2014 and 2016. Six sister blades were submitted for destructive evaluation based on midspan indications found during the inspections ([Figure 97](#)).

Figure 97: Image showing the engine at teardown and the corresponding blade serial numbers. The yellow highlighted blades were not with the set for the lifespan of the incident blade. The blades highlighted in gray were the blades destructively evaluated.
