Atmos Energy Corporation Natural Gas-Fueled Explosion  
Dallas, Texas  
February 23, 2018

NTSB/PAR-21/01  
PB2021-100901

# Pipeline Accident Report

**Abstract:** On February 23, 2018, at 6:38 a.m. local time, a natural gas–fueled explosion occurred at 3534 Espanola Drive, Dallas, Texas. The residence sustained major structural damage, but when first responders arrived on scene at 6:44 a.m., they observed no smoke or fire. Four family members were injured, and one was killed in the explosion. Following the explosion, National Transportation Safety Board (NTSB) investigators located a through-wall crack in the 71-year-old natural gas main that served the residence. In the 2 days before this explosion, two gas-related incidents occurred on the same block at houses that were served by the same natural gas main, each resulting in significant structural damage and burn injuries to one occupant. The first occurred on February 21, 2018, at 5:49 a.m., and resulted in one injury involving second-degree burns and significant structural damage to 3527 Durango Drive. The second incident occurred on February 22, 2018, at 10:21 a.m., and resulted in one injury involving second-degree burns and

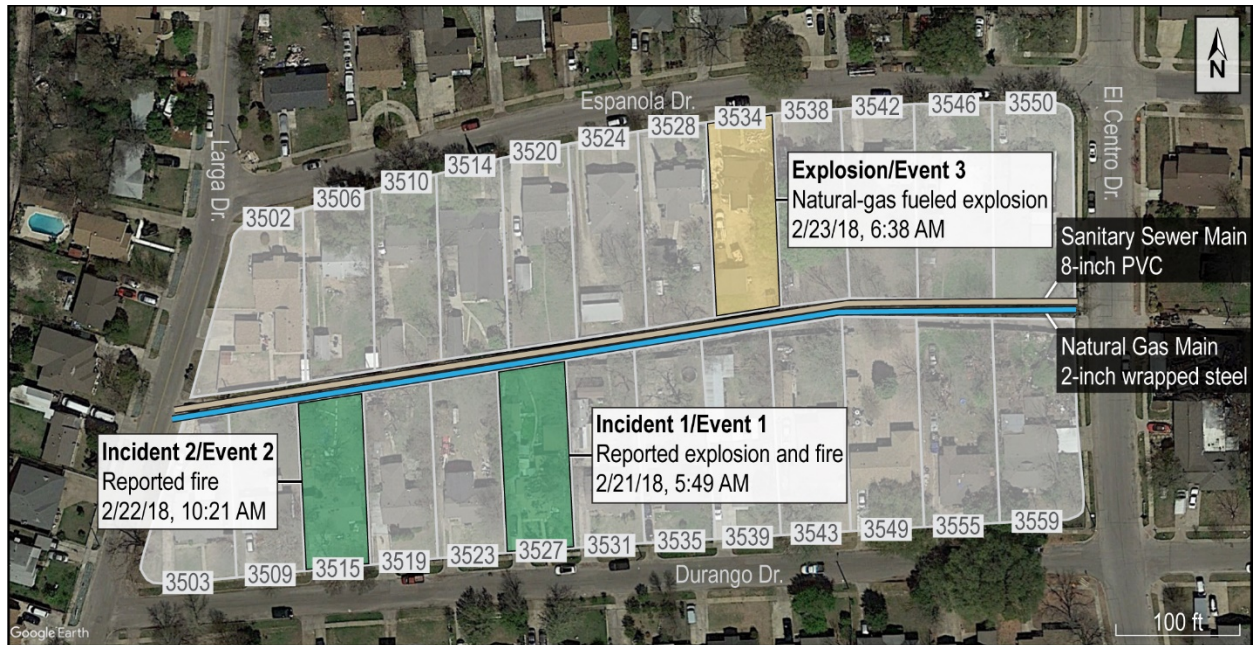
In the 2 days before this explosion, two gas-related incidents occurred on the same block at houses that were served by the same natural gas main, each resulting in significant structural damage and burn injuries to one occupant.<sup>3</sup> The first occurred on February 21, 2018, at 5:49 a.m., and resulted in one injury involving second-degree burns and significant structural damage to 3527 Durango Drive. The second incident occurred on February 22, 2018, at 10:21 a.m., and resulted in one injury involving second-degree burns and significant structural damage to 3515 Durango Drive. (See figure 1.)

**Figure 1.** Location of explosion, preceding incidents, and shared utilities.

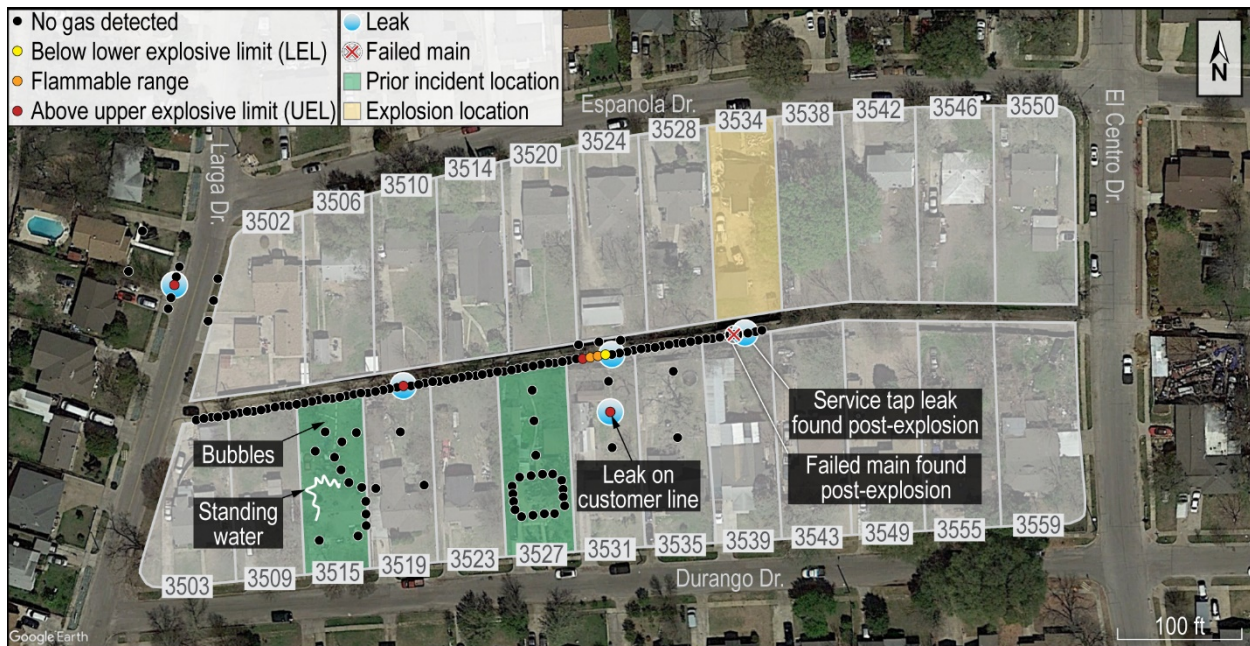
Atmos technicians returned to 3527 Durango Drive to perform additional bar hole tests. These tests, which included a perimeter around the foundation of the house, did not indicate the presence of natural gas. Technicians also conducted bar hole testing throughout the alley. Testing locations were spaced about 5 feet apart from Larga Drive to the east until and including the area behind 3539 Durango Drive. However, the technicians found the testing difficult due to the muddy, wet soil conditions. The service technician told investigators that some of the bar holes they created filled with water. He described their work process as "kind of bar holing, kind of surveying." Technicians also checked the accessible sewer boxes in the alley. This sewer testing near 3515 Durango Drive indicated the presence of gas at first, but the measurements were not sustained. The results of the Atmos employee bar hole testing and surveying are shown in figure 3.

**Figure 3.** Gas measurements taken in the block surrounding the site prior to the explosion.

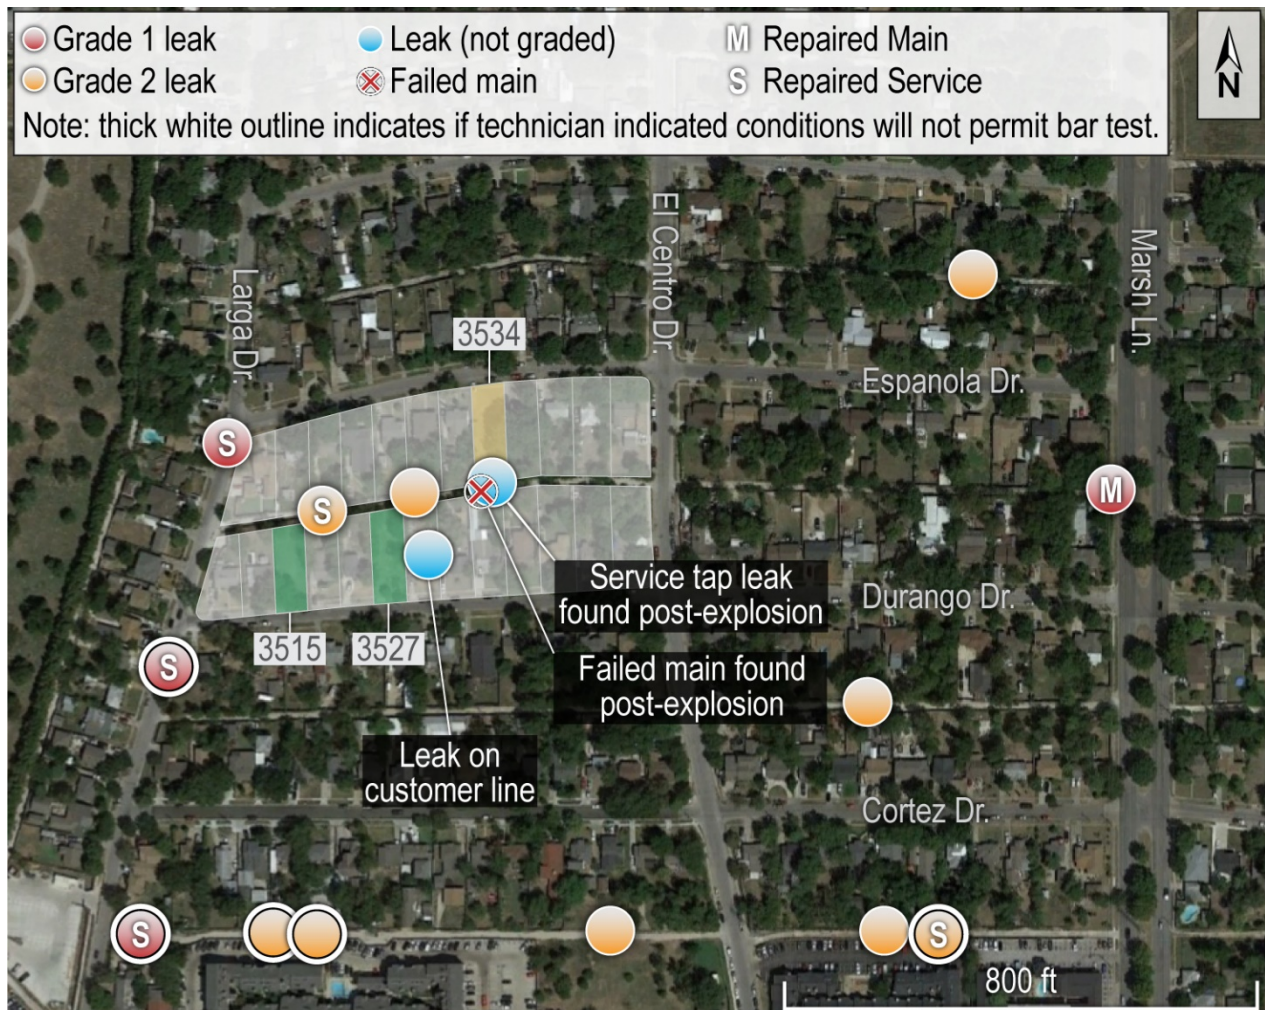
In total, Atmos identified four leaks classified as Grade 1 and nine leaks classified as Grade 2 in an 8-block area around the 3500 block of Espanola Drive prior to the explosion. (See figure 4.) Of those, Atmos had completed repairing all four Grade 1 leaks and two of the Grade 2 leaks before the explosion occurred on the morning of February 23.<sup>22</sup> An Atmos operations supervisor told NTSB investigators that excessive rain rendered the repair work difficult. He said that it was challenging to dig in the alley, and it was not possible to bring a truck with a pump into the alley because it would have gotten stuck. He said that the workers had to try to scoop water out with a bucket and that they were "trying...[to repair gas leaks] against all odds."

<sup>22</sup> All six repairs were made on coated steel, with five of those repairs being made on service lines. Atmos attributed four of the repaired leaks to a thread leak and two leaks to ground movement.

Figure 4. Leaks identified prior to the explosion.

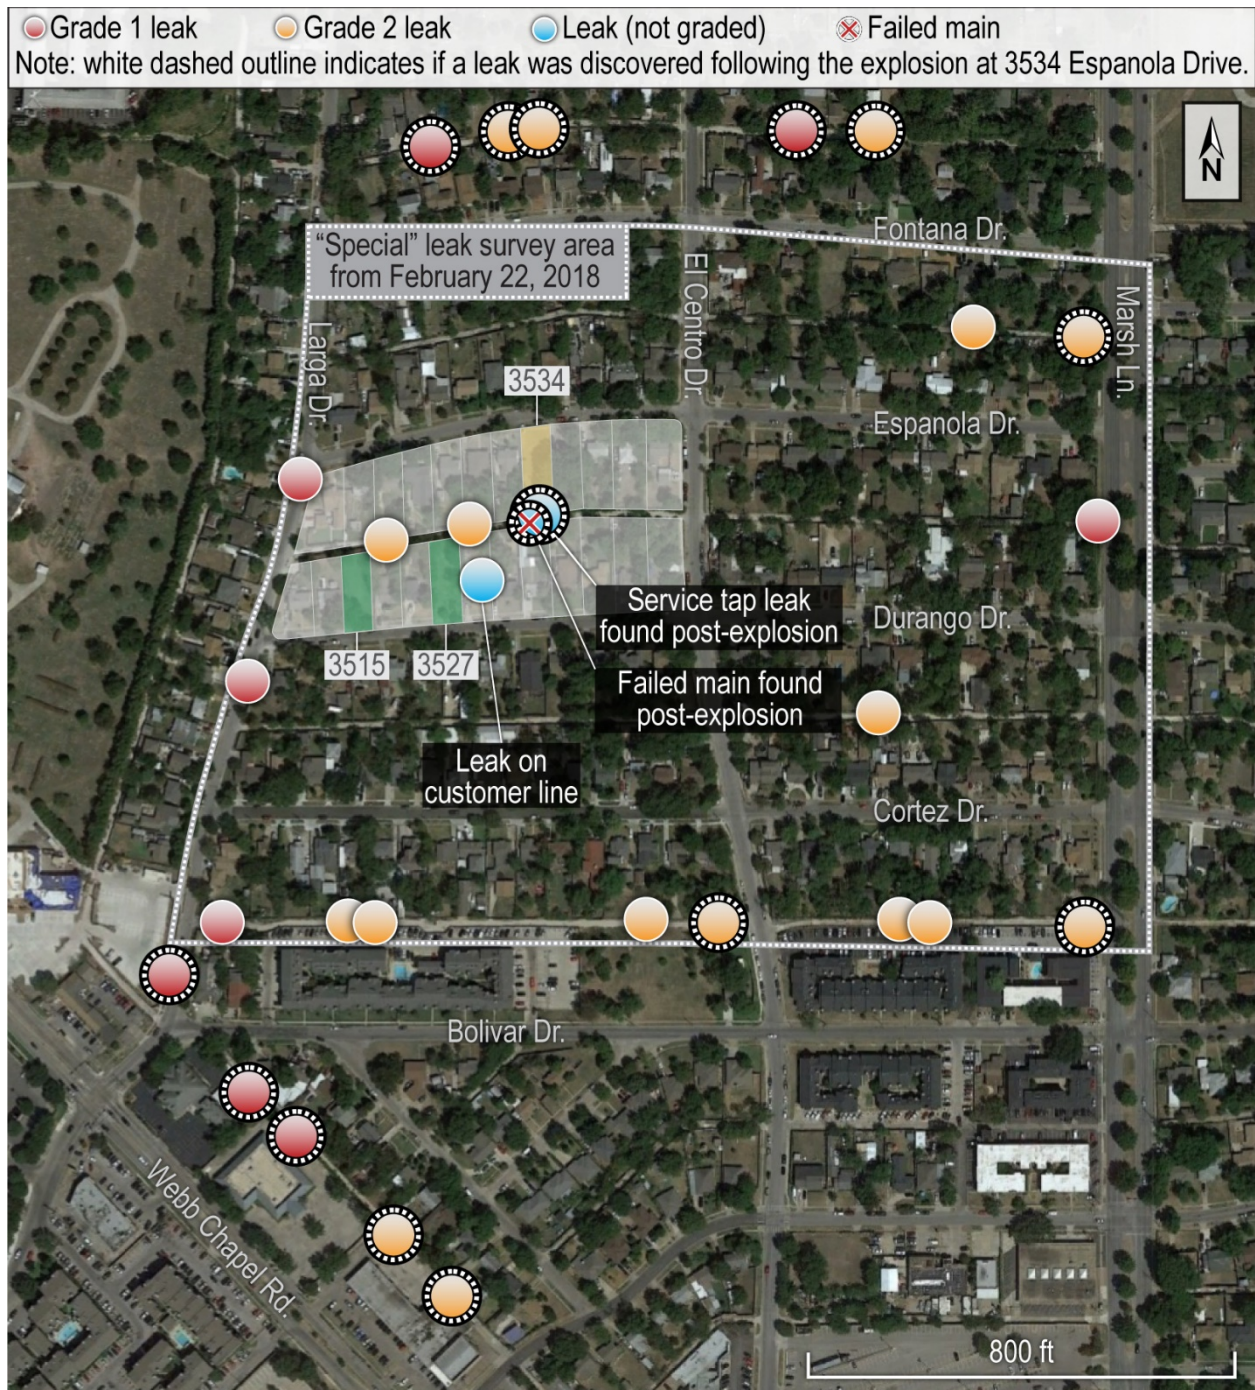
9-block area, in part, based on pipe material type and vintage. In the area shown in figure 6, technicians found nine leaks they classified as Grade 1 and 17 leaks they classified as Grade 2.<sup>26</sup> Of these 26 leaks, 11 were not excavated to determine the cause since the system was being replaced; six were attributed to stripped threads; two were attributed to corrosion; two were attributed to ground movement; and one was attributed to each of the following causes: gasket/O-ring, excessive strain, weld (steel), third-party damage, and other.

<sup>26</sup> Figure 6 shows the special leak survey area from February 22. After the explosion at 3534 Espanola Drive, additional leak surveys were performed. Grade 1 and 2 leaks that were found after the explosion are highlighted by a white dashed line in figure 6.

**Figure 6.** Leaks identified as Grade 1 or 2 and prior to system replacement.

Following the explosion, Atmos expanded its special leak surveys. In the area around the explosion, Atmos found 26 leaks that it classified as Grade 1 or Grade 2.<sup>68</sup> (See figure 6.) Of the leaks that were excavated by Atmos to determine the cause, the predominant cause was stripped threads (40 percent), followed by corrosion (13 percent), and ground movement (13 percent).

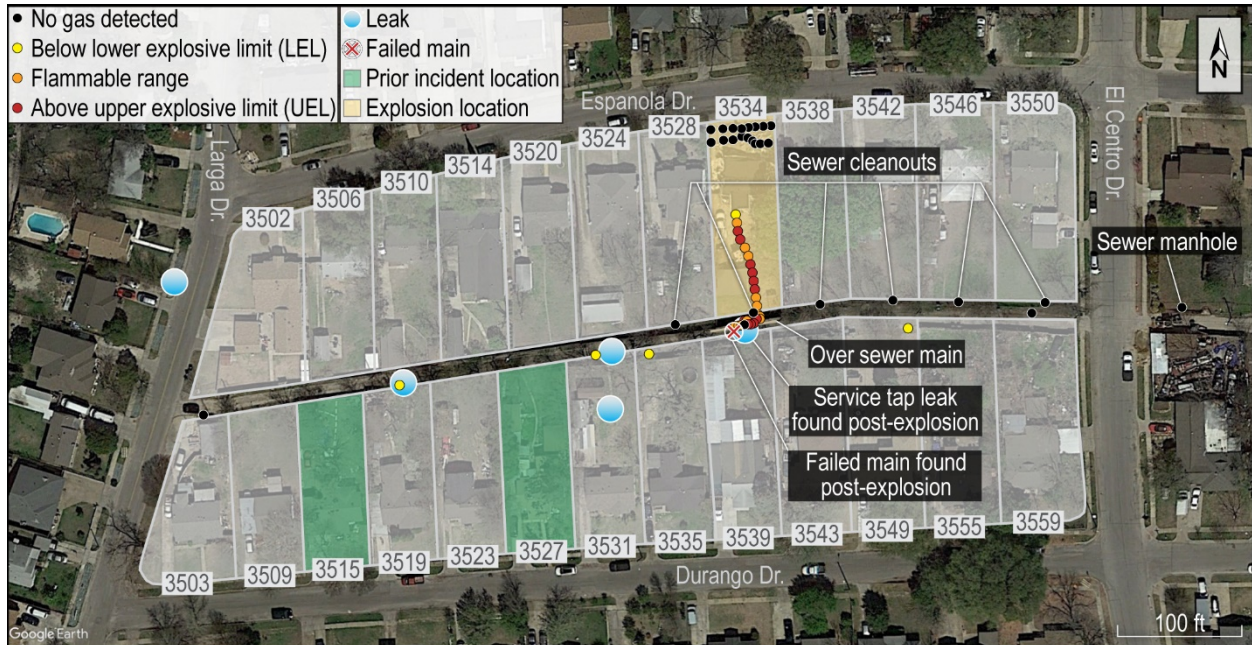
Several CGI gas measurements were taken following the explosion, as shown in figures 8 and 9.<sup>34</sup> The highest gas reading observed at each measurement location in the backyard of 3534 Espanola Drive are shown in figure 9. The approximate location of leaks found by Atmos following the second incident as well as by NTSB investigators during integrity testing after the explosion are also indicated in the figures.

**Figure 8.** Gas measurements taken in the block surrounding the site after the explosion.

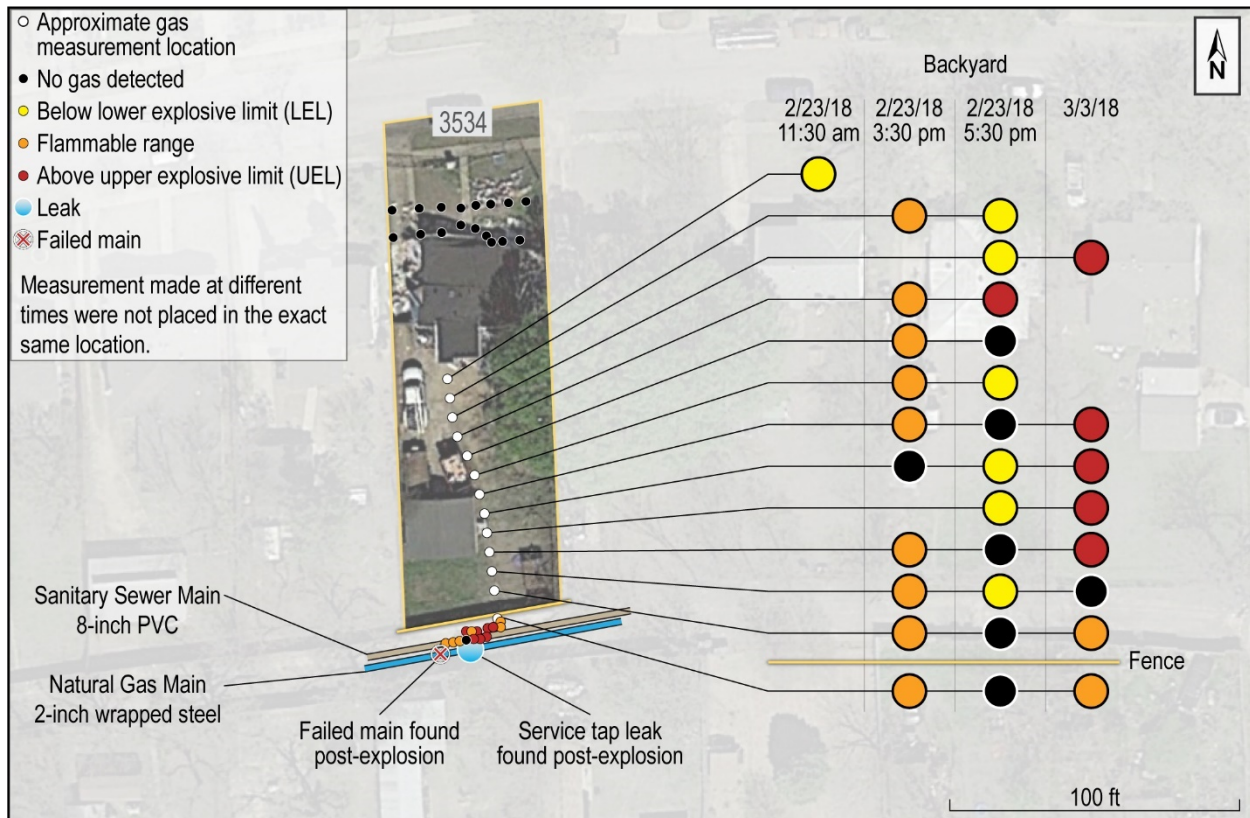
Figure 9. Gas measurements taken on and near the property after the explosion.

Atmos took gas measurements after the explosion on February 23, 2018, that indicated the presence of gas along a path between the alley and the residence involved in the explosion. NTSB investigators later confirmed the presence of gas along a path between the cracked main and the residence, obtaining readings as high as 43 percent by volume of natural gas in air over the sewer main 12 days after natural gas had been isolated in this area in response to the fatal explosion.<sup>56</sup> (See figure 9.)

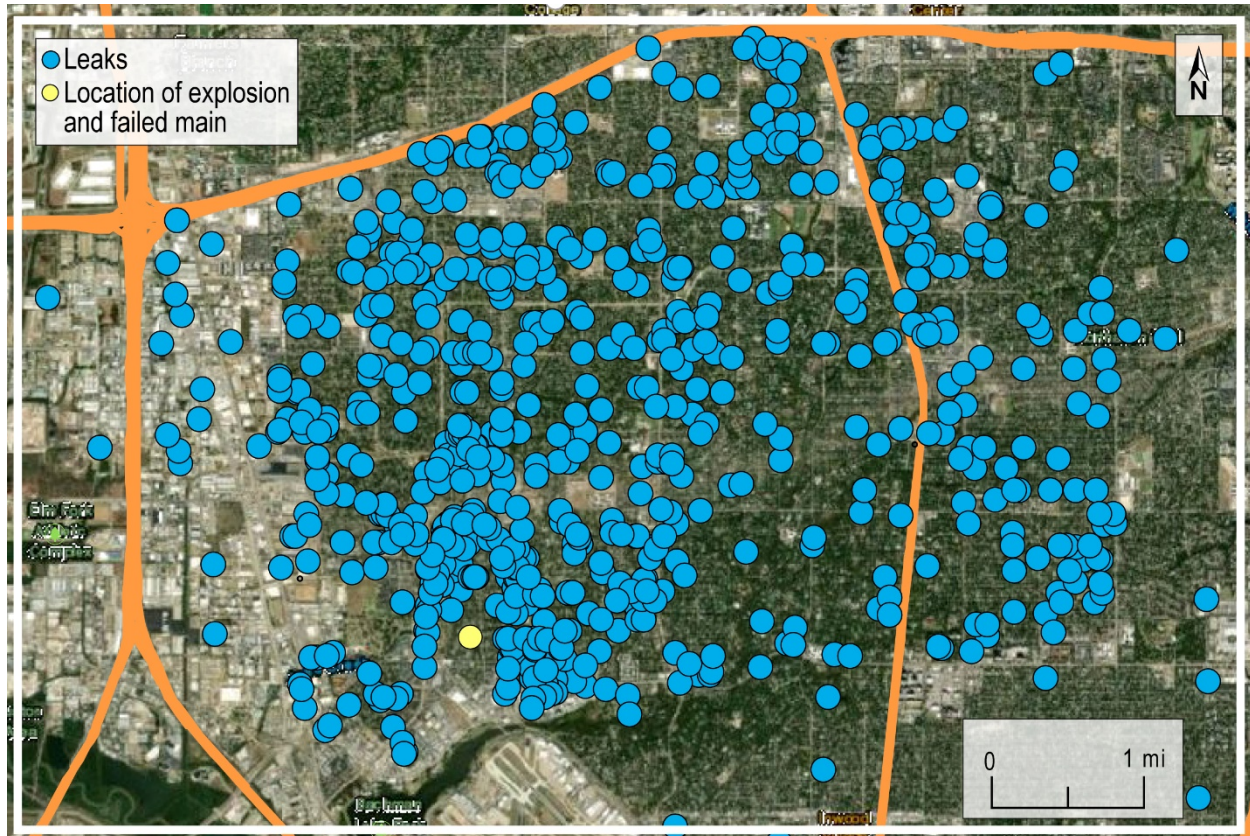
In addition to the leaks discussed above, Atmos reported to the RRC that it found 264 leaks between February 23 and February 28, 2018, and 1,001 leaks in March 2018 that it classified as Grade 1 or Grade 2 in Dallas.<sup>69</sup> Of these leaks, 741 were reported to be located within the area in northwest Dallas, shown in figure 17. Atmos reported that these northwest Dallas leaks primarily occurred on service lines (543 or 73 percent) and primarily involved coated steel (640 or 86 percent). Of these leaks that were excavated by Atmos to determine the cause, the predominant cause was stripped threads (270 or 38 percent), followed by gasket/O-ring (146 or 21 percent), corrosion (112 or 16 percent), and ground movement (45 or 6 percent).<sup>70</sup>

**Figure 17.** Leaks identified as Grade 1 or Grade 2 which were beyond the scope of this investigation.
